Recreational Use Attainability Analysis of Five Creeks along the Little Brazos River: Walnut Creek (1242O), Mud Creek (1242K), Pin Oak Creek (1242L), Spring Creek (1242M), and Campbells Creek (1242I)

Prepared for:
Texas State Soil and Water Conservation Board
Project 08-54

Data Collected by:
Brazos River Authority

June 2014

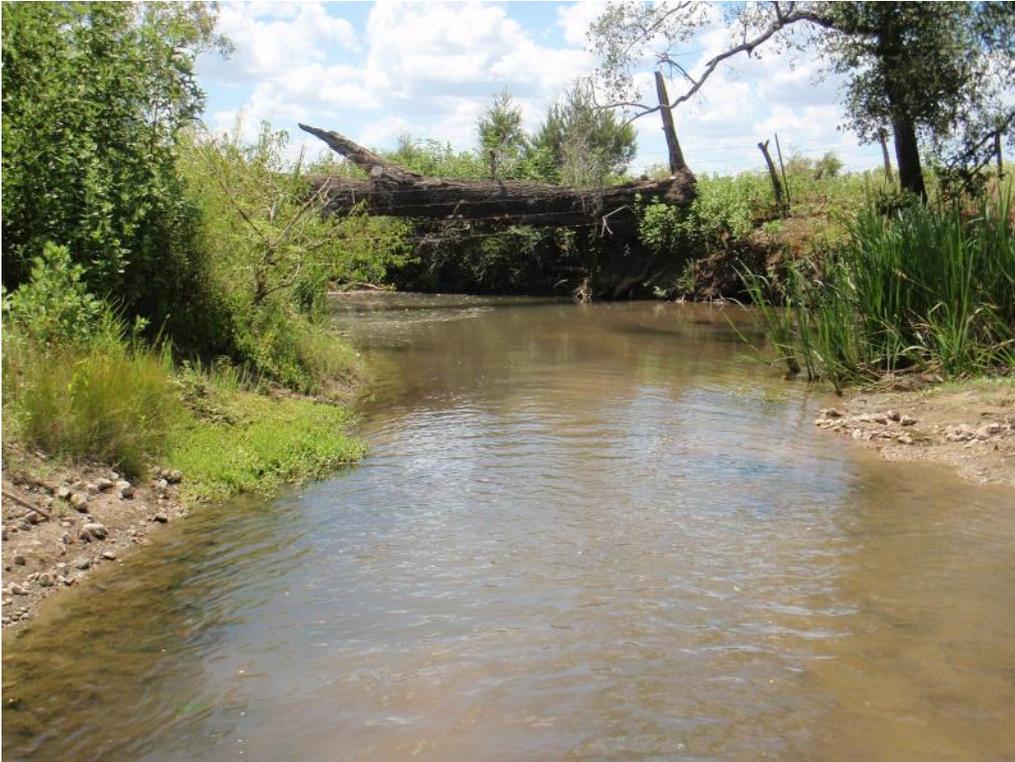
Figure 4.2 Photograph of Walnut Creek Site 16403 taken on August 10, 2010, the downstream view of the 30-m transect showing the gentle slopes and private property fence.

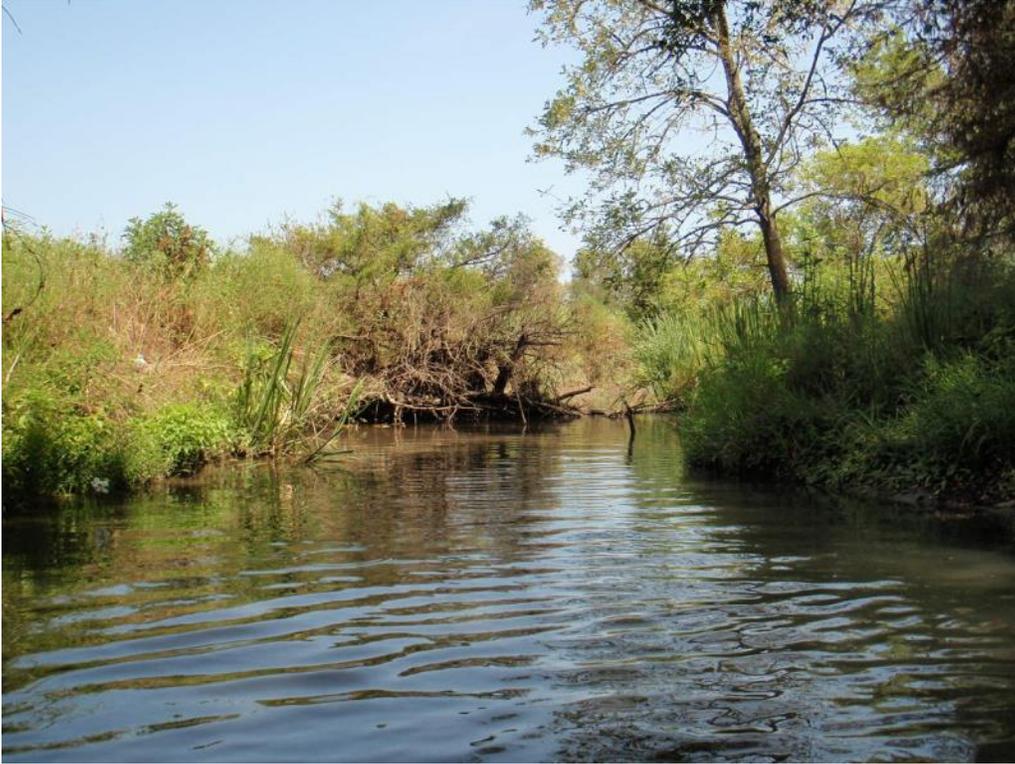
Figure 4.3 Photograph of Walnut Creek Site 16403 taken on August 16, 2010, the downstream view of the 150-m transect.

Site 16403 was wadeable for the entire 300-m reach length. During both surveys in August, the shallow water, average thalweg of 0.58 meters, and the sandy substrate made for easy wading. Stream widths ranged from 11 m to 0.8 m during both surveys with a normal flow status (Tables 4.8 and 4.9). Four pools were identified during each trip and their dimensions are shown in Tables 4.12 and 4.13. One tree obstruction was observed near the 150-m transect as shown in Figure 4.3.

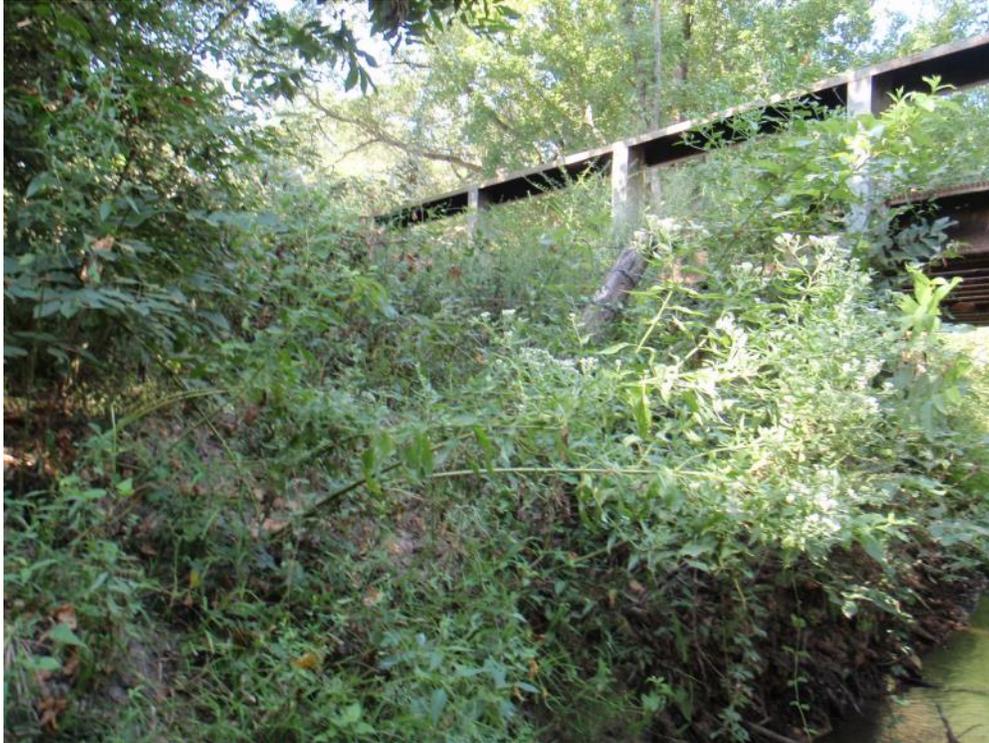
Figure 4.4 Photograph of Walnut Creek Site 20021 taken on August 16, 2010, showing the limited public accessibility at the road crossing.

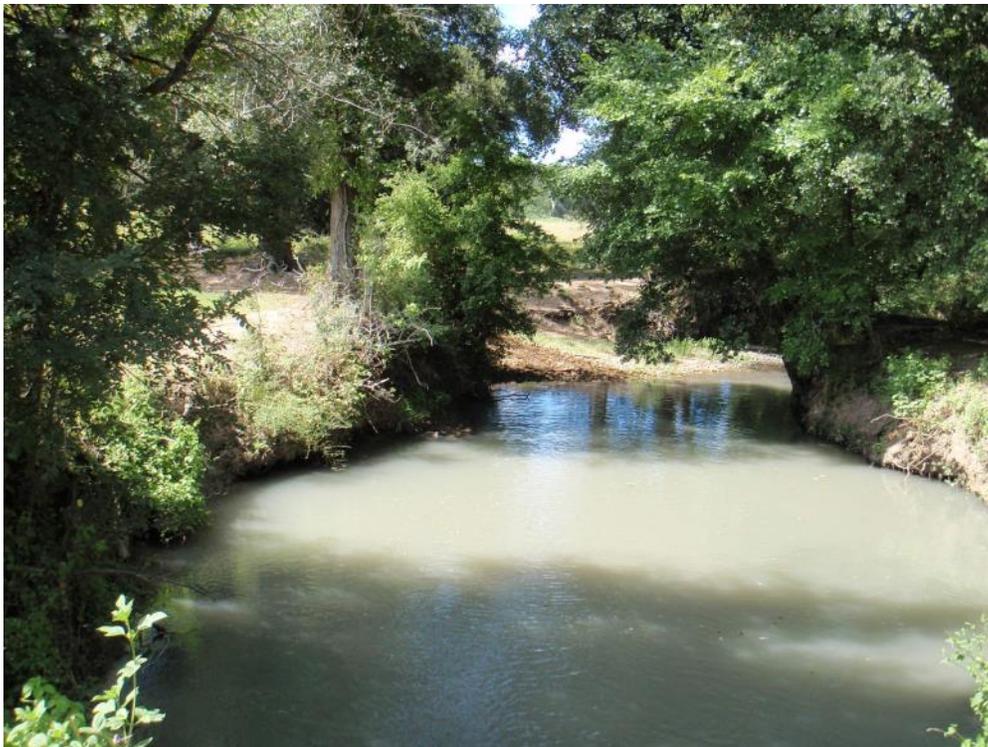
Figure 4.6 Photograph of Walnut Creek Site 99901 taken on August 10, 2010 showing a large pool and an entry point into the stream.

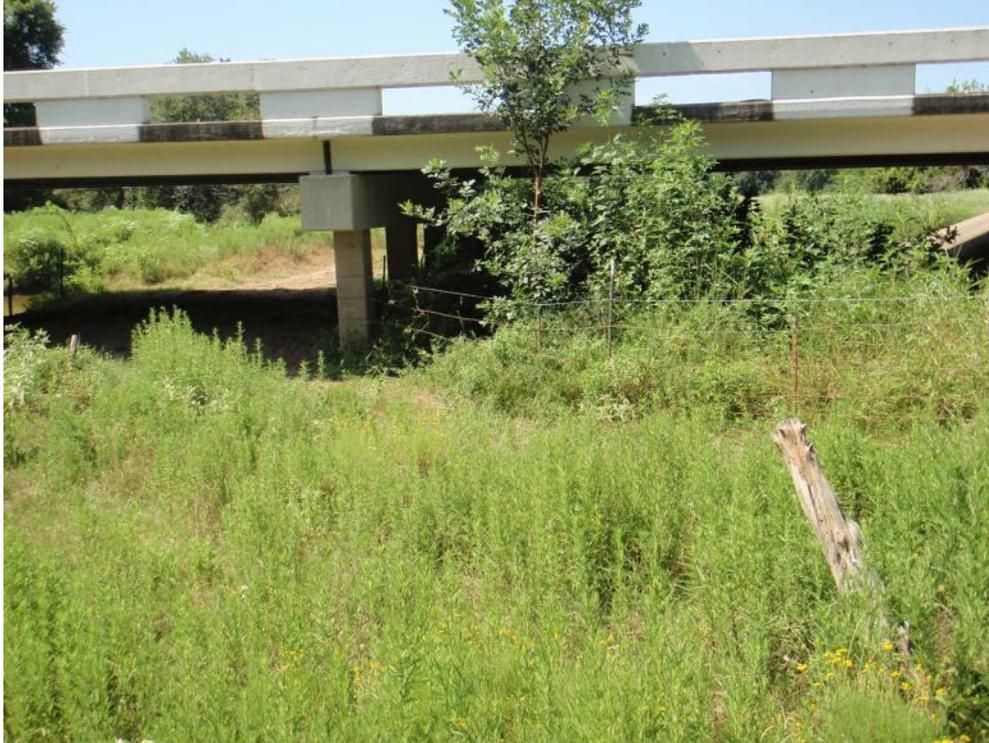
Figure 4.10 Photograph of Walnut Creek Site 99902 taken on August 13, 2010, showing very limited public access at the bridge crossing.

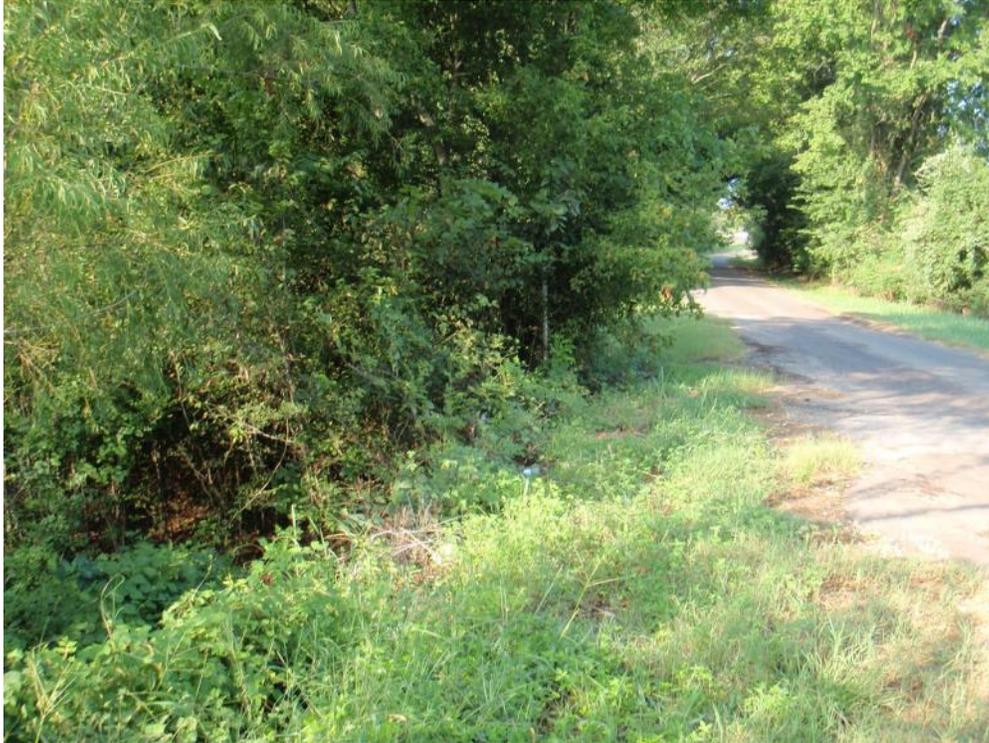
Figure 4.15 Photograph of Walnut Creek Site 99905 taken on August 13, 2010 showing limited public accessibility.

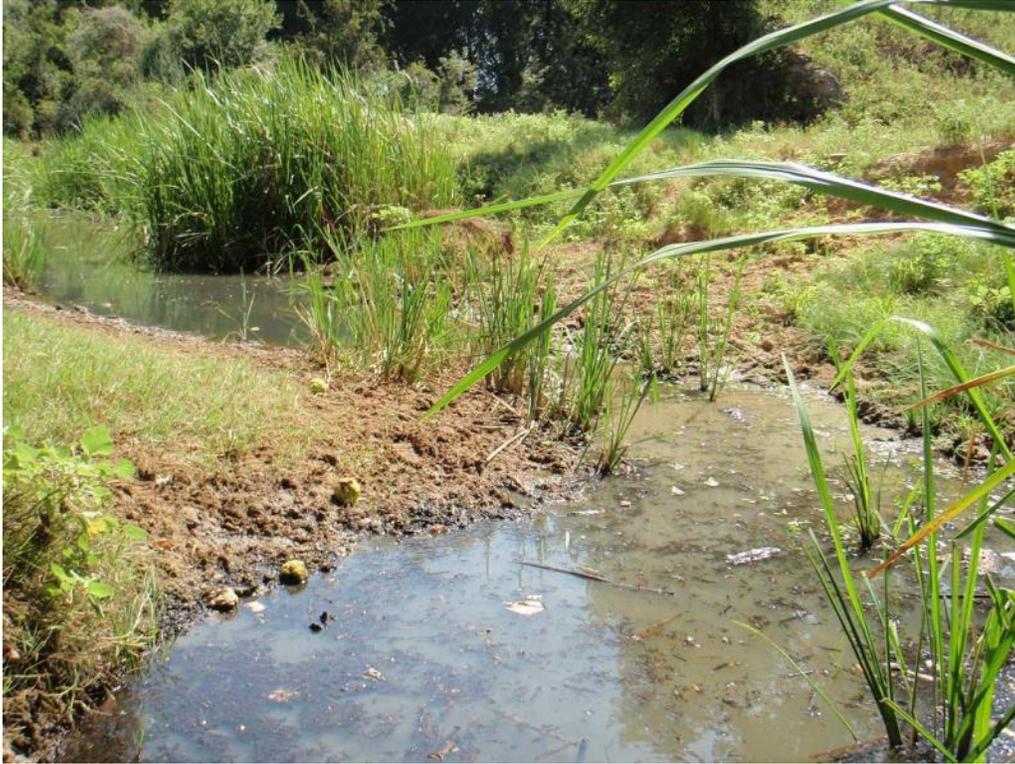
Figure 6.3 Photograph of Pin Oak Creek Site 16401 taken on August 23, 2010, the upstream view of the 300-m transect with debris on the brown-black water.

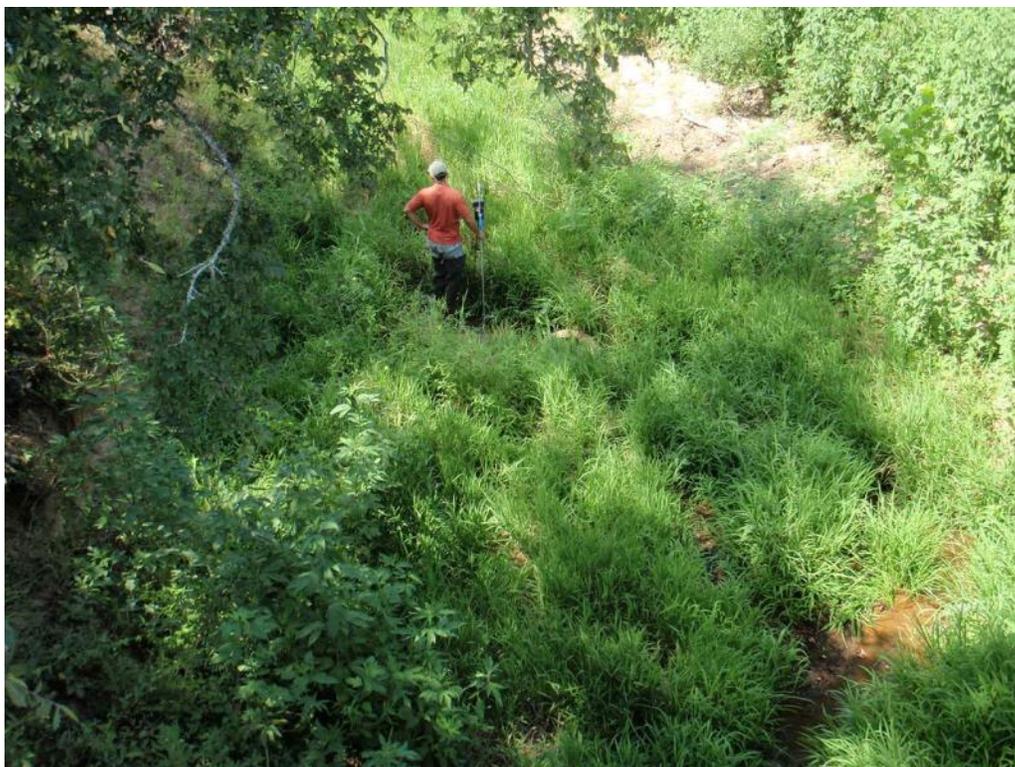
Figure 6.6 Photograph of Pin Oak Creek Site 20385 taken on August 23, 2010, the downstream view of the 0-m transect showing narrow, shallow stream under low-flow conditions. BRA personnel in photograph.

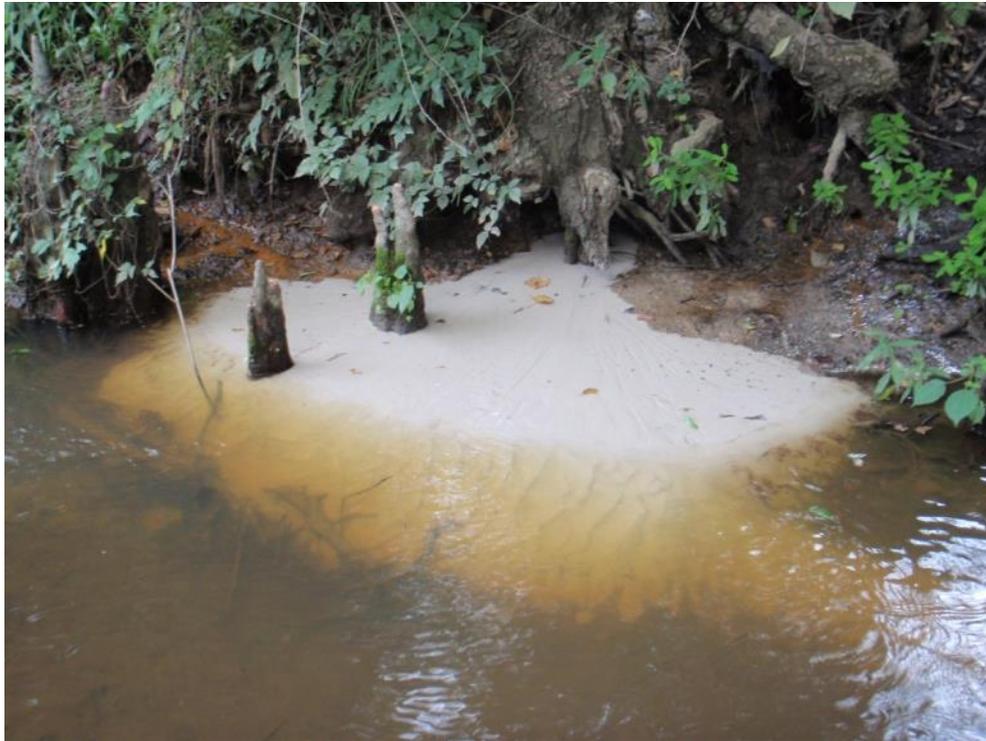
Figure 7.8 Photograph of sandy upwelling on Spring Creek Site 20564 taken on August 12, 2010.

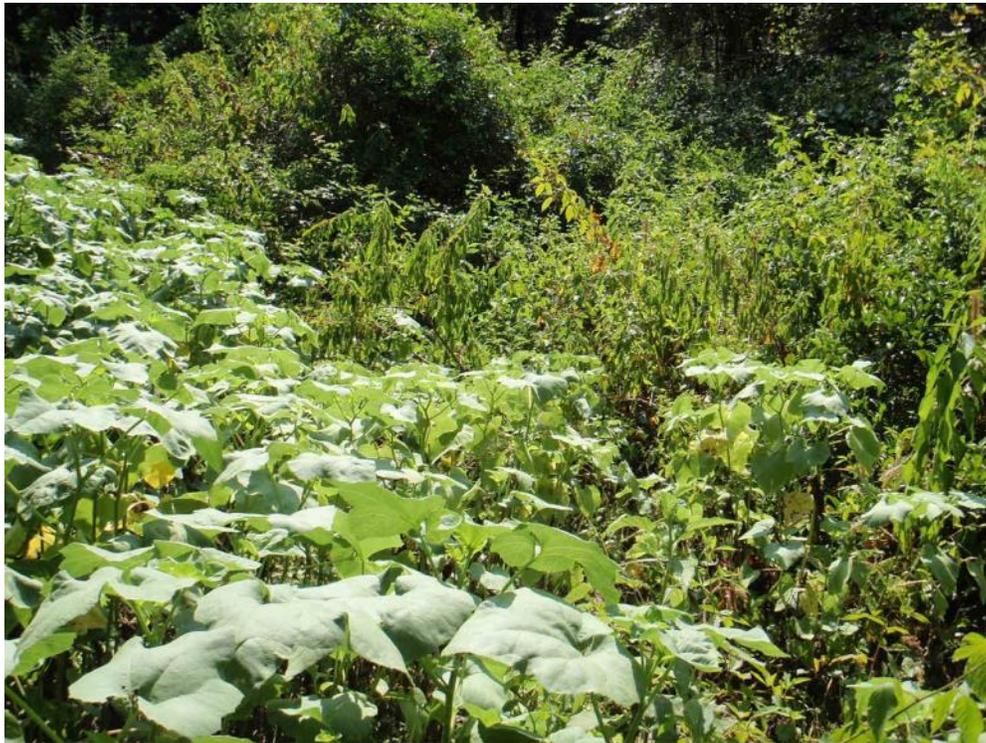
Figure 7.10 Photograph of dense brush at Spring Creek Site 99913 taken on August 18, 2010, the downstream view of the 0-m transect.

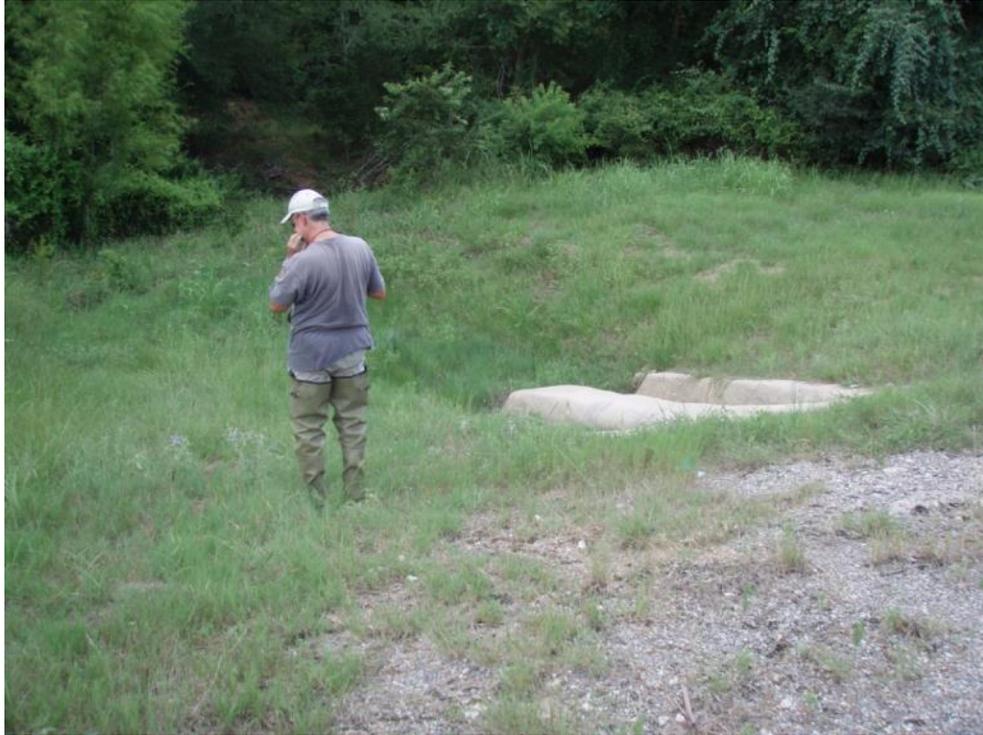
Figure 7.12 Photograph of Spring Creek Site 99914 taken on June 29, 2010, showing the dry and grassy creek bed at the downstream side of the FM 391 crossing. BRA personnel in photograph.

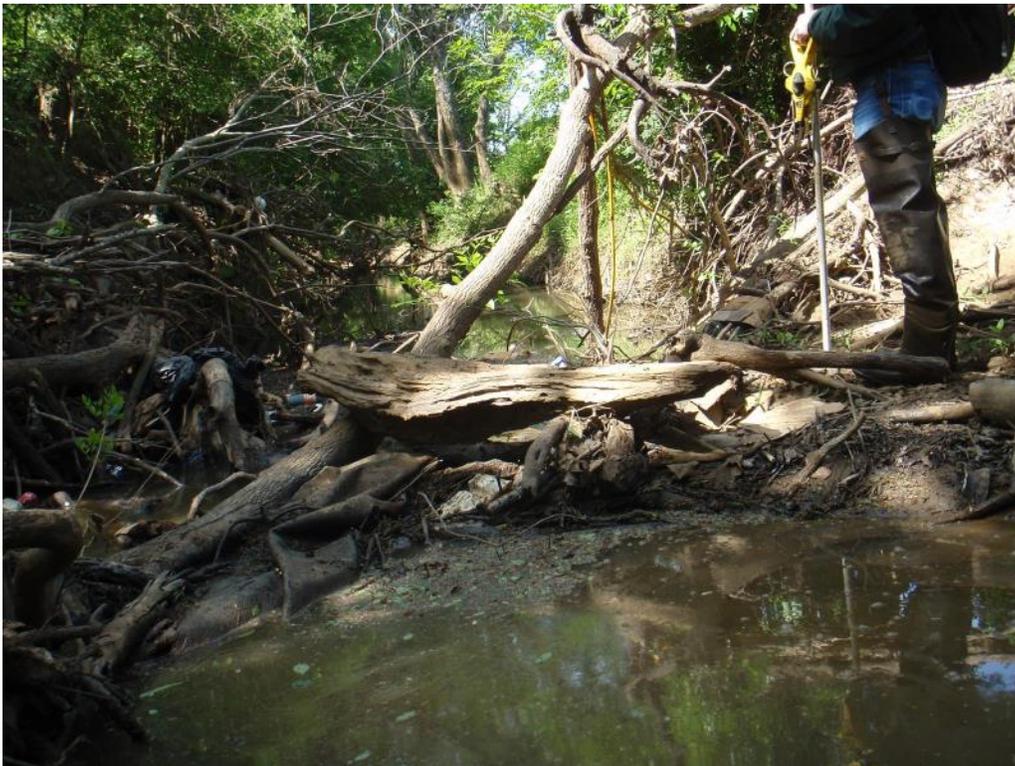
Figure 8.2 Photograph of Campbells Creek Site 99915 taken on April 9, 2010, showing log jam near the 150-m transect.

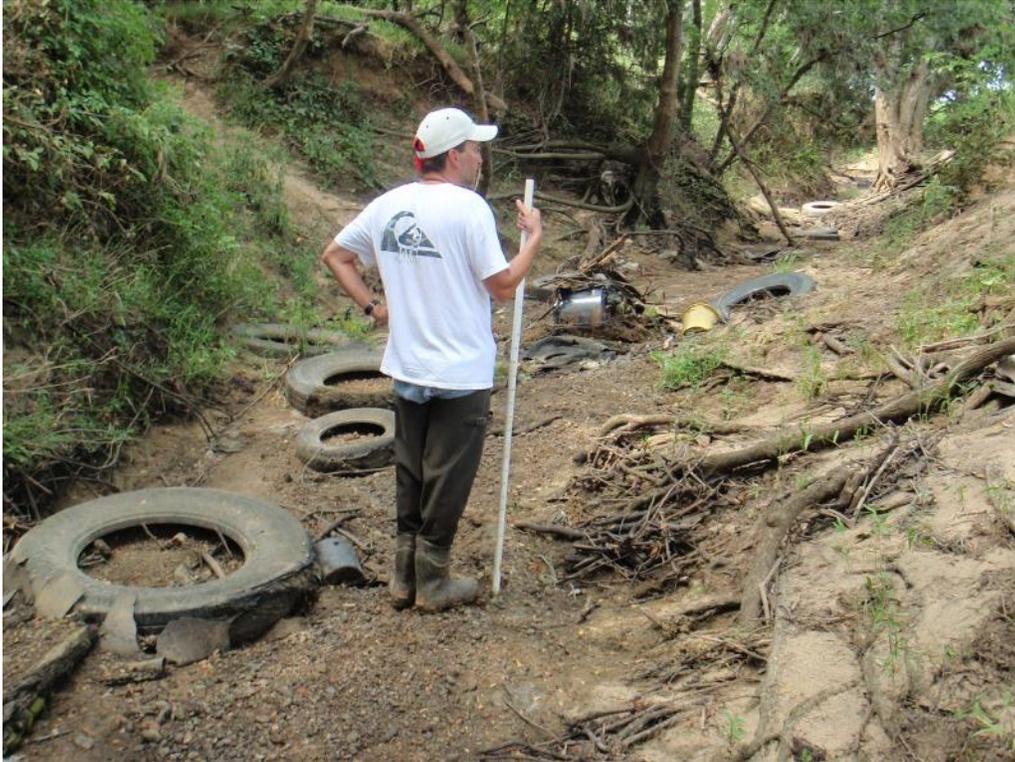
Figure 8.5 Photograph of Campbells Creek Site 99915 taken on August 12, 2010, showing trash near the 30-m transect. BRA personnel in photograph.

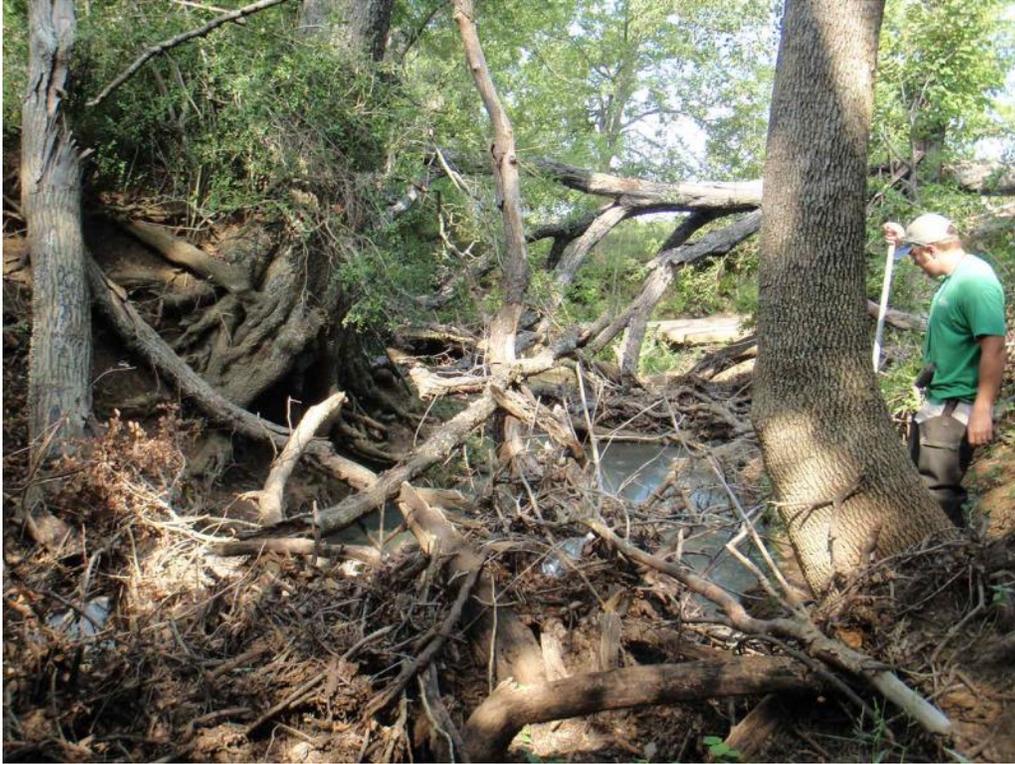
Figure 8.13 Photograph of Campbells Creek Site 99916 taken on August 24, 2010, showing snag obstruction downstream of the 150-m transect. BRA personnel in photograph.

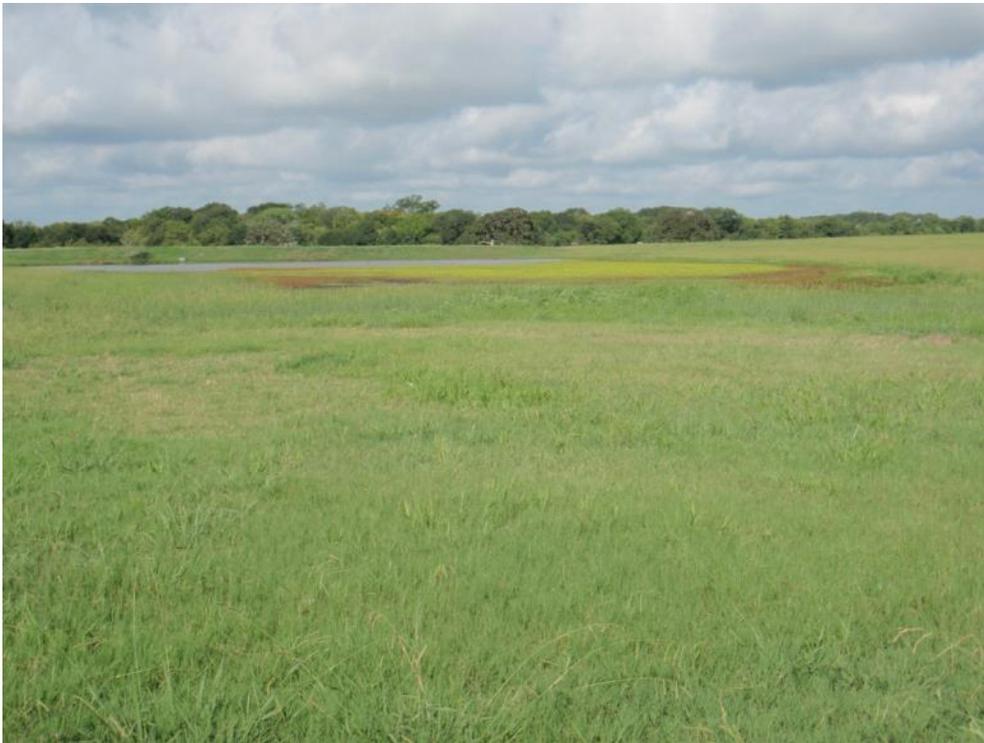
Figure 8.14 Photograph of Campbells Creek Site 99917 taken on August 9, 2010, the downstream view of the 150-m transect showing the stock pond.
