**San Miguel Creek (Segment 2108)  
Recreational Use Attainability Analysis**

**Texas State Soil and Water Conservation Board  
Project 14-51**

**Nueces River Authority – Coastal Bend Division  
Corpus Christi, Texas**

**November 2015**

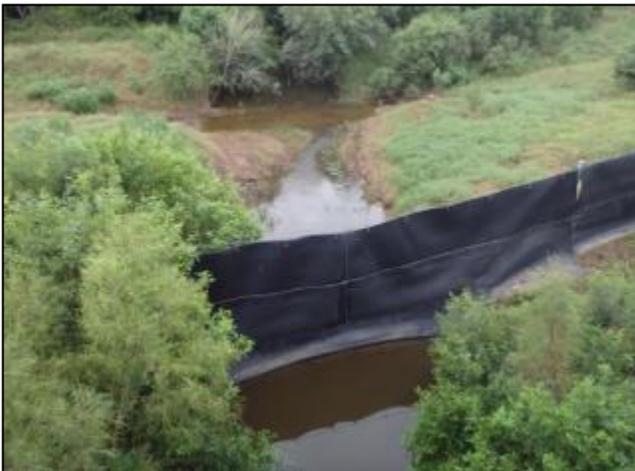
Public accessibility at SM09 is limited to the area adjacent to and under the bridge only. The creek is bordered by a high fence and liner upstream (Figure 4-33) and barbed wire fences downstream and on the right and left banks. However, the fence on the right bank was in state of disrepair and allowed easy access to the creek. Streamflow was observed during both survey site visits following the flood in May 2015. Numerous tracks were observed under the bridge indicating people and raccoon had been present. Human shoeprints along with a bedroll and food related trash was observed under the bridge. Swallow nests and droppings were observed under the bridge as were the remains of 4 dead gar in the wetted portion of the creek. Remains of wildlife were noted on the bridge and included a raccoon and a bird carcass.

**Figure 4-33.** Upstream view from bridge during Survey 1.

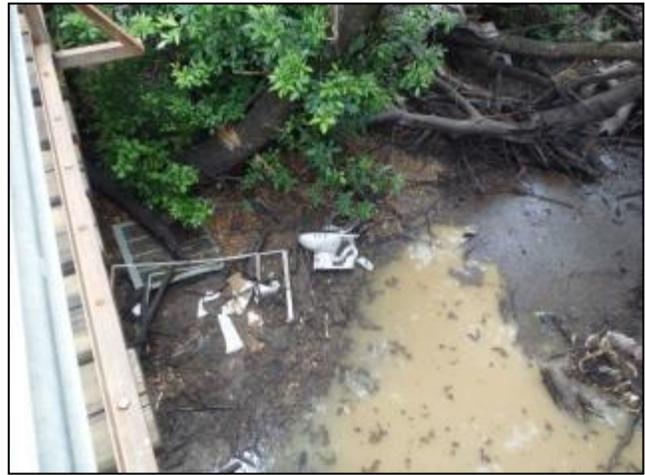
**Figure 4-78.** Trash and debris during Survey 1.

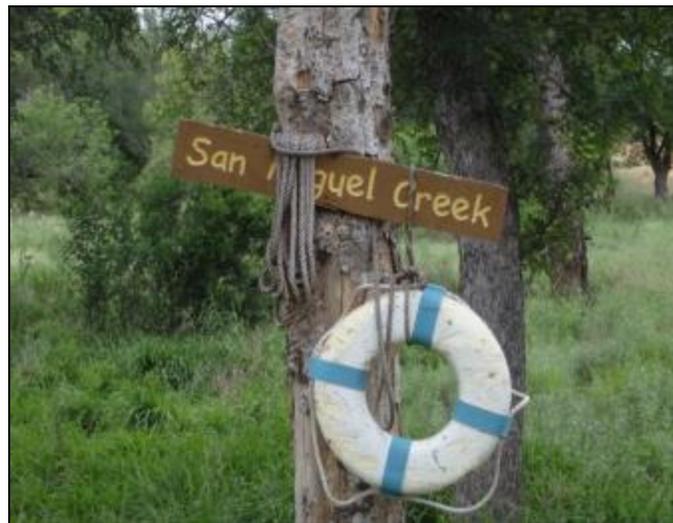
**Figure 6-1.** Ring shaped life preserver decoration at SM13
