Recreational Use Attainability Analysis for Iron Ore (0202K), Choctaw Creek (0202F), Bois D' Arc Creek (0202A), Smith Creek (0202G), and Mud Creek (0201A) in the Red River Basin

Prepared for:
Texas State Soil and Water Conservation Board
Project 14-52

Texas Institute for Applied Environmental Research
Tarleton State University
Stephenville, Texas

TR 1504
October 2015

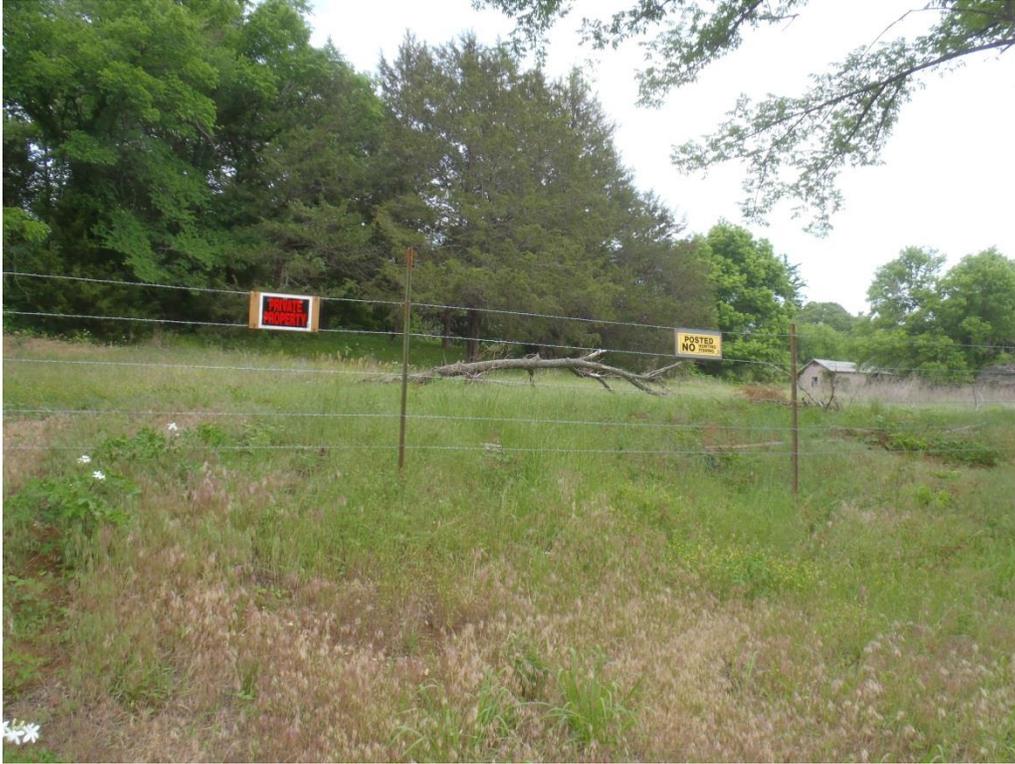
Iron Ore Creek at site IO03 was visited but no surveys were performed on May 17 or July 11, 2014. Access to this location was easy, because it occurred at a road crossing with a bridge over the stream; however, a private property fence prevented access beyond the bridge. There were posted signs saying “Private Property” and “No Trespassing” and attempts to contact the landowner for access were unsuccessful (Figure 3.7). In addition, access from the bridge or banks was extremely steep with significant drops and too much poison ivy to attempt entry (Figure 3.8). No human recreation was observed.

Figure 3.7 Photograph of posted no trespassing signs and fence at Site IO03, taken on May 17, 2014.

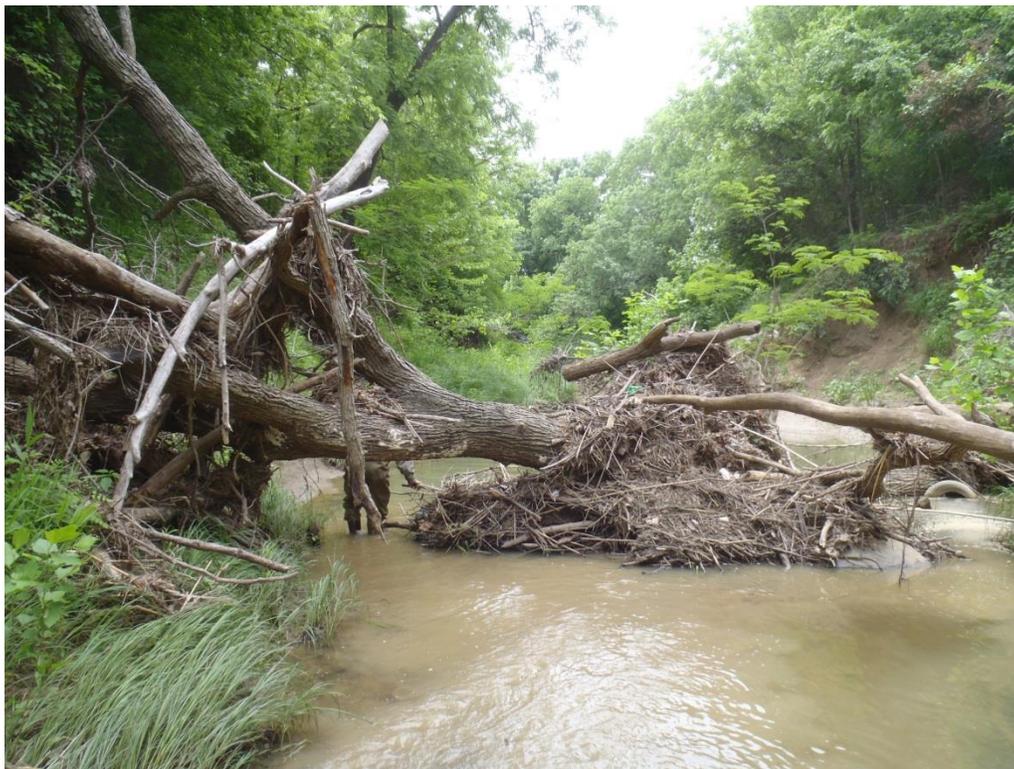
The stream was wadeable with water levels averaging 0.6 m for Trip 1 and 0.6 m for Trip 2 (Table 3.6). Three substantial pools were encountered within the reach during both trips. For Trip 1, Pool 1 measured 45 m long, 10 m wide, and had a maximum depth of 1.2 m. Pool 2 measured 30 m long, 7.0 m wide, and had a maximum depth greater than 1.5 m. Pool 3 measured greater than 120 m long, 7.0 m wide, and had a maximum depth greater than 1.5 m. Pool 3 continued past the 0 m transect of the survey reach. For Trip 2, Pool 1 measured 35 m long, 10 m wide, and had a maximum depth of 1.2 m. Pool 2 measured 30 m long, 7.0 m wide, and had a maximum depth greater than 1.5 m. Pool 3 measured 120 m long (it continued on past the end of the transect), 7.0 m wide, and had a maximum depth greater than 1.5 m. Overall, the stream had an average width of 5.0 m for Trip 1 and 4.0 m for Trip 2, both under normal flow conditions (Tables 3.7 and 3.8).

Figure 3.9 Photograph of instream obstruction encountered at Site IO04 on May 17, 2014.

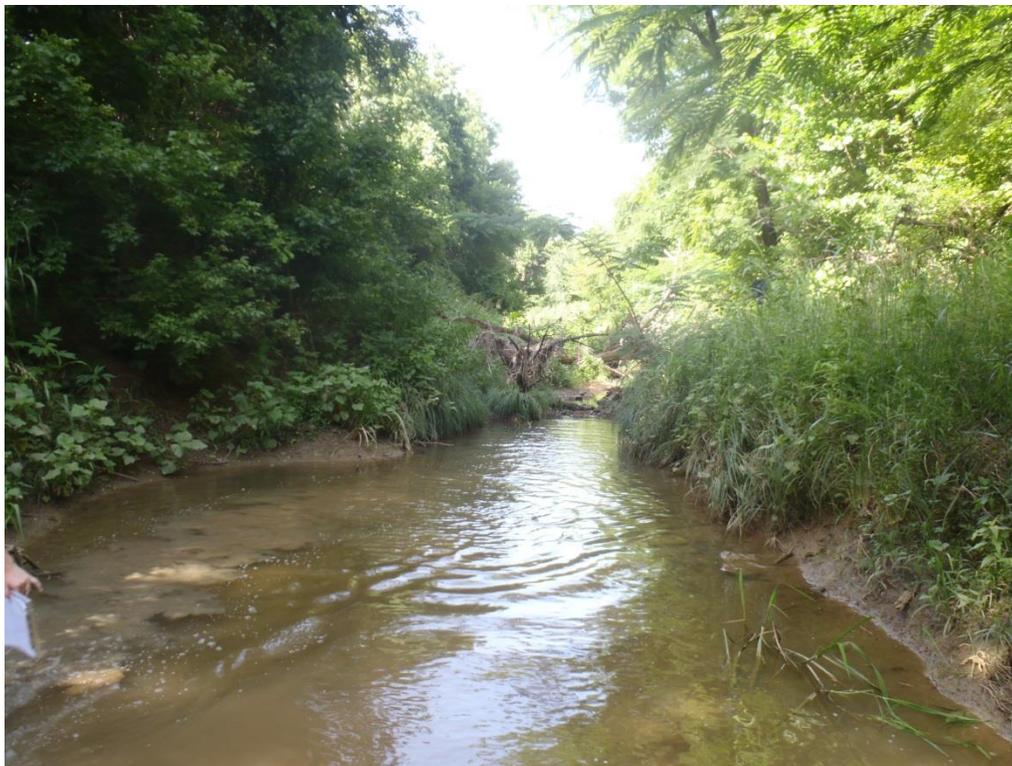
The stream channel was naturally vegetated with grass, forbs, and trees. Banks were extremely steep to vertical with sloughing in some places making travel up the banks difficult to impossible. There was no algae cover during either survey, but some common aquatic vegetation was observed during both surveys. The color of the water body was clear and brown throughout both surveys but also green in parts during the second survey. Feral hog, raccoon, and bird tracks were observed as well as bird nests under the bridge, turtles, shells, and crawdads dead and alive. Feral hog feces were observed both times. Garbage such as plastics, aluminum cans, glass bottles, and trash bags were present but rare. Large items, such as plastics and tires (common) were seen throughout the reach (Tables 3.9 and 3.10). No other signs of human recreation were observed.

Figure 3.10 Photograph of Site IO04, taken on July 11, 2014. Upstream view at 150-m transect.

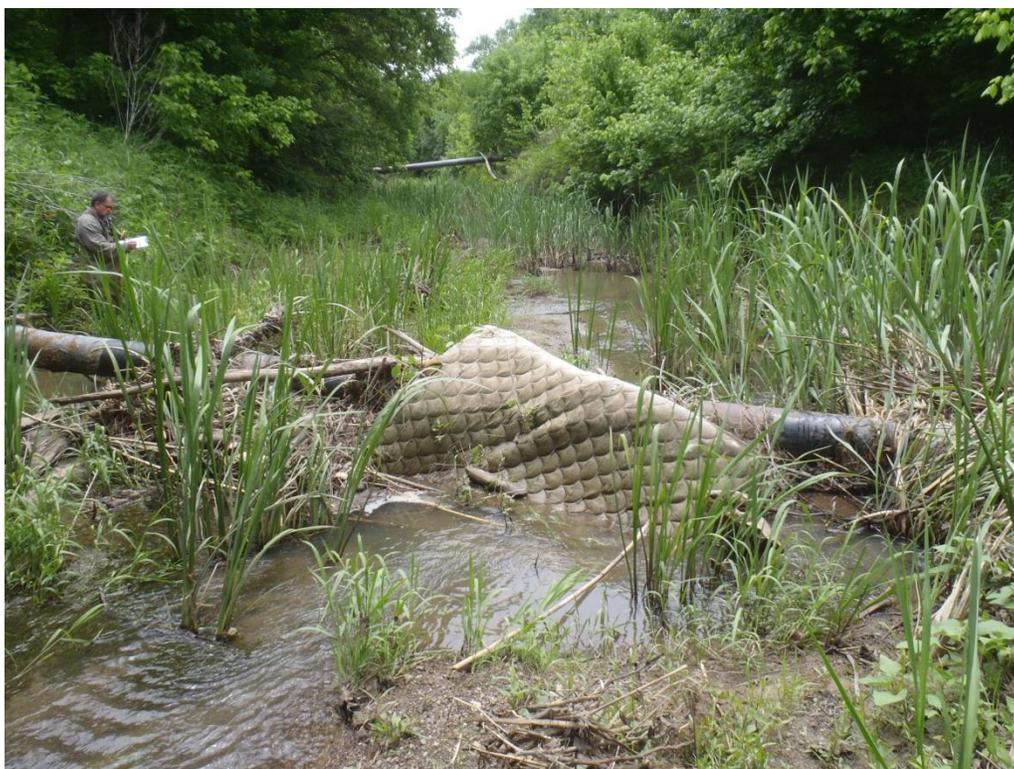
The stream channel was naturally vegetated with grass, forbs, and trees. Banks were moderately steep to vertical making travel up the banks difficult to impossible at points. There was some rare algae cover during the first survey but none at the second survey, and some common aquatic vegetation, including cattails and reeds, at both. The color of the water was clear throughout both surveys. Bird nests were observed under the bridge, as well as small fish, minnows, and shells throughout the reach. Feral hog feces and tracks were observed. Garbage such as plastics, aluminum cans, and glass bottles were present, but rare. Large items, such as a mattress and tires were seen throughout the reach (Tables 3.9 and 3.10). No other signs of human recreation were observed.

Figure 3.11 Photograph of pipe crossing and other instream obstructions at site IO05, taken on May 17, 2014. TIAER personnel in photograph.

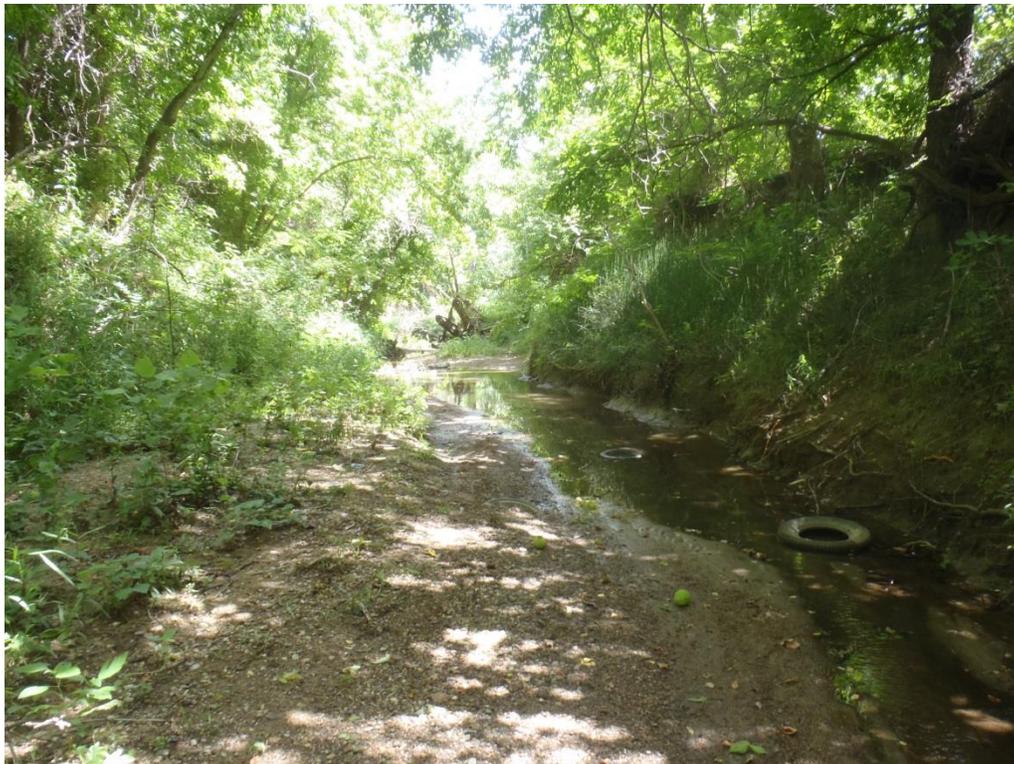
and fish carcasses were seen throughout the reach. Tracks from feral hogs and raccoons were observed, in addition to feral hog feces. Garbage such as plastics, aluminum cans, glass bottles, and papers were present, but rare. Large items, such as a TV and tires (20+) were seen throughout the reach (Figure 3.15). Although there were no other signs of human recreation, there were several fish carcasses and a single shoe (flip flop sandal) at the bridge.

Figure 3.15 Photograph of Site IO06, taken July 11, 2014. Downstream view at the 300-m transect.

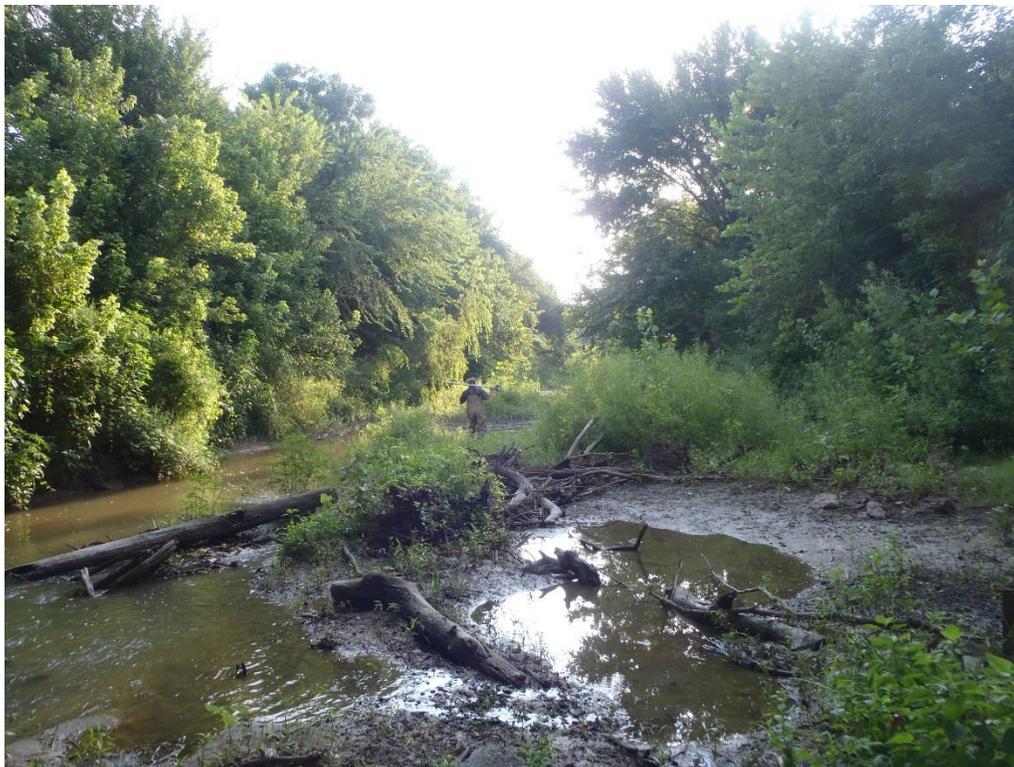
Figure 5.6 Photograph of Site BA02, taken August 9, 2014. Downstream view at 300-m transect. Note log obstructions and bank vegetation.

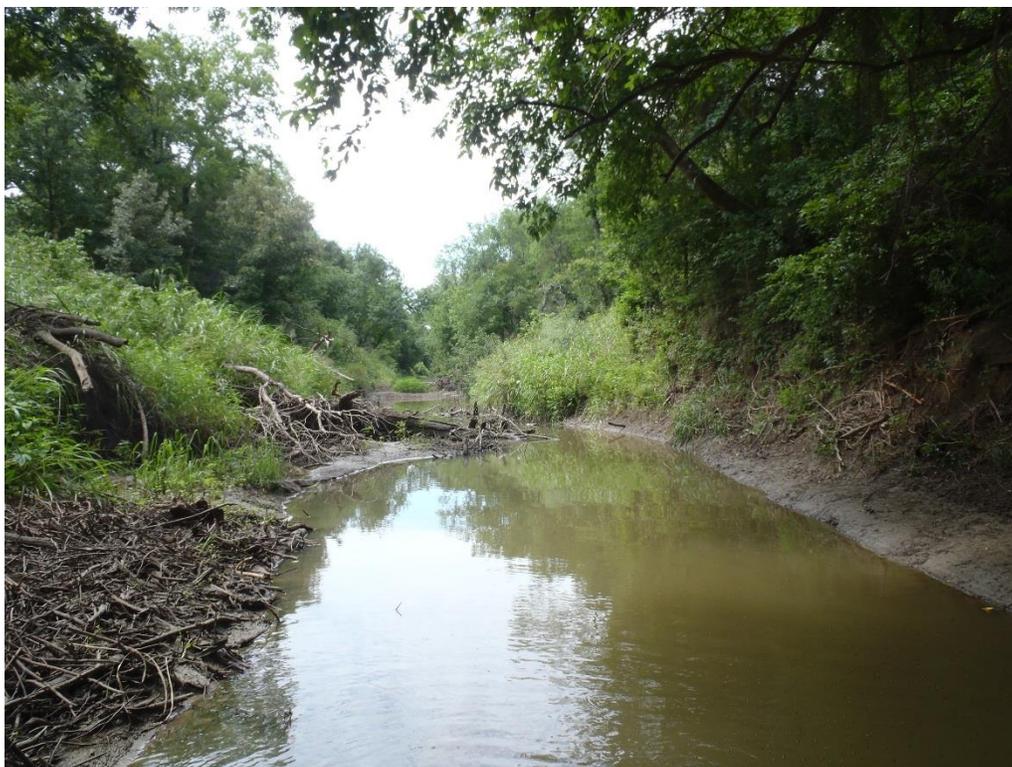
Figure 5.9 Photograph of Site BA04, taken June 18, 2014. Upstream view at 0-m transect. Note steep, vegetated banks and debris accumulation.

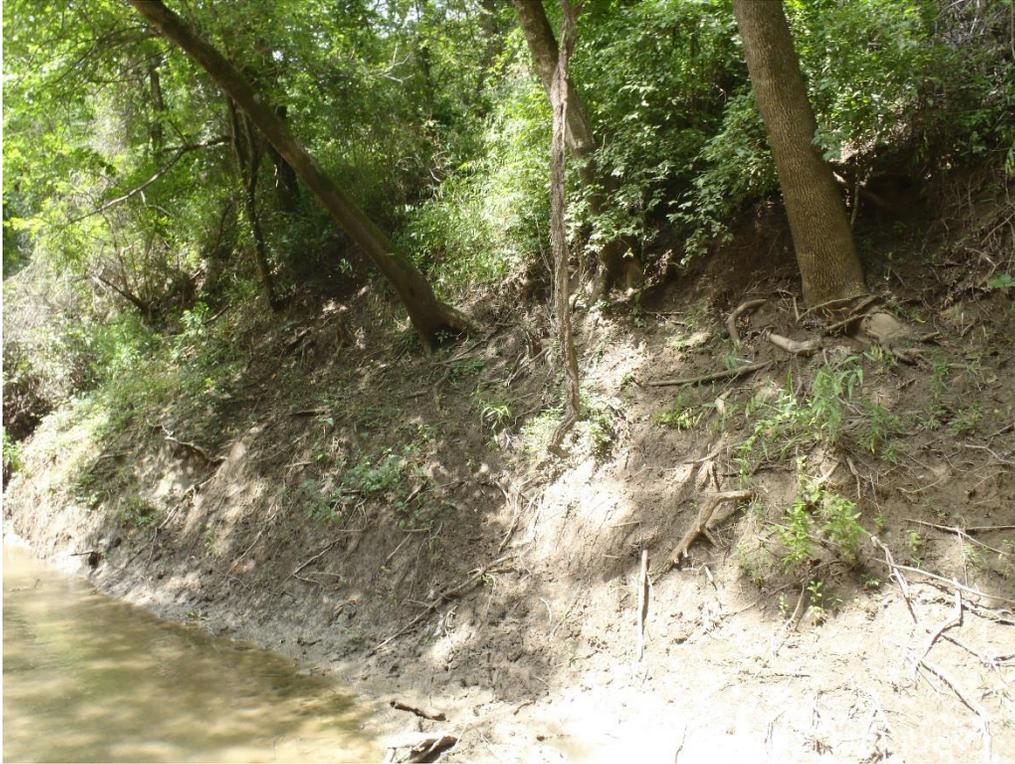
Figure 5.10 Photograph of Site BA04, taken August 9, 2014. Left bank view at 150-m transect. Note steep, muddy banks.

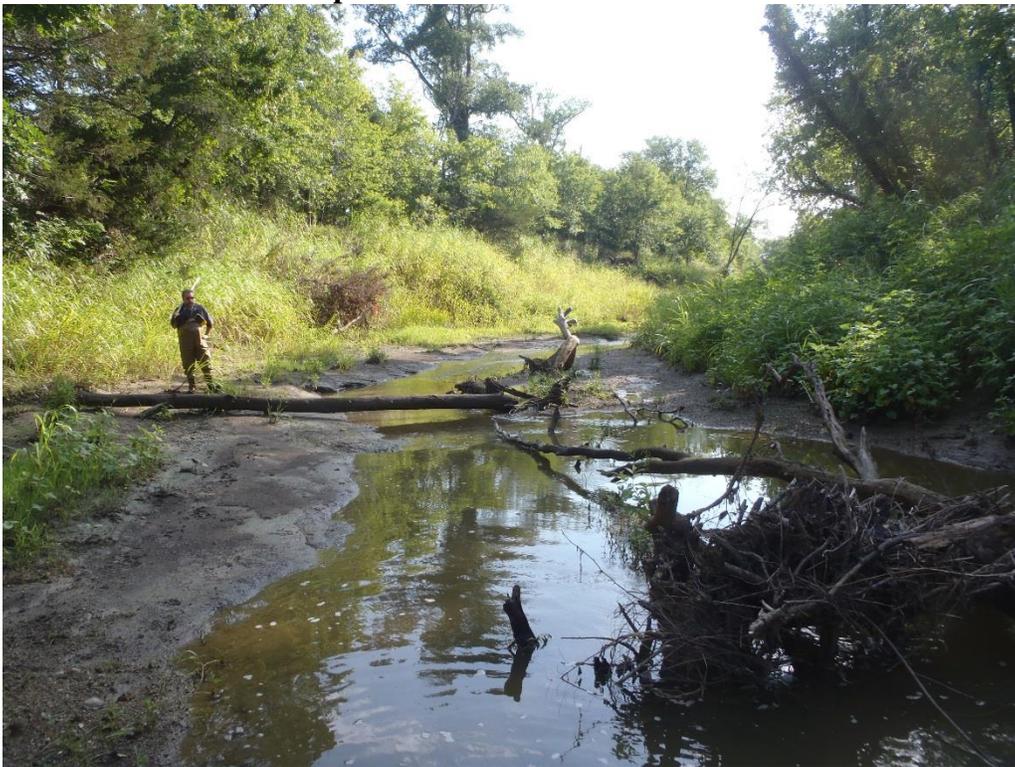
Figure 5.15 Photograph of Site BA06, taken on August 9, 2014. Downstream view at 0-m transect. Note - log jams. TIAER staff in photo.

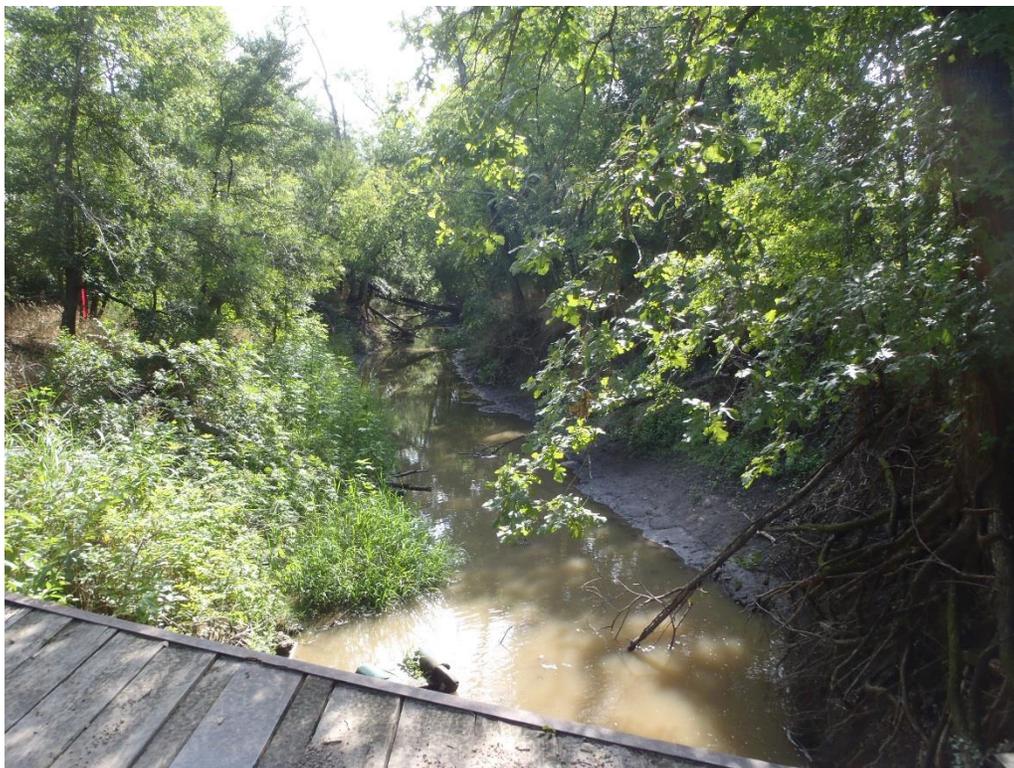
Figure 5.25 Photograph of Site BA09, taken on August 9, 2014. Downstream view at 300-m transect from bridge access. Note the steep banks, forested corridor and downed trees in channel.

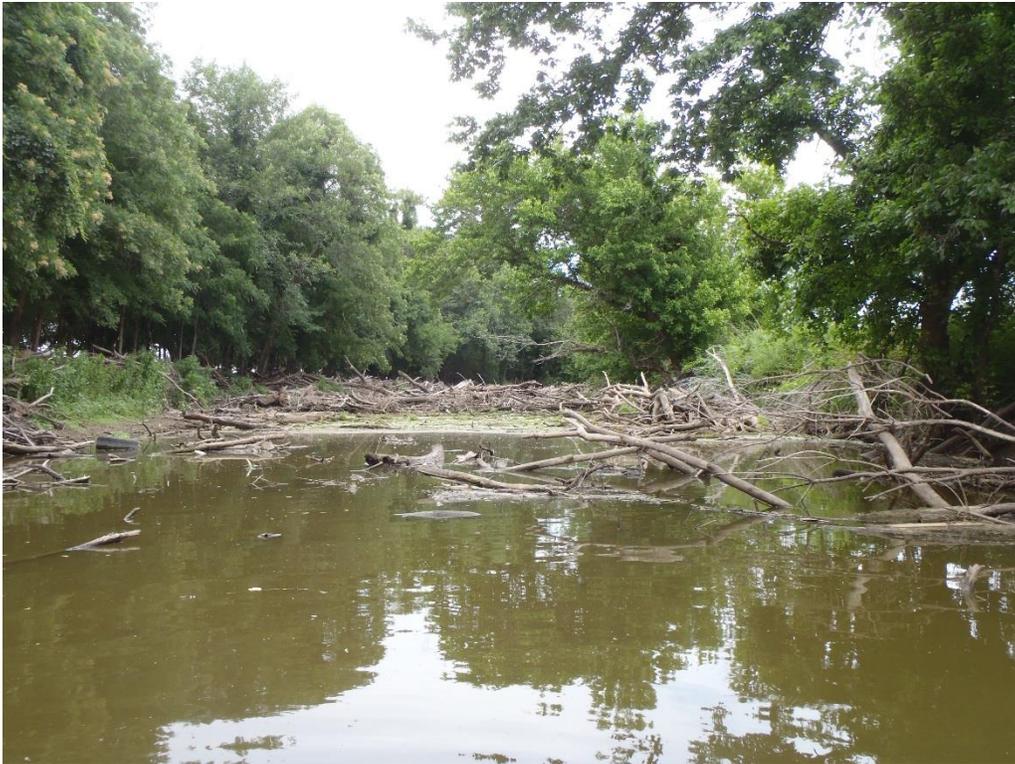
Figure 5.34 Photograph of Site BA11, taken June 17, 2014. Downstream at 60-m transect. Note significant amount of submerged debris and large log jam.

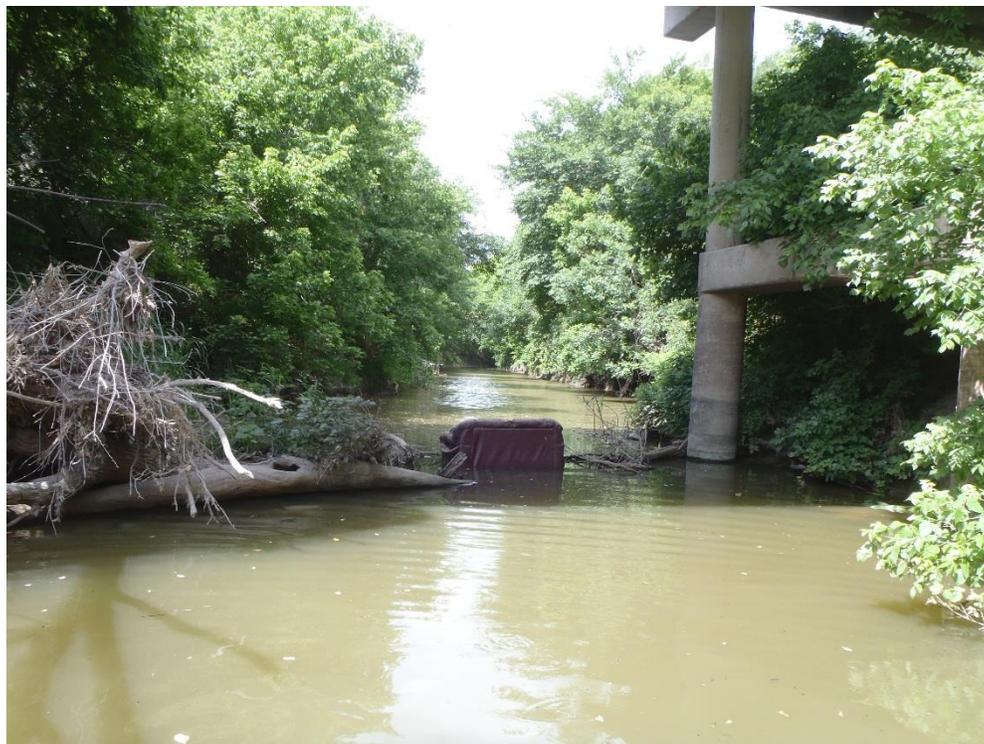
Figure 5.46 Photograph of Site BA15, taken June 17, 2014. Large garbage at 300-m transect. Note densely vegetated banks.

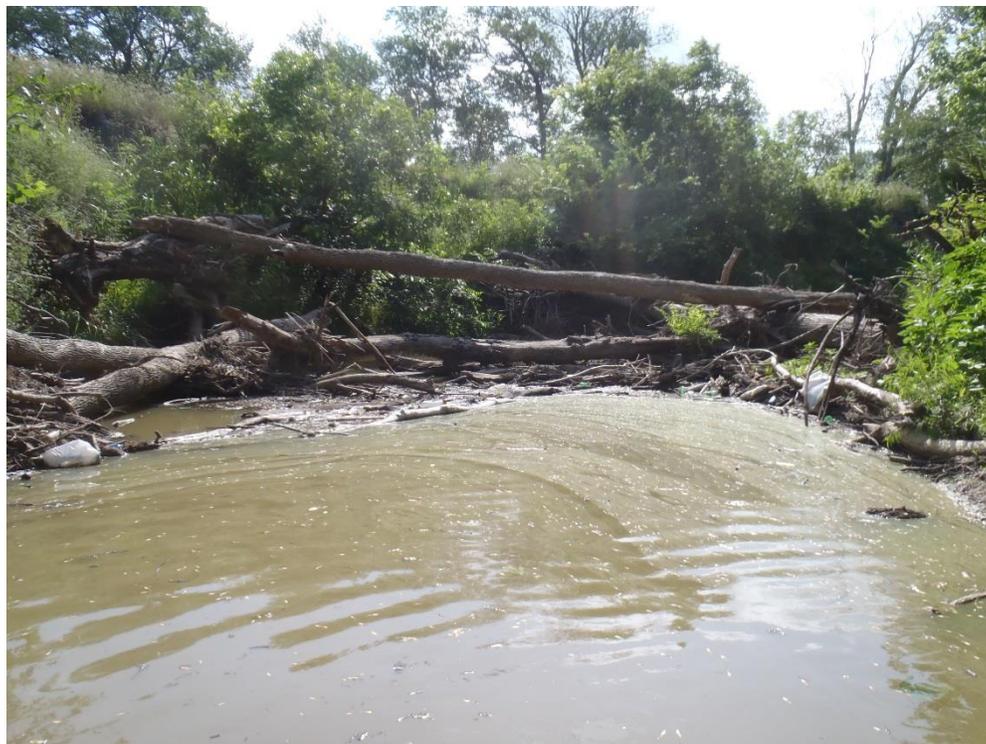
Figure 5.54 Photograph of Site BA19, taken June 17, 2014. Log obstruction at 270-m transect.

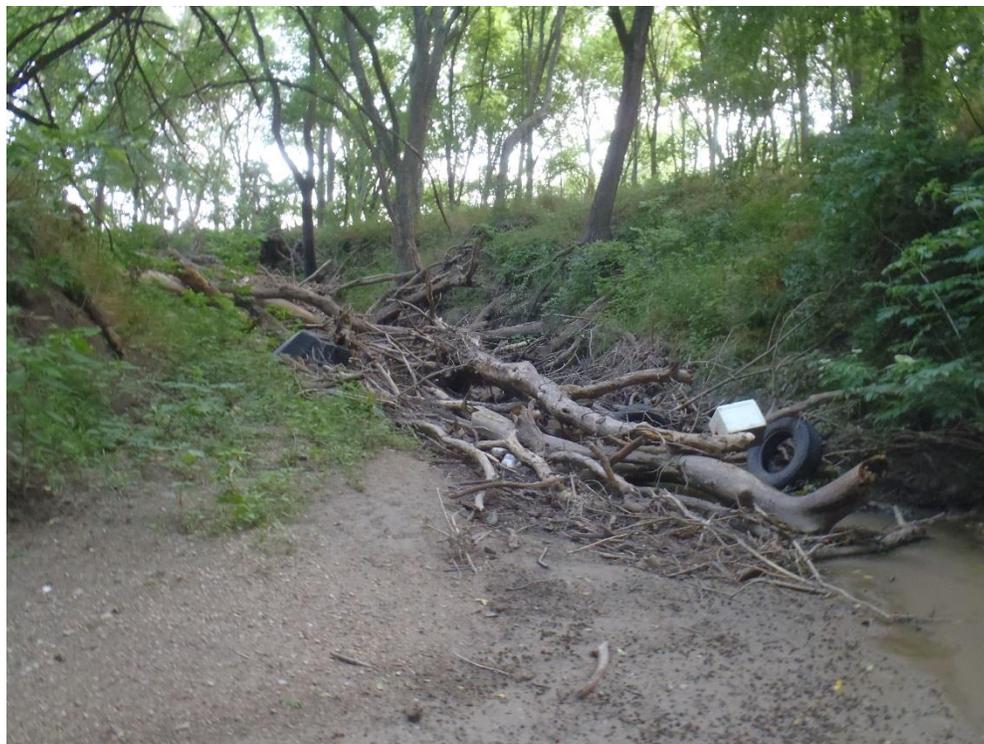
Figure 5.62 Photograph of Site BA22, taken June 16, 2014. Downstream view at the 150-m transect. Note obstruction, garbage and bank vegetation.

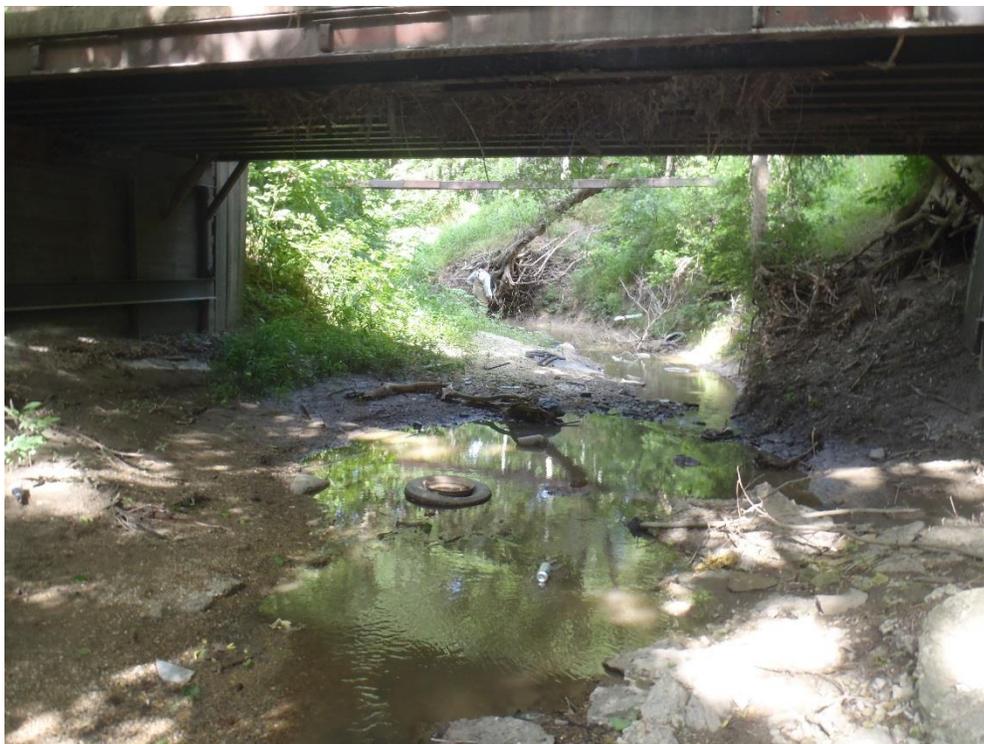
Figure 5.63 Photograph of Site BA22 taken June 16, 2014. Downstream view at the 0-m transect. Note garbage under bridge. TIAER staff in photo.

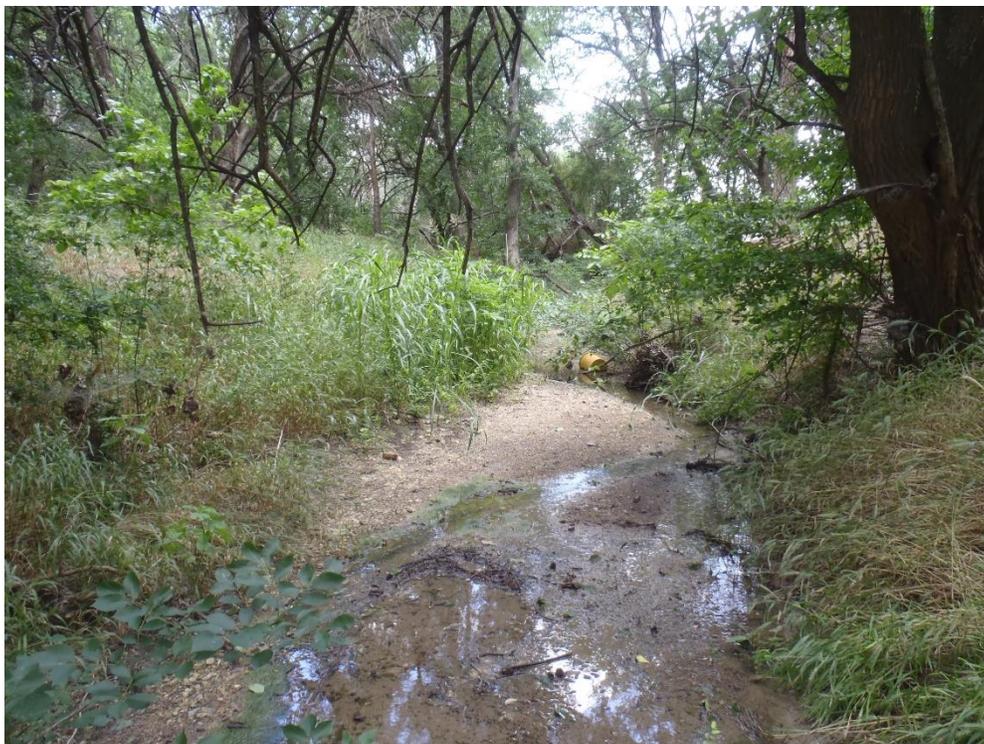
Figure 5.71 Photograph of Site BA26, taken June 16, 2014. Upstream view at the 150-m transect. Note yellow 5 gallon bucket in stream.

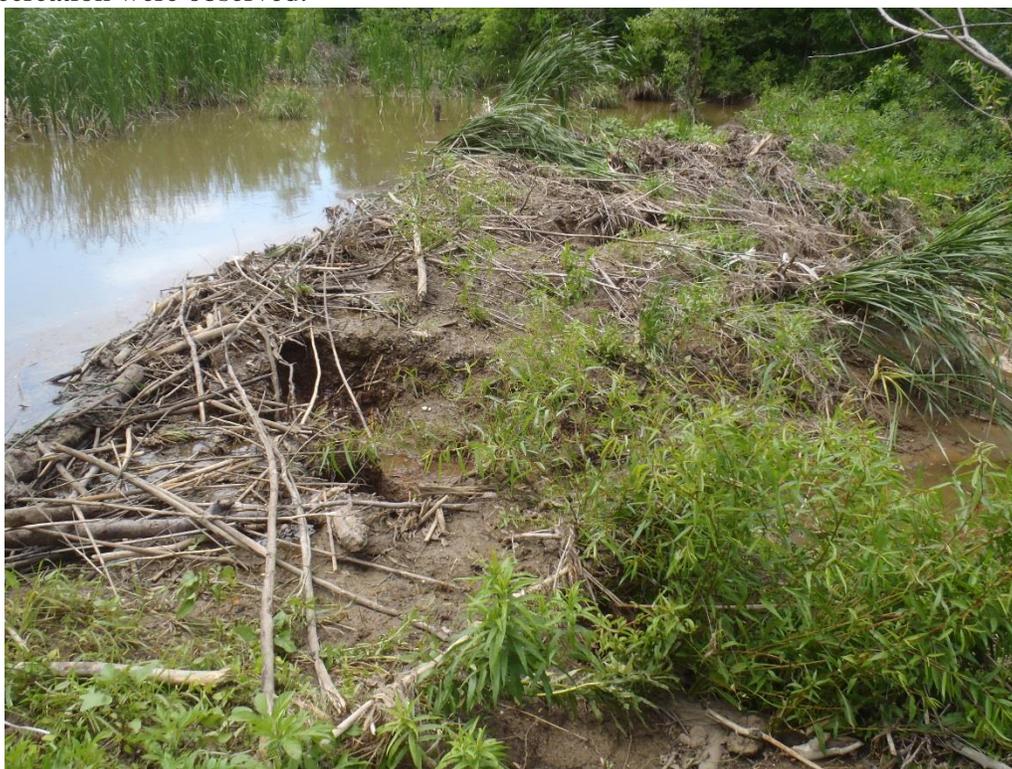
Figure 6.10 Photograph of Site SM03 of a beaver dam near the 150-m transect. Note water impounding on the left.

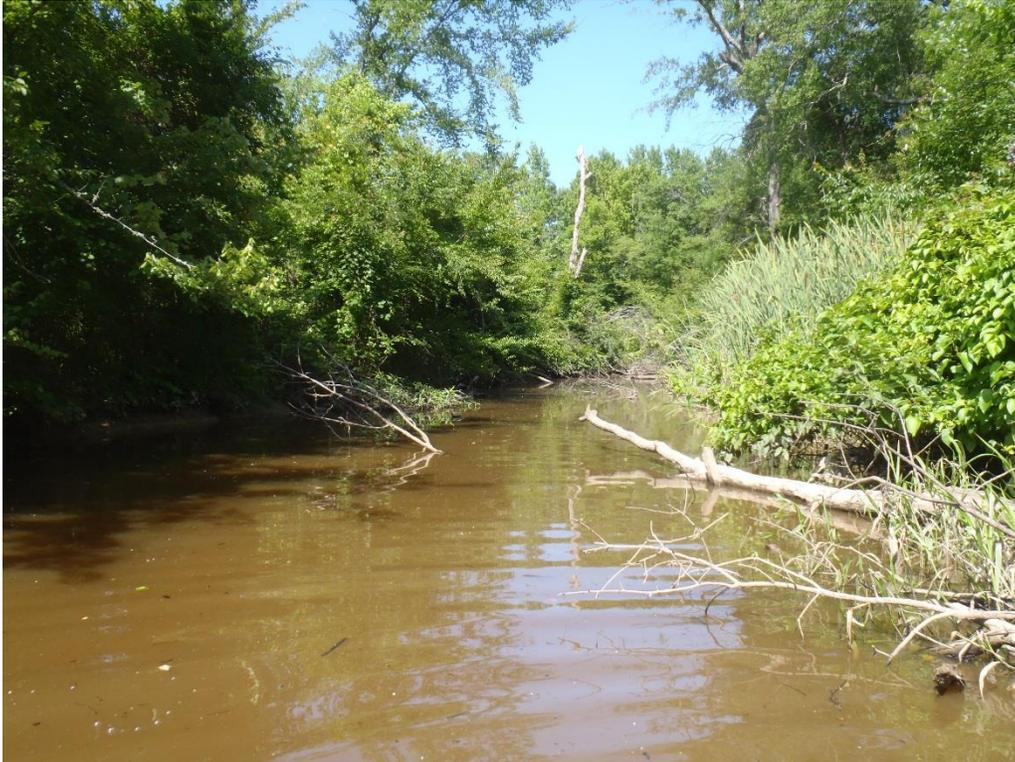
Figure 7.14 Photograph of MU05, taken on June 18, 2014. Downstream view at 90-m transect. Note brown water with foam and dense bank vegetation.

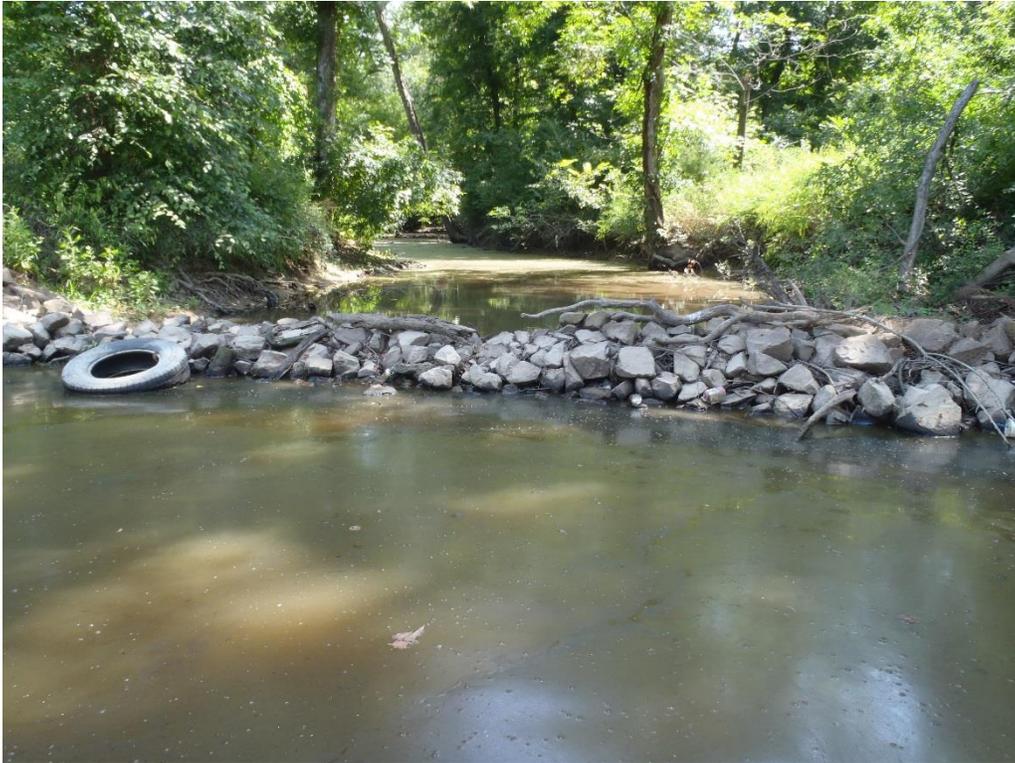
Figure 7.17 Photograph of MU06, taken on August 8, 2014. Water modification structure near bridge. Note oily scum on water surface and tire garbage.

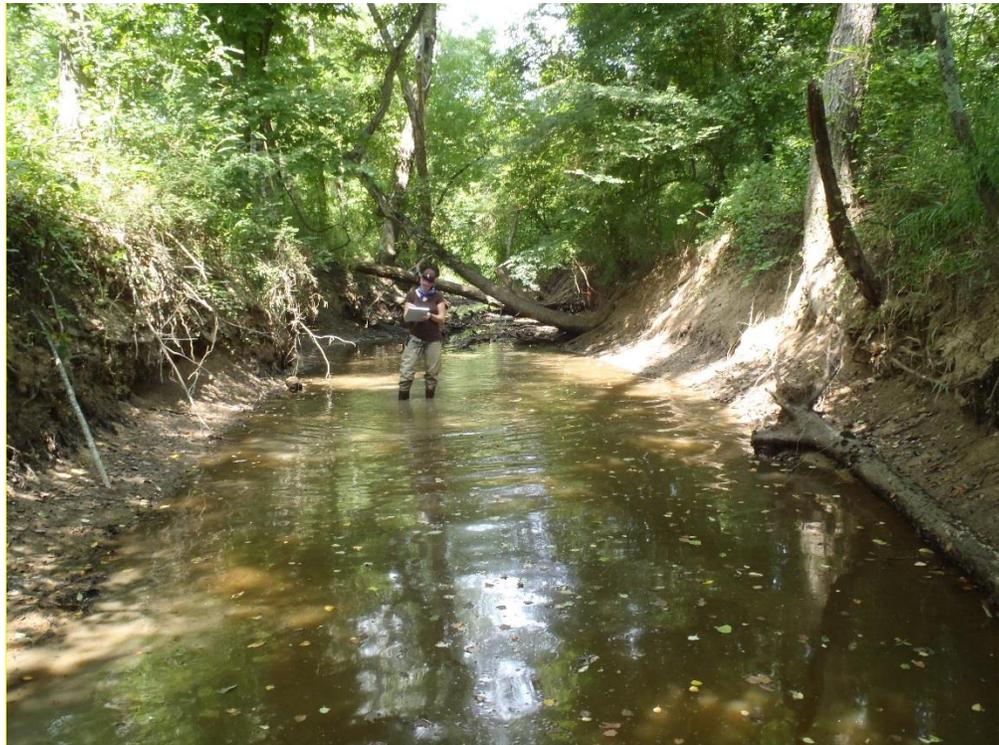
Figure 7.20 Photograph of MU07, taken on August 8, 2014. Upstream view at 150-m transect. Note steep vegetated banks and log obstruction. TIAER staff in photo.

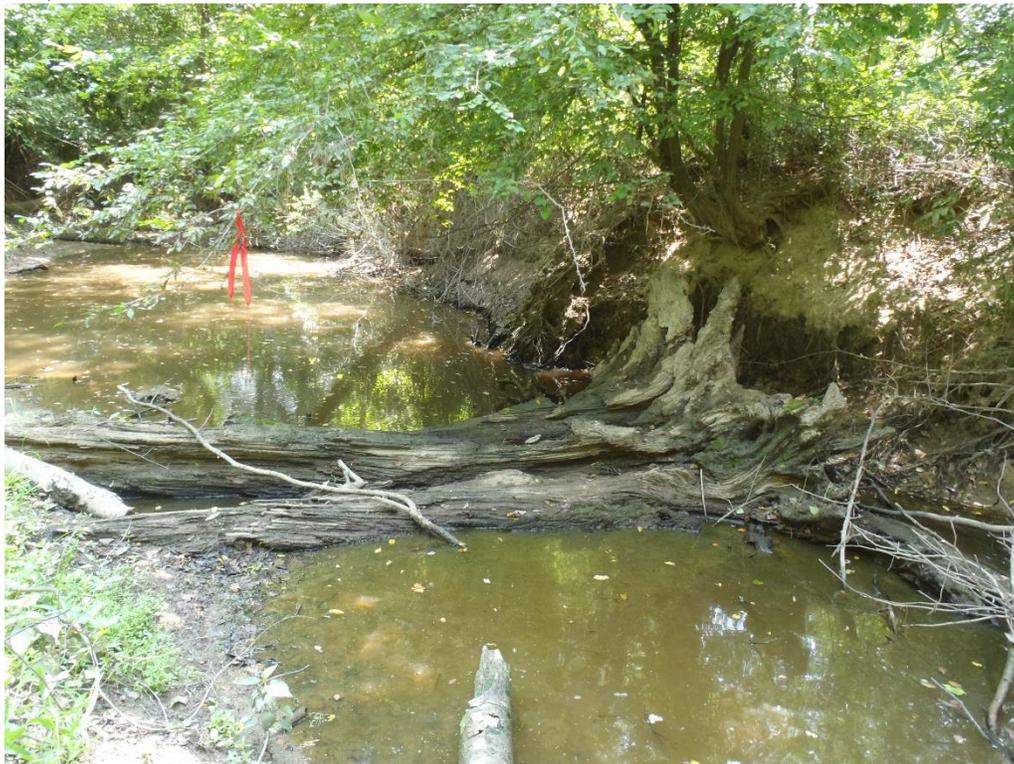
Figure 7.21 Photograph of MU07, taken on August 8, 2014. Log obstruction.

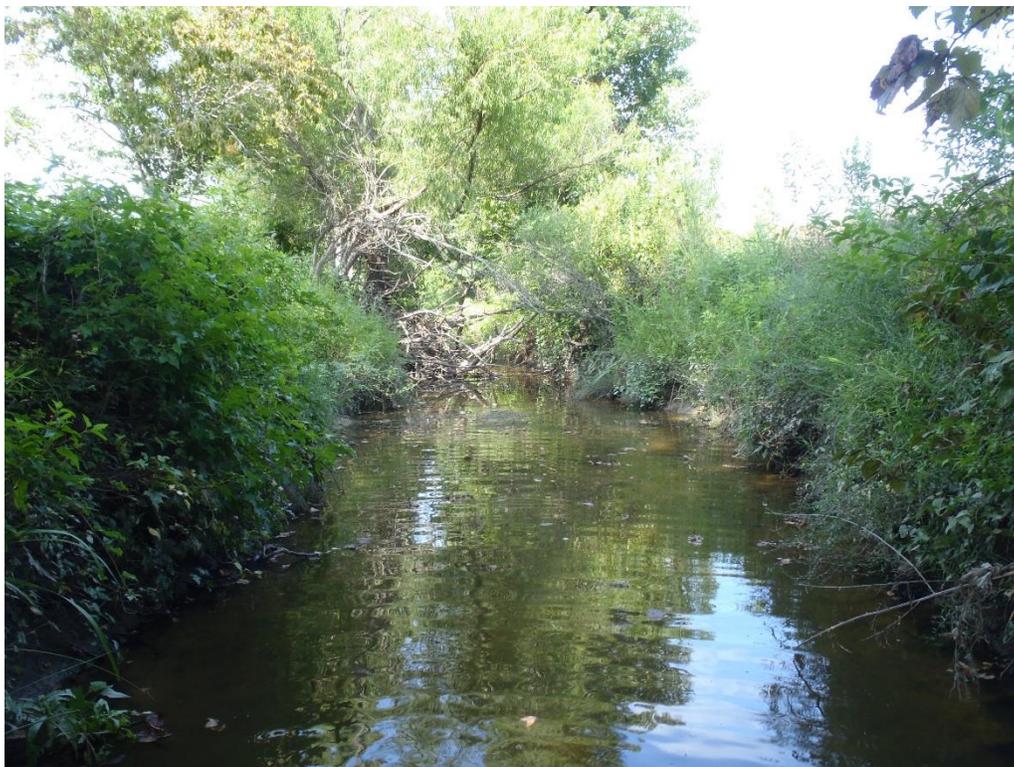
Figure 7.31 Photograph of MU11, taken on August 8, 2014. Downstream view at 0-m transect. Note steep vegetated banks and obstruction.
