Bacterial Monitoring for the Buck Creek Watershed

Final Report

TSSWCB Project 03-07

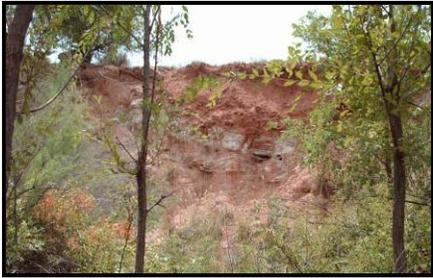
Creek bank showing soil profile and erosion near site 10B. June 2006

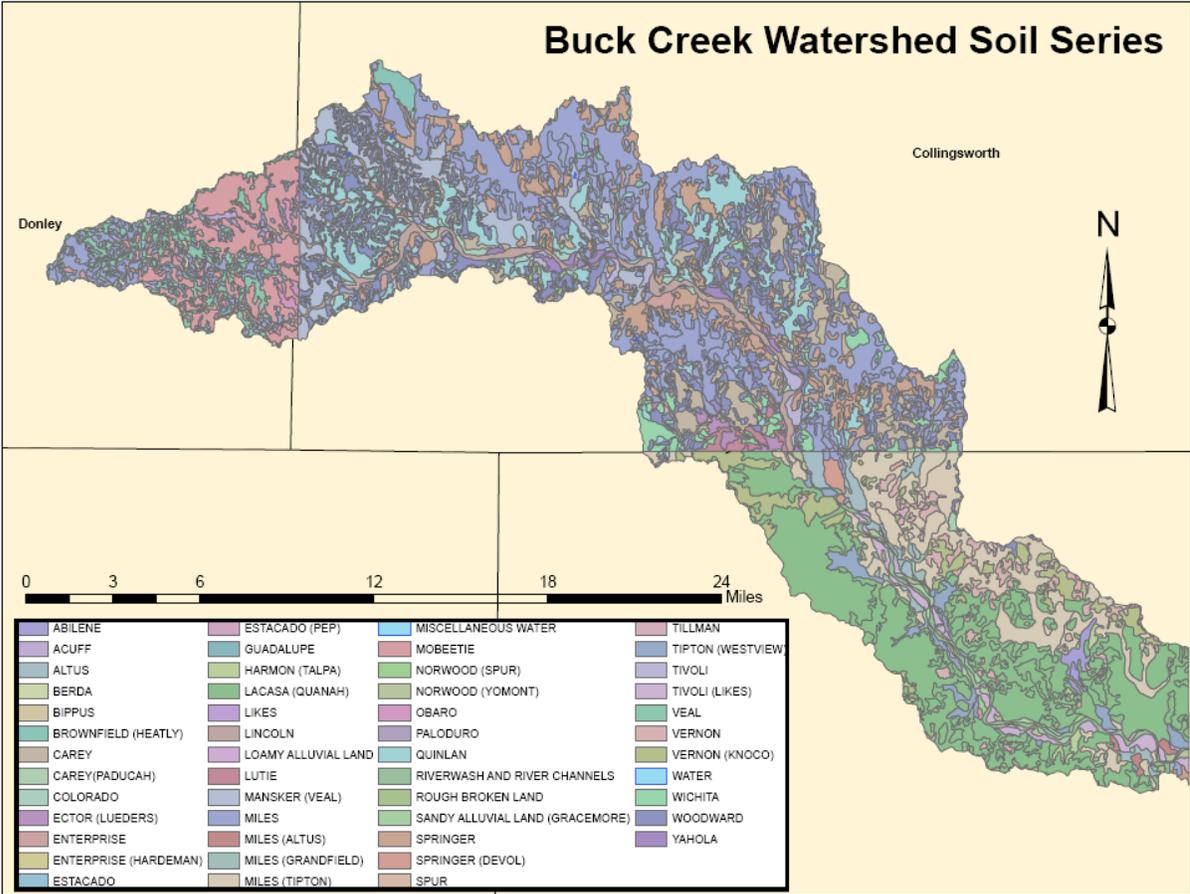
Figure 2: Soils map of the Buck Creek watershed

The La Casa-Harmon association is the third most common soil group in the area and covers about 11.5 percent of the watershed. These soils are characterized by broad, gently sloping areas of La Casa soils and frequent outcrops of Harmon soils. La Casa soils are deep, silty soils that occupy gently sloping areas while Harmon soils are very shallow and occur as limestone outcrops and ridges. The majority of these soils are associated with rangeland, but the La Casa soils are suitable for crop production (USDA, 1963). Springer soils are also common throughout the watershed and occupy almost 7 percent of the watershed. They are deep soils that are typically under cultivation, but can be hampered by severe erosion if not properly managed. The Mobeetie-Veal-Potter association covers about 4.5 percent of the watershed and has slopes ranging from 1 to 45 percent. Soils are generally loamy and range from deep to very shallow and are typically found in upland areas. These soils are usually associated with rangeland due to their low potential for cultivated crop growth caused by the steep slopes, shallow soils and high erosion potential (USDA, 1980).

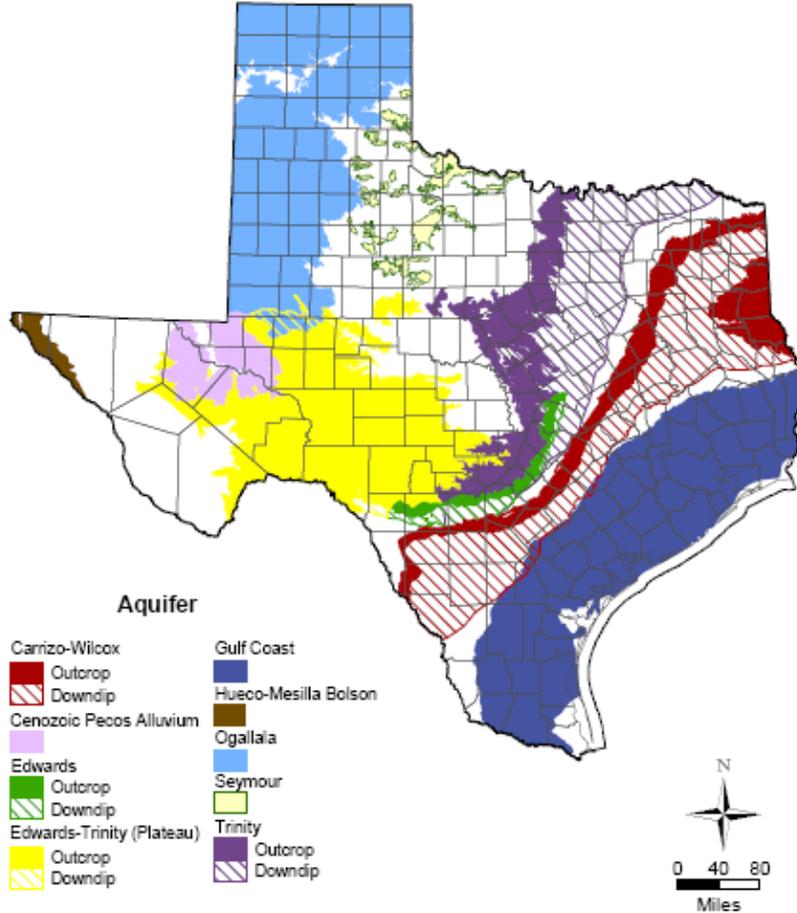
Major aquifers in Texas (Source: Texas Water Development Board)

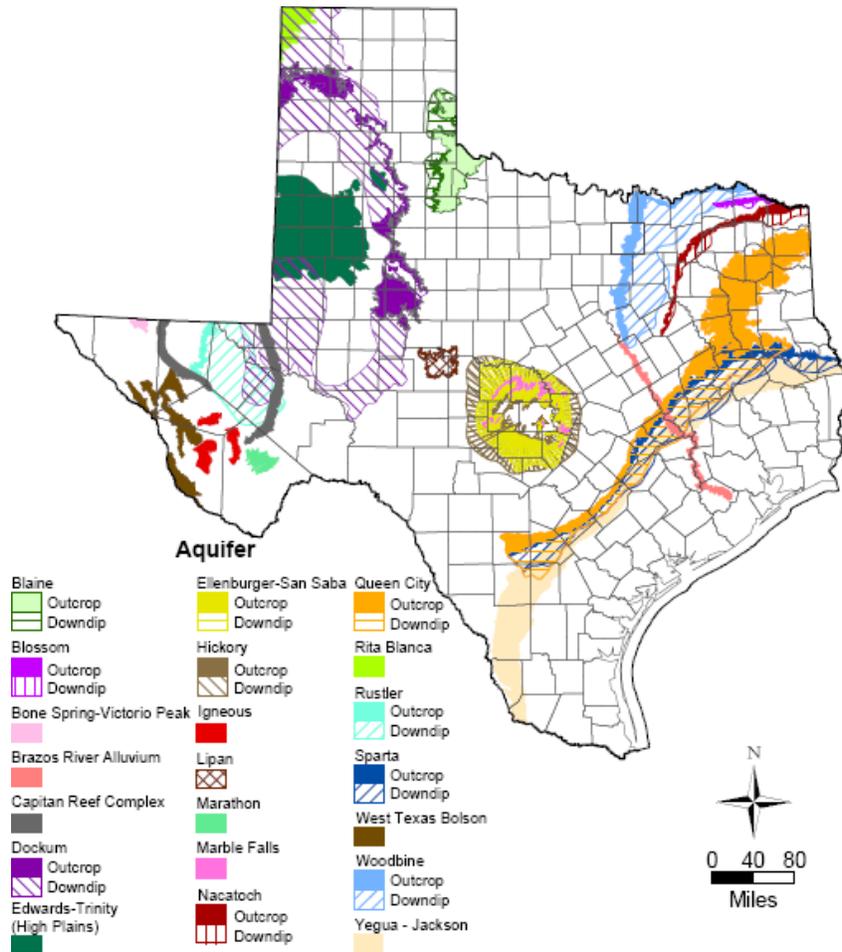
Minor aquifers of Texas (Source: Texas Water Development Board)

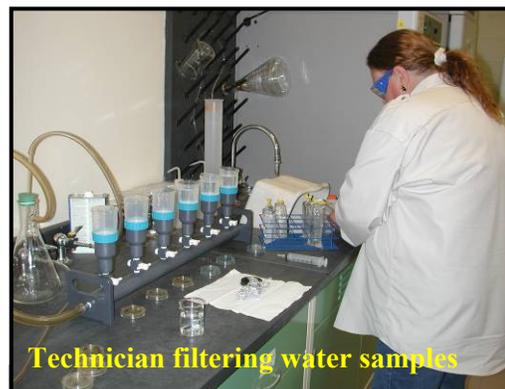
Technician filtering water samples

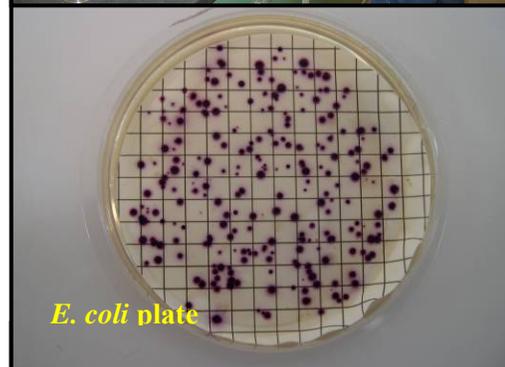
E. coli plate

The membrane is subsequently placed on prepared modified mTEC (selective for *E. coli*) agar petri dishes and incubated at 35.1° C for two hours to resuscitate the bacteria. The petri dishes are then moved to a water jacketed incubator and kept at 44.5°C for 20 to 22 hours allowing sufficient time for bacterial colonies to develop. *E. coli* colonies are recognized by their magenta color.

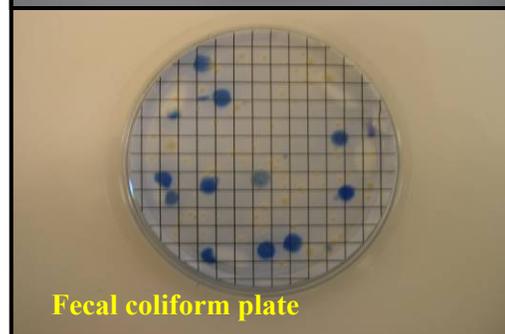
Fecal coliform plate

Fecal coliform samples are treated similarly, but a different culture medium (m-FC) is used for colony development. This media is selective for fecal coliform and is recognized by its blue color. Fecal coliform testing was performed only at site 11. Water samples were taken above and below the bridge (sites 11A&B) to compare water quality as it passed under a large colony of cliff swallows nesting on the downstream side of the bridge.

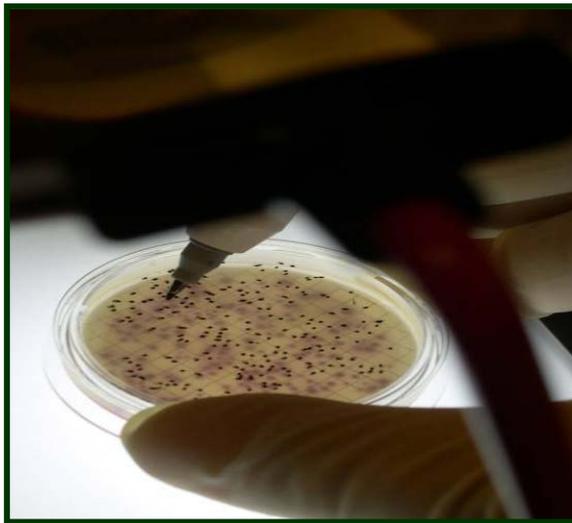
Colony counter leaves a permanent dot

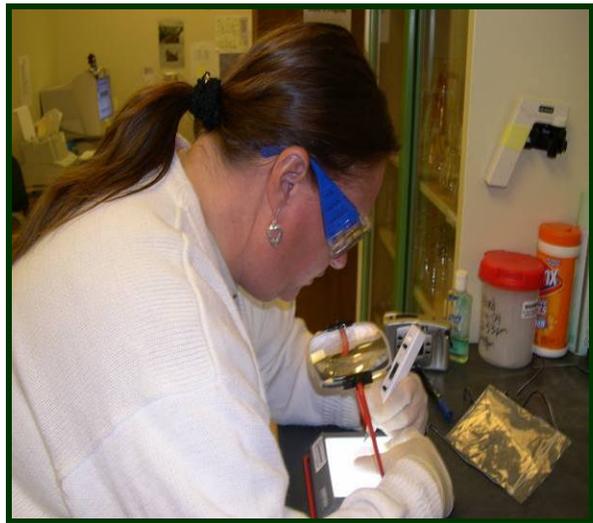
Counting colonies

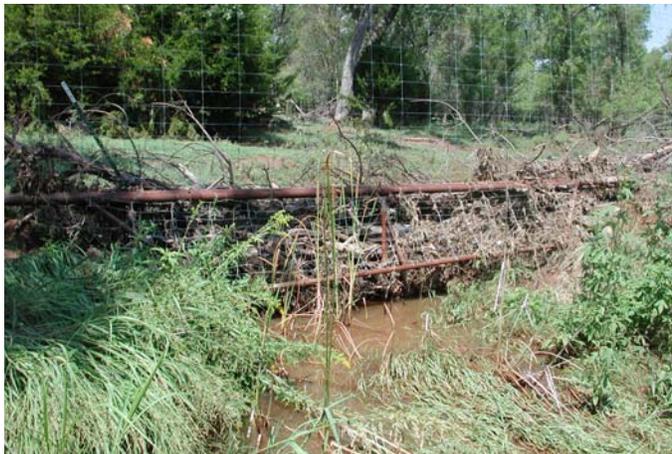
Evidence of high flow in Buck Creek
