**Mid Pecan Bayou  
Recreational Use Attainability Analysis**

**Texas State Soil and Water Conservation Board  
Project 10-53**

**Texas Institute for Applied Environmental Research  
Tarleton State University  
Stephenville, Texas**

**January 2012**

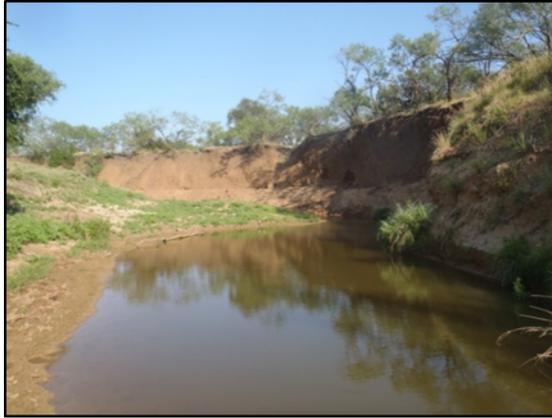
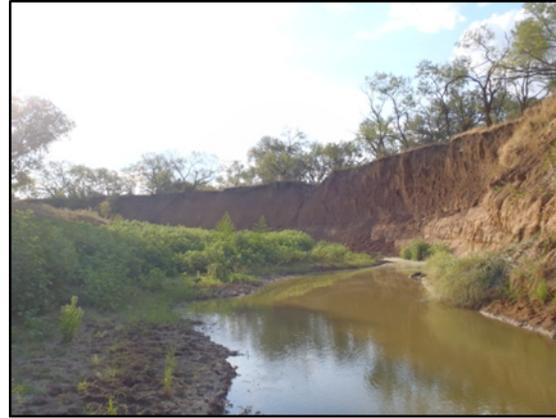
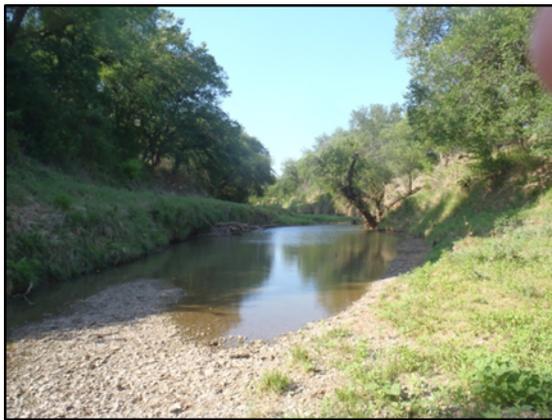
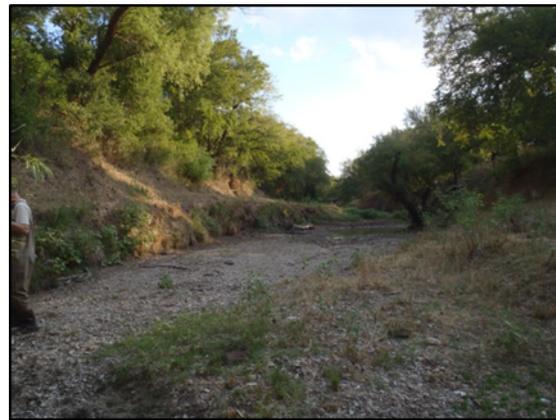
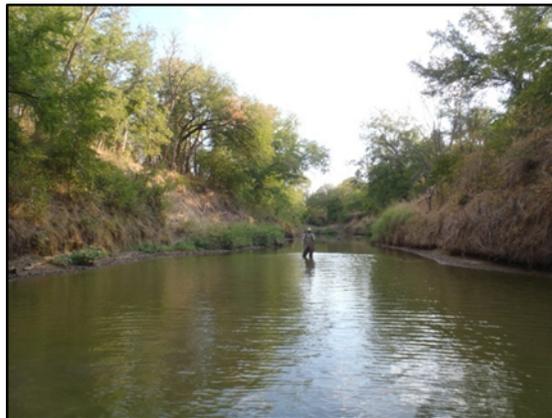
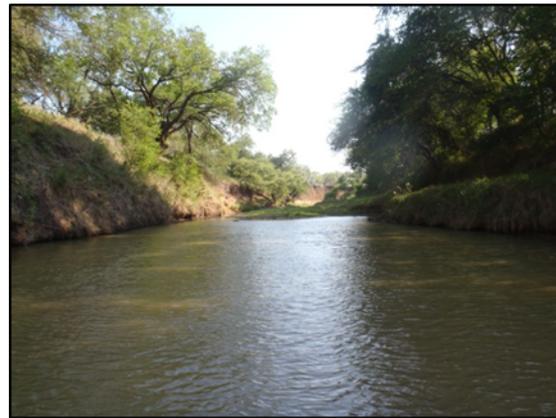
**Photogroup 4-1** Mid Pecan Bayou site MP001 depicting general appearance of the site (All individuals pictured are TIAER staff). Top Left - 0-m transect, upstream view, June 2011; Top Right - 0-m transect, upstream view, September 2011; Middle Left – 150-m transect upstream view, June 2011; Middle Right – 150-m transect upstream view, September 2011; Bottom Left – 270-m transect, upstream view, September 2011; Bottom Right – 300-m transect downstream view, June 2011. [Return to Text](#)

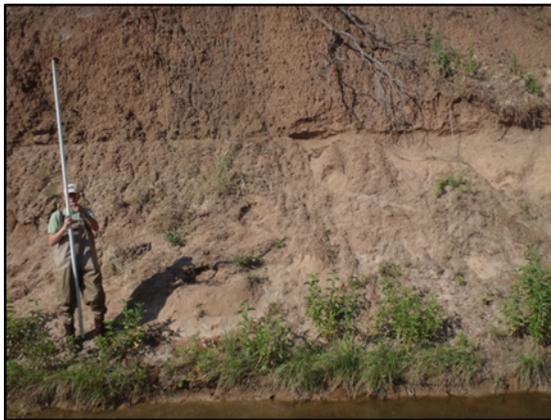
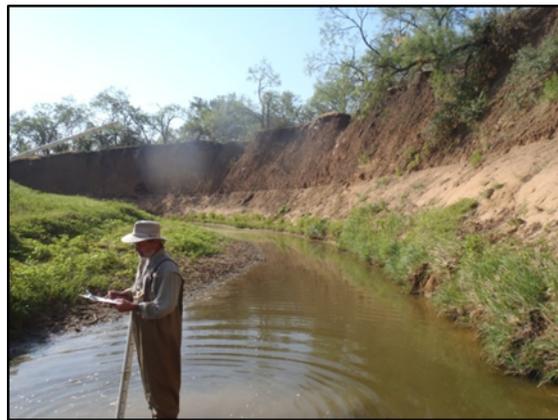
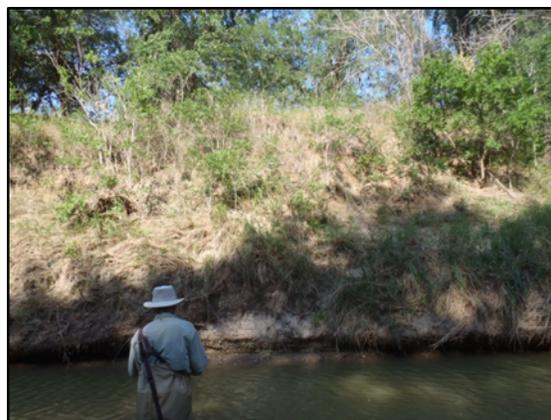
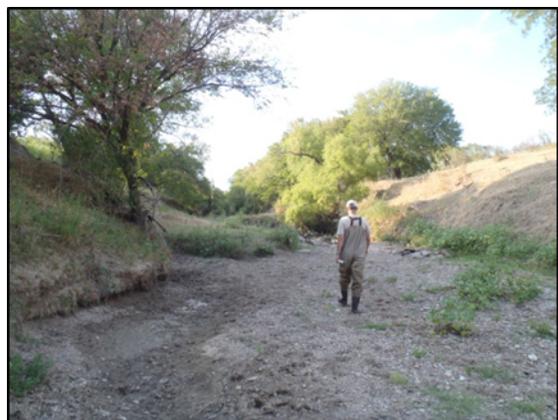
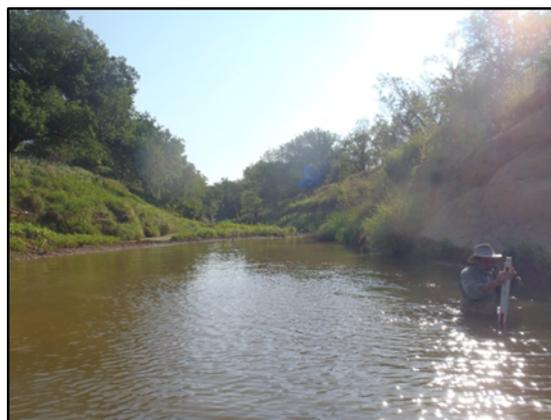
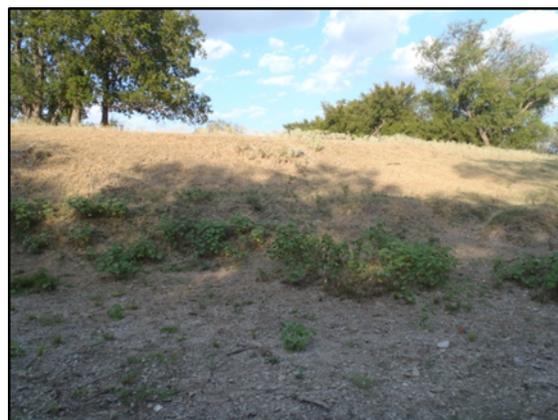
Site MP001 was wadeable for the entire 300-m reach length. During neither survey did depths exceed one meter at any of the eleven transects. Wading was relatively easy, although the presence of fine sediments in some locations caused some difficulties. [Photogroup 4-2](#) depicts surveying the stream and stream bank access.

**Photogroup 4-2** Mid Pecan Bayou site MP001 depicting field staff in the stream and stream bank access (All individuals pictured are TIAER Staff). Top Left – 90-m transect, June 2011; Top Right – 120-m transect, June 2011; Middle Left – 300-m transect, June 2011; Middle Right – 120-m transect, September 2011; Bottom Left – 30-m transect, June 2011; Bottom Right – bank access 120-m transect, September 2011. [Return to Text](#)

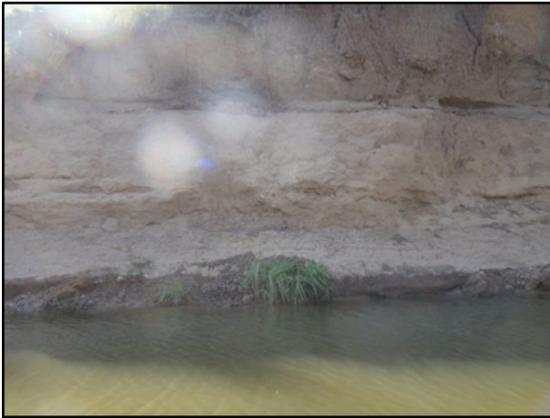
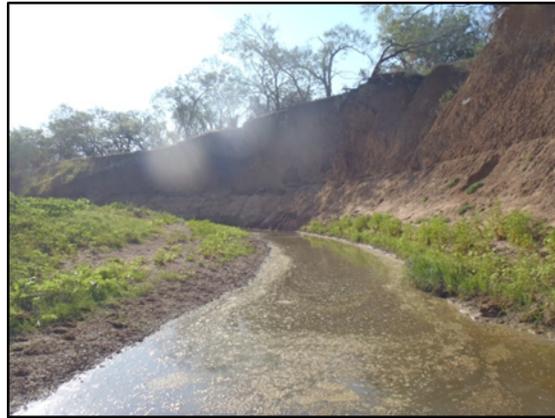
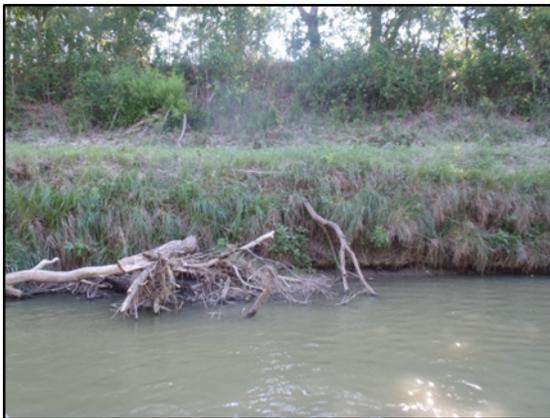
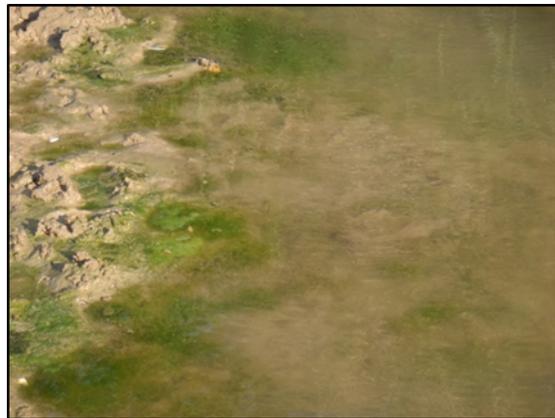
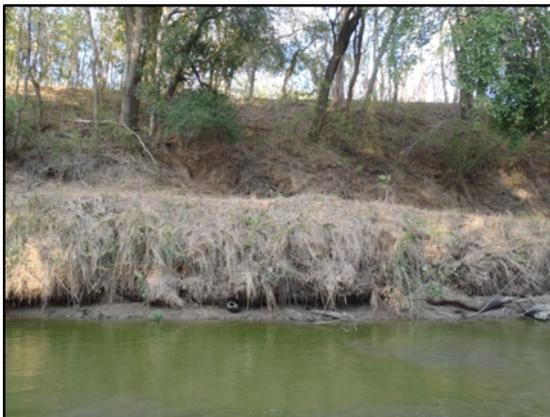
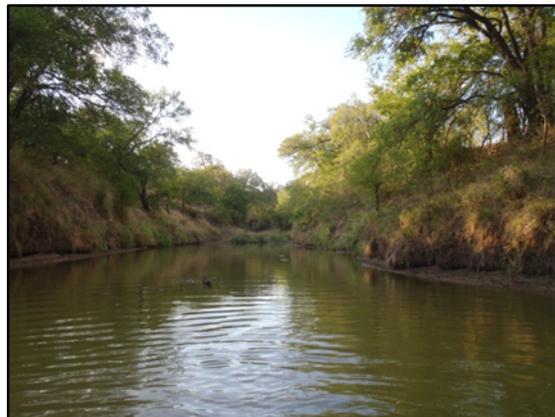
**Photogroup 4-3** Mid Pecan Bayou site MP001 illustrating the water color, general appearance and clarity of the water surface. Top Left – 30-m transect, June 2011; Top Right – 90-m transect, June 2011; Middle Left – 210-m transect, June 2011; Middle Right – 0-m transect, September 2011; Bottom Left – 240-m transect, June 2011; Bottom Right – 300-m transect, September 2011. [Return to Text](#)

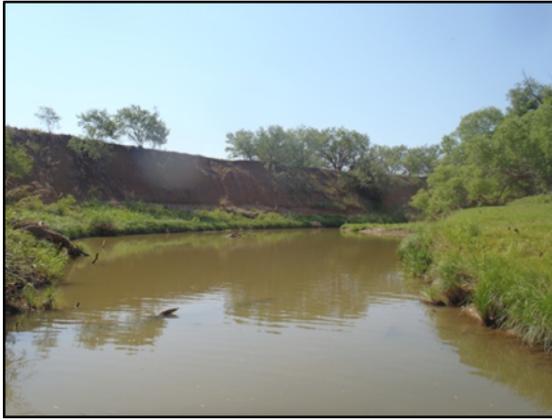
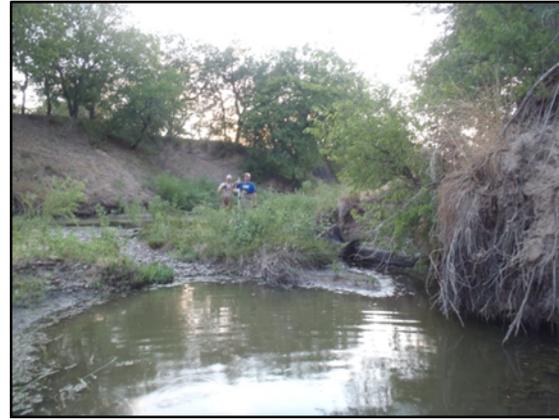
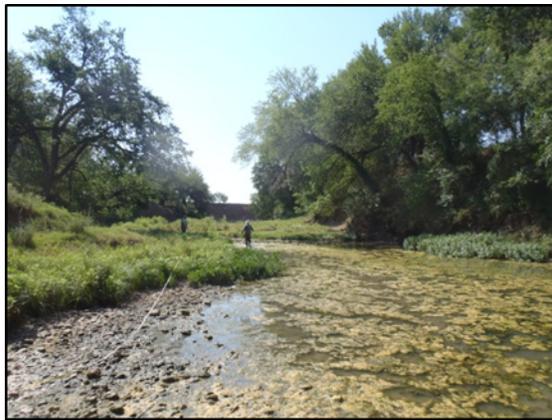
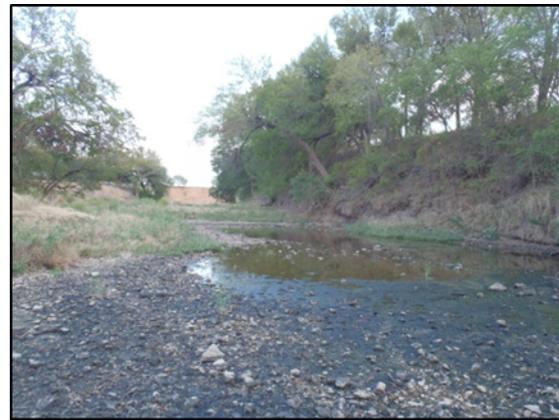
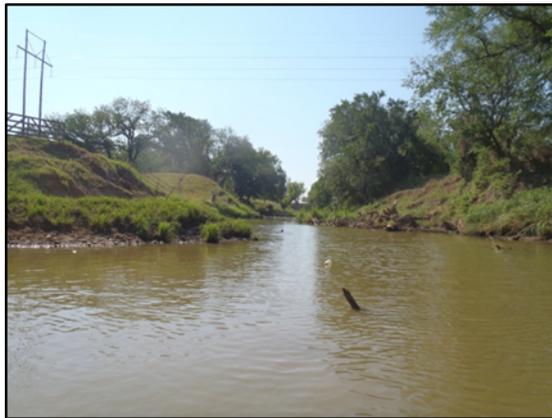
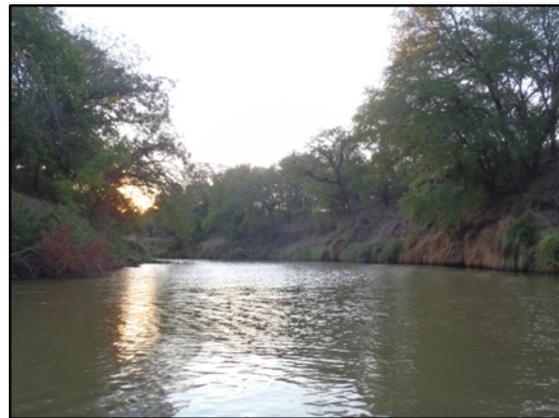
**Photogroup 4-4** Mid Pecan Bayou site MP002 depicting general appearance of the site (All individuals pictured are TIAER staff). Top Left – 0-m transect, downstream view, June 2011; Top Right – 0-m transect, upstream view, September 2011; Middle Left – 150-m transect downstream view, June 2011; Middle Right – 150-m transect downstream view, September 2011; Bottom Left – 300-m transect, downstream view, June 2011; Bottom Right – 300-m transect upstream view, September 2011. [Return to Text](#)

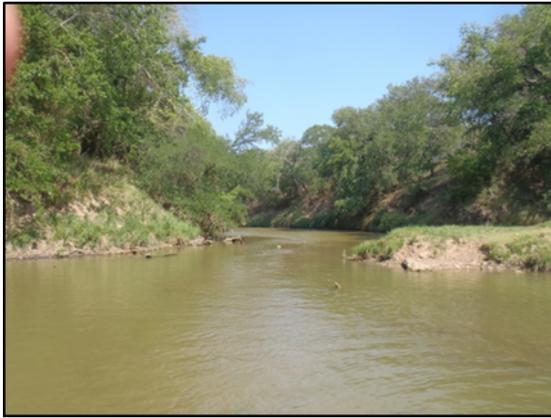
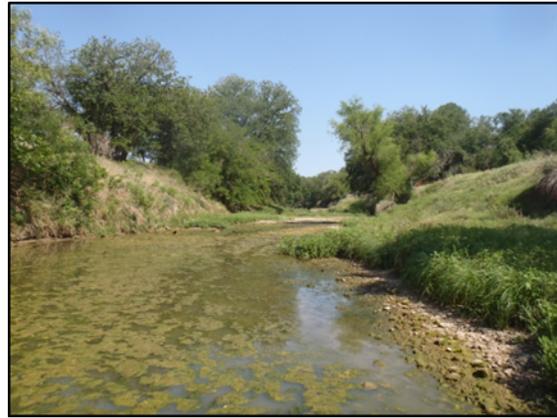
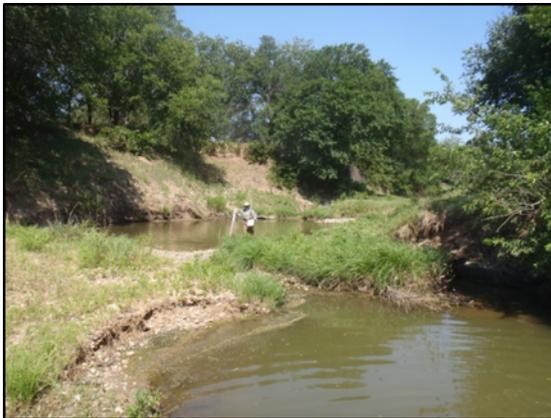
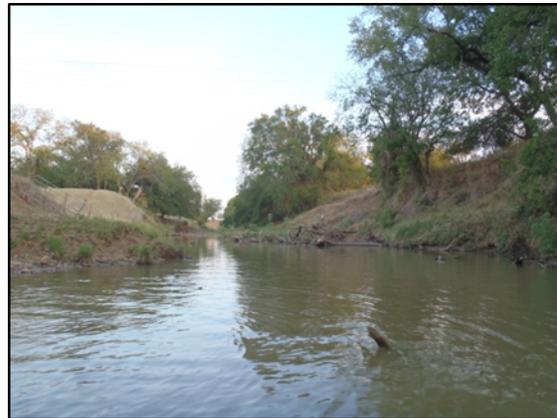
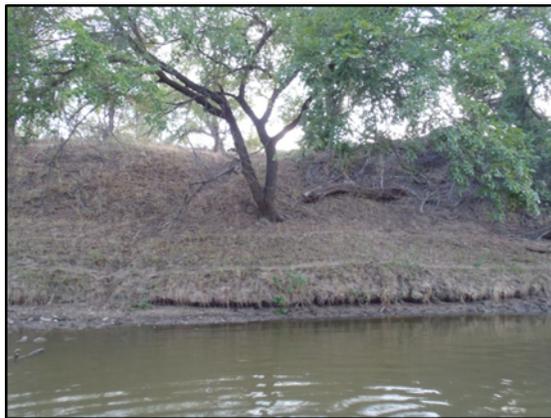
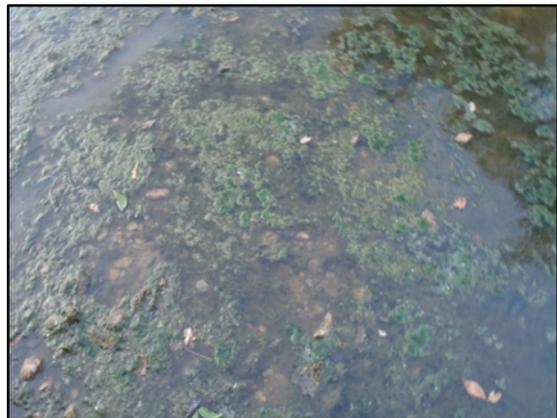
**Photogroup 4-6** Mid Pecan Bayou site MP002 illustrating the water color, general appearance and clarity of the water surface. Top Left – 270-m transect downstream, June 2011; Top Right – 120-m transect downstream, June 2011; Middle Left – 0-m transect upstream, June 2011; Middle Right – 300-m transect downstream, September 2011; Bottom Left – 210-m transect, September 2011; Bottom Right – 150-m transect, September 2011. [Return to Text](#)

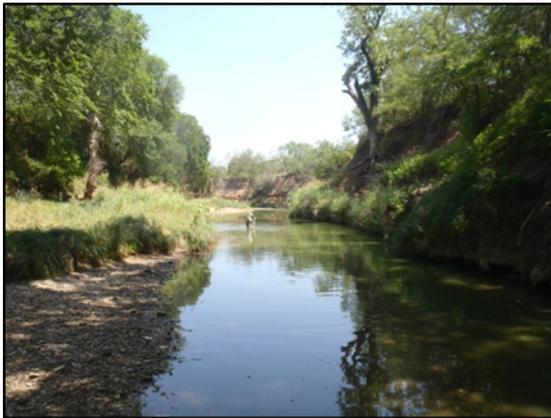
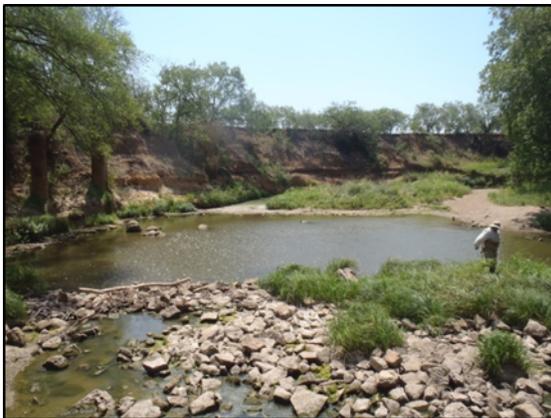
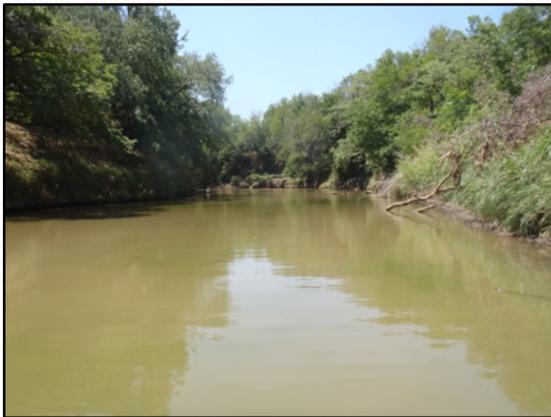
**Photogroup 4-7** Mid Pecan Bayou site MP003 depicting general appearance of the site (All individuals pictured are TIAER staff). Top Left – 0-m transect upstream, June 2011; Top Right – 0-m transect upstream, September 2011; Middle Left – 150-m transect downstream, June 2011; Middle Right – 150-m transect downstream, September 2011; Bottom Left – 300-m transect downstream, June 2011; Bottom Right – 210-m transect downstream, June 2011.

Mid Pecan Bayou at site MP003 was visited on June 10 and September 3, 2011. This site was accessible from a low water crossing at CR 257 south of Brownwood, Texas in Brown County. Away from the crossing, the bayou is bordered by private property both upstream and downstream and access is limited by high, steep banks and fences along the top of the banks. No flow was measured in either June or September, although a flow estimate of <0.01 cfs was recorded in September as water was observed moving across the apron of the crossing but was too shallow (0.01 m) and below the threshold of the flow monitoring equipment. Other than the concrete apron of the bridge crossing in June, no dry bed was observed. No other access points were observed along the 300-m reach. Table 4-3 describes the stream channel and riparian zone appearance of this site. [Photogroup 4-7](#) depicts the general appearance of the stream at this site.

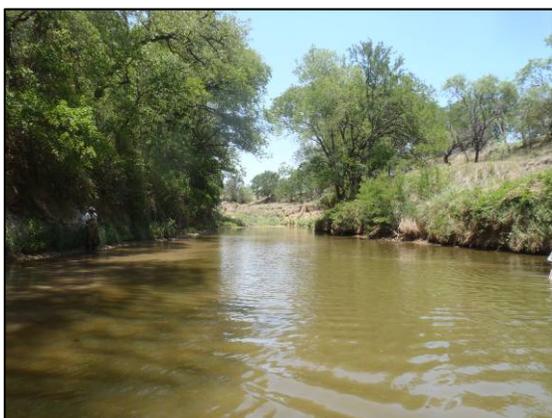
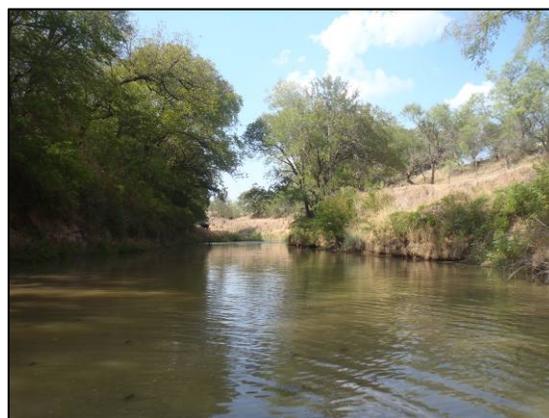
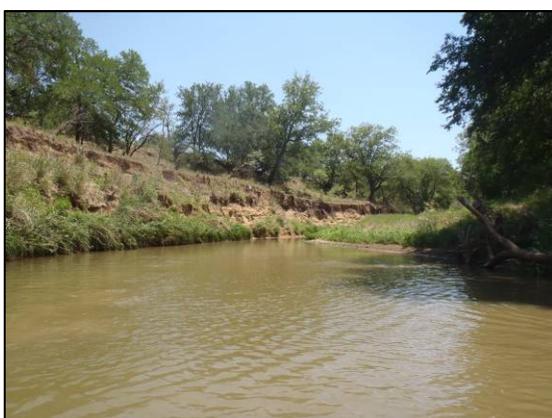
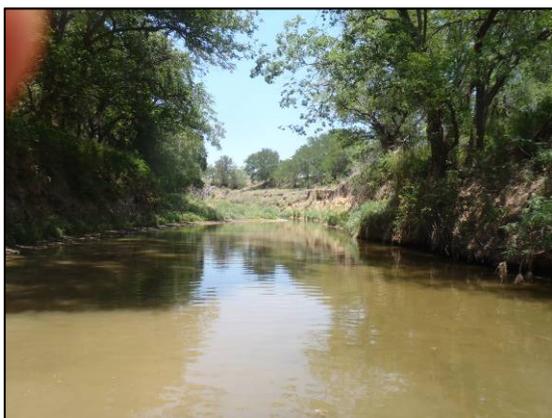
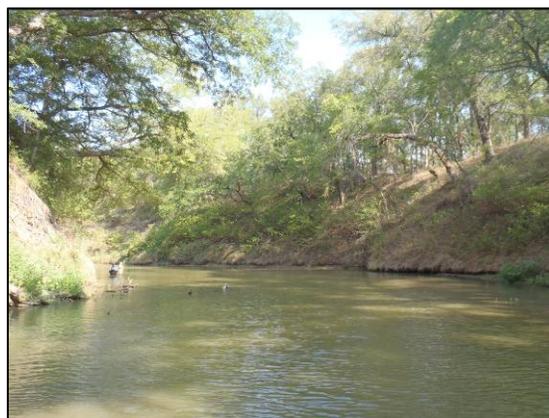
**Photogroup 4-9** Mid Pecan Bayou site MP003 illustrating the water color, general appearance and clarity of the water surface. Top Left – 60-m transect, June 2011; Top Right – 210-m transect, June 2011; Middle Left – 270-m transect, June 2011; Middle Right – 90-m transect, September 2011; Bottom Left – 120-m transect, June 2011; Bottom Right – 300-m transect, September 2011. [Return to Text](#)

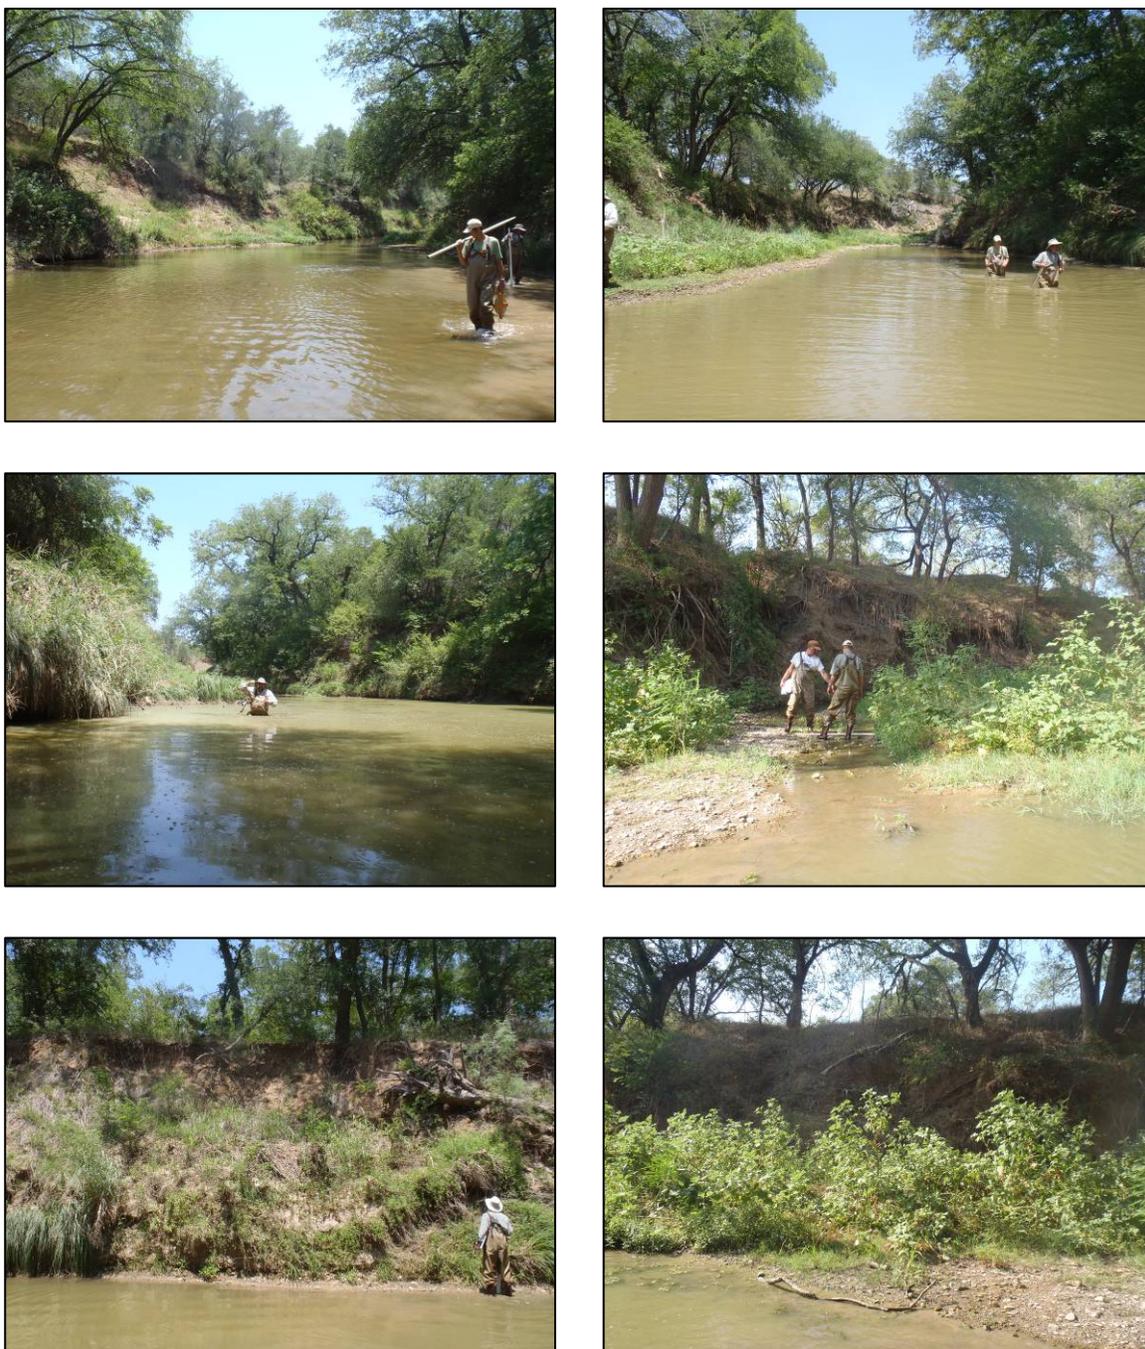
**Photogroup 4-10** Mid Pecan Bayou site MP004 depicting general appearance of the site (All individuals pictured are TIAER staff). Top Left – 0-m transect upstream, June 2011; Top Right – 0-m transect upstream, September 2011; Middle Left – 150-m transect upstream, June 2011; Middle Right – 150-m transect upstream, September 2011; Bottom Left – 270-m transect upstream, June 2011; Bottom Right – 300-m transect downstream, September 2011. [Return to Text](#)

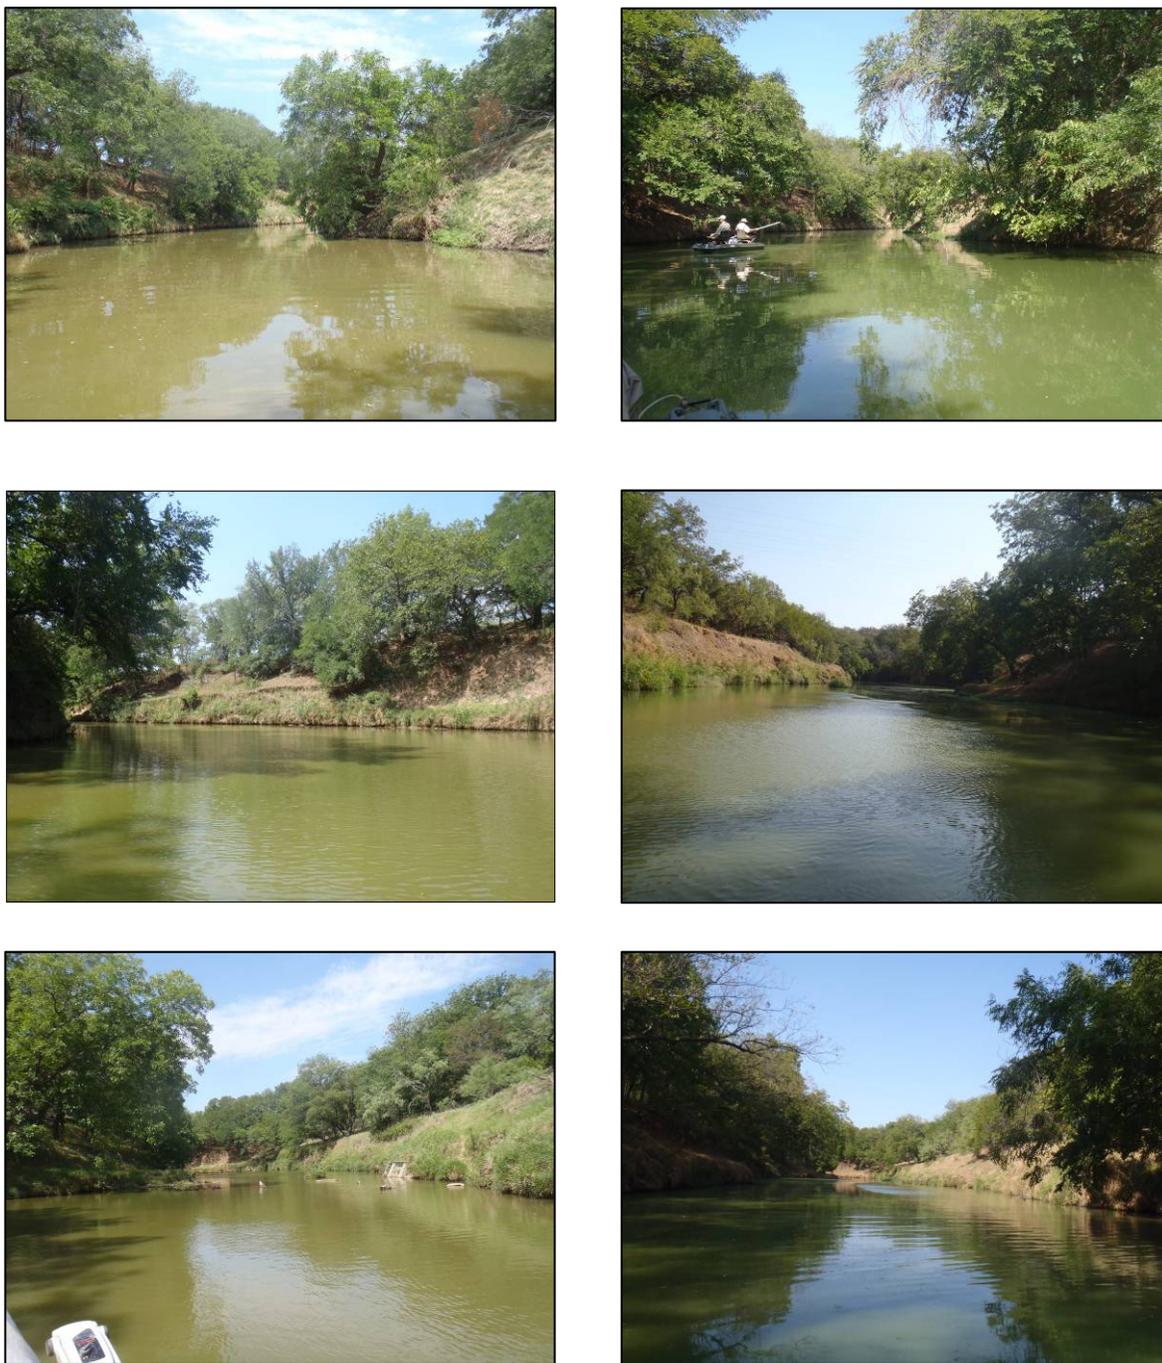
**Photogroup 4-12** Mid Pecan Bayou site MP004 illustrating the water color, general appearance and clarity of the water surface. Top Left – 240-m transect, June 2011; Top Right – 180-m transect, June 2011; Middle Left – 30-m transect, June 2011; Middle Right – 0-m transect, September 2011; Bottom Left – 150-m transect, September 2011; Bottom Right – 90-m transect, September 2011. [Return to Text](#)

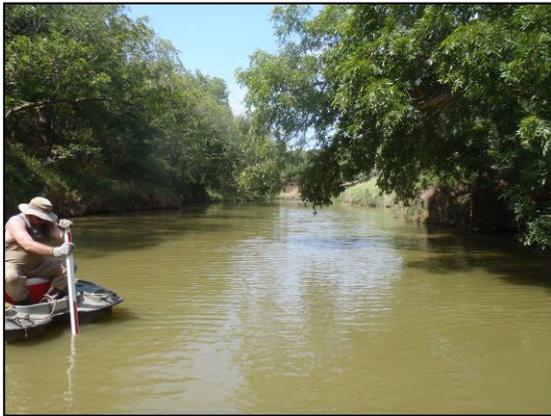
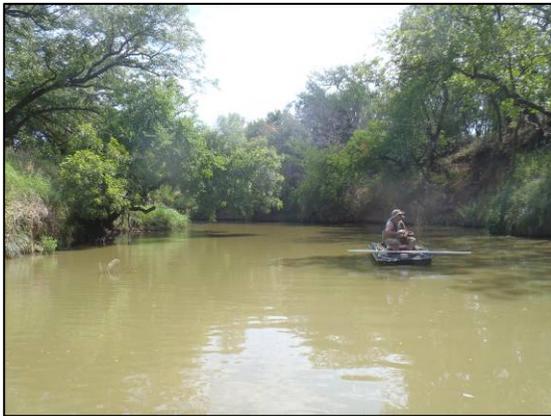
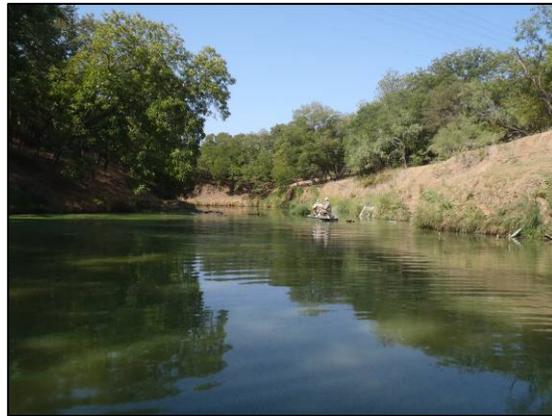
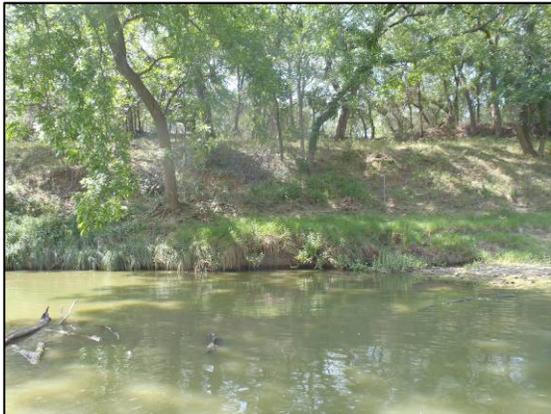
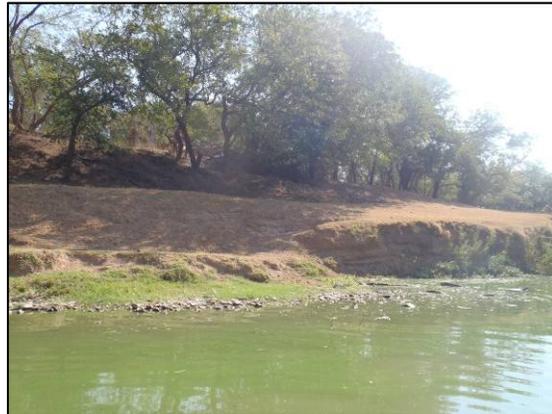
**Photogroup 4-13** Mid Pecan Bayou site MP005 depicting general appearance of the site (All individuals pictured are TIAER staff). Top Left – 0-m transect upstream, June 2011; Top Right – 0-m transect upstream, September 2011; Middle Left – 150-m transect downstream, June 2011; Middle Right – 150-m transect upstream, September 2011; Bottom Left – 240-m transect downstream, June 2011; Bottom Right – 300-m transect downstream, September 2011. [Return to Text](#)

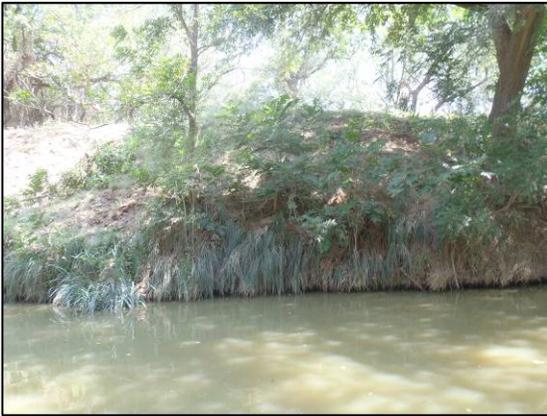
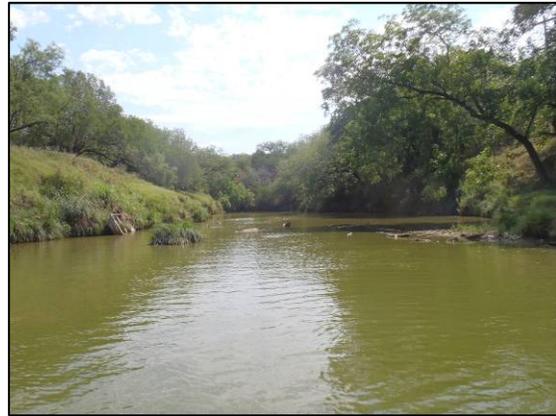
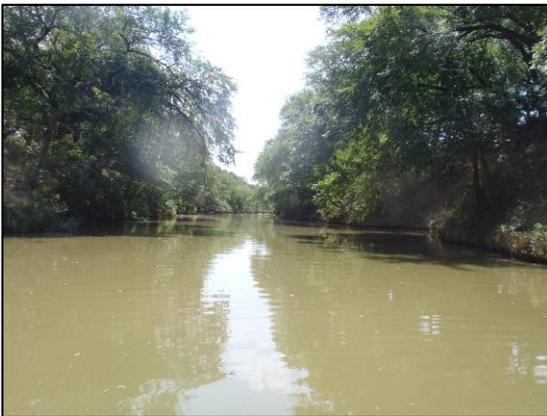
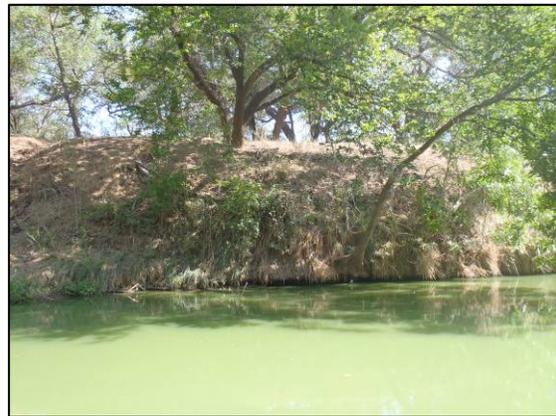
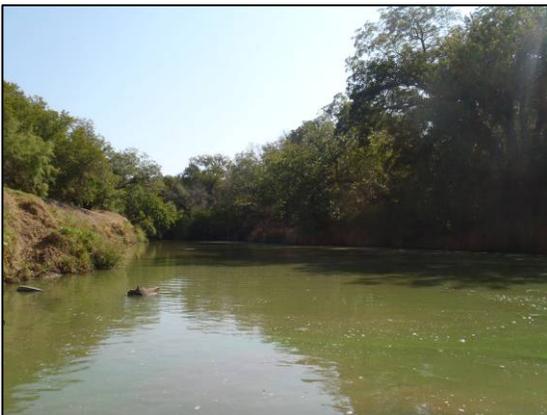
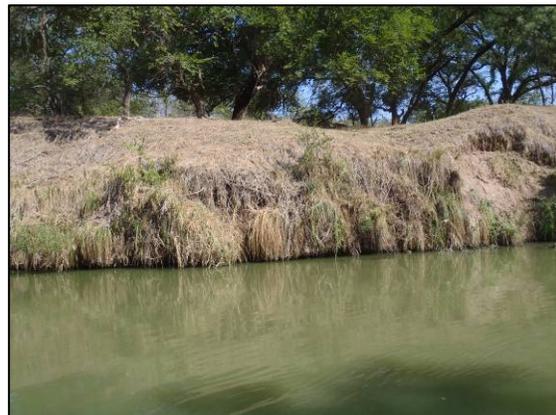
**Photogroup 4-14** Mid Pecan Bayou site MP005 depicting field staff in the stream and stream bank access (All individuals pictured are TIAER Staff). Top Left – 0-m transect, June 2011; Top Right – 0-m transect, September 2011; Middle Left – 30-m transect, June 2011; Middle Right – 240-m transect, September 2011; Bottom Left – 240-m bank access left, June 2011; Bottom Right – 90-m bank access left, September 2011. [Return to Text](#)

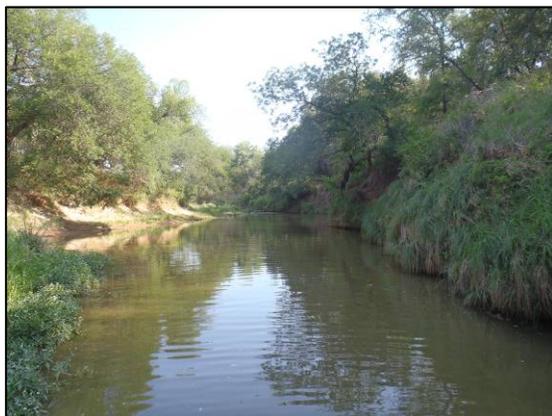
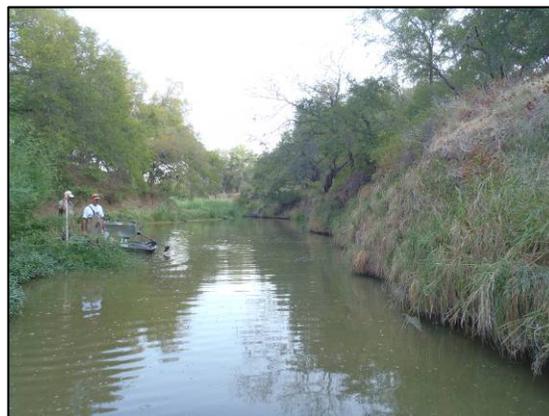
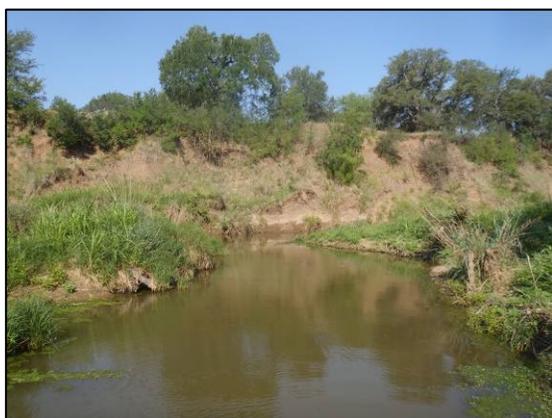
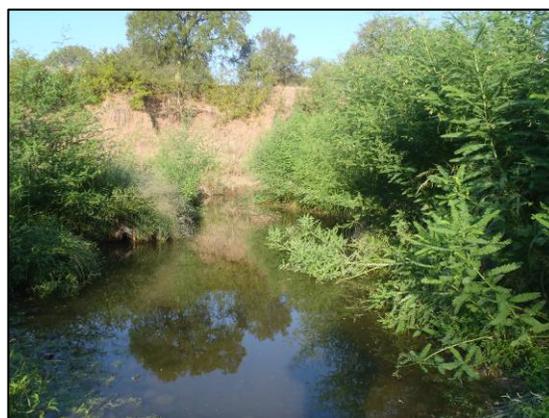
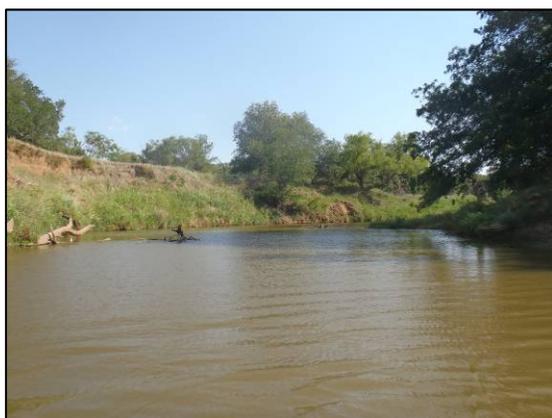
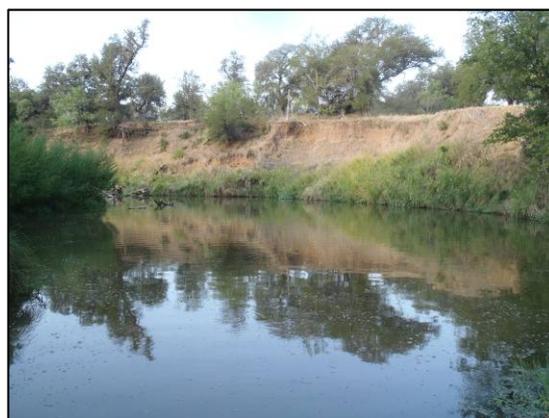
**Photogroup 4-15** Mid Pecan Bayou site MP005 illustrating the water color, general appearance and clarity of the water surface. Top Left – 0-m transect, June 2011; Top Right – 150-m transect, June 2011; Middle Left – 30-m transect, June 2011; Middle Right – 0-m transect, September 2011; Bottom Left – 210-m transect, September 2011; Bottom Right – 270-m transect, September 2011. [Return to Text](#)

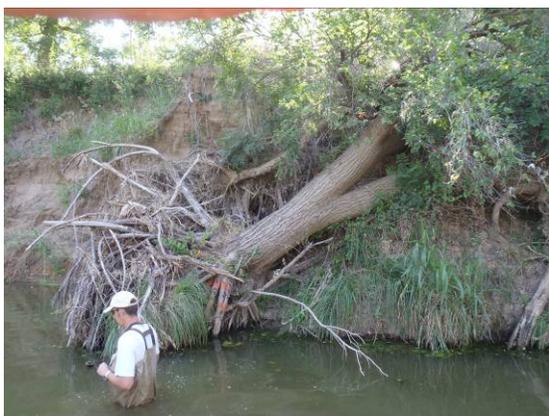
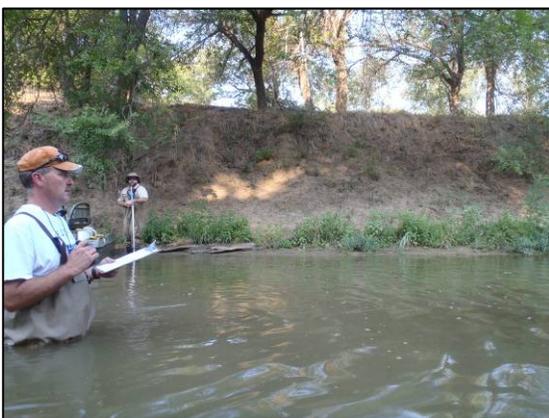
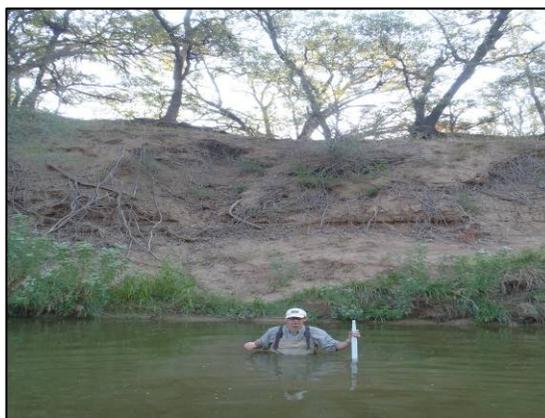
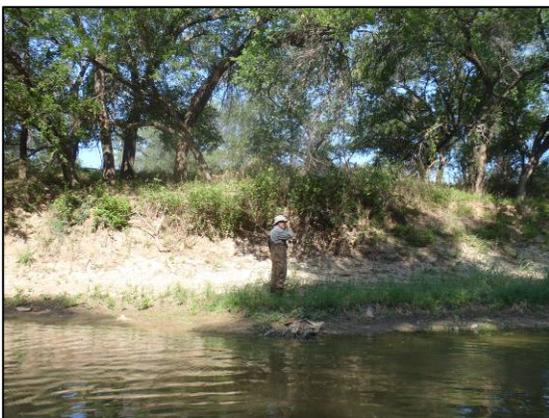
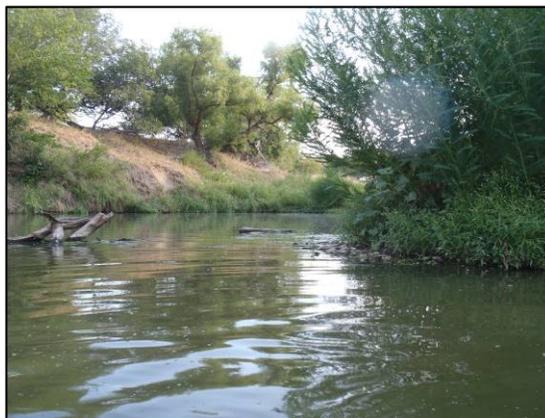
**Photogroup 4-16** Mid Pecan Bayou site MP006 depicting general appearance of the site (All individuals pictured are TIAER staff). Top Left – 0-m transect upstream, June 2011; Top Right – 0-m transect upstream, September 2011; Middle Left – 150-m transect upstream, June 2011; Middle Right – 150-m transect upstream, September 2011; Bottom Left – 210-m transect upstream, June 2011; Bottom Right – 300-m transect downstream, September 2011. [Return to Text](#)

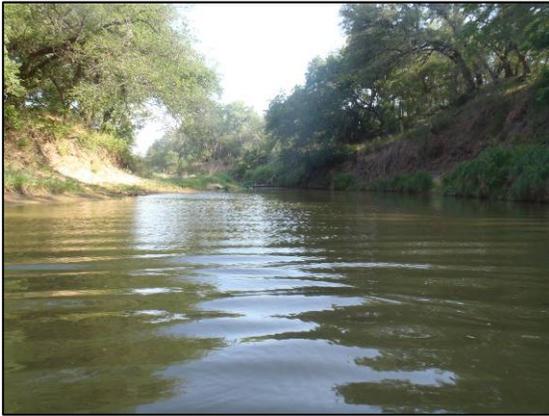
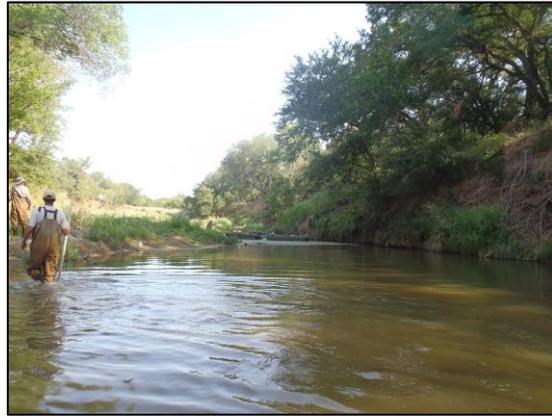
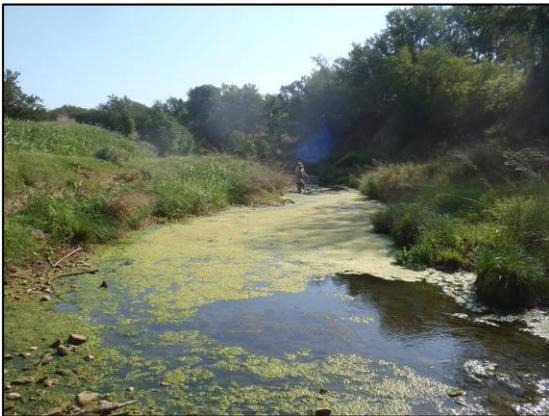
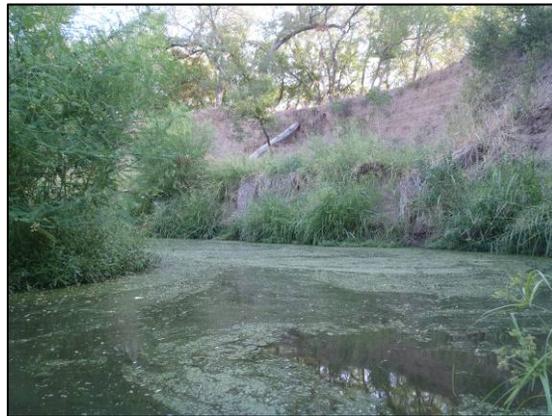
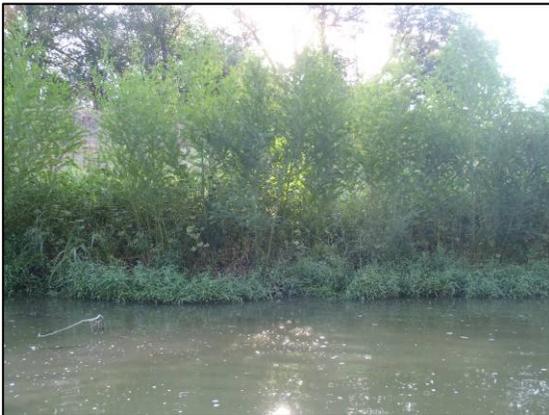
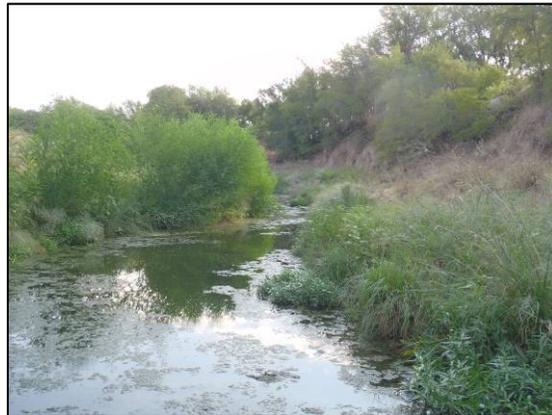
**Photogroup 4-17** Mid Pecan Bayou site MP006 depicting field staff in the stream and stream bank access (All individuals pictured are TIAER Staff). Top Left – 120-m transect, June 2011; Top Right – 0-m transect, September 2011; Middle Left – 30-m transect, June 2011; Middle Right – 60-m transect, September 2011; Bottom Left – 60-m bank access right, June 2011; Bottom Right – 270-m bank access, September 2011. [Return to Text](#)

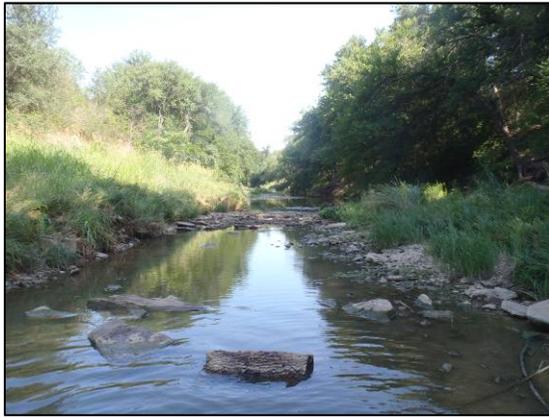
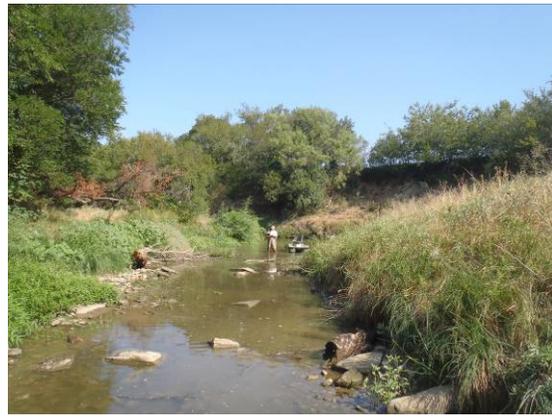
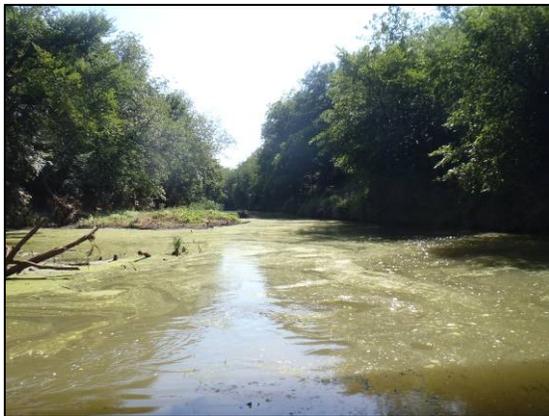
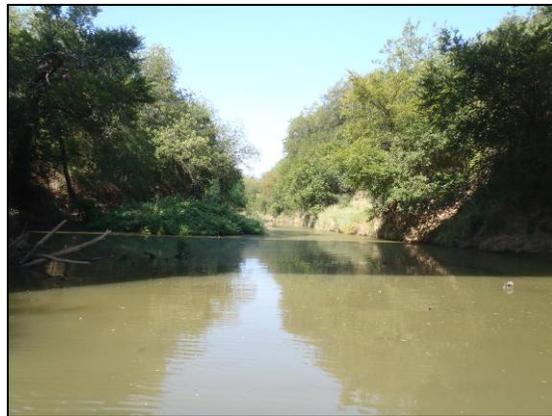
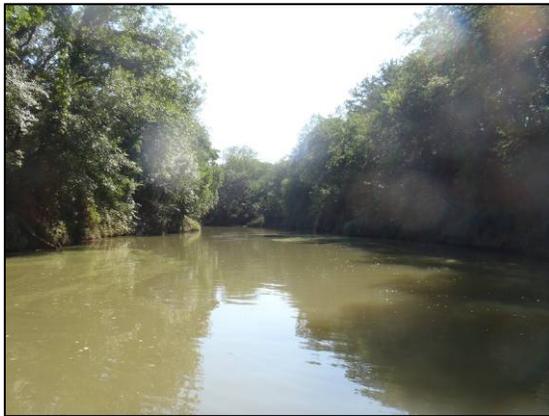
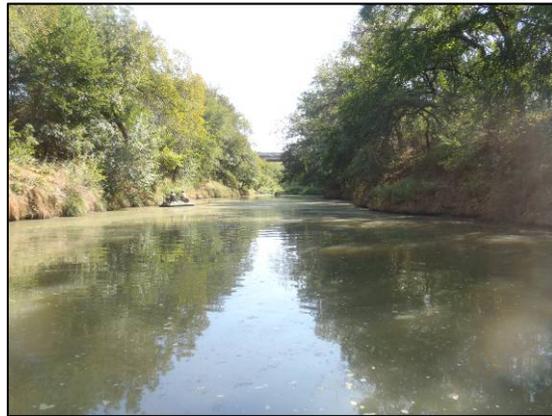
**Photogroup 4-18** Mid Pecan Bayou site MP006 illustrating the water color, general appearance and clarity of the water surface. Top Left – 30-m transect, June 2011; Top Right – 60-m transect, June 2011; Middle Left – 270-m transect, June 2011; Middle Right – 120-m transect, September 2011; Bottom Left – 240-m transect, September 2011; Bottom Right – 300-m transect, September 2011. [Return to Text](#)
