**Mid Pecan Bayou  
Recreational Use Attainability Analysis**

**Texas State Soil and Water Conservation Board  
Project 10-53**

**Texas Institute for Applied Environmental Research  
Tarleton State University  
Stephenville, Texas**

**January 2012**

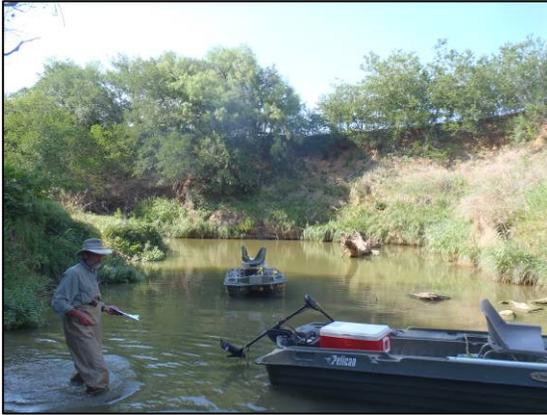
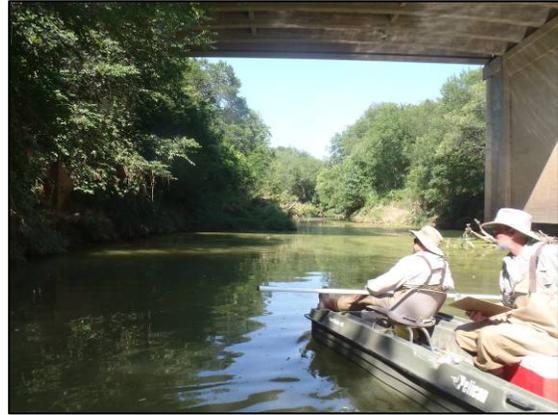
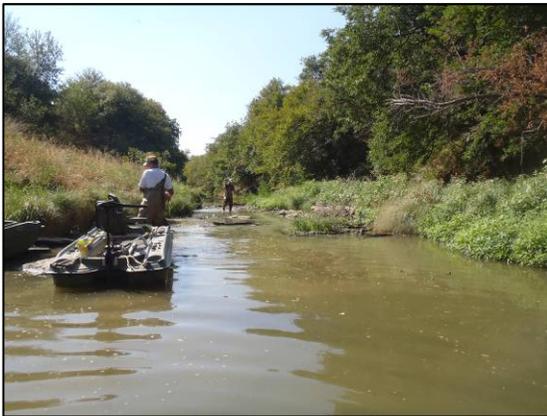
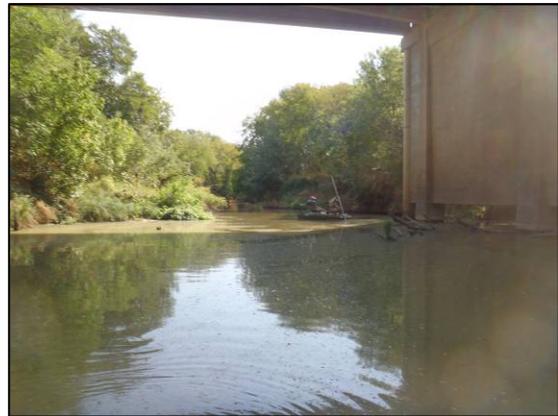
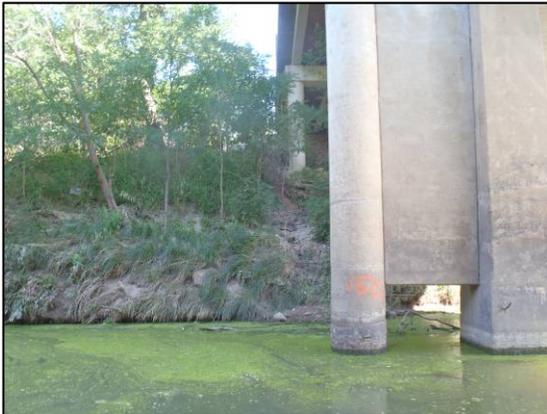
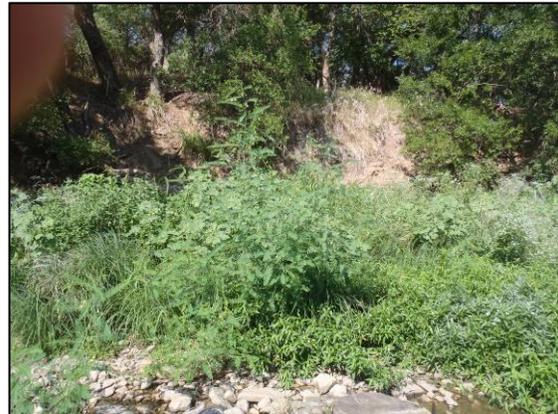
**Photogroup 4-19** Mid Pecan Bayou site MP007 depicting general appearance of the site (All individuals pictured are TIAER staff). Top Left – 0-m transect downstream, June 2011; Top Right – 0-m transect upstream, September 2011; Middle Left – 150-m transect upstream, June 2011; Middle Right – 150-m transect upstream, September 2011; Bottom Left – 210-m transect upstream, June 2011; Bottom Right – 300-m transect downstream, September 2011. [Return to Text](#)

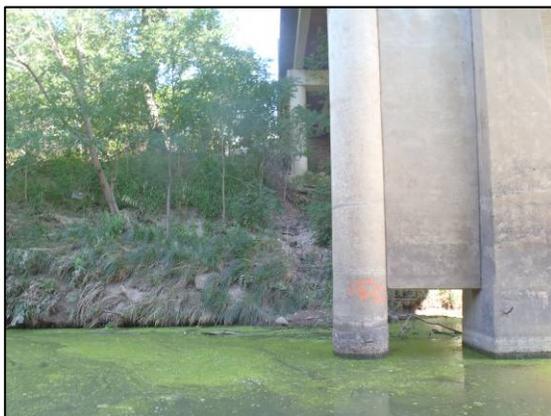
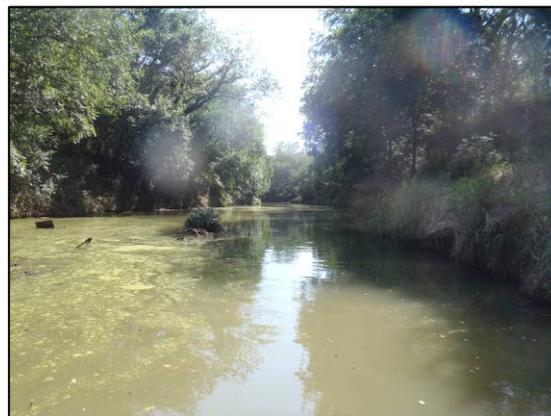
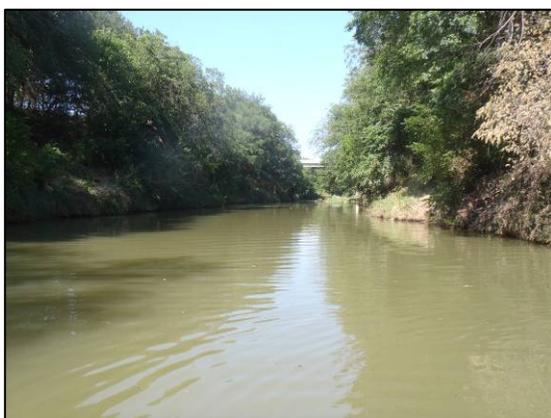
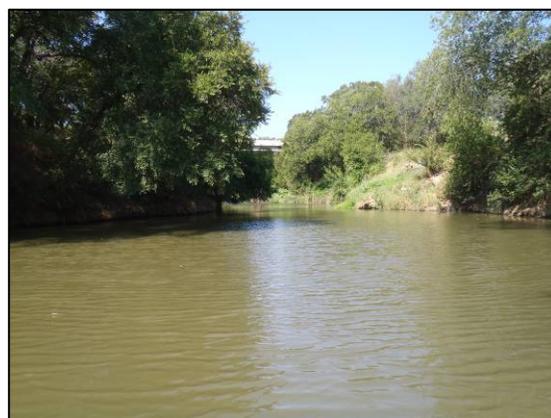
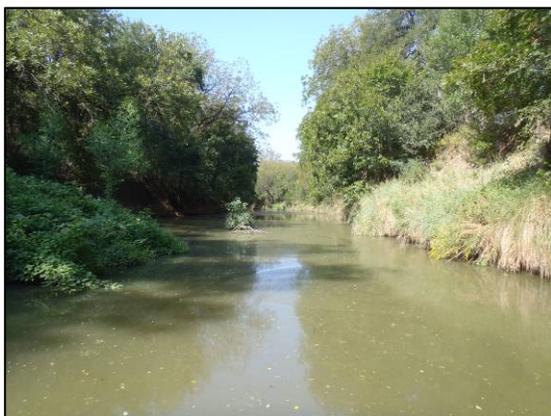
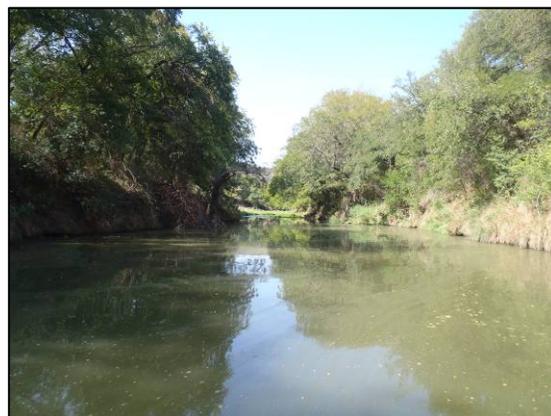
**Photogroup 4-20** Mid Pecan Bayou site MP007 depicting field staff in the stream and stream bank access (All individuals pictured are TIAER Staff). Top Left – 0-m transect, June 2011; Top Right – 180-m transect, September 2011; Middle Left – 30-m transect, June 2011; Middle Right – 150-m transect, September 2011; Bottom Left – 150-m bank access right, June 2011; Bottom Right – 0-m bank access right, September 2011. [Return to Text](#)

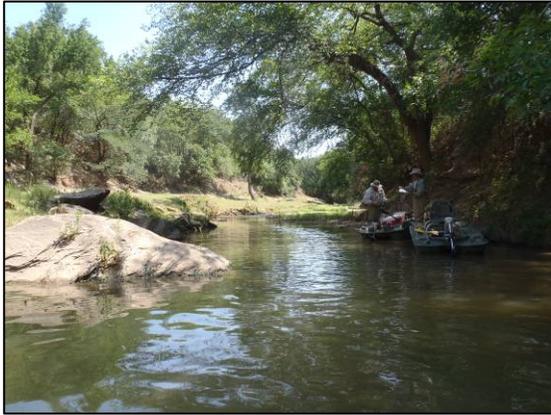
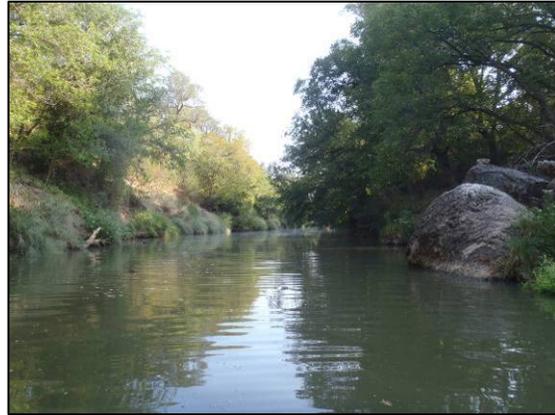
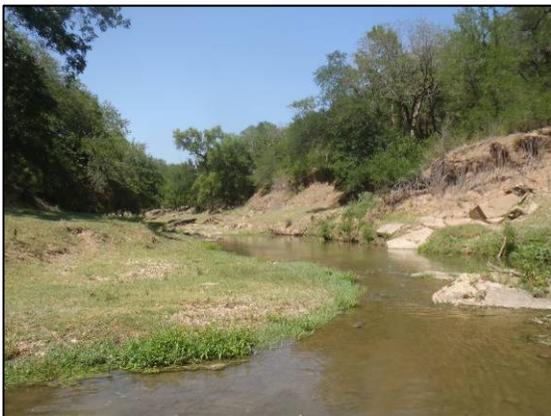
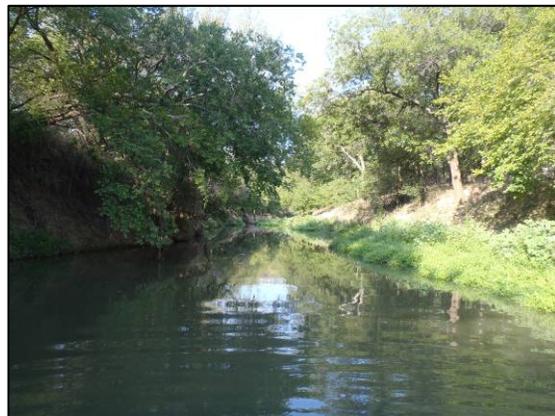
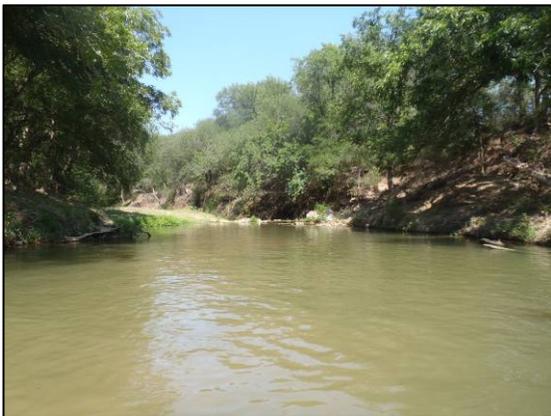
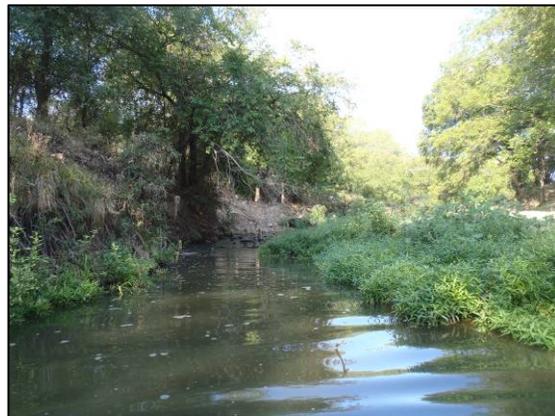
**Photogroup 4-21** Mid Pecan Bayou site MP007 illustrating the water color, general appearance and clarity of the water surface. Top Left – 150-m transect, June 2011; Top Right – 180-m transect, June 2011; Middle Left – 300-m transect, June 2011; Middle Right – 60-m transect, September 2011; Bottom Left – 180-m transect, September 2011; Bottom Right – 270-m transect, September 2011. [Return to Text](#)

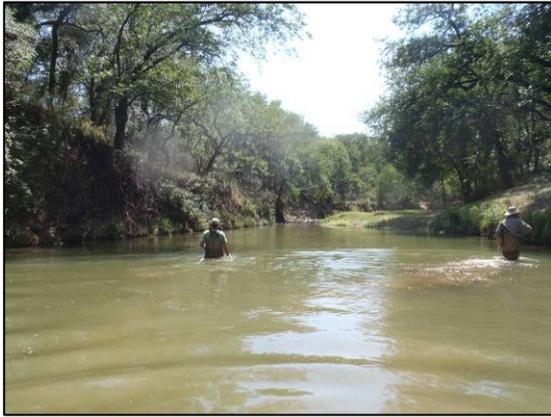
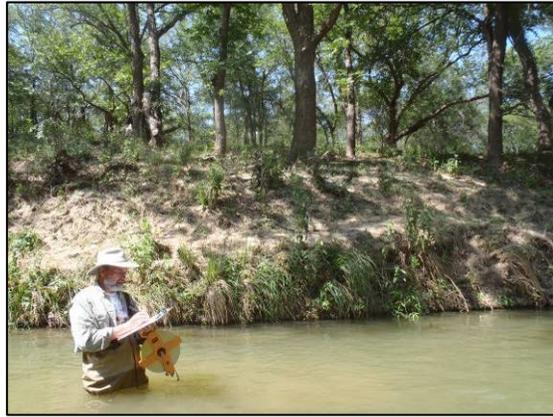
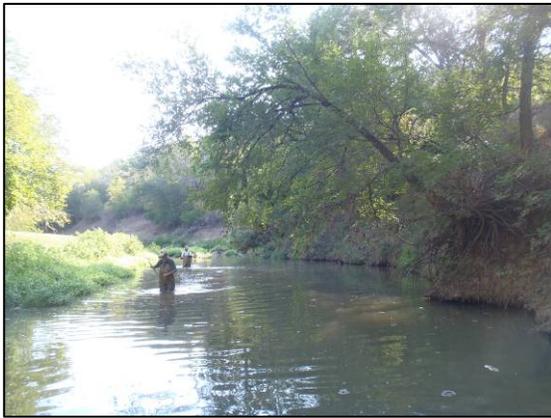
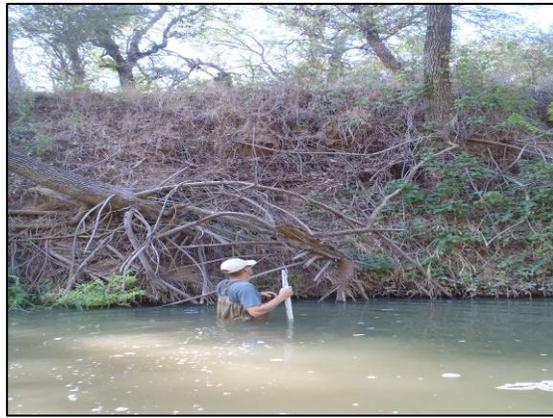
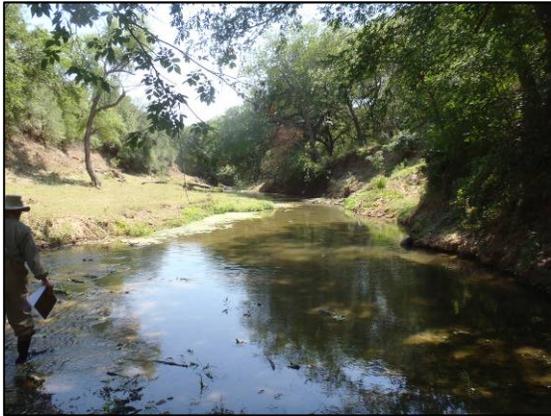
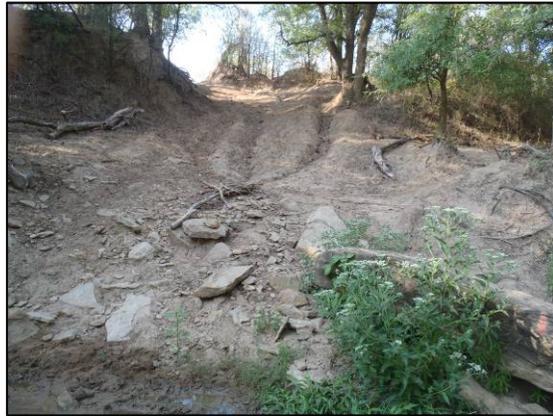
**Photogroup 4-22** Mid Pecan Bayou site MP008 depicting general appearance of the site (All individuals pictured are TIAER staff). Top Left – 0-m transect upstream, June 2011; Top Right – 0-m transect downstream, September 2011; Middle Left – 150-m transect downstream, June 2011; Middle Right – 150-m transect upstream, September 2011; Bottom Left – 300-m transect downstream, June 2011; Bottom Right – 240-m transect upstream, September 2011. [Return to Text](#)

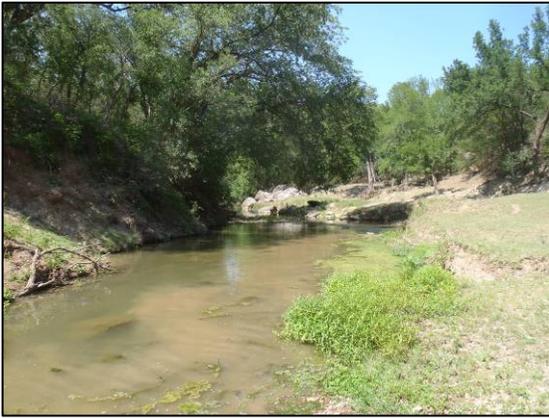
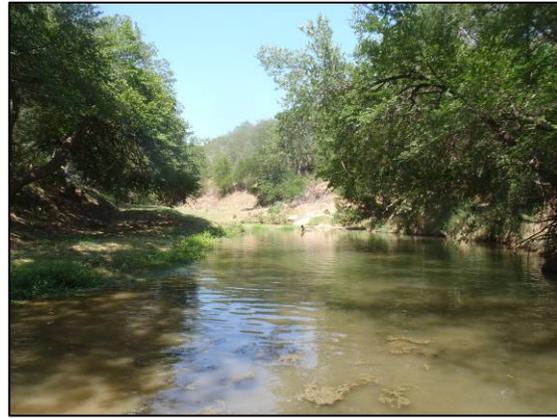
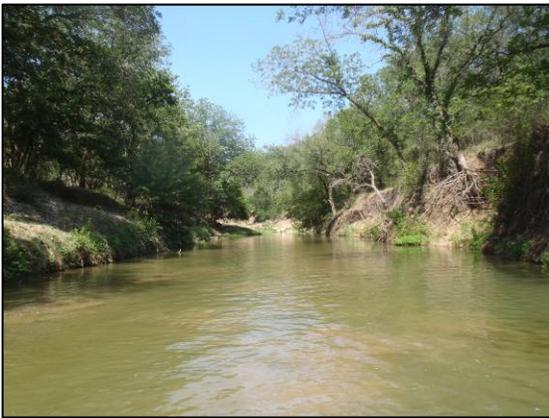
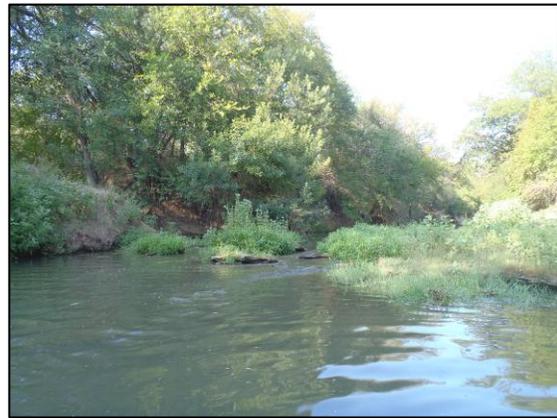
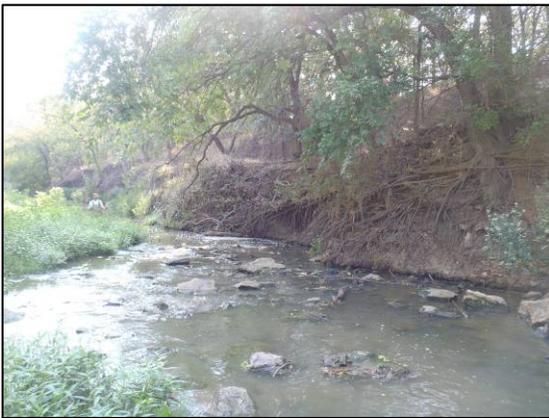
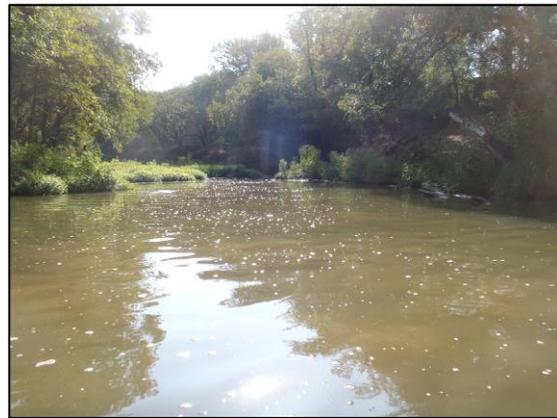
**Photogroup 4-23** Mid Pecan Bayou site MP008 depicting field staff in the stream and stream bank access (All individuals pictured are TIAER Staff). Top Left – 210-m transect, June 2011; Top Right – 300-m transect, September 2011; Middle Left – 180-m transect, June 2011; Middle Right – 210-m transect, September 2011; Bottom Left – 30-m bank access right, June 2011; Bottom Right – 270-m bank access right, September 2011. [Return to Text](#)

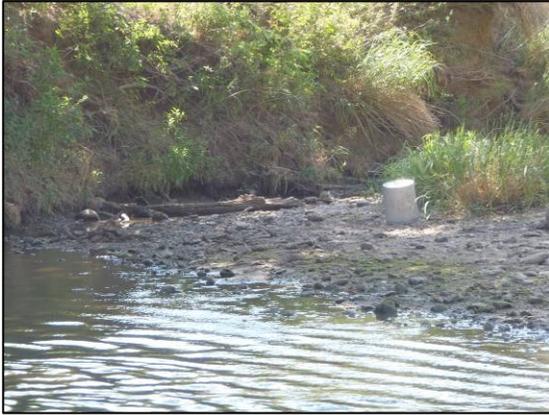
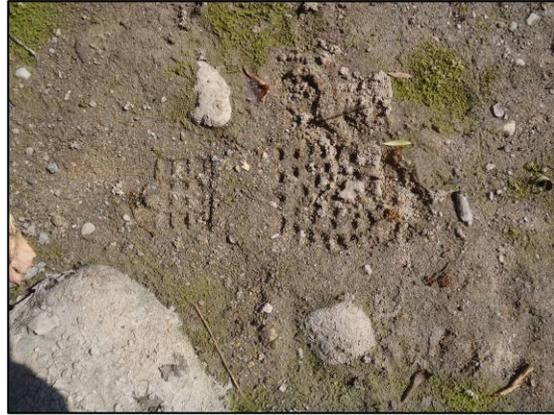
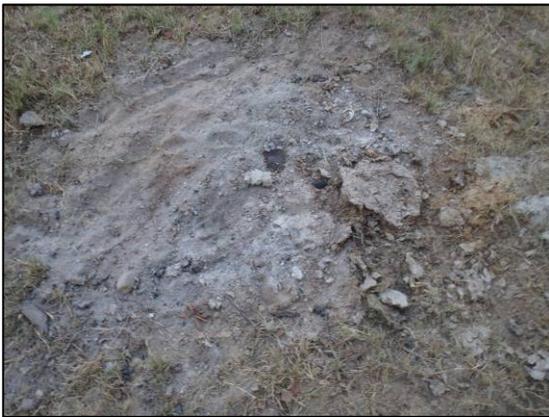
No contact (primary or secondary) or noncontact recreational activities were observed by TIAER employees at any of the sites during the field surveys. At site MP002, a shoe print was observed in the stream bed near an inverted 5-gallon bucket during the June 2011 field survey. It is not known if the bucket had been used as a seat or not. Only one shoe print was observed in the area of the bucket at the site. In addition, during the September 2011 field survey, remnants of a campfire were found just below the bottom transect of the reach. [Photogroup 5-1](#) illustrates the aforementioned items.

**Photogroup 5-1** Mid Pecan Bayou site MP002 illustrating the inverted 5-gallon bucket, the single shoe print located near the bucket, and the remnants of a campfire. [Return to Text](#)

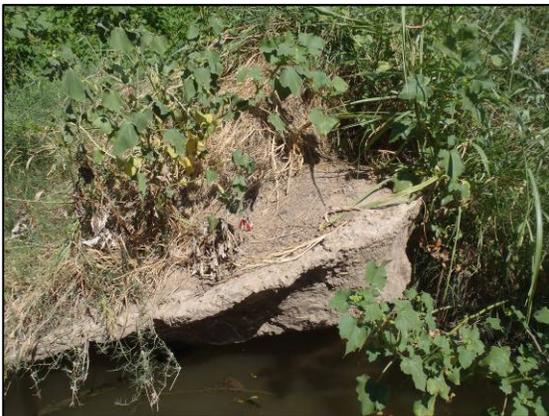
Possible evidence of fishing was observed at site MP007 in the form of a fishing bobber found downstream of the bridge crossing. It is not known if it washed in from upstream or was lost at the site. During the second visit, a fishing lure was observed on a rock at the 150-m transect, directly underneath the bridge at site MP007. Field personnel who observed the lure did not have a camera; therefore, a picture was not collected. [Photogroup 5-2](#) shows the fishing bobber.

**Photogroup 5-2** Mid Pecan Bayou site MP007 illustrating the fishing bobber located on the piece of concrete. [Return to Text](#)

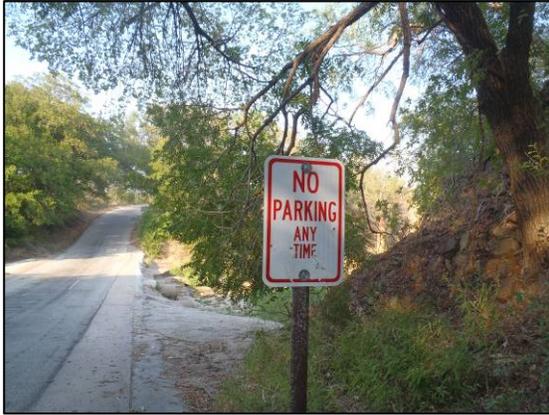
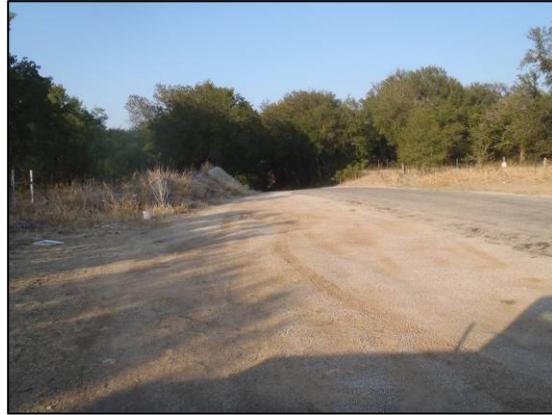
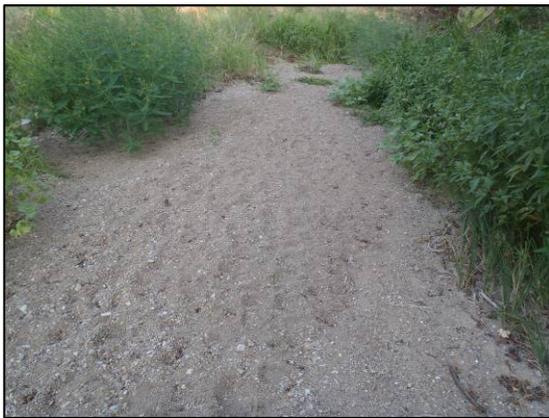
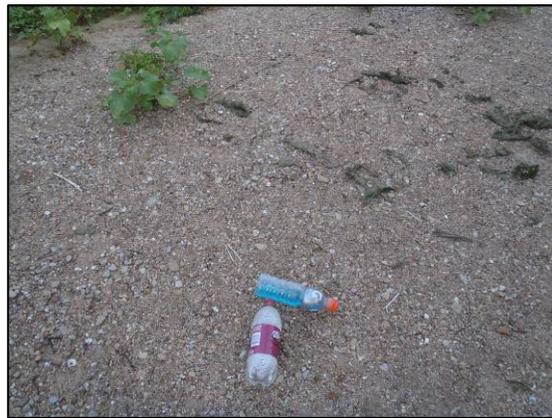
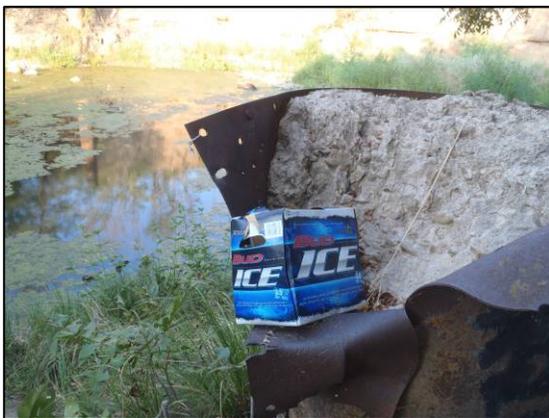
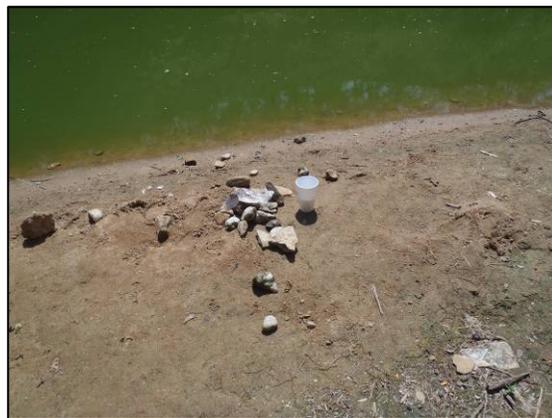
**Photogroup 5-3** Mid Pecan Bayou site MP003 showing the no parking sign, parking area, walking path, and beverage containers. [Return to Text](#)

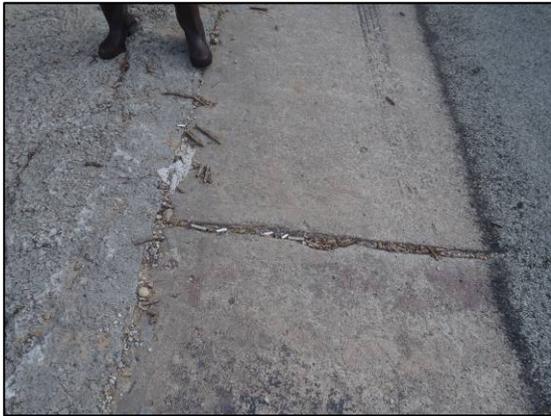
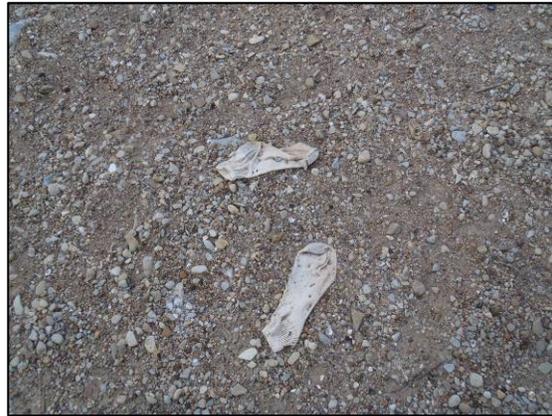
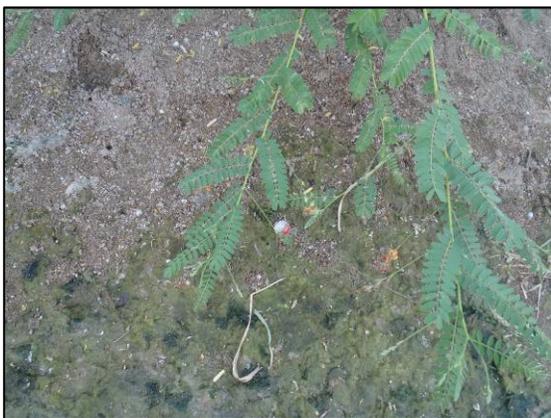
At site MP003, evidence of use was observed by TIAER personnel during both of the field surveys. Although there is a no parking sign along Brown CR 257 prohibiting parking on the low water crossing over Mid Pecan Bayou, a small, graveled parking area is located at the top of the hill west of the Bayou. Downstream from the low water crossing, a well-used path leads to a gravel bar suitable for access to the Bayou. It was in this area that human tracks and trash were observed during both surveys [Photogroup 5-3](#). While these observations indicate the site appears to be used and has public access, the gravel bar, path, and trash are all on private property downstream of the public road crossing. The trash included beverage cups and bottles, cigarette butts and a pair of socks. The only evidence of fishing was a bobber that was found during the second trip. [Photogroup 5-4](#) illustrates the aforementioned observations.

**Photogroup 5-4** Mid Pecan Bayou site M003 showing cigarette butts, a pair of socks and a fishing bobber. (TIAER field personnel in upper left photograph). [Return to Text](#)
