FINAL REPORT

EROSION AND SEDIMENT CONTROL WITH VEGETATIVE BARRIERS

Cooperative Agreement No. 96-7

**KIKA DE LA GARZA PLANT MATERIALS CENTER
KINGSVILLE, TEXAS
2000**

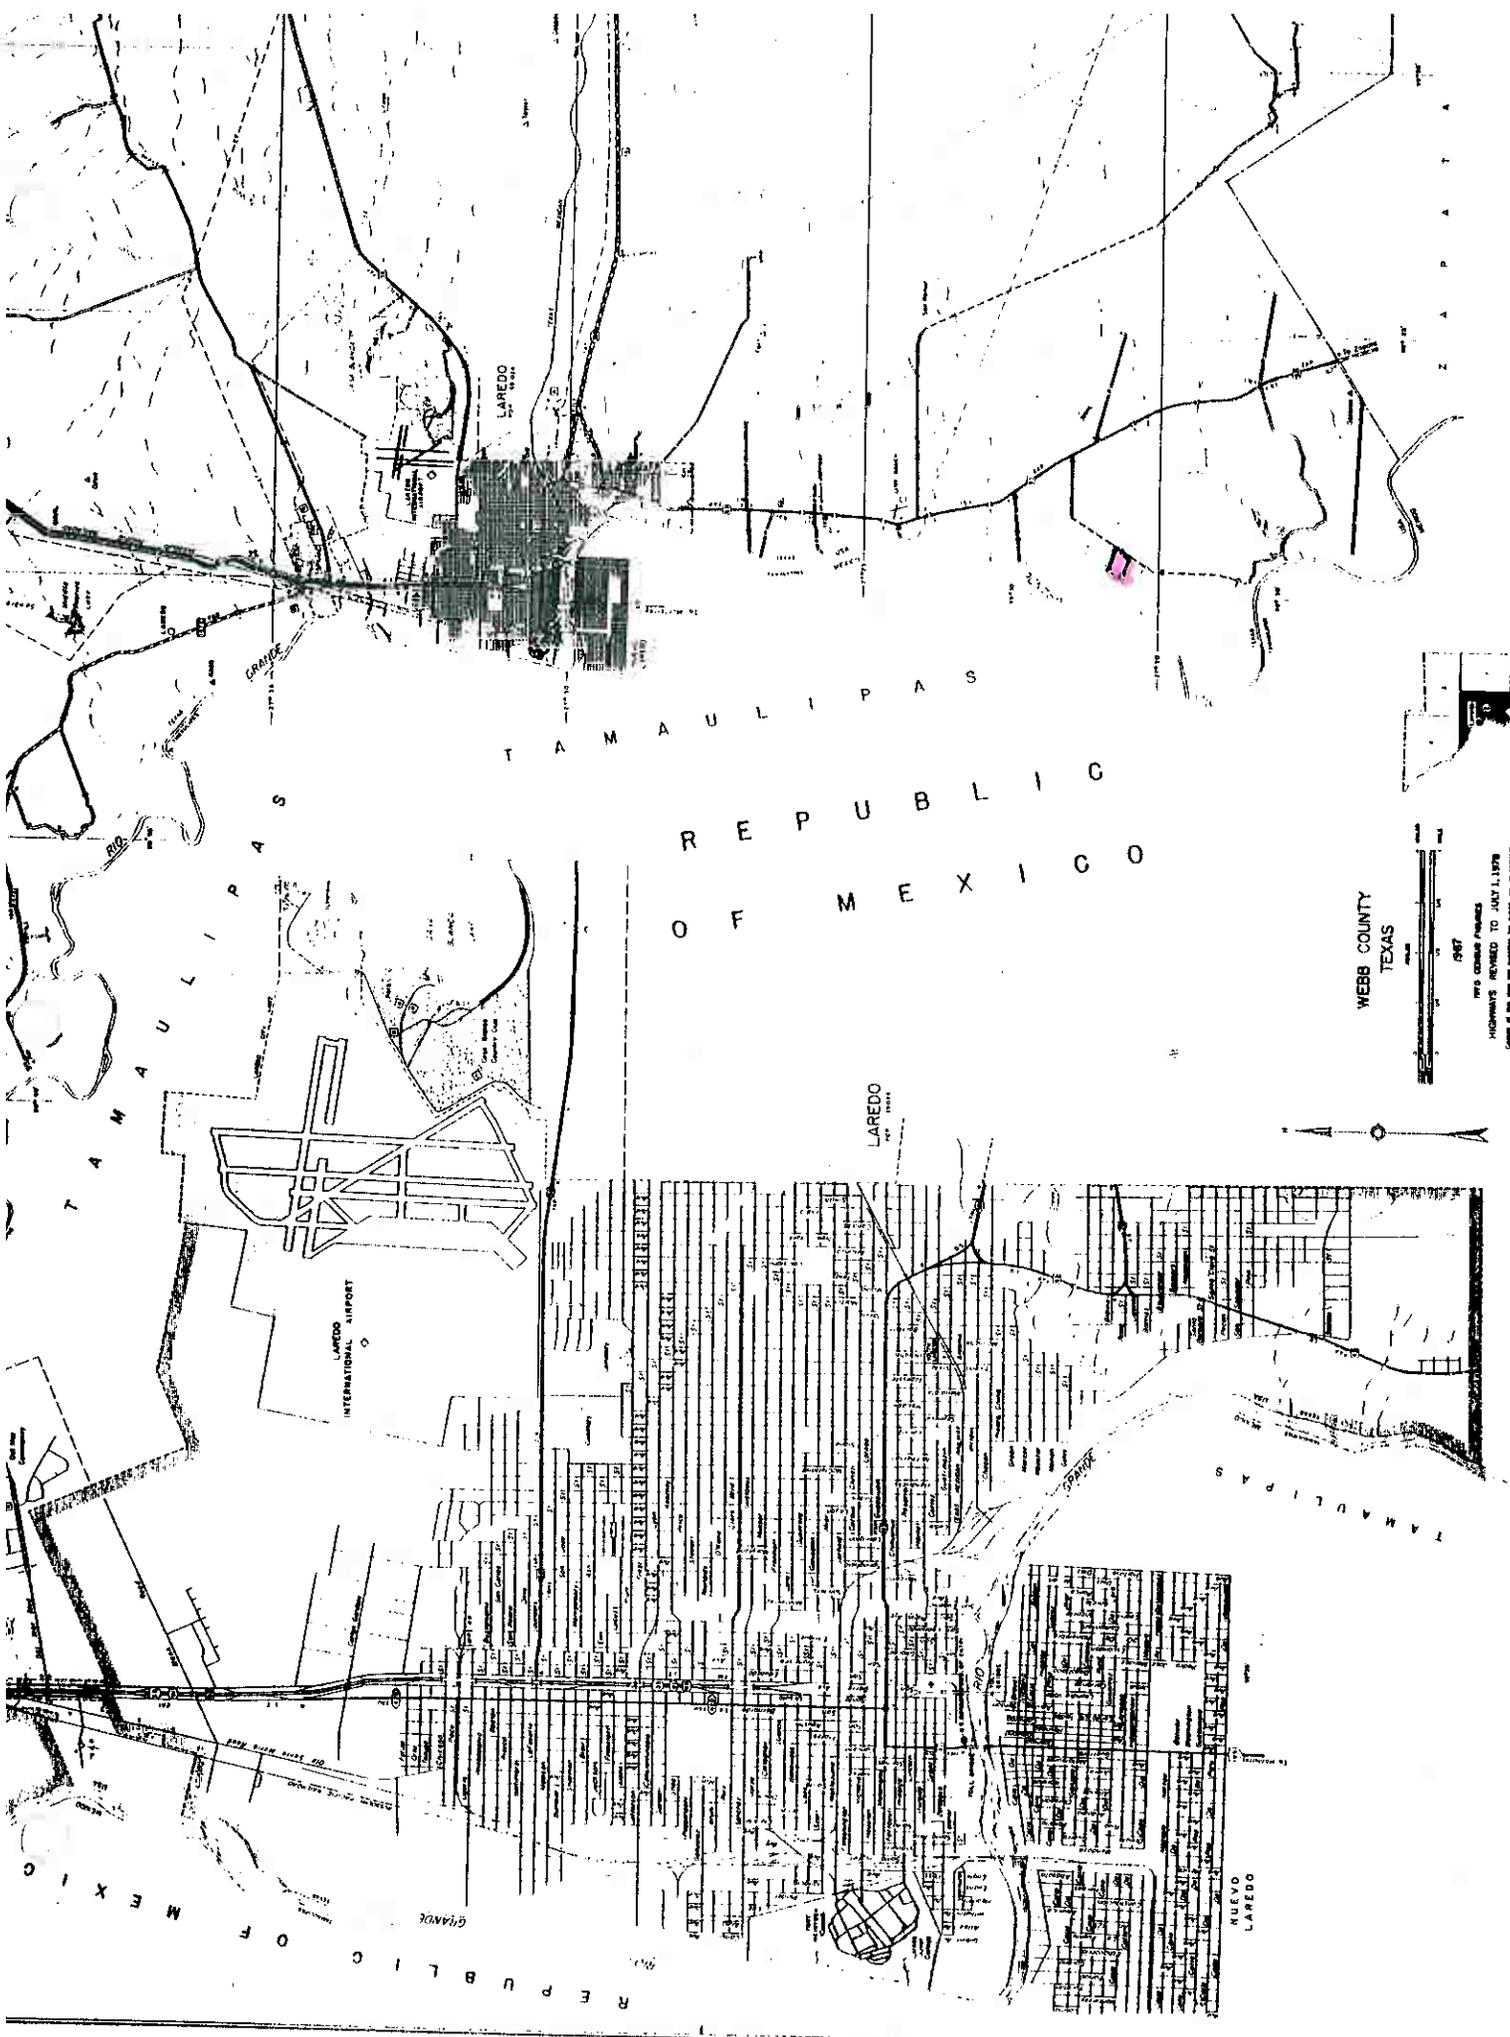
WEBB COUNTY
TEXAS

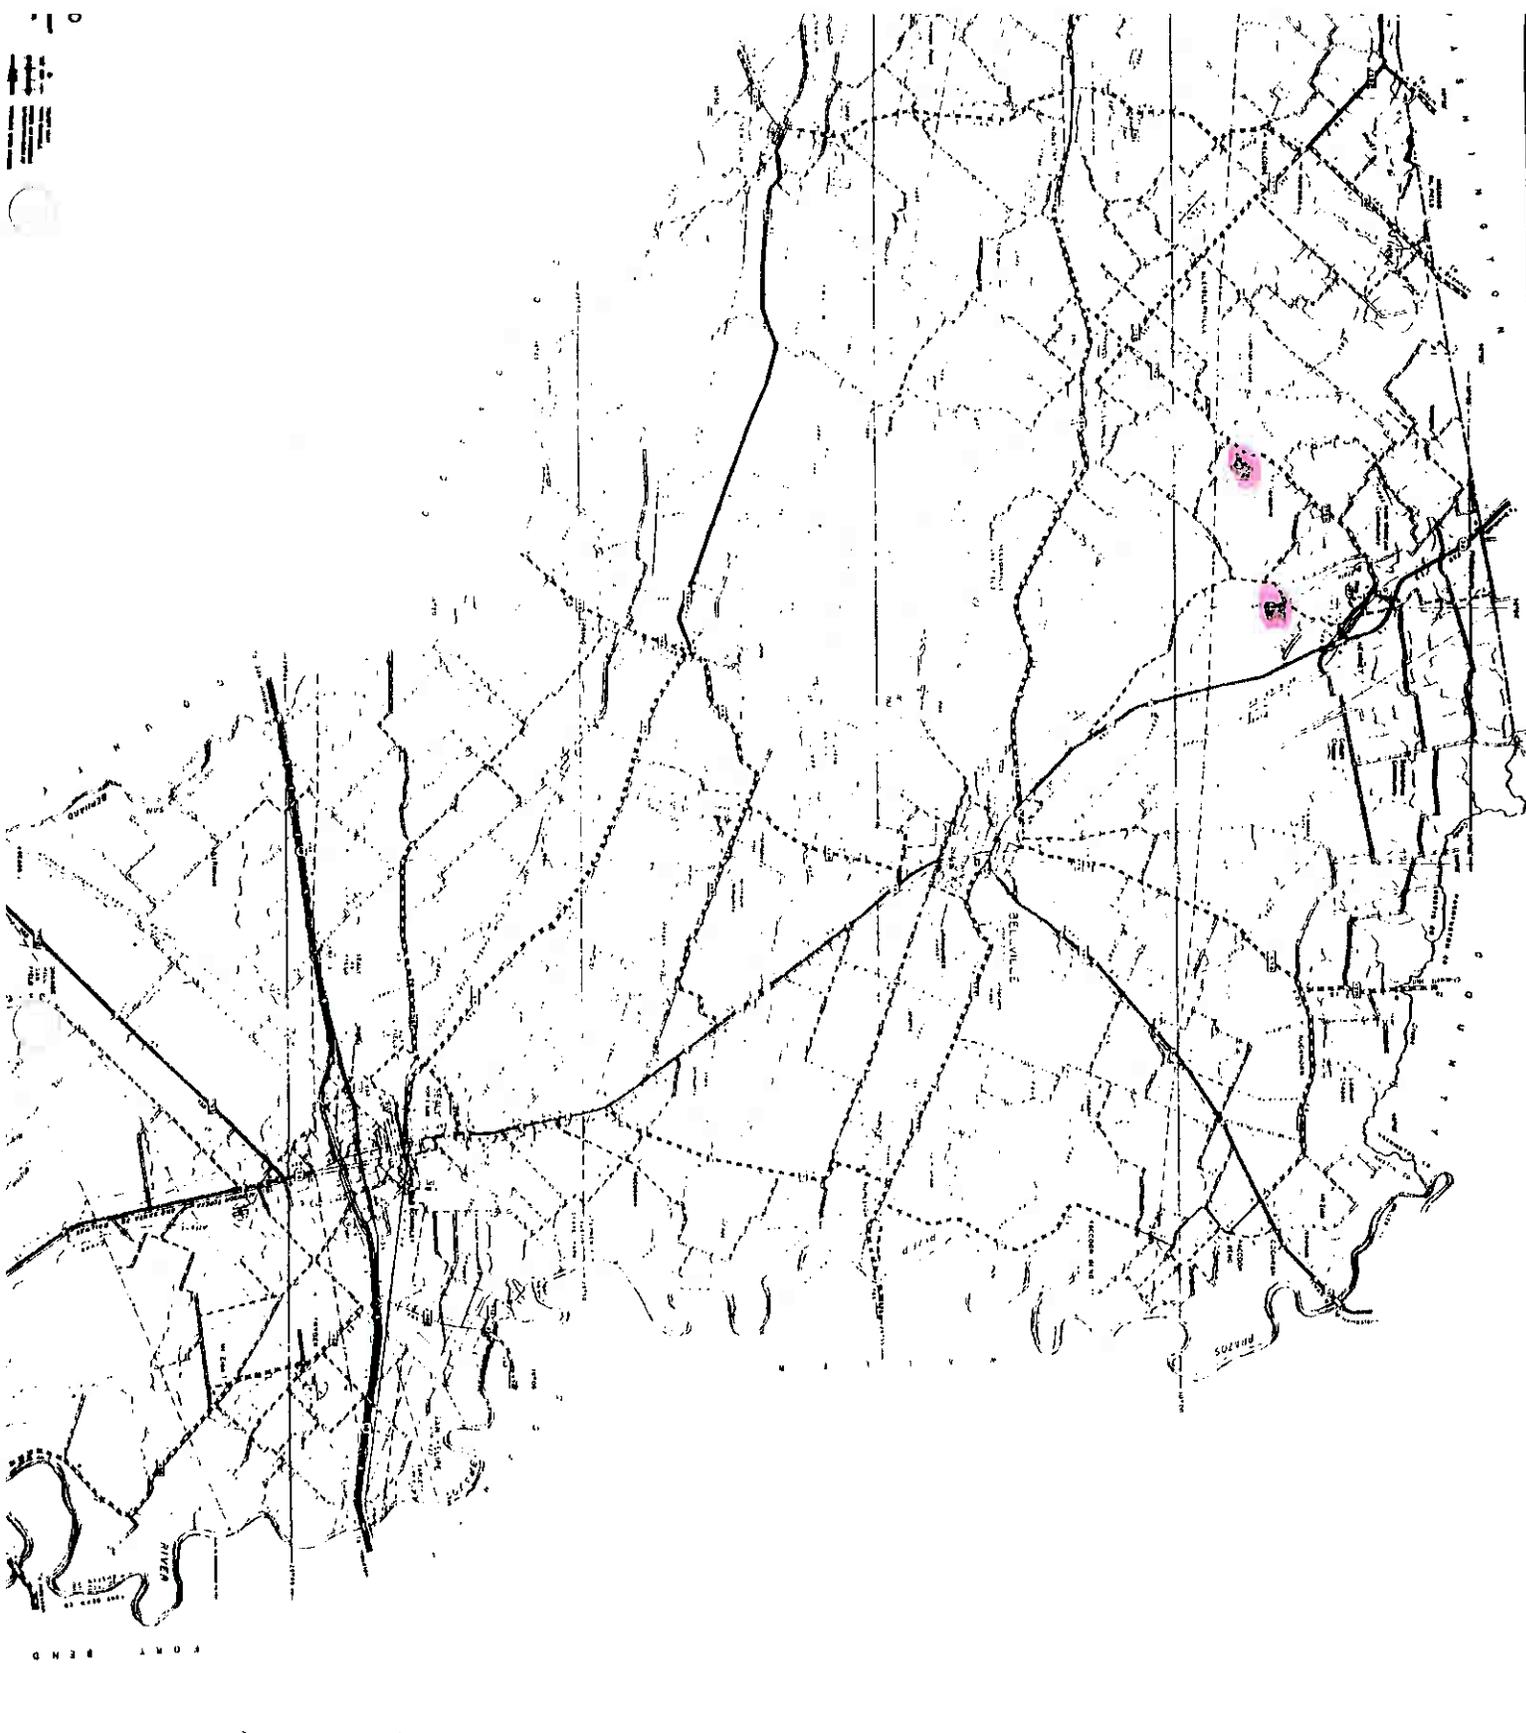
AUSTIN COUNTY

GENERAL HIGHWAY M
AUSTIN COUN
TEXAS

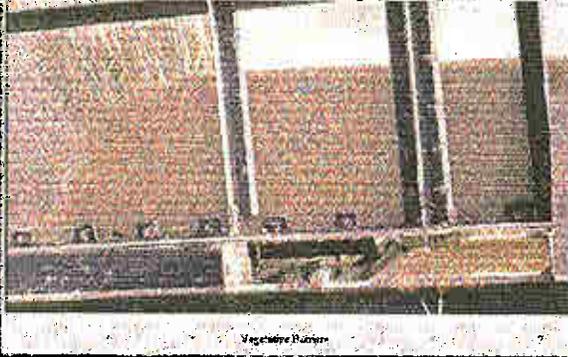
Narrow stiff-grass barriers can cause backwaters over a foot deep, spreading runoff

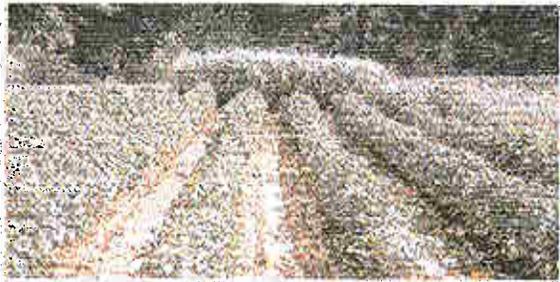
On standard USLE scale plots, 70% of silt loam sediment was trapped, runoff was reduced as much as by no-till management.

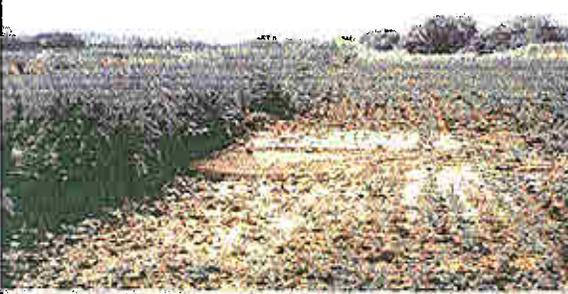
Sediment deposited upslope of barriers and soil moved from shoulders by tillage gradually level flow areas

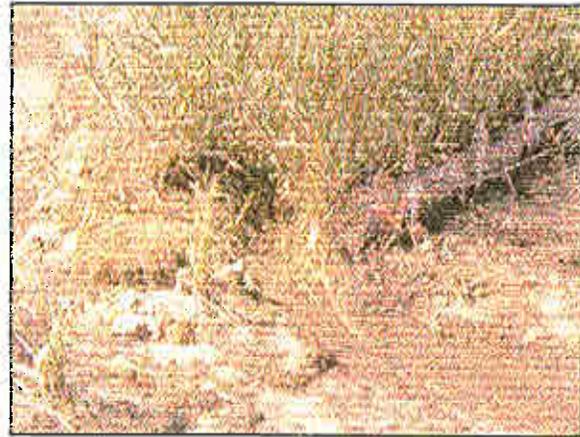
- 50 stems per square foot in all barriers
- $N \times D^2 > 0.1$ to resist concentrated runoff
- Example:
 - N = 70 stems ft²
 - D = diameter of 0.2 inches
 - $70 \times 0.2^2 = 0.112$ (exceeds the 0.1 criteria)
- Mowing decreases average stem diameter

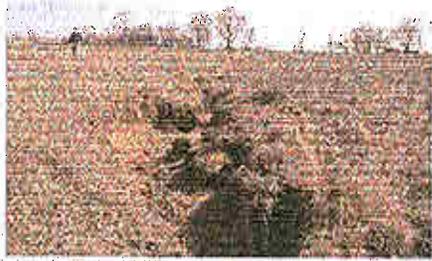
Ephemeral gullies can grow if unchecked, even in no-till fields with low sediment yield

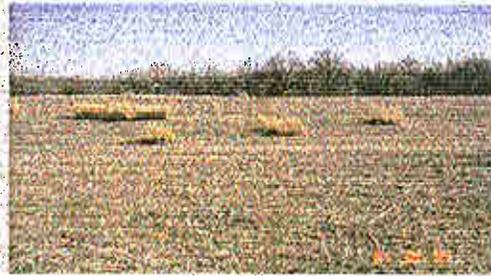
Discrete hedge segments can trap residues and control ephemeral gullies in no-till fields

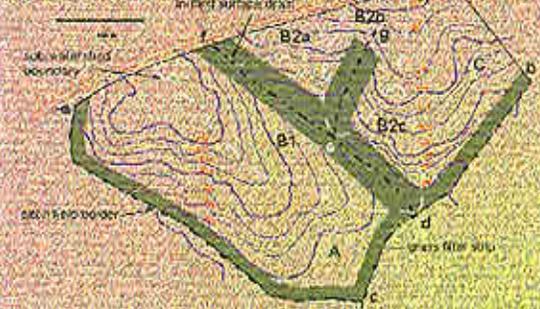
Filter Strip Design of Hills and Hedges (NSZ)

20-m (66 ft) wide filter strips on 1% grade
on both side of drainage ways

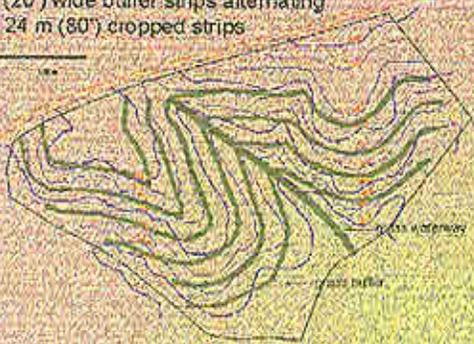
Buffer Strip Design

6-m (20') wide buffer strips alternating
with 24 m (80') cropped strips

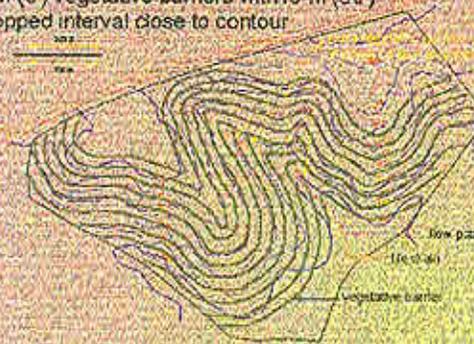
Paralleled Contour Vegetative Barrier Design

2-m (6') vegetative barriers with 15-m (50')
cropped interval close to contour

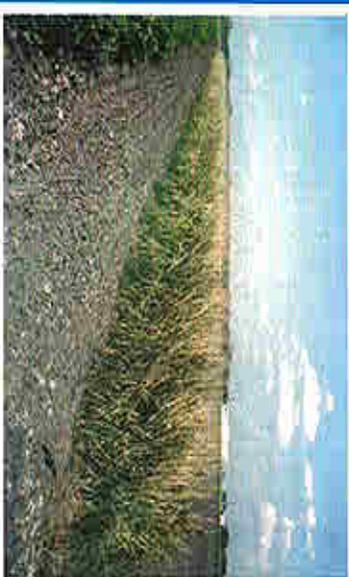
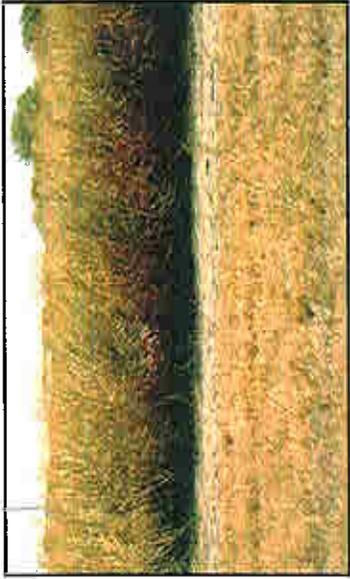
Erosion Control

Vegetative barriers are narrow strips (1 -3 feet wide) of stiff, erect, densely growing plants, usually grasses, planted across the slope perpendicular to the dominant slope. Vegetative barriers stair-step water down the hillside. These barriers retard surface runoff, slowing and ponding water and capturing and preventing sediment from flowing downhill.
