Water Quality Monitoring in the Buck Creek Watershed and Facilitation of Buck Creek Watershed Partnership: Final Report

Water Quality Monitoring in the Buck Creek Watershed and Facilitation of Buck Creek Watershed Partnership

Final Report

TSSWCB Project 10-06

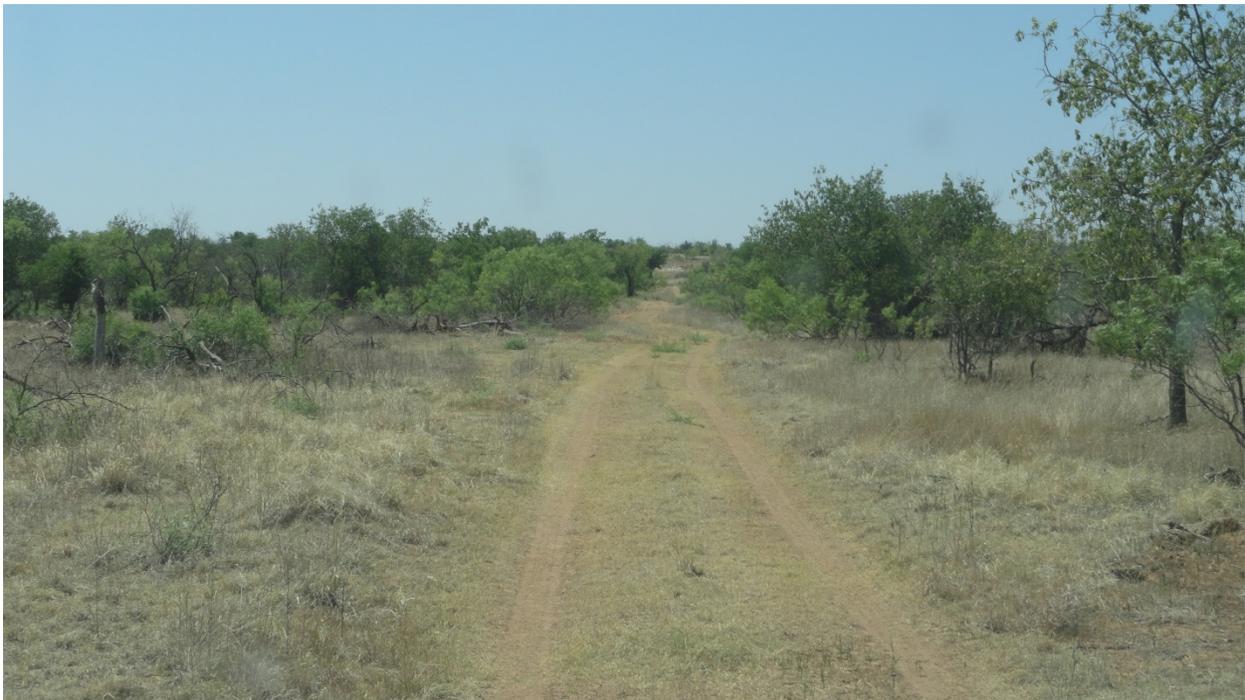
Deep dry grasses were typical on rangelands in late summer 2011. This was the beginning of the worst fire season Texas has seen in years.
