Aransas Creek: Historical Water Quality, Source Survey and Geographical Information Systems Inventory

**Texas State Soil and Water Conservation Board
Project 11-52**

**Nueces River Authority
Coastal Bend Division
Corpus Christi, Texas**

May 2013

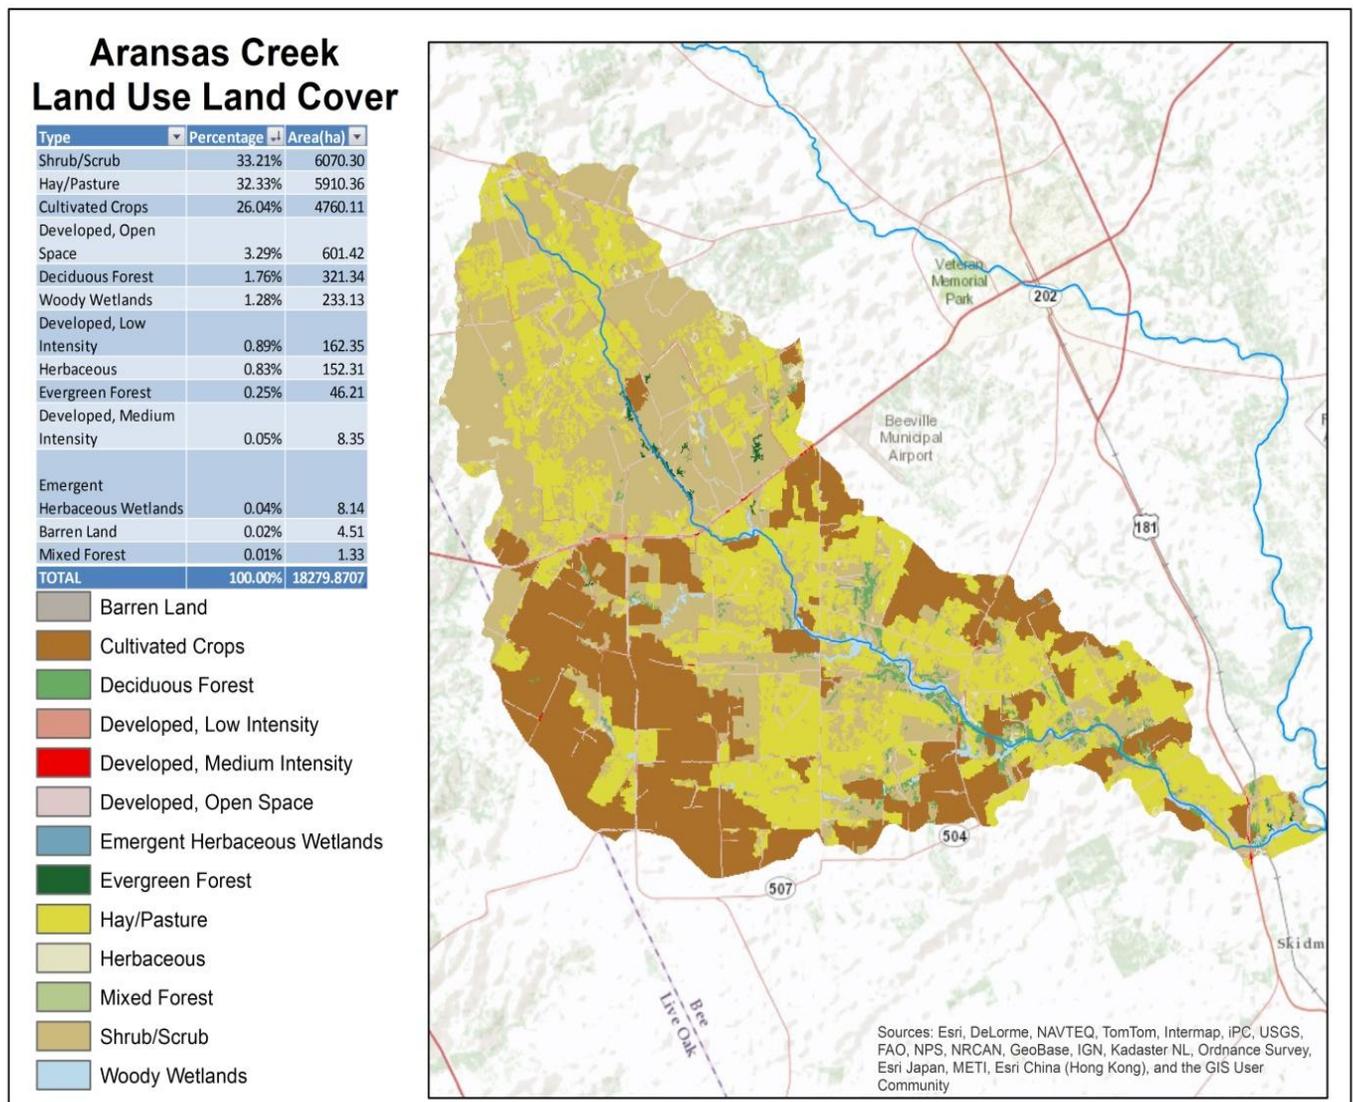
The watershed of 2004A is largely rural and is dominated by shrub/scrub (33%), hay/pasture (32%), and cultivated crops (26%) (Figure 2-1). Tributaries to Aransas Creek include Dry Creek, Elm Creek, and Olmos Creek.

Figure 2-1. Land use/land cover within the Aransas Creek watershed.

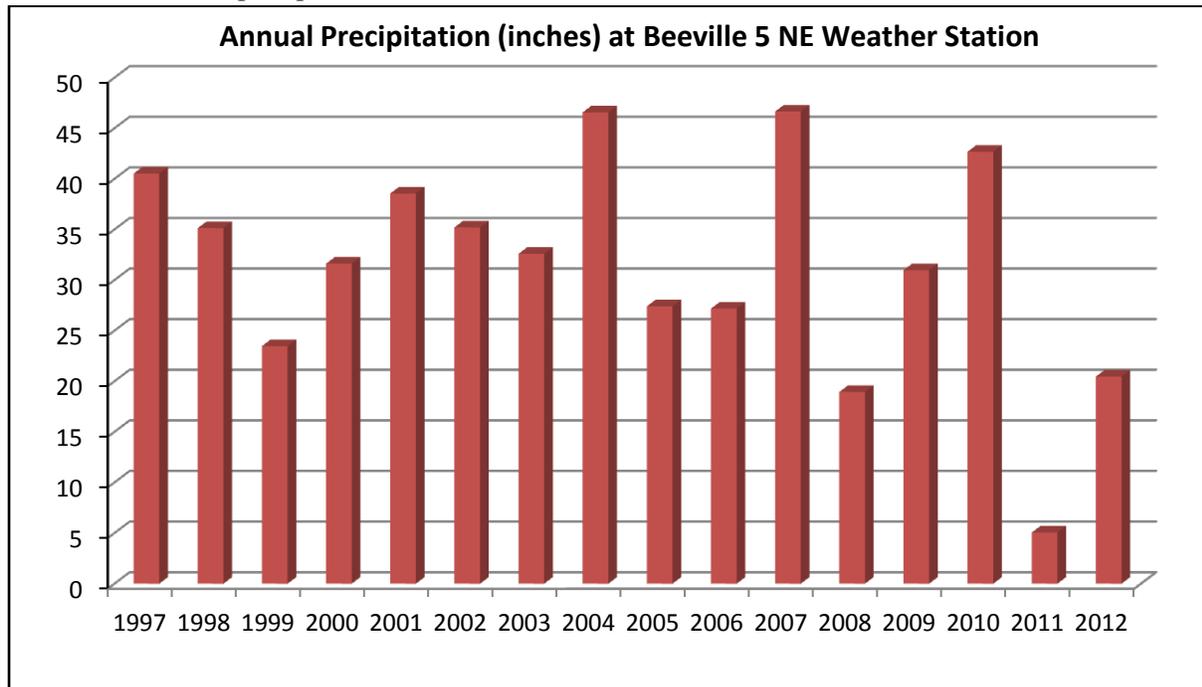
Table 3-2. Annual precipitation totals at Beeville 5 NE from 1997-2012 (NCDC, 2013)

Annual precipitation data obtained from the NWS is variable from year to year. Precipitation amounts recorded during the study period for this RUAA (June 2011 – May 2013) are well below historical averages. The weather station recorded just 5.06 inches in 2011 and 20.47 inches in 2012. Average annual precipitation for the Beeville 5 NE station is 31.97 inches.

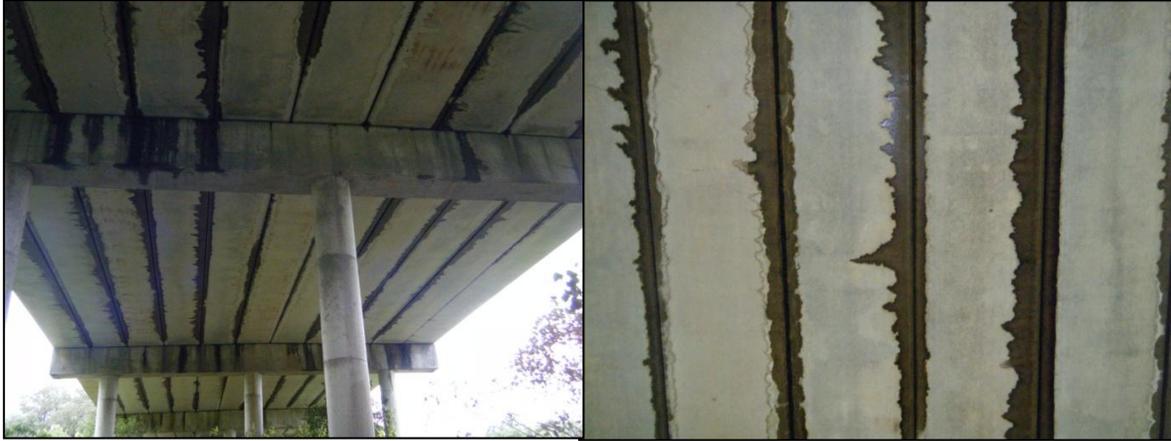
Figure 4-1. Stains from bat urine/guano under the bridge at ACk02.

A bat population was observed under the bridge at the crossing of Aransas Creek at US 181 (Site ACk02). Figure 4-1 show stains under US 181 attributed to bat urine/guano. Roosting was observed under the entirety of the bridge and directly over Aransas Creek. Figure 4-2 shows fecal material dropped by the bats onto the streambed. It is important to note that the creek was in flood stage 5 days prior to taking the picture (figure 4-2). The input of fecal material at this

site, combined with typical streamflow rates typically less than 0.5 CFS, likely contributes significant amounts of fecal bacteria, phosphorus and nitrates to the creek.

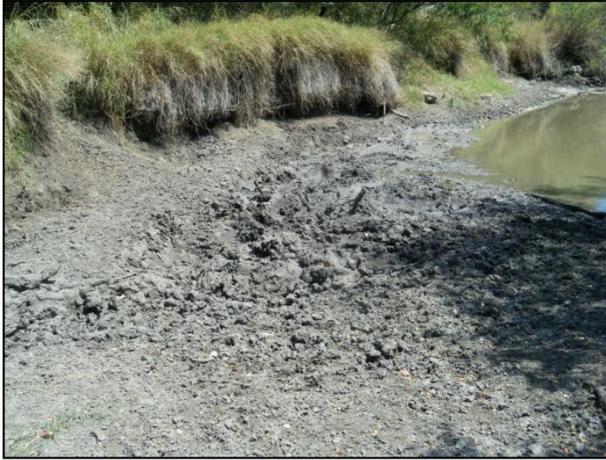
Figure 4-3. Evidence of feral hogs at ACk03.

Also mentioned earlier in this chapter under the Wildlife and Unmanaged Nondomestic Animals section, numerous feral hogs have been observed in the watershed for Aransas Creek. NRA encountered a group (sounder) of approximately 30 wild hogs crossing the highway west of Skidmore while conducting reconnaissance. Evidence of hogs also occurred at survey stations ACk03 and ACk06 (figures 4-3 and 4-4). The landowner at ACk03 mentioned that feral hogs frequent the creek from his property. No hogs were photographed during the site surveys.

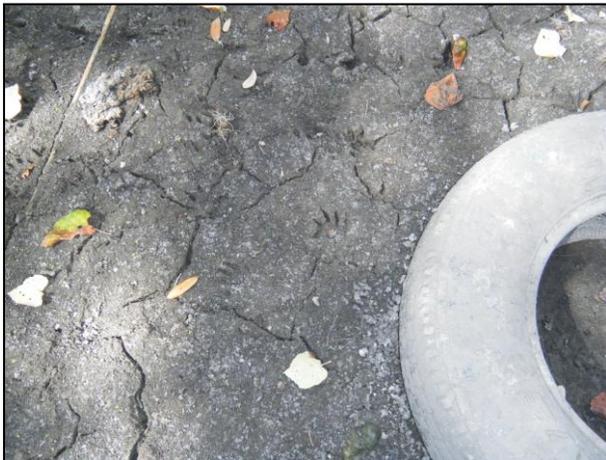
Figure 4-5. Raccoon tracks near ACk05.

Evidence of wildlife in the form of raccoons, deer and bird species was observed at ACk02, ACk04 and ACk05. Raccoon tracks were visible in the dried pool within the 300 m reach associated with survey site ACk05 (figure 4-5). A flock of quail was photographed on Ridgeway lane that crosses through the Aransas Creek watershed. Numerous white-tailed deer were observed as well but not photo-documented.

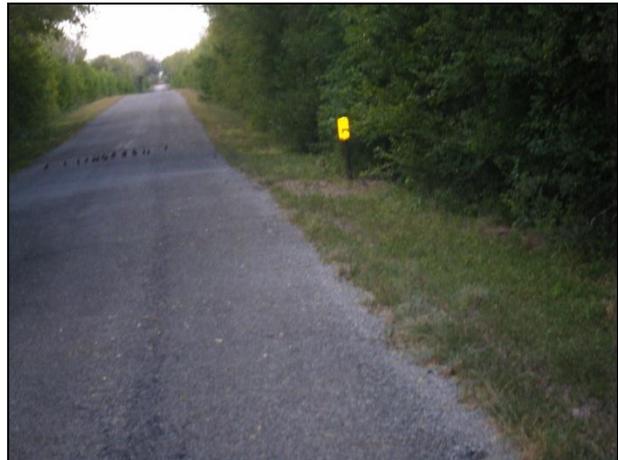
Figure 4-6. Quail on Ridgeway Lane.

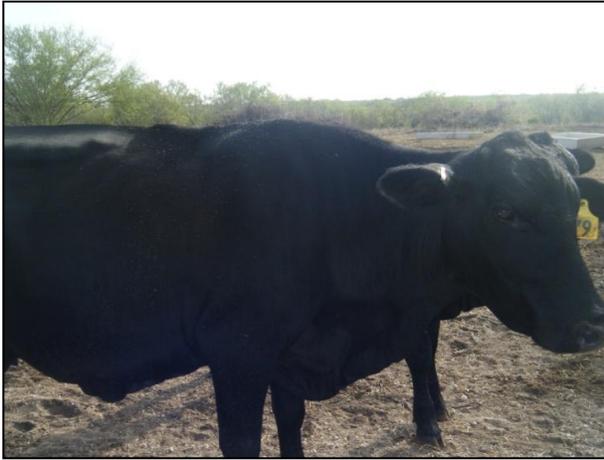
Figure 4-7. Livestock observed at ACk08

Evidence of livestock in the form of cattle was observed at sites ACk02, ACk07, ACk08, and ACk08B during monitoring surveys that occurred in August and September 2012. Cattle were also observed in the inaccessible property upstream from sites ACk02, and ACk05 which are the only two publically accessible sites in the Aransas Creek watershed.

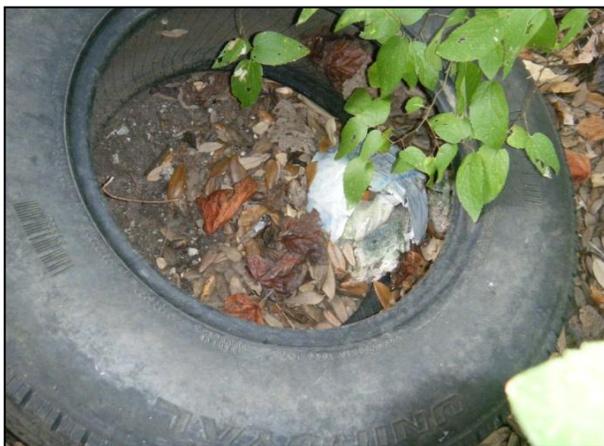
Figure 4-9. Trash at site ACk05

Illegal dumping was observed under the bridge crossing at FM 888 (ACk05 and TCEQ site 20066). Illegal dumping is not generally regarded as an indicator of a bacteria non-point source problem although it has the potential if the items dumped are diapers (figures 4-9 and 4-10). NRA came across a large bag loaded with soiled diapers that was discarded at this bridge crossing. Site ACk05 is a dumping ground for items such as old vehicle seats, fast food trash, religious candles, and tires.
