**Surface Water Quality Monitoring in the Geronimo and Alligator
Creeks Watershed to Support the Implementation of the Geronimo
and Alligator Creeks Watershed Protection Plan**

FINAL REPORT
TSSWCB PROJECT #17-57

Guadalupe-Blanco River Authority

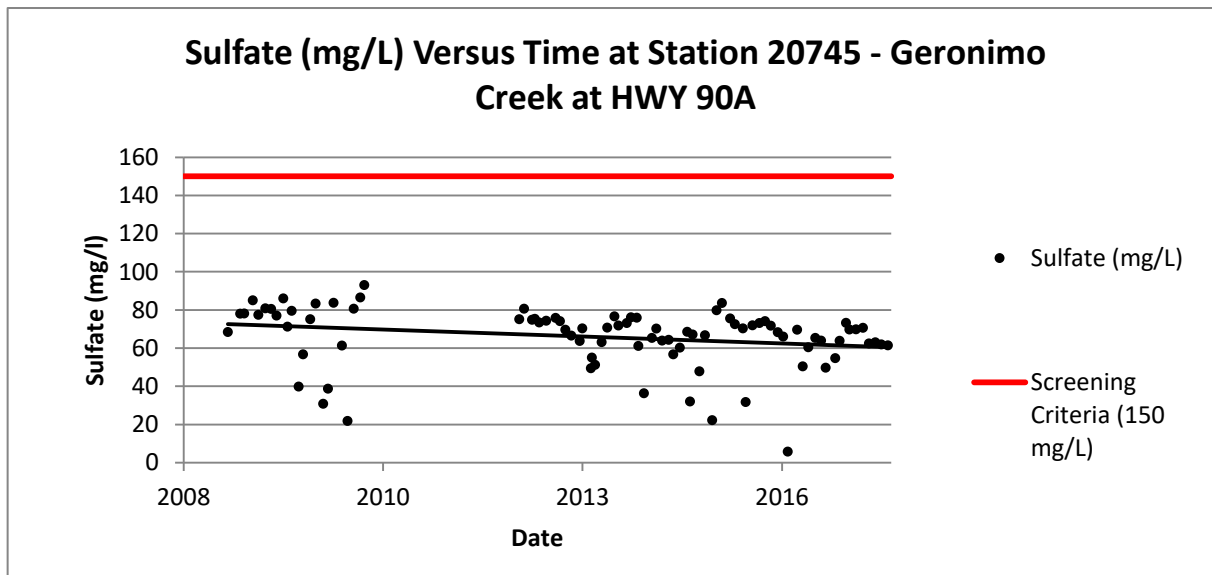
Figure 11. Sulfates (mg/L) versus Time at Station 20745 - Geronimo Creek at Highway 90A.

At the Geronimo Creek at Highway 90A station (20745) statistically significant correlations were found between several water quality parameters and time. Chlorides were decreasing with time; $t(87)=-3.15$, $p=0.00$ (Figure 10). Sulfates were also decreasing with time; $t(87)=-2.21$, $p=0.03$ (Figure 11). Several parameters also showed significant correlations with stream flow. Total phosphorus is increasing with stream flow $t(87)=6.53$, $p=0.00$ and *E. coli* is also increasing with stream flow $t(87)=9.97$, $p=0.00$. This station is located only about 4 kilometers upstream of the Geronimo Creek at Hollub Road station (20747) and 0.4 km upstream of the confluence of the Baer Creek tributary, but seems to be experiencing similar trending to the previous station downstream station.

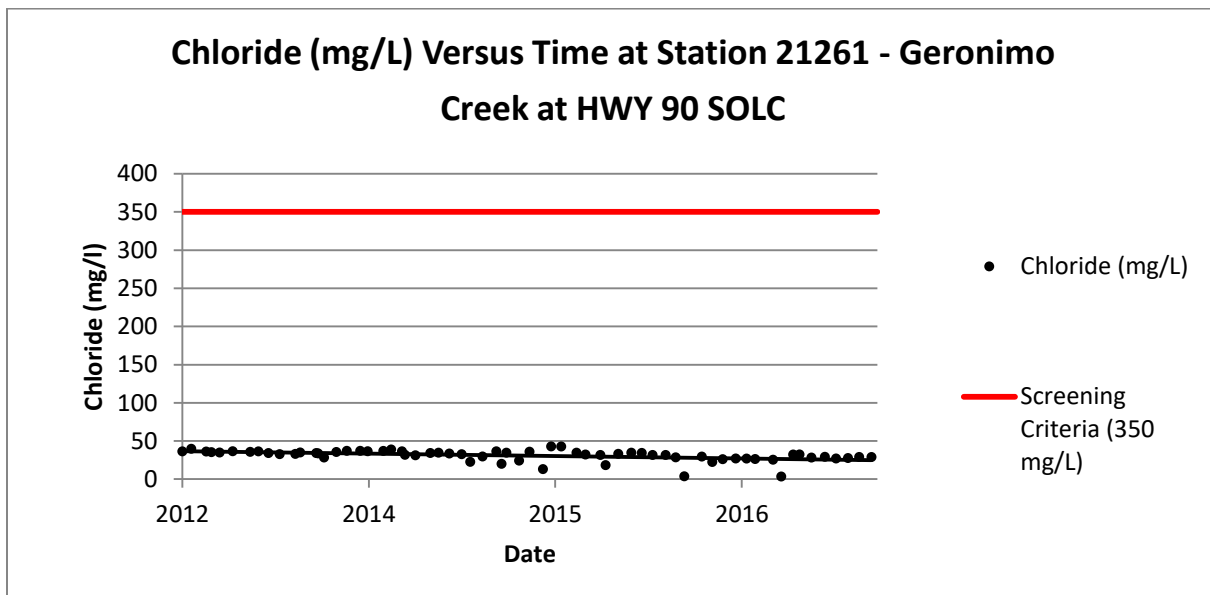
Figure 13. Chlorides (mg/L) versus Time at Station 21261 - Geronimo Creek at Highway 90 Near the ILSOLC.

The Geronimo Creek at Highway 90 near the ILSOLC (21261) had four statistically significant correlations of water quality parameters with time. Ammonia-Nitrogen (mg/L); $t(64)=-4.09$, $p=0.00$, at this station is decreasing with time (Figure 12). Chlorides are decreasing over time; $t(64)=-4.35$, $p=0.00$ (Figure 13). Sulfates are also decreasing over time; $t(64)=-3.33$, $p=0.00$ (Figure 14). This station is only located about 2.1 kilometers upstream of the Geronimo Creek at Highway 90A station (20745), but water quality trends at this station are quite different. Station 21261 was added to the Geronimo Creek monitoring project in September of 2012 and has much less data available than many of the other monitoring stations on Geronimo Creek. The trends at

this station may differ from other portions of the Geronimo Creek for this reason. The decrease in ammonia-nitrogen and salt anions concentrations at this location are generally indicators of better water quality conditions and are most likely due to a statistically significant increase in ambient stream flows at this station over the study period; $t(64)=5.40$, $p=0.00$. Ammonia nitrogen, chlorides and sulfates all showed statistically significant correlations with stream flow. The increase in flow over the study period is most likely diluting the concentrations of these parameters at this station.
