Recreational Use Attainability Analysis of Five Creeks along the Little Brazos River: Walnut Creek (1242O), Mud Creek (1242K), Pin Oak Creek (1242L), Spring Creek (1242M), and Campbells Creek (1242I)

Prepared for:
Texas State Soil and Water Conservation Board
Project 08-54

Data Collected by:
Brazos River Authority

June 2014

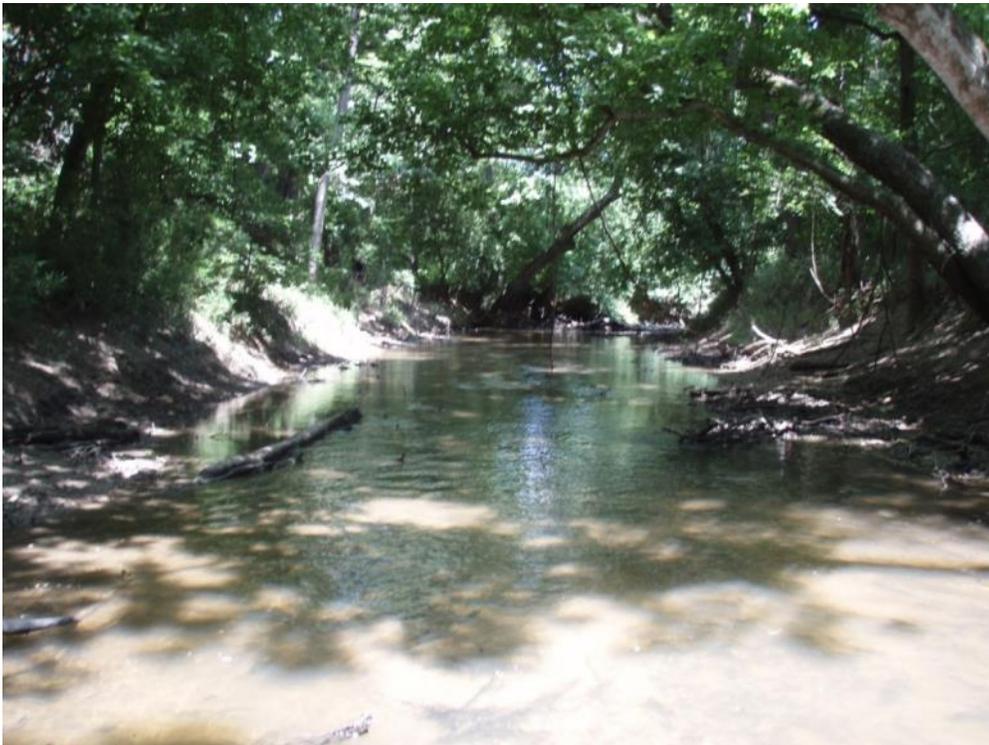
Figure 4.5 Photograph of Walnut Creek Site 20021 taken on June 22, 2010, the downstream view of the 300-m transect.

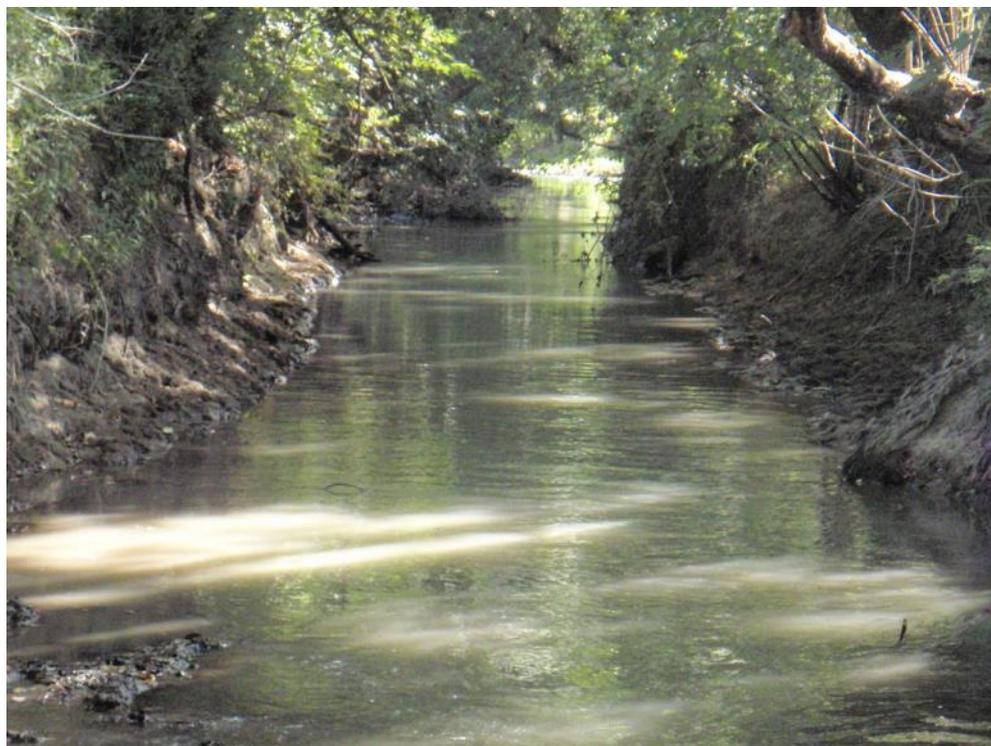
Figure 4.7 Photograph of Walnut Creek Site 99901 taken on August 23, 2010, the upstream view of the 150-m transect.

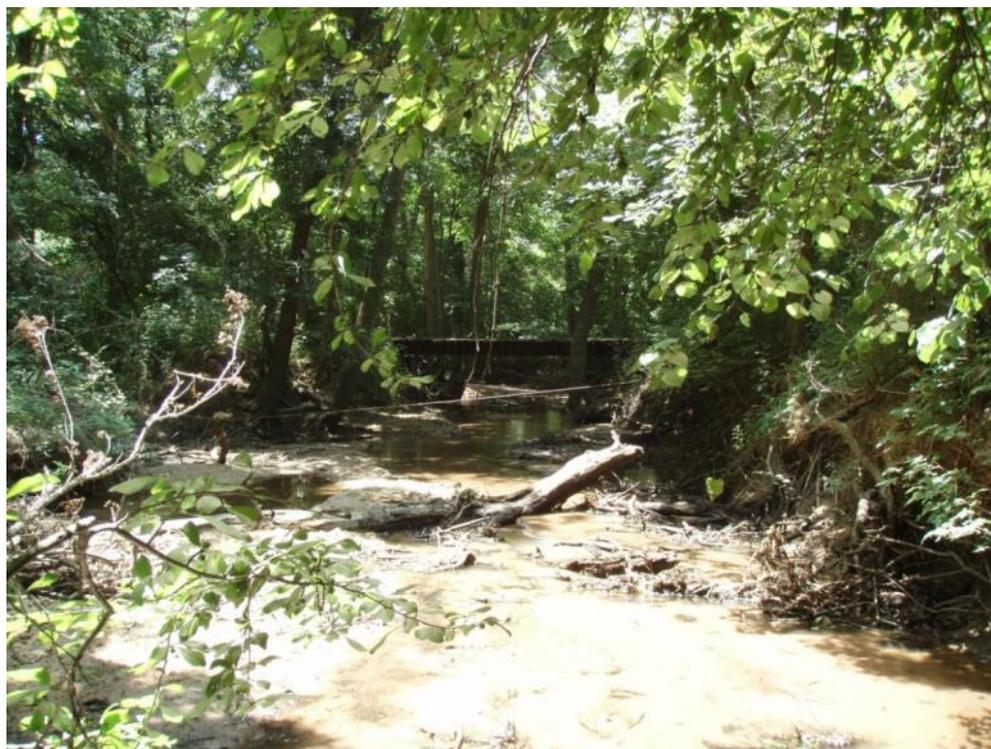
Figure 4.8 Photograph of Walnut Creek Site 20565 taken on June 22, 2010, the downstream view of the 30-m transect.

Site 20565 was wadeable for the entire 300-m reach length. Average thalweg ranged from 0.17 m during the first survey to 0.06 m during the second survey (Table 4.7). During both surveys, the shallow water depths and sandy substrate made wading in the stream channel easy. Widths of the stream ranged from a maximum of 4.5 m during the first survey to a minimum of 0.3 m during the second survey (Tables 4.8 and 4.9). At least two log jam obstructions were encountered during each survey, which would make boating or tubing the stream difficult.

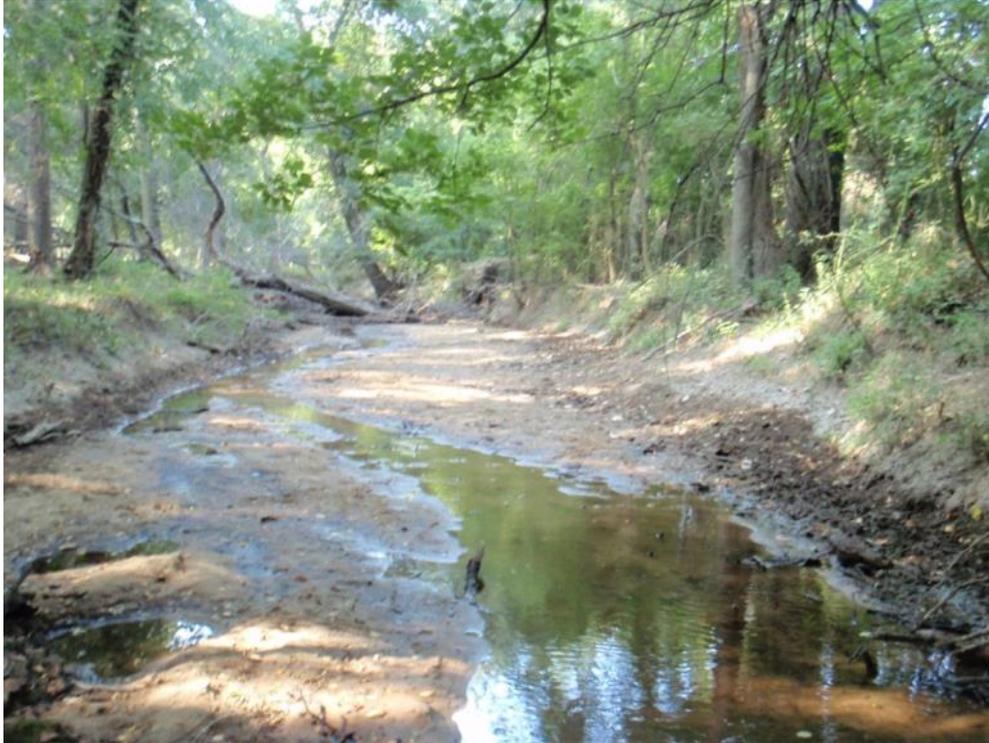
Aesthetic appearance of the water and wildlife observations for the site during each survey have been previously provided in Tables 4.10 and 4.11, respectively. There was a slight presence of livestock during the both surveys with no other mammals, snakes, or water dependent birds encountered during either survey. Tracks observed during each trip consisted of deer and hogs. Aquatic vegetation ranged from rare to absent between the first and second surveys, respectively. Algae was absent with no color, odor, surface scum or foam encountered during either survey. One tire was observed in the streambed. No other signs of human presence were observed.

Figure 4.9 Photograph of Walnut Creek Site 20565 taken on August 16, 2010, the downstream view of the 300-m transect.

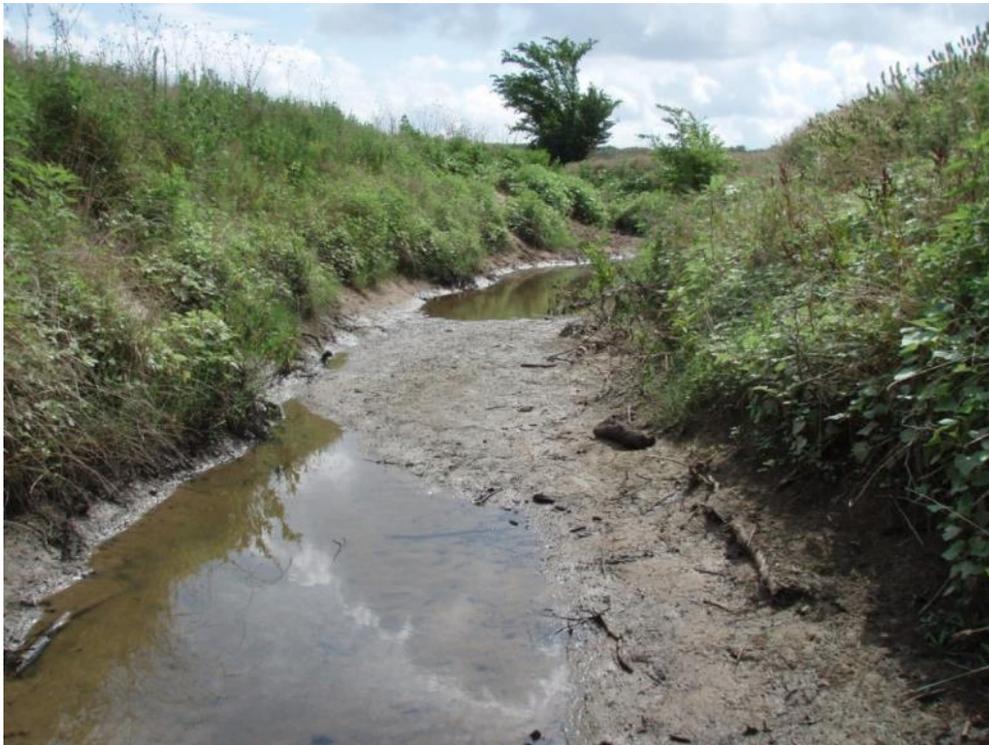
Walnut Creek at Site 99902 was visited on June 24 and August 13, 2010. This site, located northeast of Calvert, Texas in Robertson County, was only publicly accessible at the bridge crossing FM 46. Although the site is listed as being publicly accessible, private property fences severely hinder access to the creek as shown in Figure 4.10. The site is located in a pasture and shrub dominated corridor (Table 4.6). At the site, access to the stream was moderately easy due to the thick vegetation, property fence and moderate slopes (Table 4.7). Figures 4.11 and 4.12 depict the appearance of the site during each of the surveys.

Figure 4.11 Photograph of Walnut Creek Site 99902 taken on June 24, 2010, the upstream view of the 300-m transect.

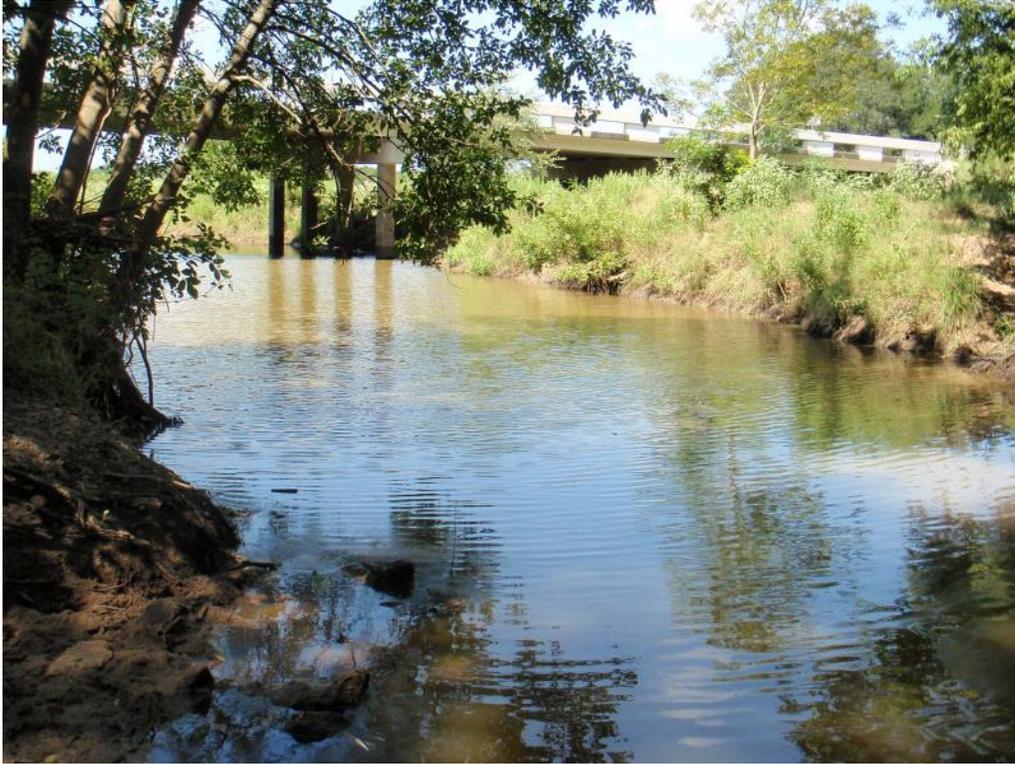
Figure 4.12 Photograph of Walnut Creek Site 99902 taken on August 13, 2010, the downstream view of the 30-m transect.

Aesthetic appearance of the water and wildlife observations for the site during each survey have been provided in Tables 4.10 and 4.11, respectively. During the first survey, there was a slight presence of wildlife, a moderate presence of feral hogs, and a large presence of livestock. No snakes, alligators, or water dependent birds were observed. No animals were encountered during the second survey. Tracks were observed during both surveys and fecal dropping were encountered during the second survey only. Aquatic vegetation and algae were rare during both surveys. The water color was brown during both surveys with surface scum and debris. One oil jug was encountered during the first survey with no other trash encountered during the second survey. No evidence of recreation was observed within the reach.

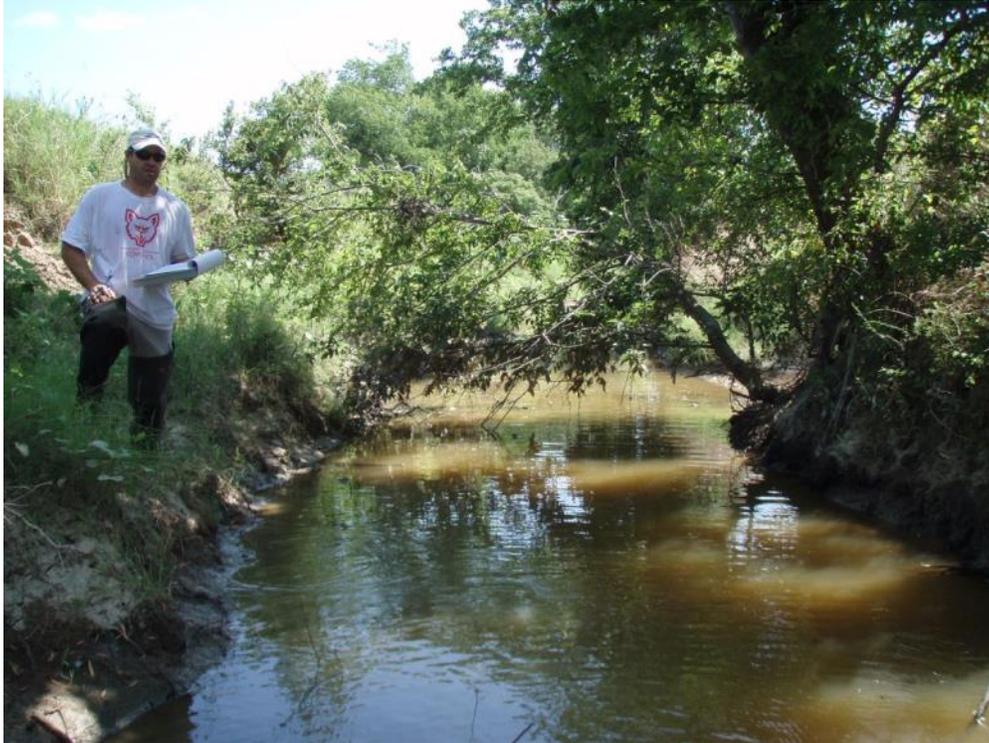
Walnut Creek at site 99903 was visited on June 22 and August 13, 2010. This site, located northeast of Calvert, Texas in Robertson County, was publicly accessible only at the bridge crossing FM 2293. Although the site is listed as being publicly accessible, private property fences severely hinder access to the creek. The site is located in a pasture dominated corridor for the entire length of the reach (Table 4.6). At the site, access to the stream was easy (Table 4.7), although other locations within the reach had more challenging entrances due to steep banks, dense vegetation, and trees. Figures 4.13 and 4.14 depict the appearance of the site during each of the surveys.

Figure 4.13 Photograph of Walnut Creek Site 99903 taken on June 22, 2010, the upstream view of the 150-m transect. BRA personnel in photograph.

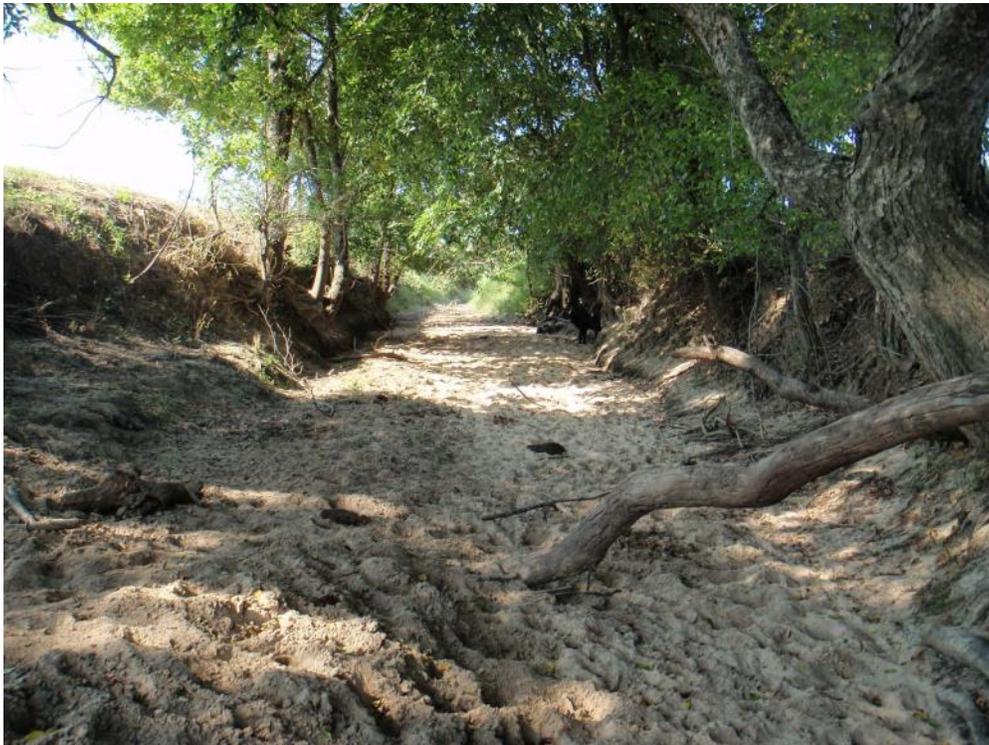
Figure 4.14 Photograph of Walnut Creek Site 99903 taken on August 13, 2010, the downstream view of the 30-m transect.

Site 99903 was wadeable for the entire 300-m reach length. Average thalweg ranged from 0.20 m during the first survey to 0.13 m during the second survey (Table 4.7). During both surveys, the shallow water depths or lack of water with the sandy substrate made wading in the stream channel easy. Widths of the stream ranged from 3.0 m to 0 m during the first survey (Table 4.8). Water widths were not recorded during the second survey as the stream was dry (Table 4.9). One pool was identified during the first survey with a length of 120 meters, width of 2.0 meters and a maximum depth of 0.5 meters. Other than a few overhanging tree branches, there were no obstructions encountered in the stream channel during either survey.

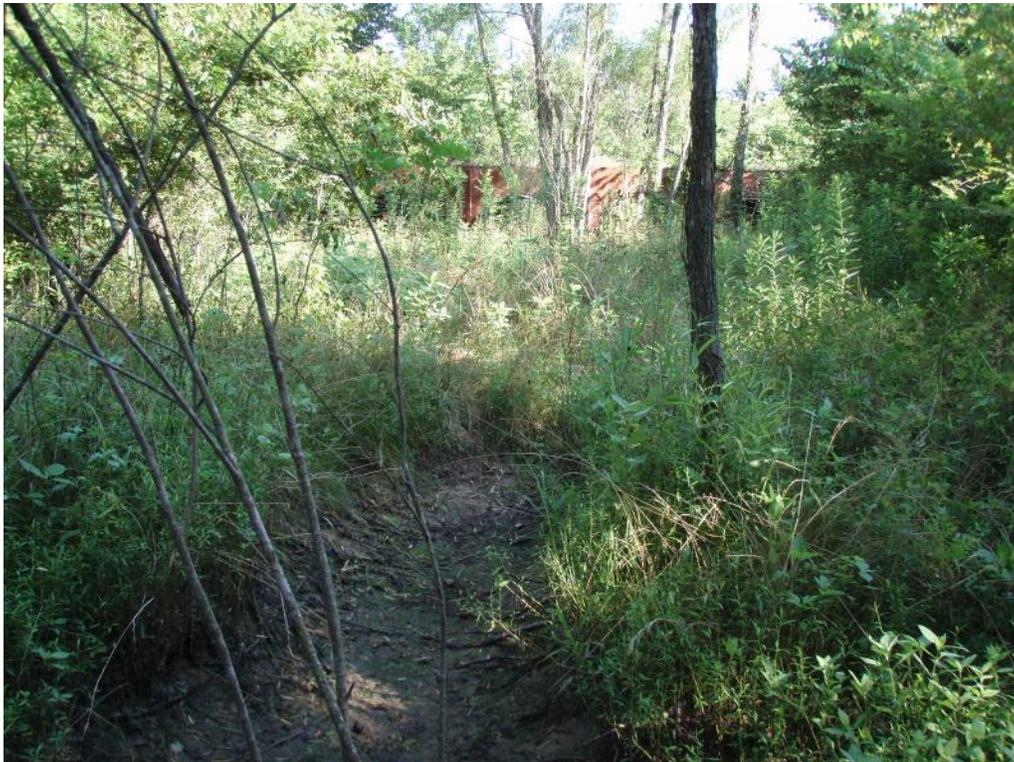
Walnut Creek at Site 99905 was visited on June 22 and August 13, 2010. This site, located northeast of Calvert, Texas in Robertson County, was publicly accessible only at the bridge crossing Wasik Road. Although the site is listed as being publicly accessible, private property fences overgrown with brush and thick vegetation limit public accessibility as depicted in Figure 4.15. BRA personnel entered private property through the brush and over the fence to reach the site. The site is located in a forest and shrub dominated corridor (Table 4.6). At the site, access to the stream was moderately difficult due to the thick vegetation (Table 4.7). Figures 4.16 and 4.17 depict the appearance of the site during each of the surveys.

Figure 4.16 Photograph of Walnut Creek Site 99905 taken on June 22, 2010, the upstream view of the 30-m transect.

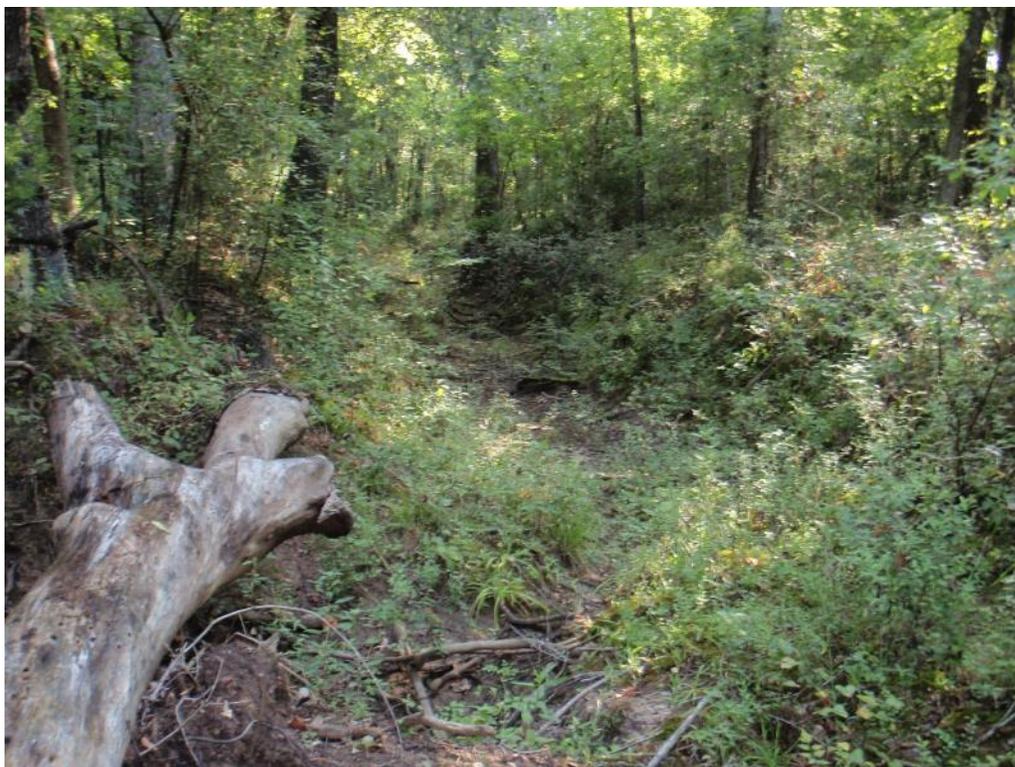
Figure 4.17 Photograph of Walnut Creek Site 99905 taken on August 13, 2010, the upstream view of the 300-m transect.

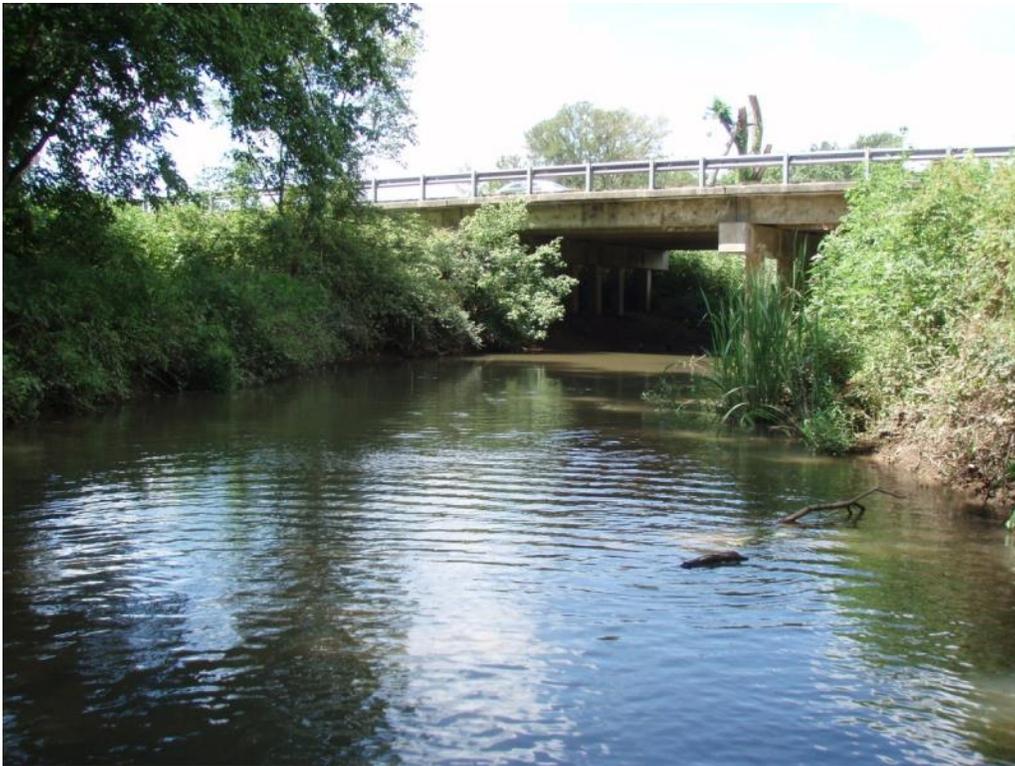
Mud Creek at Site 16402 was visited on June 25 and August 27, 2010. This site, located on State Highway 6 approximately 4.5 miles northwest of Hearne, Texas, was accessible at the area immediately underneath the bridge crossing via a concrete curtain. Accessibility to the stream was moderately difficult due to tall, dense vegetation along the steep stream banks (Figure 5.2). Downstream access was blocked due to a fence that crossed the stream immediately downstream of the State Highway 6 crossing. Deep deposits of sludge were encountered on the streambed that began at the State Highway 6 crossing and ended at the 120-meter transect. Log jams were also encountered along the survey reach (Figure 5.3). Figures 5.2 and 5.3 depict the appearance of the site during each of the surveys. Average thalweg depth was 0.64 meters during the June event and 0.54 meters during the August event. Five pools were identified during the June survey and two were identified during the August survey, most of which were over a meter deep (Tables 5.12 and 5.13).

Figure 5.2 Photograph of Mud Creek Site 16402 taken on June 25, 2010, the downstream view of the 30-m transect.

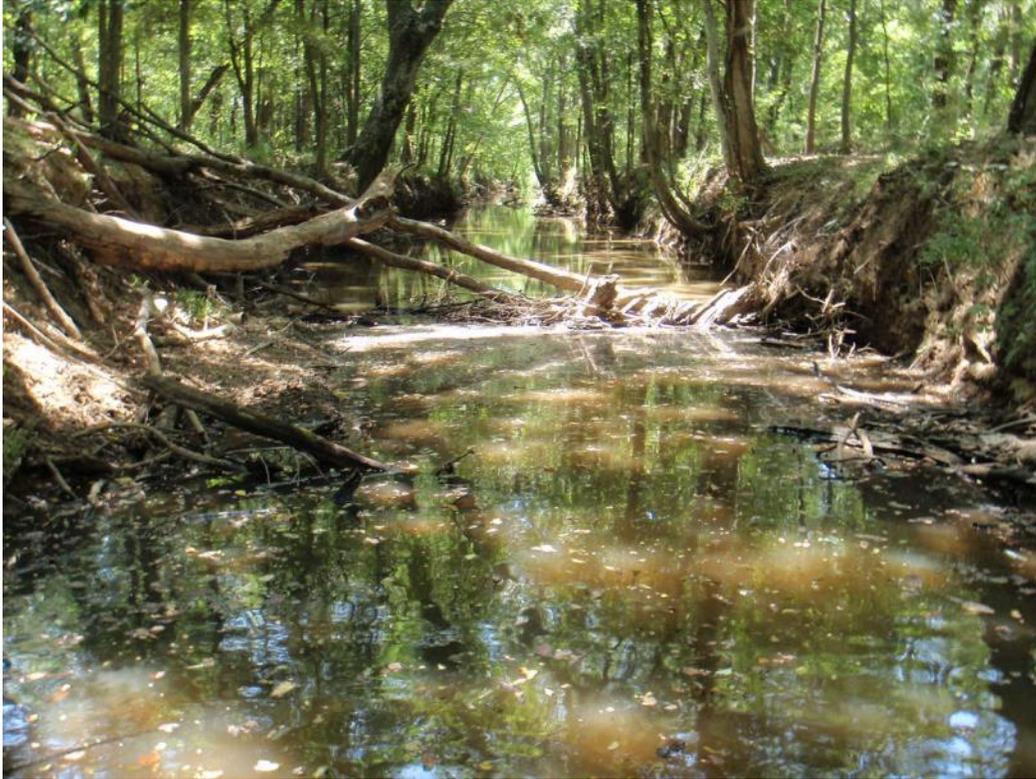
Figure 5.3 Photograph of Mud Creek Site 16402 taken on August 27, 2010, the downstream view of the 300-m transect.

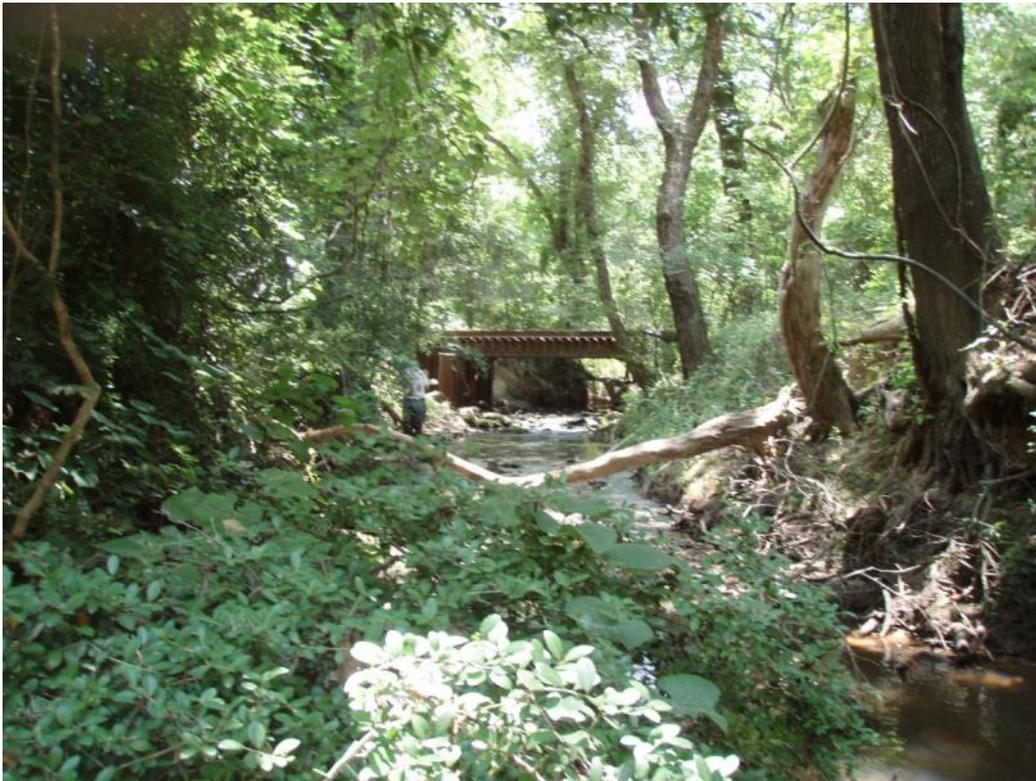
Mud Creek at Site 99906 was visited on June 23 and August 27, 2010. This site is located at Mud Creek Road approximately 3.3 miles east of Calvert, Texas and 2.5 miles upstream of Site 16402. Site 99906 was accessible at the area immediately underneath the bridge crossing. Accessibility to the stream was moderately difficult due to steep, overgrown stream banks. During the August survey large debris piles composed of logs and other woody debris within the stream channel were observed throughout the reach. Figures 5.4 and 5.5 depict the appearance of the site during each of the surveys. Average thalweg depth was 0.46 meters during the June event and 0.32 meters during the August event. Five pools were identified during the June survey (Table 5.14); however, all five were less than 1 m deep. No pools were identified in the August survey.

Figure 5.4 Photograph of Mud Creek Site 99906 taken on June 23, 2010, the upstream view of the 30-m transect.

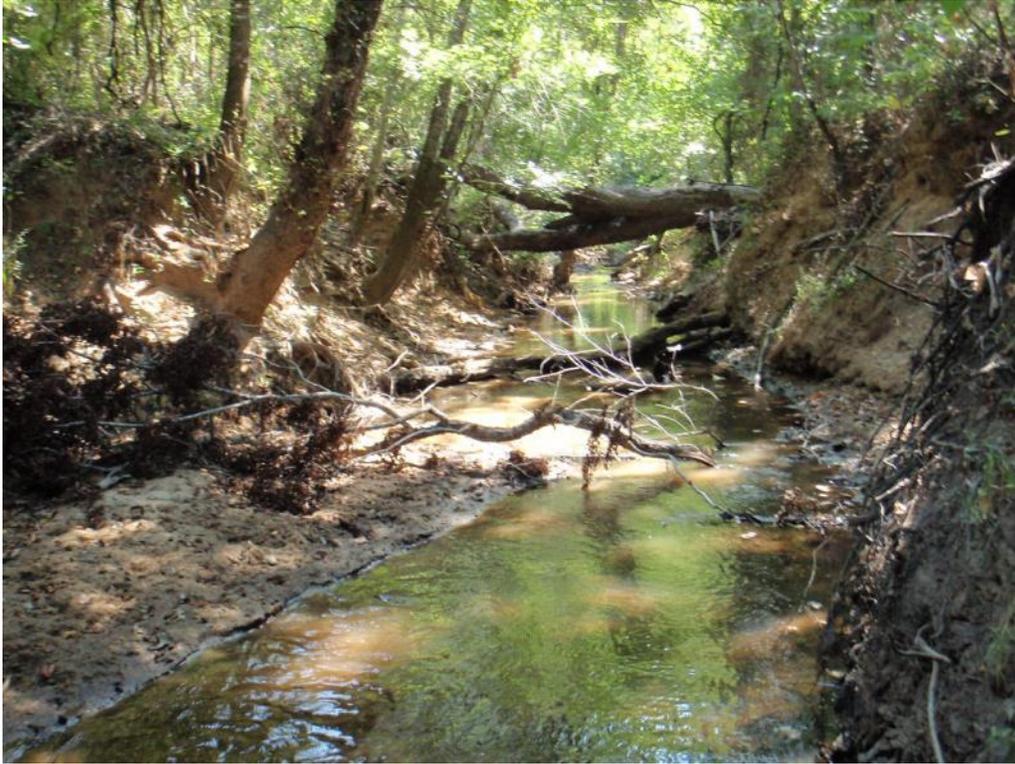
Figure 5.5 Photograph of Mud Creek Site 99906 taken on August 27, 2010, the upstream view of the 300-m transect.

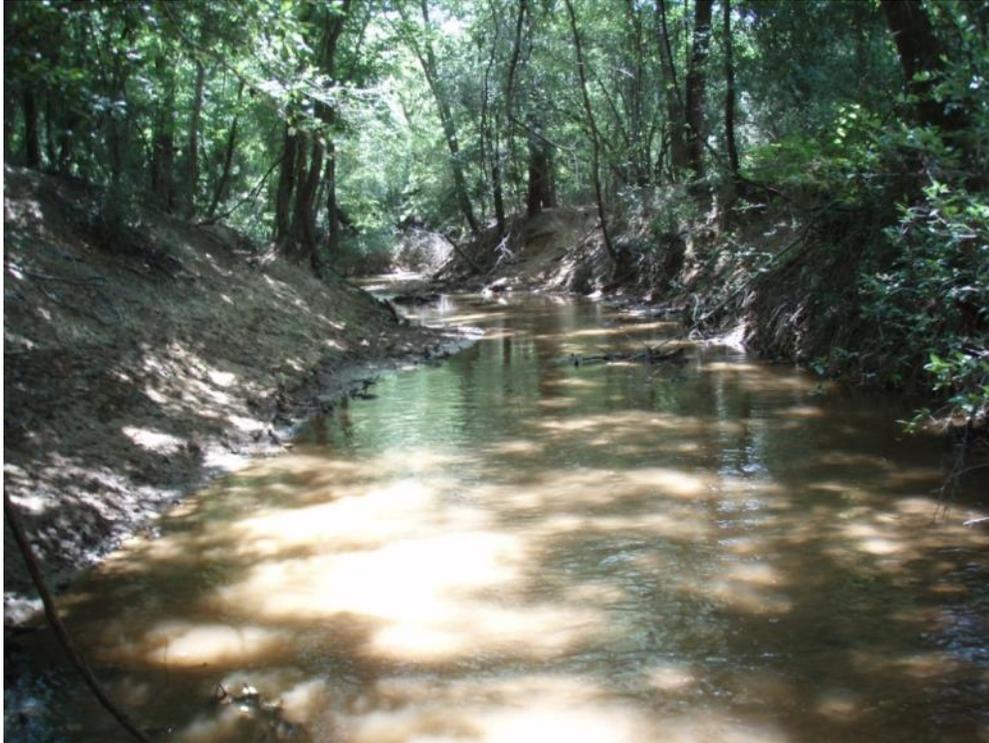
Average thalweg depth was 0.30 meters during the June survey and 0.22 meters during the August survey. Four pools were identified during the June survey but only two during the August survey (Tables 5.15 and 5.16). Of these pools, only Pool 4 encountered in June was deeper than 1 meter.

Figure 5.7 Photograph of Mud Creek Site 20562 taken on August 24, 2010, the upstream view of the 30-m transect.

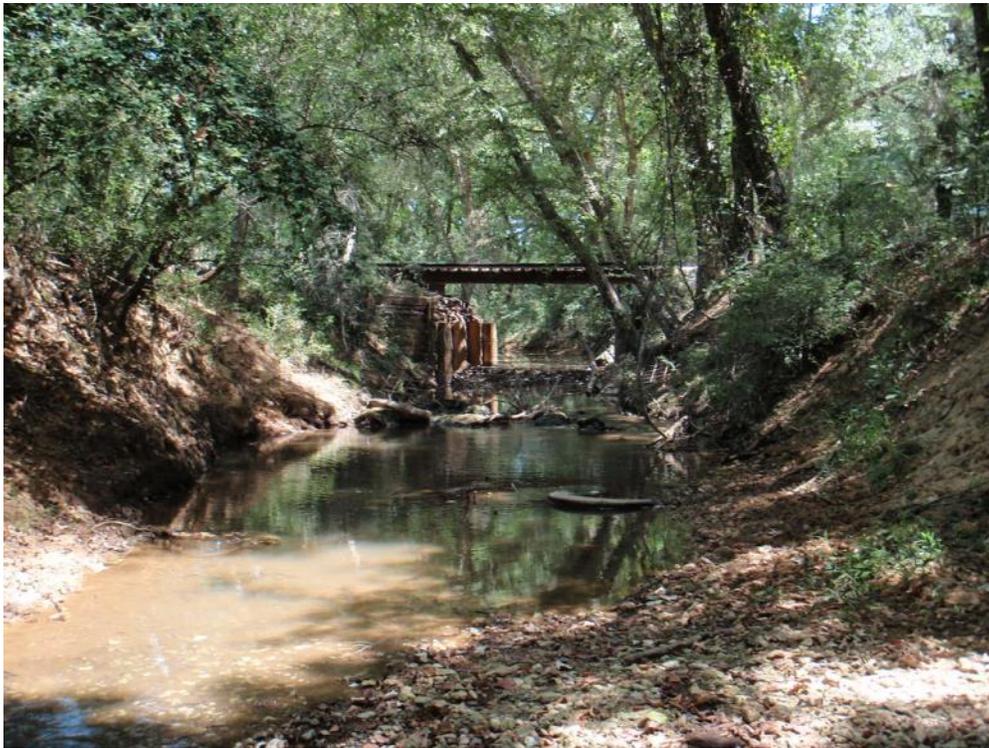
Figure 5.8 Photograph of Mud Creek Site 20562 taken on August 24, 2010, the upstream view of the 30-m transect.

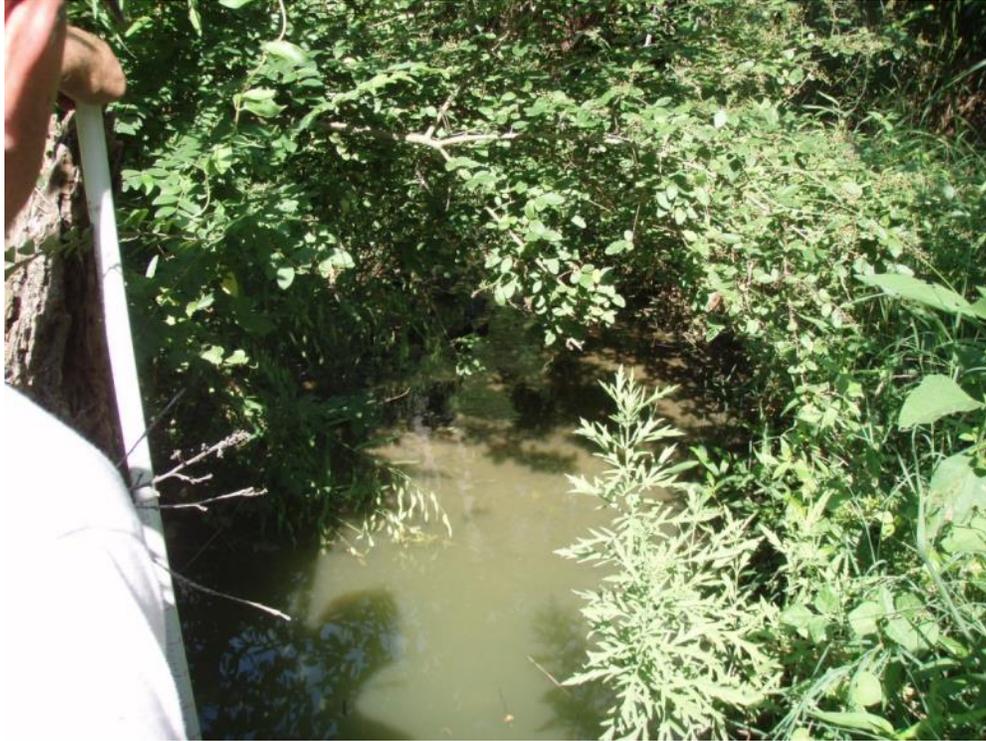
Mud Creek at Site 99907 was visited on June 23 and August 27, 2010. This site is located on State Highway 79 approximately 1 mile west of Franklin, Texas, and 5.9 miles upstream of Site 20562. The site is located downstream of the City of Franklin WWTP discharge. Site 99907 was accessible at the area immediately underneath the bridge crossing; however, the stream was fenced off immediately downstream of the bridge crossing. Accessibility to the stream was moderately easy due to the mowed State Highway 79 right-of-way. Log jams within the stream channel and thick vegetation along the banks were encountered during both surveys. Figures 5.9 and 5.10 depict the appearance of the site during each of the surveys. Average thalweg depth was 0.31 meters during the June event and 0.27 meters during the August event. Five pools were identified during the June survey and one was identified during the August survey, all with depths less than 1 meter (Tables 5.17 and 5.18).

Figure 5.9 Photograph of Mud Creek Site 99907 taken on June 23, 2010, the upstream view of the 300-m transect. BRA personnel in photograph.

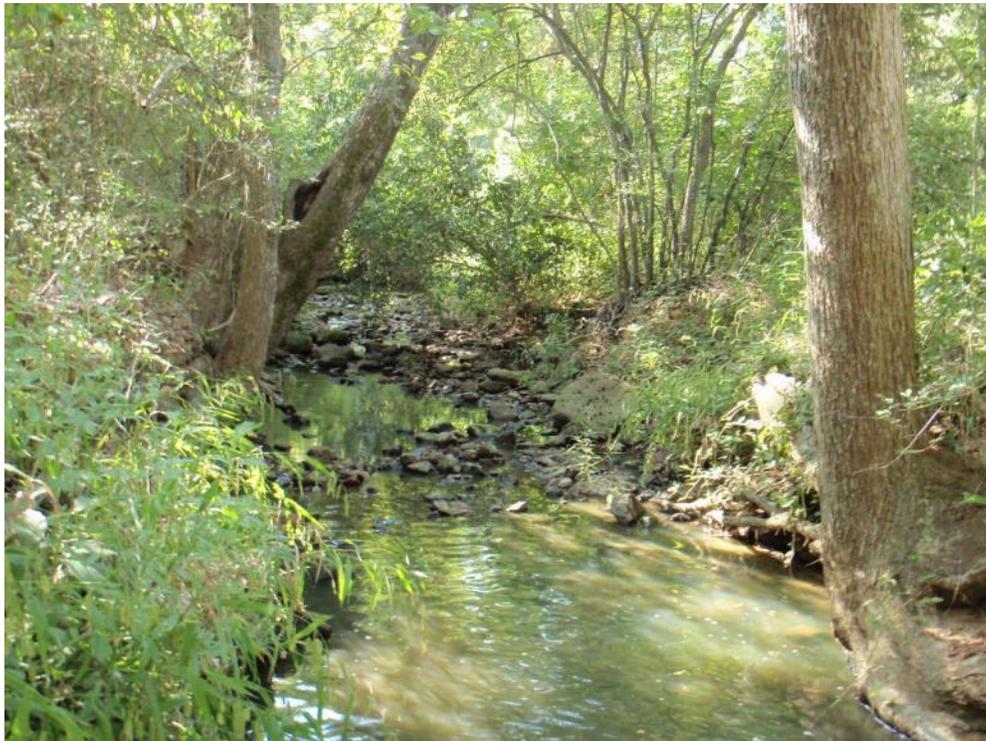
Figure 5.10 Photograph of Mud Creek Site 99907 taken on August 27, 2010, the upstream view of the 300-m transect.

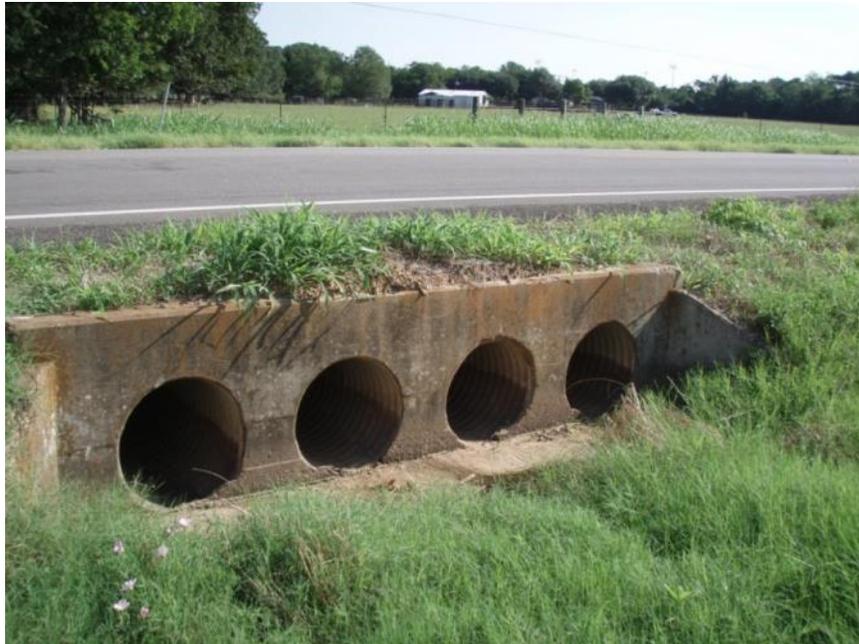
Figure 5.11 Photograph of Mud Creek Site 99908 taken on June 23, 2010, the upstream view from FM 1644.

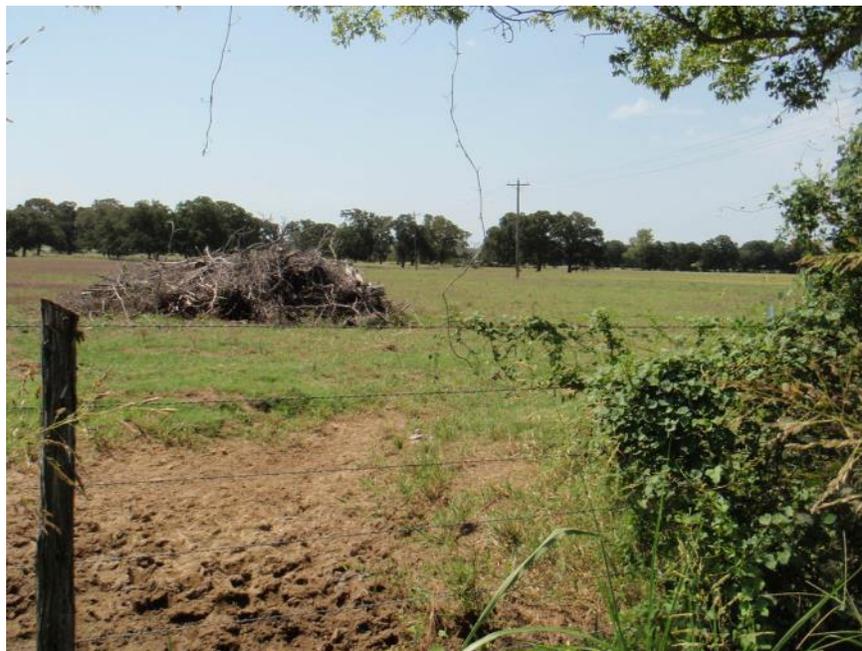
Figure 5.12 Photograph of Mud Creek Site 99908 taken on August 24, 2010, the upstream view from FM 1644.

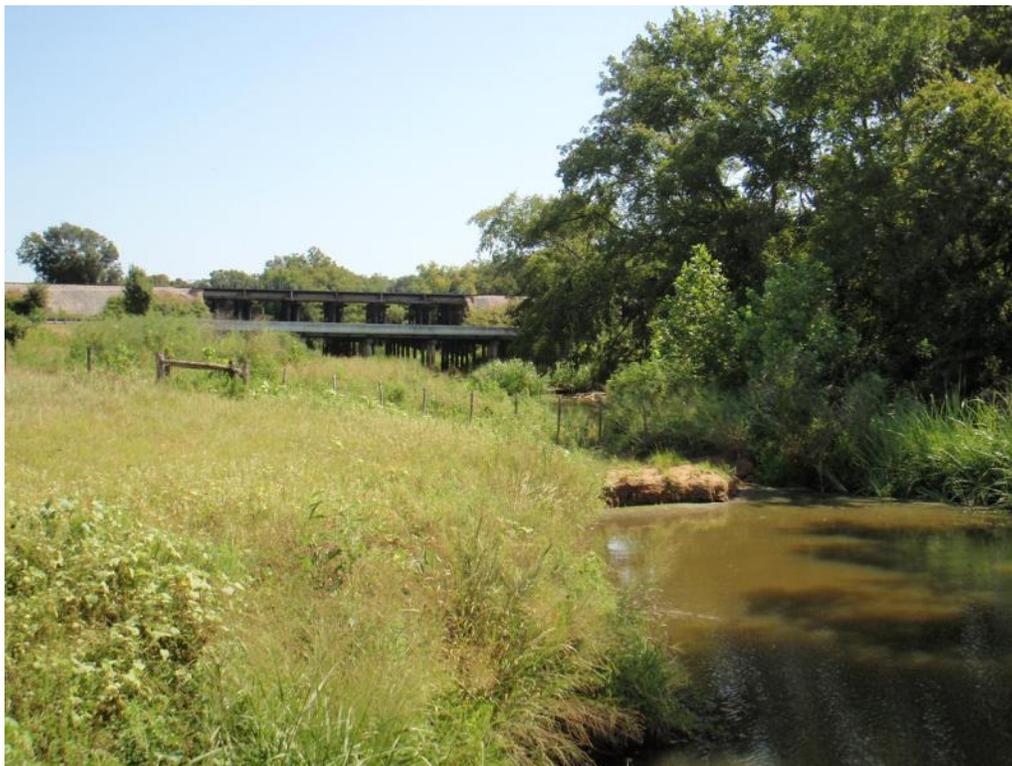
The two surveys at Site 16401 were conducted only two weeks apart and conditions did not change significantly in that span. Stream widths ranged from 0.0 to 18.0 m with a typical width of 5 m (Tables 6.8 and 6.9). Average thalweg depth was 0.69 ft during both surveys (Table 6.9), but the stream was non-wadeable due to several deep pools greater than 1.2 m deep (Tables 6.12 and 6.13; Figure 6.2). The stream channel was difficult to wade even when not in the pools, because of the sludge substrate. Figures 6.2 and 6.3 illustrate the brown to black water color witnessed during both surveys (Tables 6.10 and 6.11).

Figure 6.2 Photograph of Pin Oak Creek Site 16401 taken on August 23, 2010, the upstream view of the 30-m transect, including deep pool.

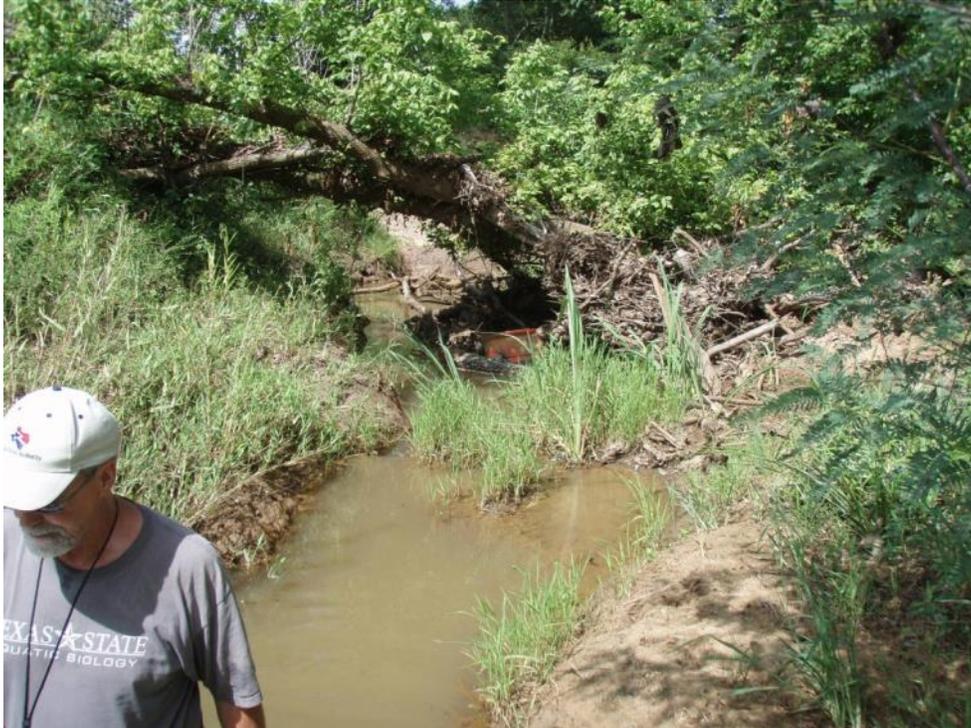
Site 20385 was wadeable for the entire 300-m reach length with occasional log jams and a felled tree acting as moderate obstacles (Figure 6.4). Several pools were present during both surveys, but none of them exceeded 1.0 m in depth (Tables 7.14 and 7.15). Average thalweg depth decreased from 0.32 m during the first survey to 0.27 m during the second survey when some portions of the reach were very narrow (0.6 m) and shallow (< 0.2 m) (Figure 6.6). Stream widths varied from 0.6 to 7.0 m during the first survey and 0.6 to 4.5 m during the second survey (Tables 6.8 and 6.9).

Figure 6.4 Photograph of Pin Oak Creek Site 20385 taken on June 29, 2010, the downstream view of the 30-m transect including felled tree. BRA personnel in photograph.

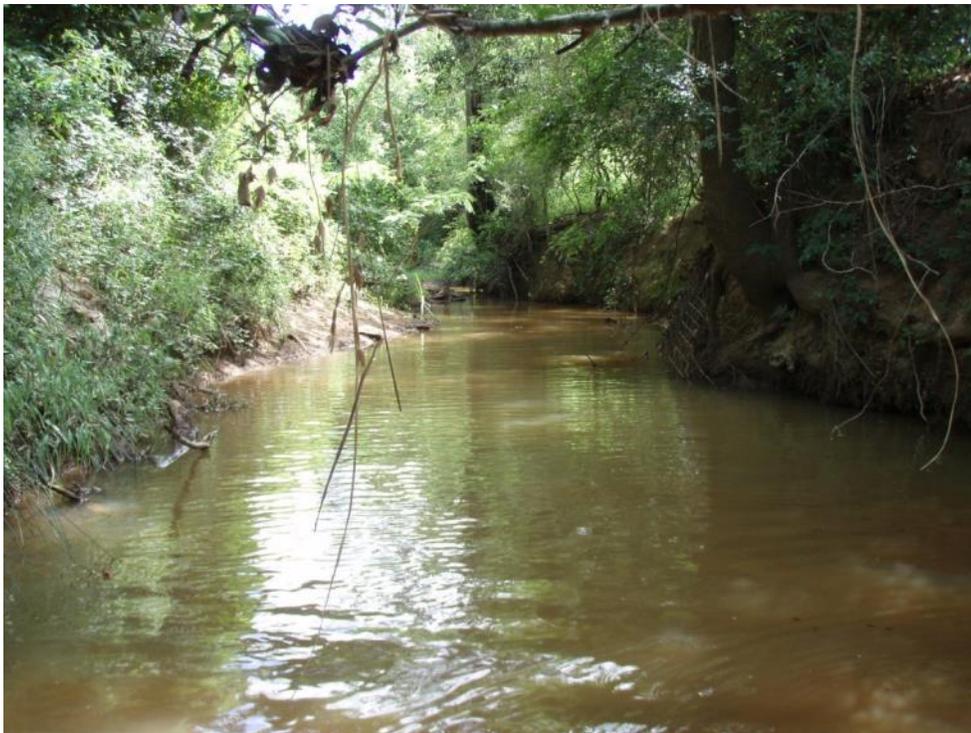
Figure 6.5 Photograph of Pin Oak Creek Site 20385 taken on June 29, 2010, the upstream view of the 150-m transect.

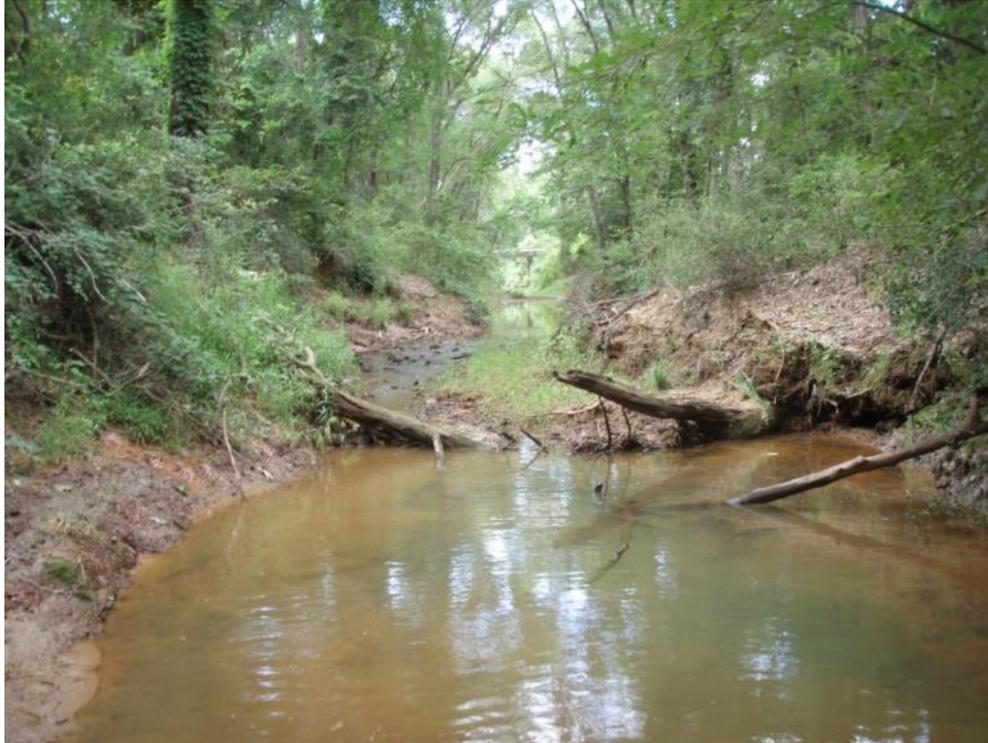
Pin Oak Creek at Site 20563 was visited on June 28 and August 20, 2010. Located east of Hearne, Texas, in Robertson County, this site was accessible from the right-of-way at the FM 391 crossing. The site is located in a forest and shrub dominated corridor (Table 6.6 and Figure 6.7). Stream access was moderately difficult due to steep, muddy banks and occasional dense brush (Figures 6.7 and 6.8).

Figure 6.7 Photograph of Pin Oak Creek Site 20563 taken on June 28, 2010, the upstream view of the 150-m transect.

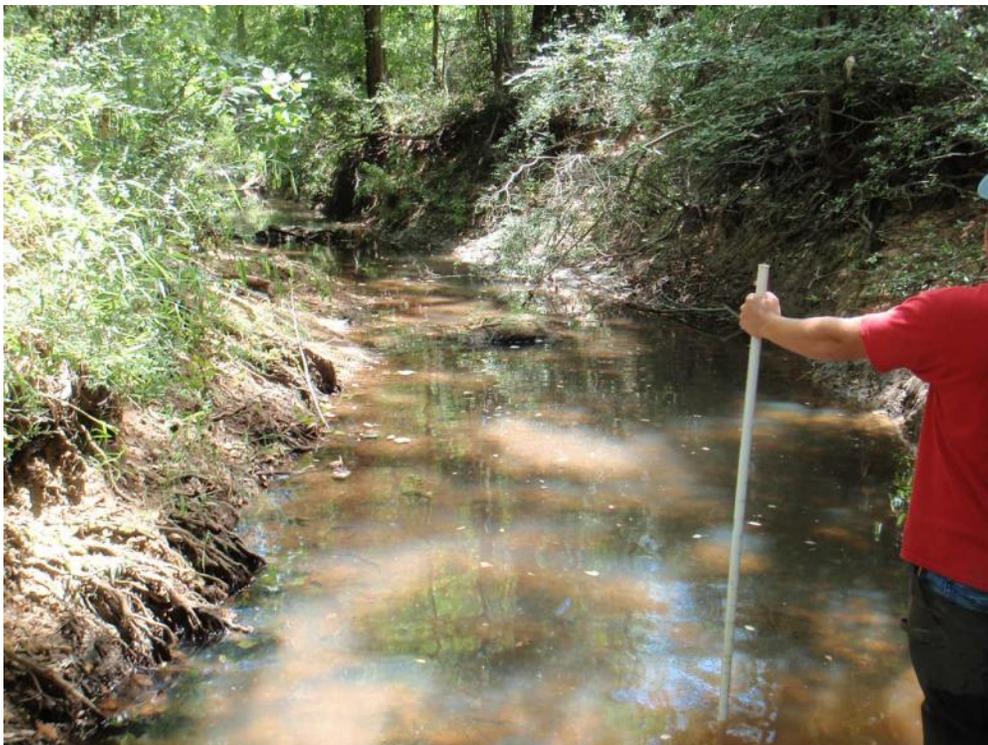
Figure 6.8 Photograph of Pin Oak Creek Site 20563 taken on August 20, 2013, the downstream view of the 300-m transect. BRA personnel in photograph.

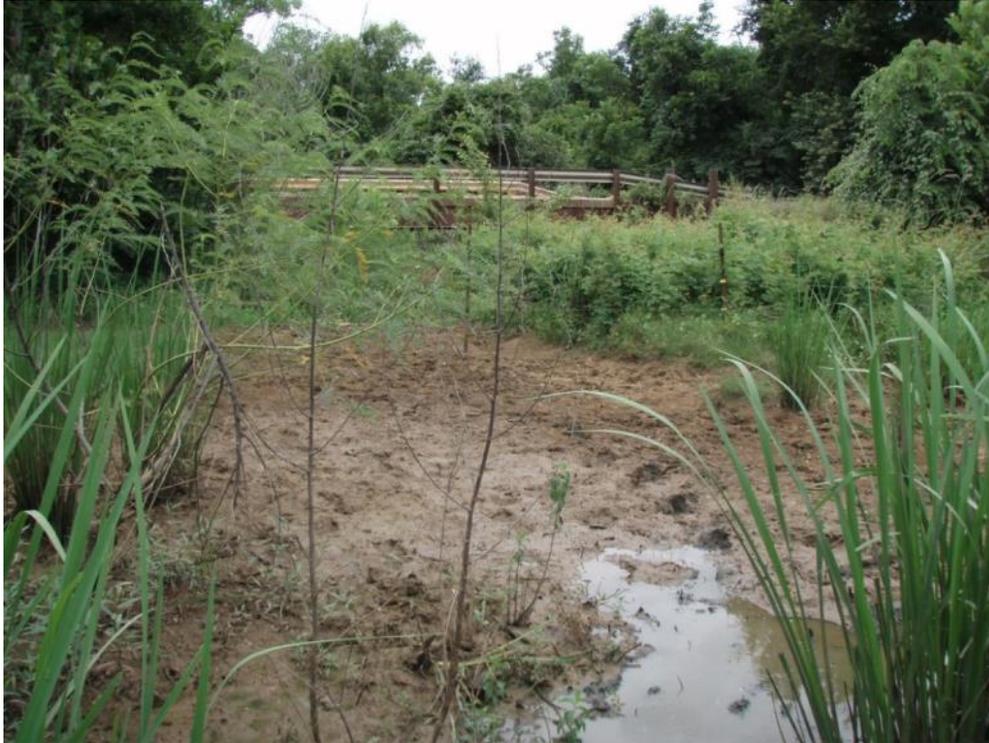
Aesthetic appearance of the water and wildlife observations for the site during each survey are provided in Tables 6.10 and 6.11. In August, a few cows were observed in the creek bed and bovine tracks were common during both surveys (Figures 6.9 and 6.10). No other mammals or vertebrates were observed during either survey. Aquatic vegetation was abundant in the mostly-dry channel during both surveys and terrestrial vegetation as also common during the second survey. Algae was rare in June and absent in August. The water color was brown and often covered in scum when it was present during the first survey. Trash was rare, confined mostly to the bridge area, and was comprised of bottles, cans, and some household garbage. No human presence or signs of recreation were found within the reach.

Figure 6.9 Photograph of Pin Oak Creek Site 99910 taken on June 28, 2010, the upstream view of the 30-m transect, including a portion of one pool.
