Recreational Use Attainability Analysis of Five Creeks along the Little Brazos River: Walnut Creek (1242O), Mud Creek (1242K), Pin Oak Creek (1242L), Spring Creek (1242M), and Campbells Creek (1242I)

Prepared for:
Texas State Soil and Water Conservation Board
Project 08-54

Data Collected by:
Brazos River Authority

June 2014

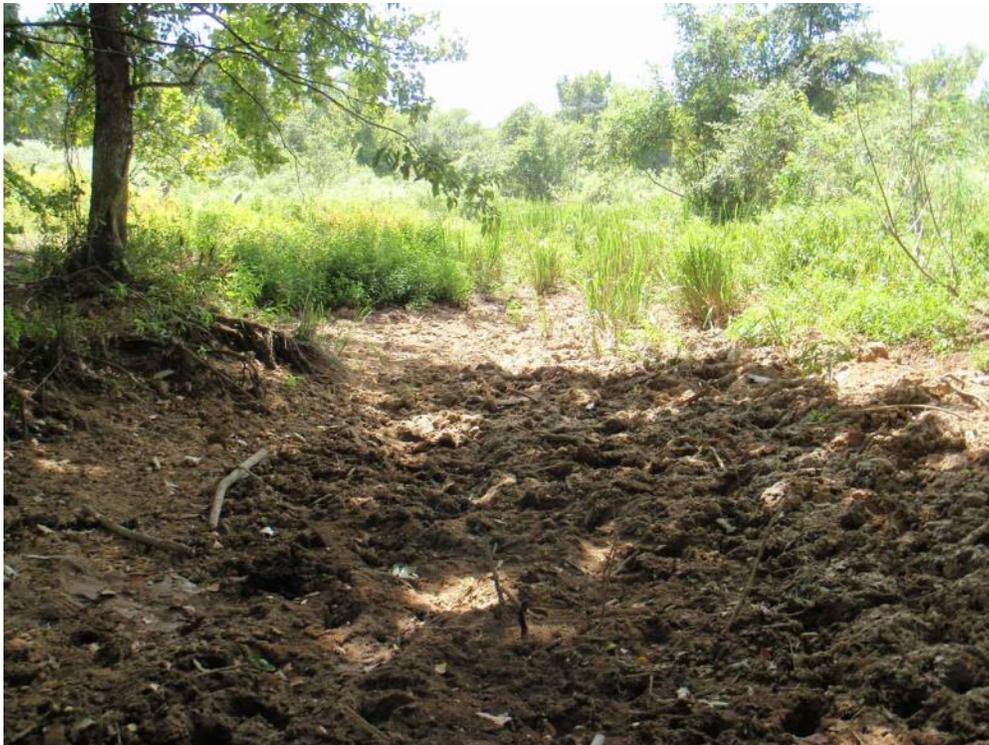
Pin Oak Creek at Site 99910 was visited on June 28 and August 20, 2010. Located northeast of Hearne, Texas, in Robertson County, this site was surrounded on all sides by forest and brush, but was accessible from the right-of-way of Pin Oak Road / CR 229. Access to the stream was easy, except for fences and brush (Figure 6.9). Flow was not observed during the two surveys and the average thalweg depth was 0.12 m. Shallow, stagnant pools were only large enough to measure during the June event (Figure 6.9). These pools were all wadeable ranging 0.06 – 0.45 m deep and 24 – 73 m in length. During the second survey the stream was mostly dry with only a few insignificant muddy puddles (Figure 6.10). No major obstructions in the stream channel were observed.

Aesthetic appearance of the water and wildlife observations for the site during each survey are provided in Tables 6.10 and 6.11. In August, a few cows were observed in the creek bed and bovine tracks were common during both surveys (Figures 6.9 and 6.10). No other mammals or vertebrates were observed during either survey. Aquatic vegetation was abundant in the mostly-dry channel during both surveys and terrestrial vegetation as also common during the second survey. Algae was rare in June and absent in August. The water color was brown and often covered in scum when it was present during the first survey. Trash was rare, confined mostly to the bridge area, and was comprised of bottles, cans, and some household garbage. No human presence or signs of recreation were found within the reach.

Figure 6.10 Photograph of Pin Oak Creek Site 99910 taken on August 20, 2010, the upstream view of the 150-m transect.

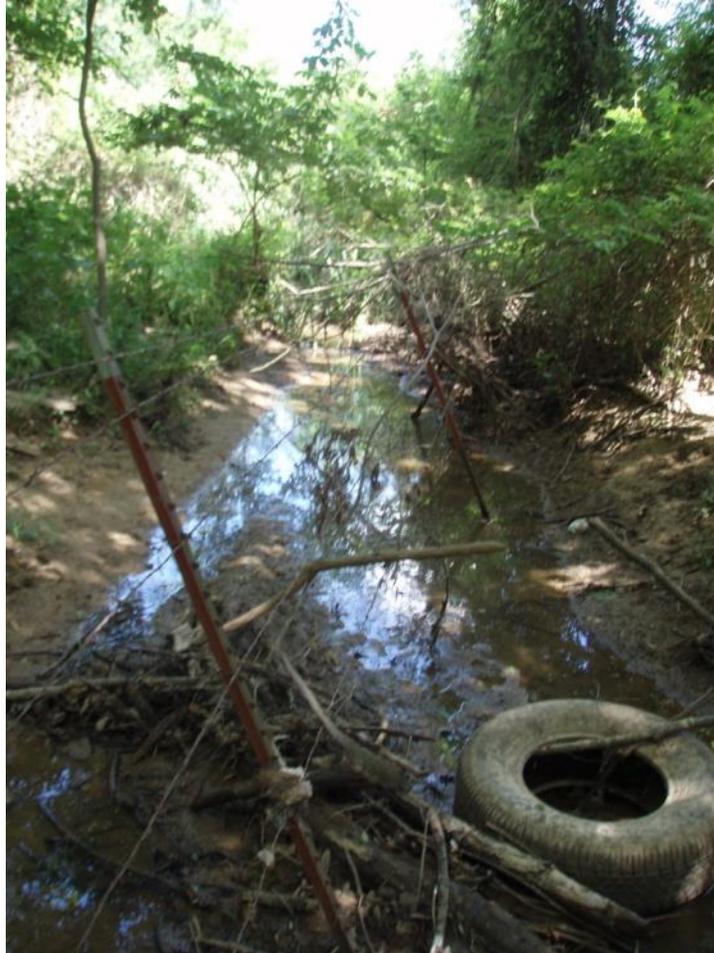
Pin Oak Creek at Site 99911 was visited on June 28 and August 20, 2010. Located northeast of Hearne, Texas, in Robertson County, this site was accessible from Pin Oak Road / CR 329. The 300-m reach downstream of the road crossing runs through private land and had several fences (Figure 6.11) and posted no-trespassing signs crossing the creek. The survey reach originates from a culvert under Pin Oak Road / CR 329 (Figure 6.12) that empties into a dammed pond and flows through a forest and shrub-dominated corridor. Figures 6.12 and 6.13 depict the appearance of the site during each of the surveys.

Figure 6.11 Photograph of Pin Oak Creek Site 99911 taken on June 28, 2010, the downstream view between the 150-m and 300-m transects showing fence crossing stream channel.

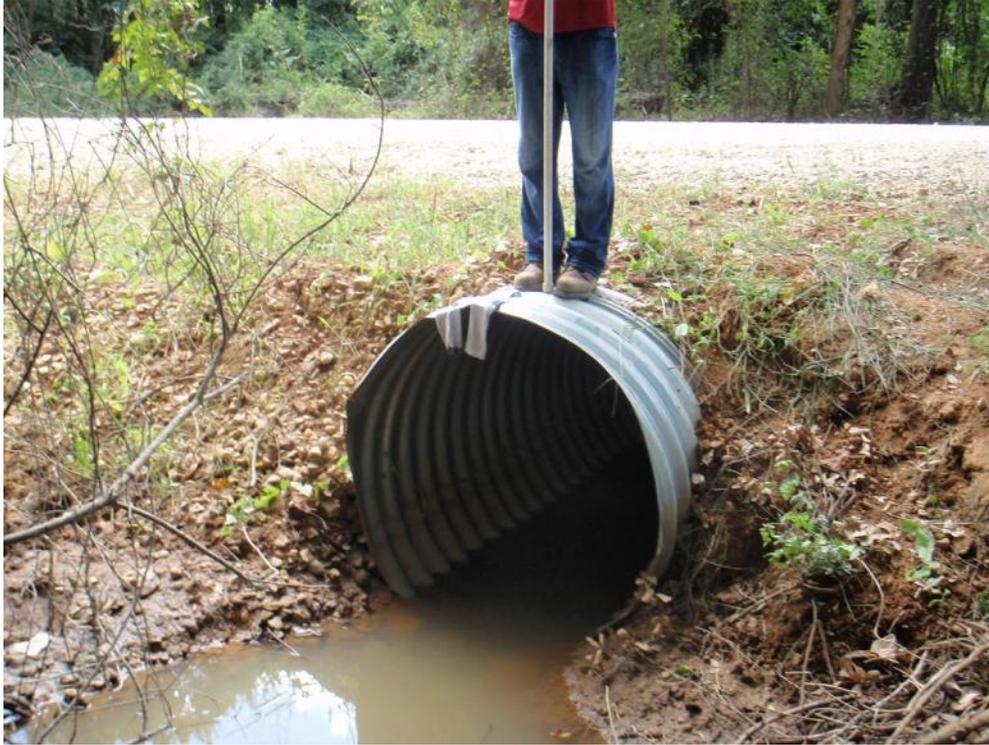
Figure 6.12 Photograph of Pin Oak Creek Site 99911 taken on August 20, 2010, the upstream view at the 0-m transect. BRA personnel in photograph.

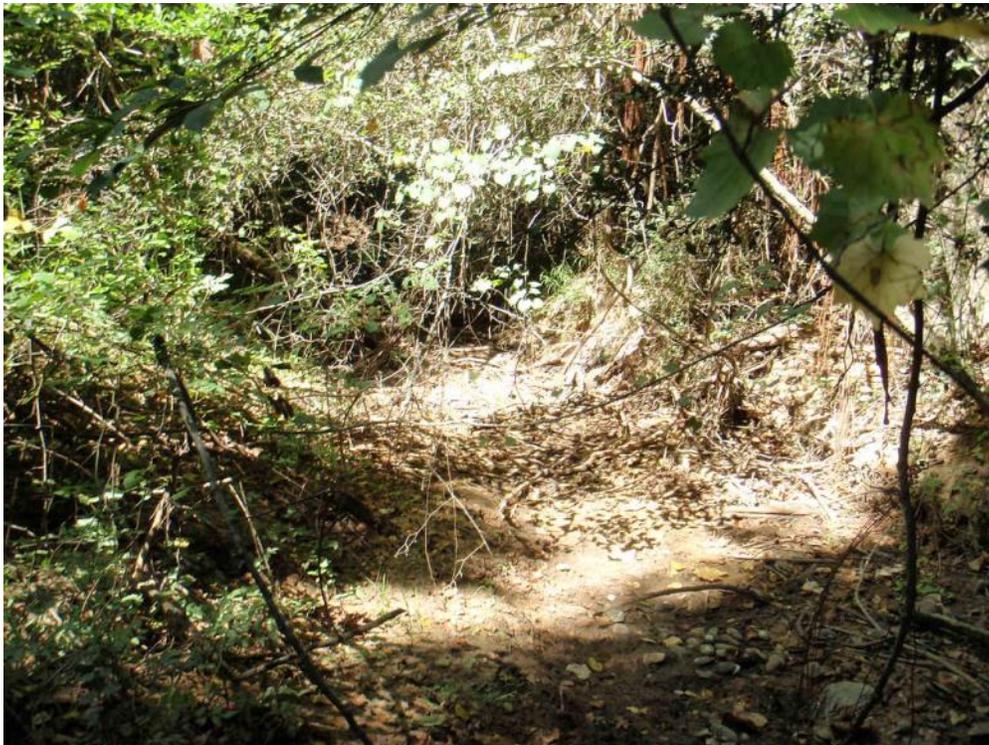
Figure 6.13 Photograph of Pin Oak Creek Site 99911 taken on August 20, 2010, the downstream view of the 30-m transect.

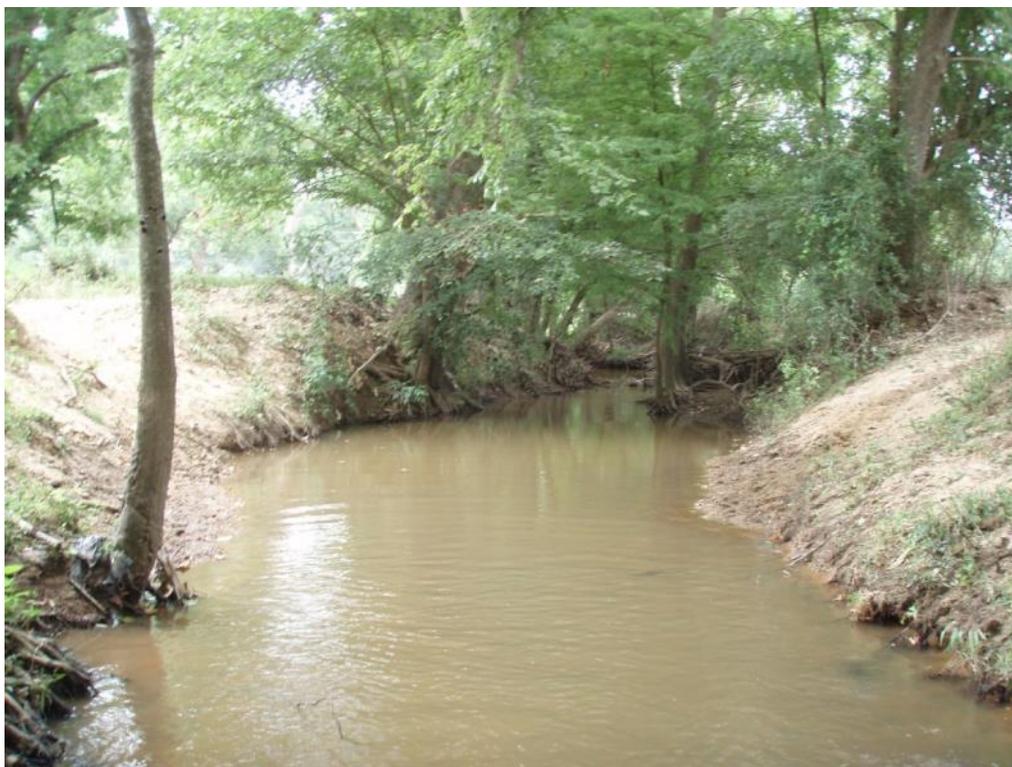
Figure 7.2 Photograph of Spring Creek Site 99912 taken on June 30, 2010, the upstream view of the 150-m transect.

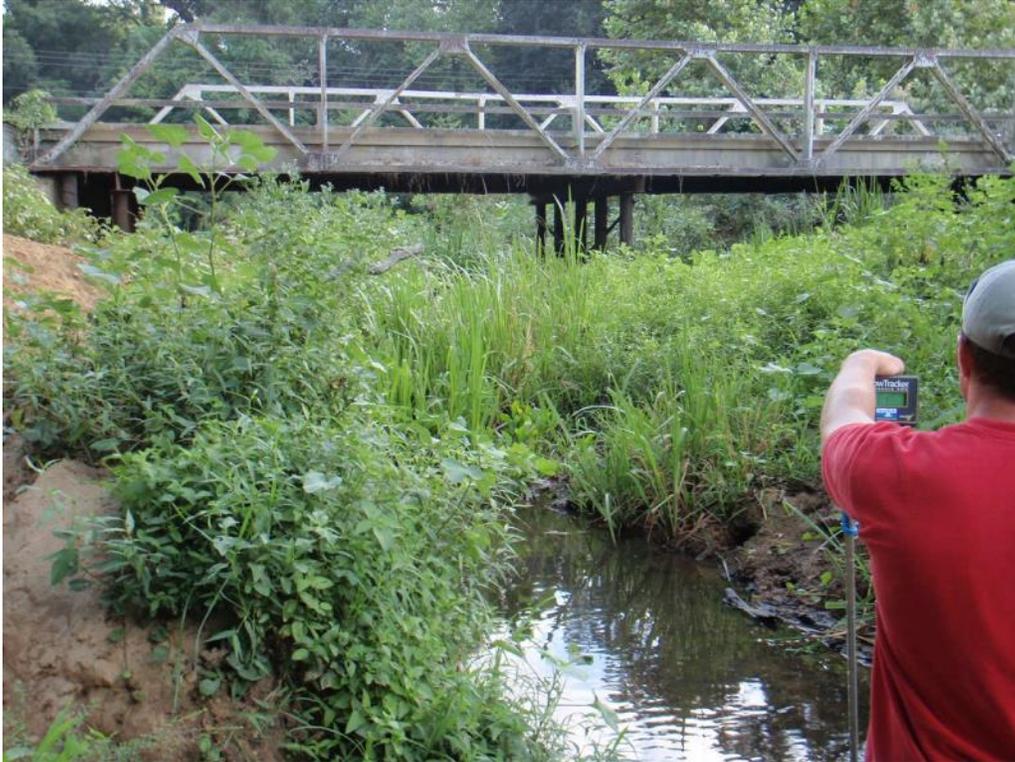
Figure 7.3 Photograph of Spring Creek Site 99912 taken on August 20, 2010, the upstream view of the 300-m transect. BRA personnel in photograph.

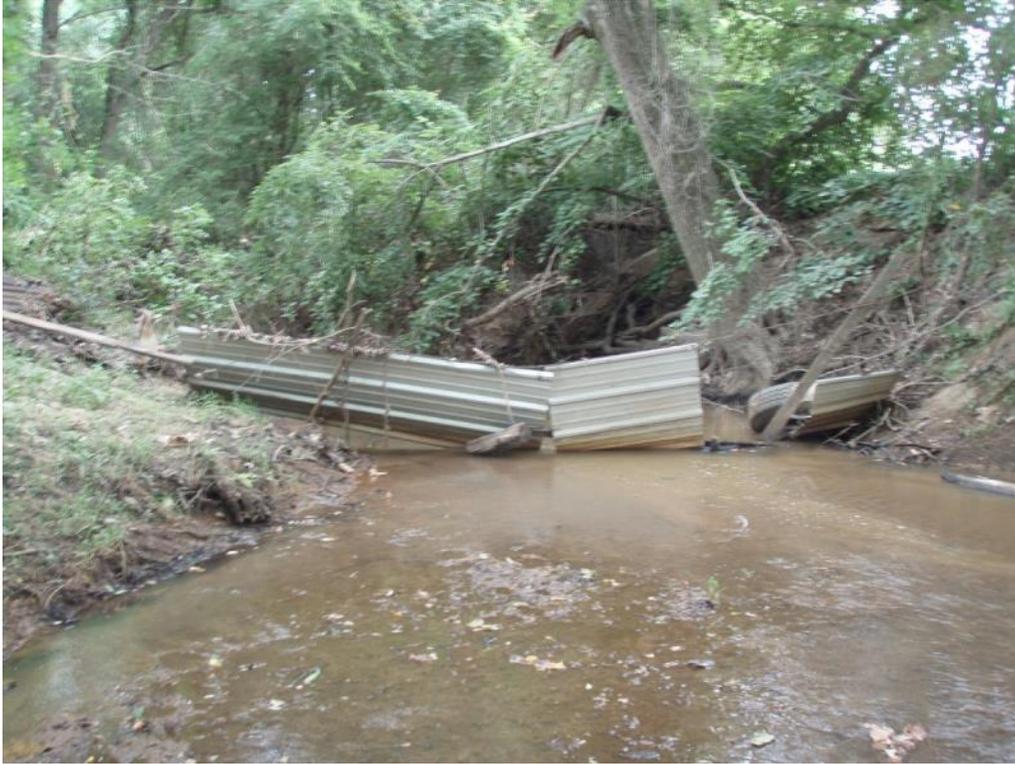
Figure 7.4 Photograph of Spring Creek Site 99912 taken on June 30, 2010, the downstream view of the 150-m transect.

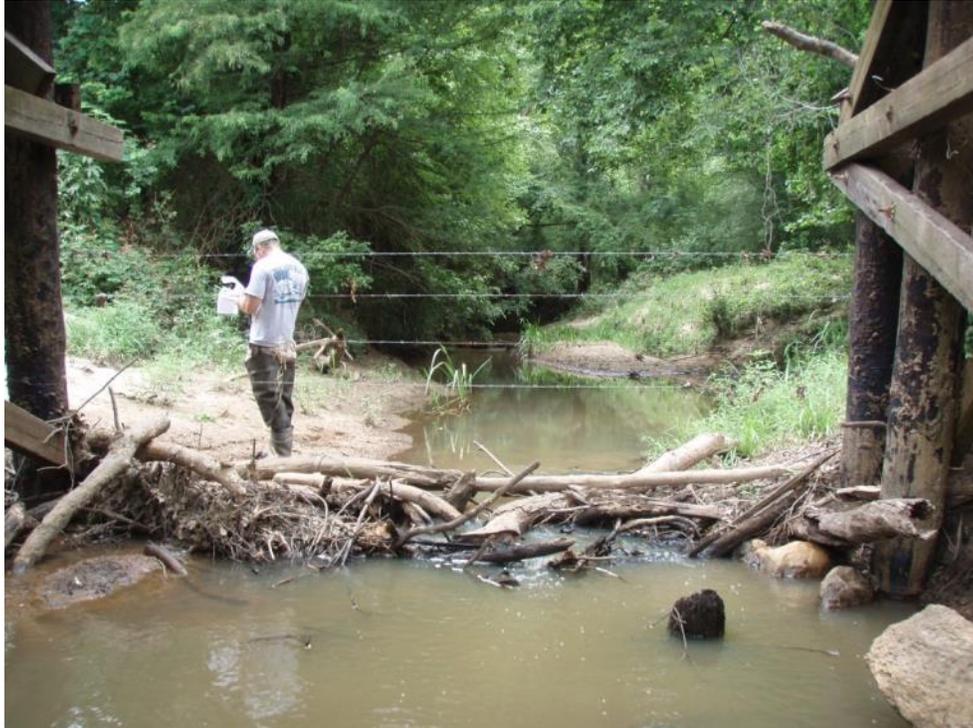
Figure 7.5 Photograph of Spring Creek Site 16394 taken on June 30, 2010, the upstream view of the 30-m transect. BRA personnel in photograph.

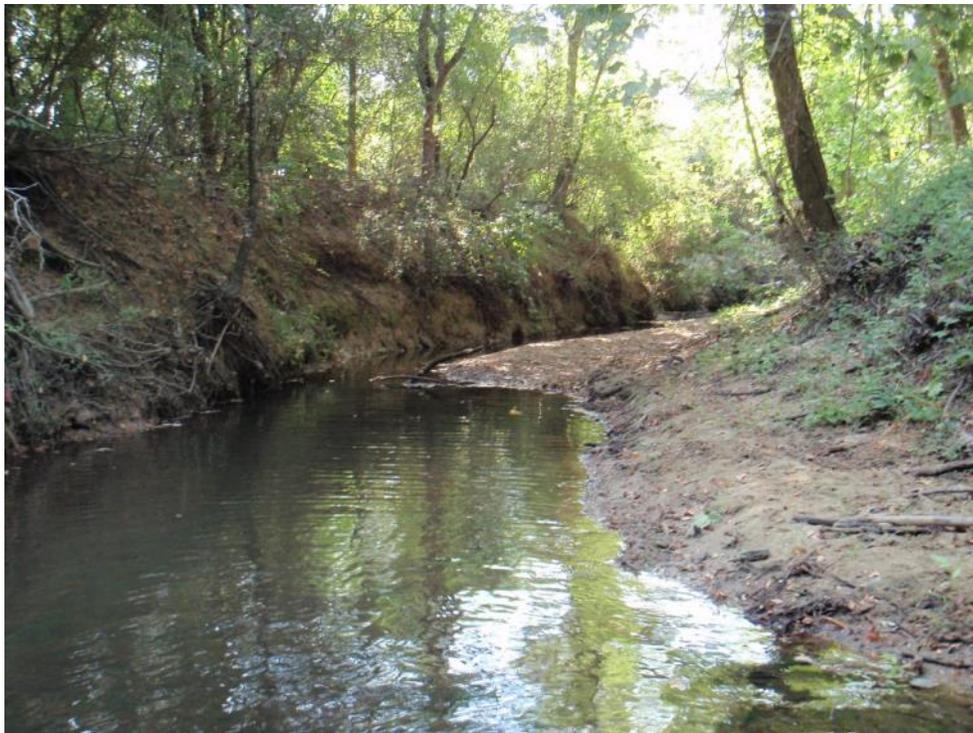
Figure 7.6 Photograph of Spring Creek Site 20385 taken on June 30, 2010, the downstream view of the 300-m transect.

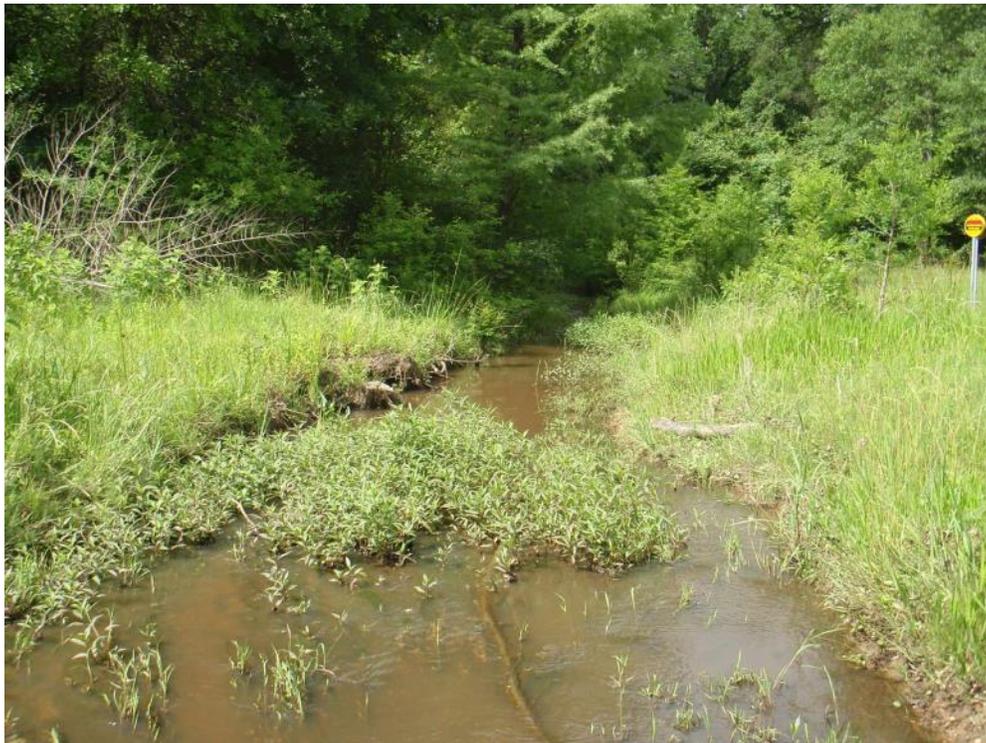
Figure 7.7 Photograph of Spring Creek Site 20564 taken on May 21, 2010, the downstream view of the 30-m transect.
