Recreational Use Attainability Analysis for Iron Ore (0202K), Choctaw Creek (0202F), Bois D' Arc Creek (0202A), Smith Creek (0202G), and Mud Creek (0201A) in the Red River Basin

Prepared for:
Texas State Soil and Water Conservation Board
Project 14-52

Texas Institute for Applied Environmental Research
Tarleton State University
Stephenville, Texas

TR 1504
October 2015

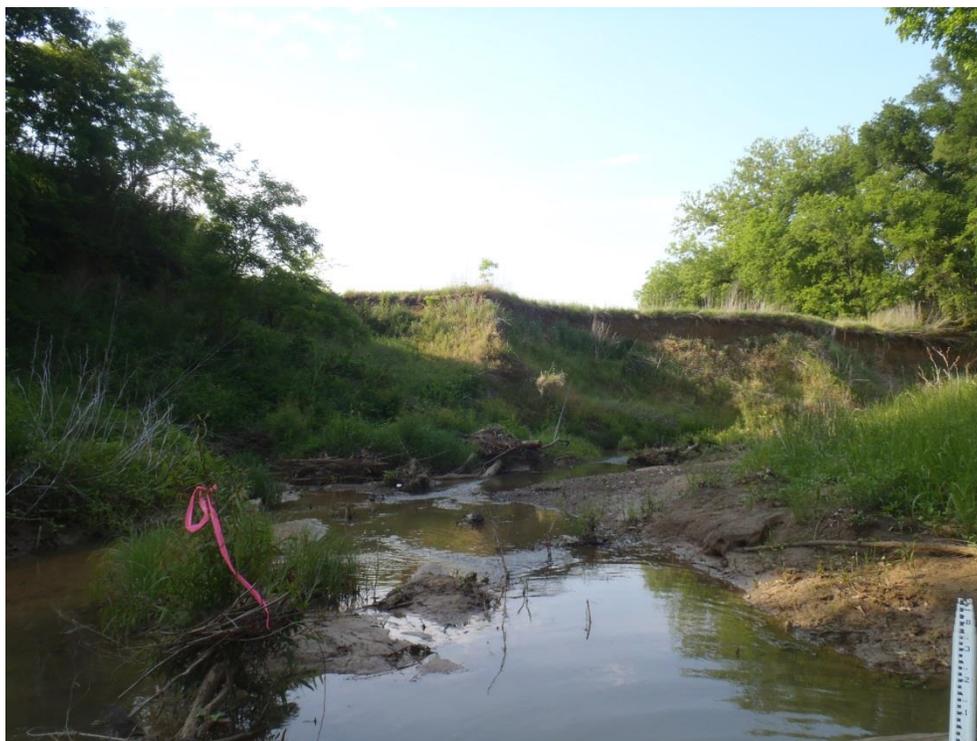
Figure 3.3 Photograph of Iron Ore Creek at Site IO01, taken on May 17, 2014. Downstream view of the 0-m transect.

The stream channel was naturally vegetated with grass, forbs, and trees. Banks were steep to vertical with sloughing in some places making travel up the banks difficult to impossible. There was no algae cover during the first survey but was rare during the second survey along with some surface foam and scum, and with some rare aquatic vegetation during both surveys. The color of the water body was clear throughout. Canine, feral hog, and raccoon tracks were observed as well as bird nests under the bridge, crawdad shells and live crawdads. A white bird was observed in the reach the first trip, a rabbit was observed on the second trip, and pig feces were observed both times. Garbage such as plastics, aluminum cans, glass bottles, and trash bags were present but rare. Large items, such as a single couch, fencing material, and abundant tires were throughout the reach (Tables 3.9 and 3.10). A young female on a 4 wheeler with fishing rods drove by on the road during the first trip. There was evidence of a trail visible from the bridge crossing and a set of tracks in the stream bed.

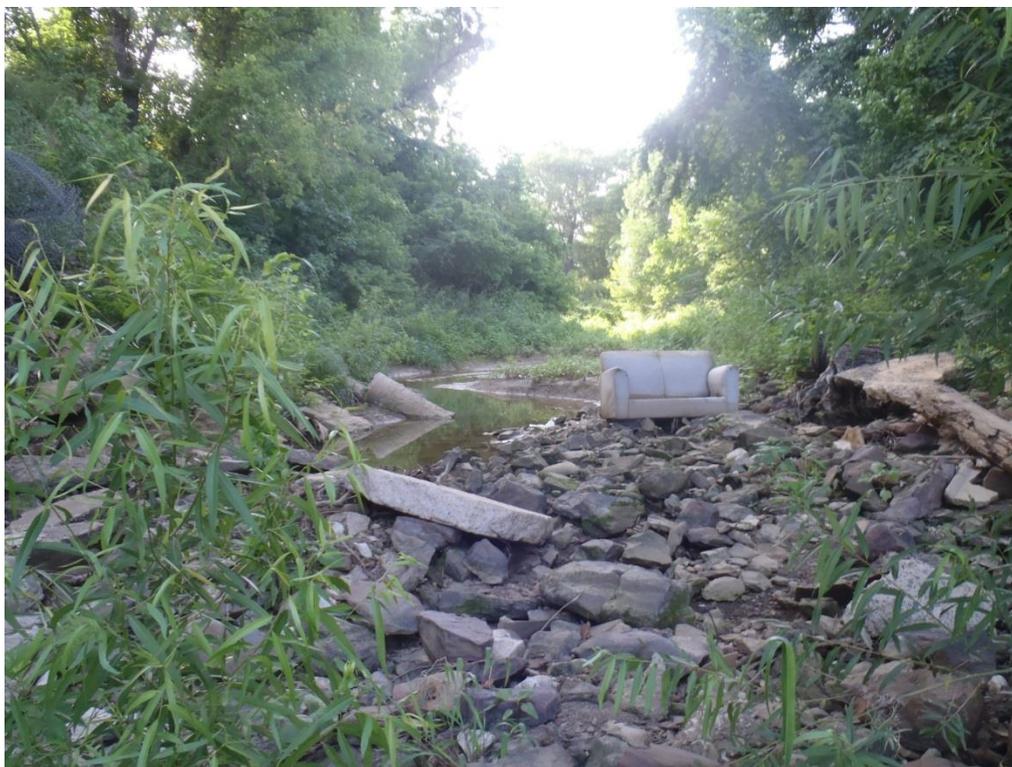
Figure 3.4 Photograph of Iron Ore Creek at Site IO01 taken July 11, 2014. Upstream view at 300-m transect.

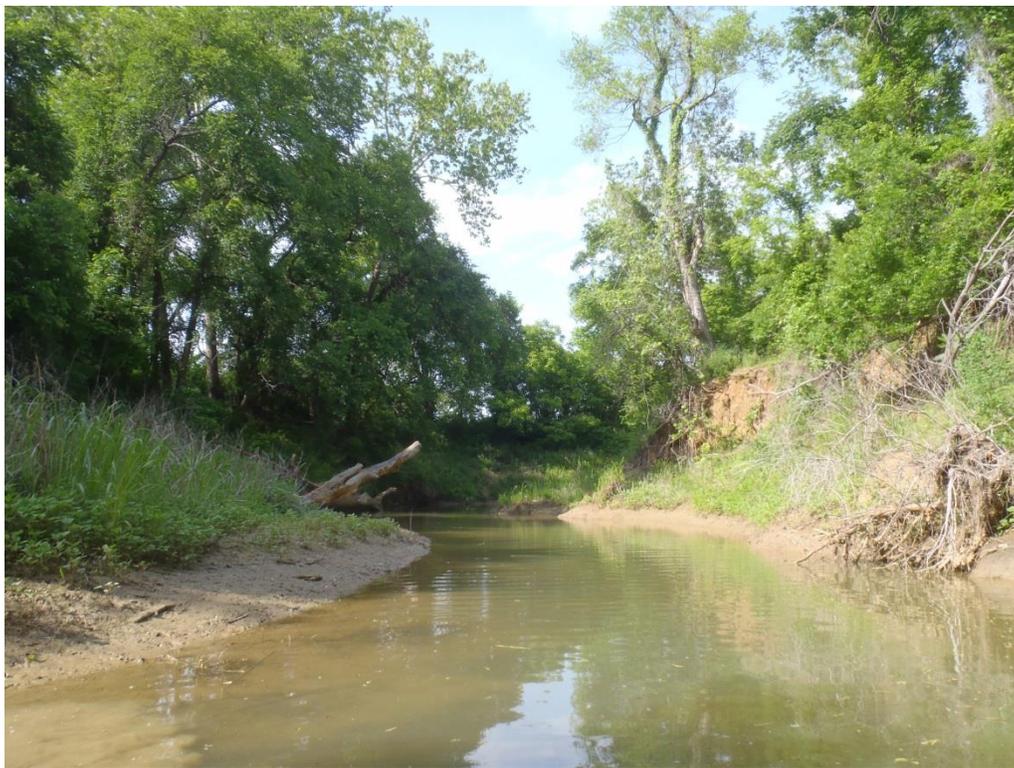
Figure 3.5 Photograph of Site IO02, taken on May 17, 2014, downstream view at 0-m transect.

The stream channel was naturally vegetated with grass, forbs, and trees. Banks were steep to vertical with sloughing in some places making travel up the banks difficult to impossible. There was no algae cover during either survey. Some surface scum, leaf debris, and some rare aquatic vegetation were seen during the first survey. Some surface oil was seen during Trip 2. The color of the water body was clear throughout but significantly brown during the first survey. Canine, deer, raccoon, and turtle tracks were observed as well as bird nests under the bridge, including crawfish shells and live crawfish. Deer and feral hog feces were observed during both surveys. Ducks, geese, and feral hogs were heard, but not observed. Garbage such as plastics, aluminum cans, glass bottles, papers, and trash bags were present, but rare. Large items, such as a single couch, fencing material, metal, and abundant tires were seen throughout the reach (Tables 3.9 and 3.10). No other signs of human recreation were observed.

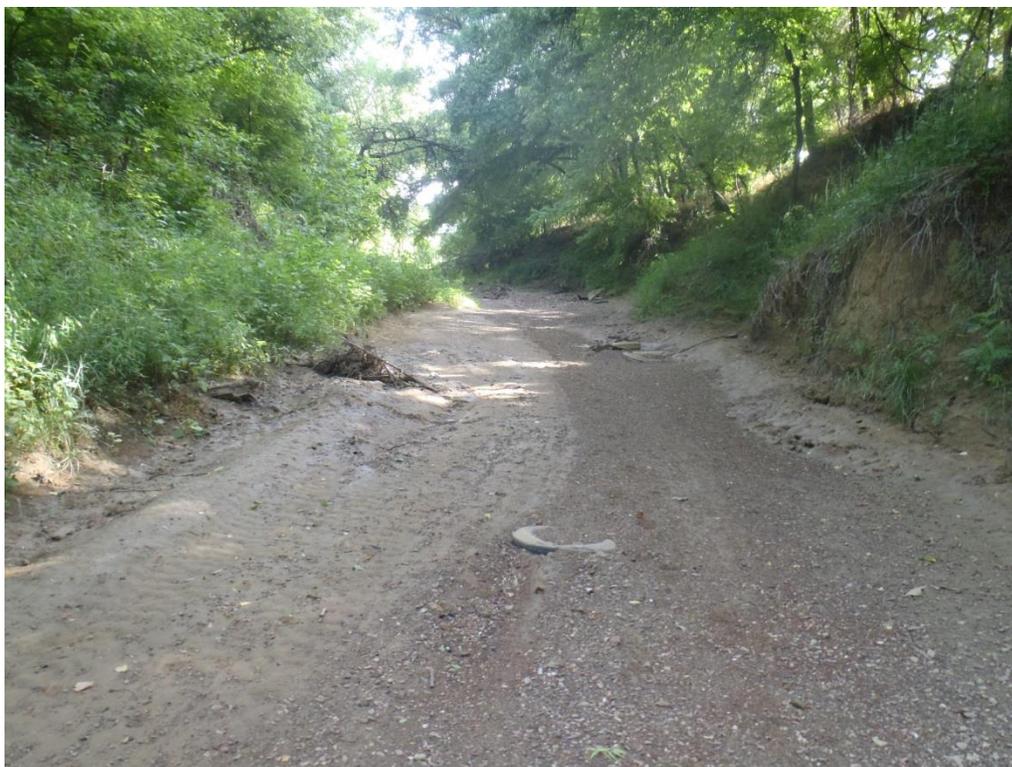
Figure 3.6 Photograph of site IO02, taken July 11, 2014. Upstream view at 150-m transect.

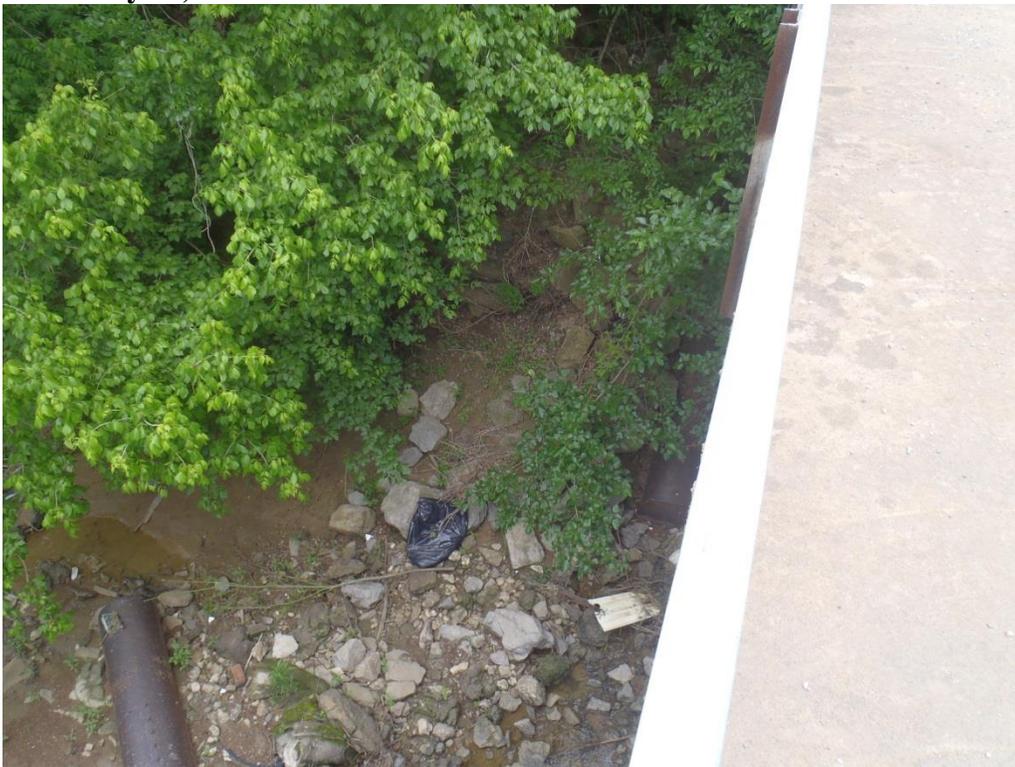
Iron Ore Creek at site IO03 was visited but no surveys were performed on May 17 or July 11, 2014. Access to this location was easy, because it occurred at a road crossing with a bridge over the stream; however, a private property fence prevented access beyond the bridge. There were posted signs saying “Private Property” and “No Trespassing” and attempts to contact the landowner for access were unsuccessful (Figure 3.7). In addition, access from the bridge or banks was extremely steep with significant drops and too much poison ivy to attempt entry (Figure 3.8). No human recreation was observed.

Figure 3.8 Photograph of difficult access at bridge at Site IO03, taken on May 17, 2014.

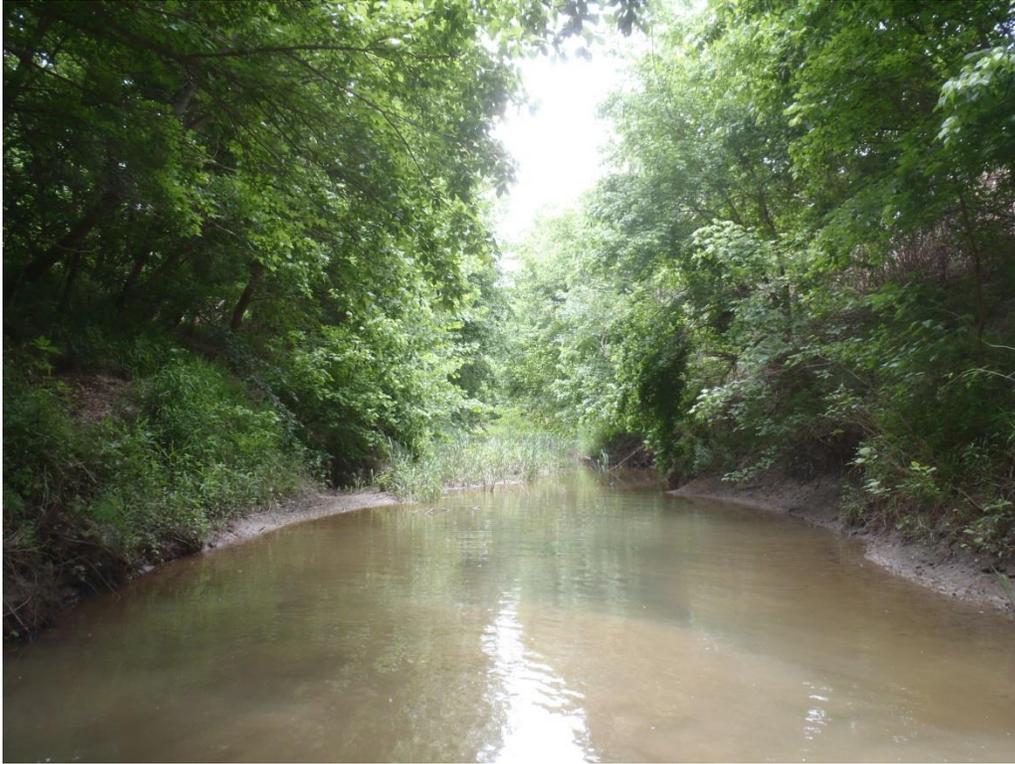
Figure 3.12 Photograph of IO05, taken on May 17, 2014, the downstream view at the 0-m transect.

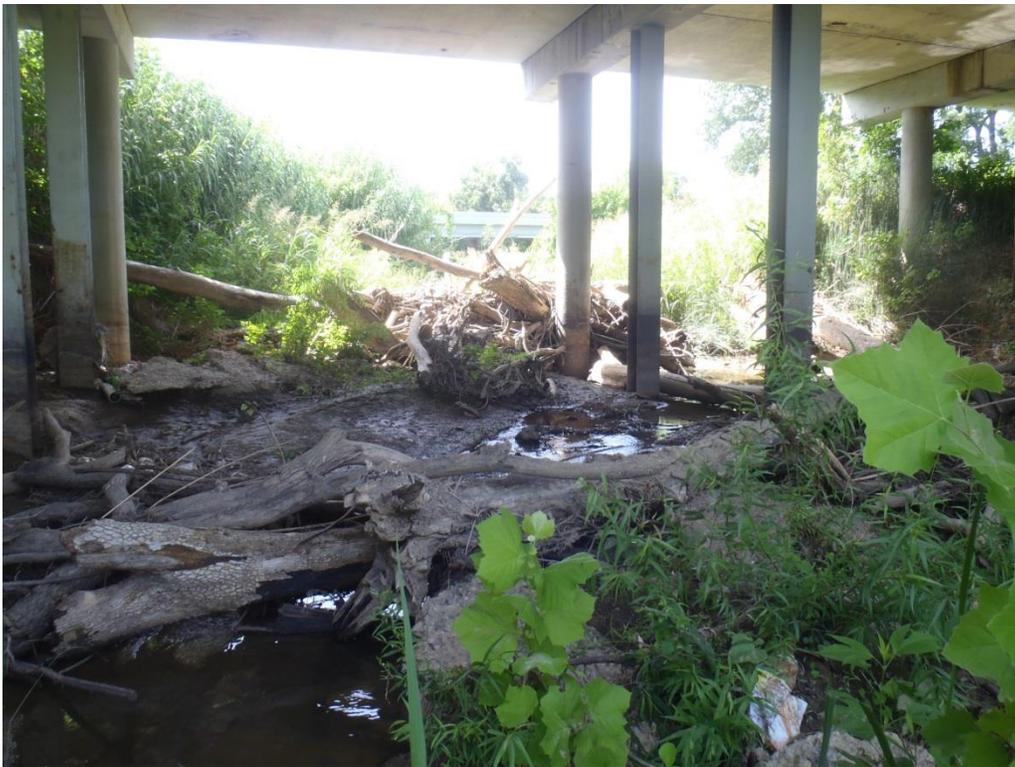
Figure 3.13 Photograph of Site IO05, taken on July 11, 2014. Upstream view at 300-m transect.

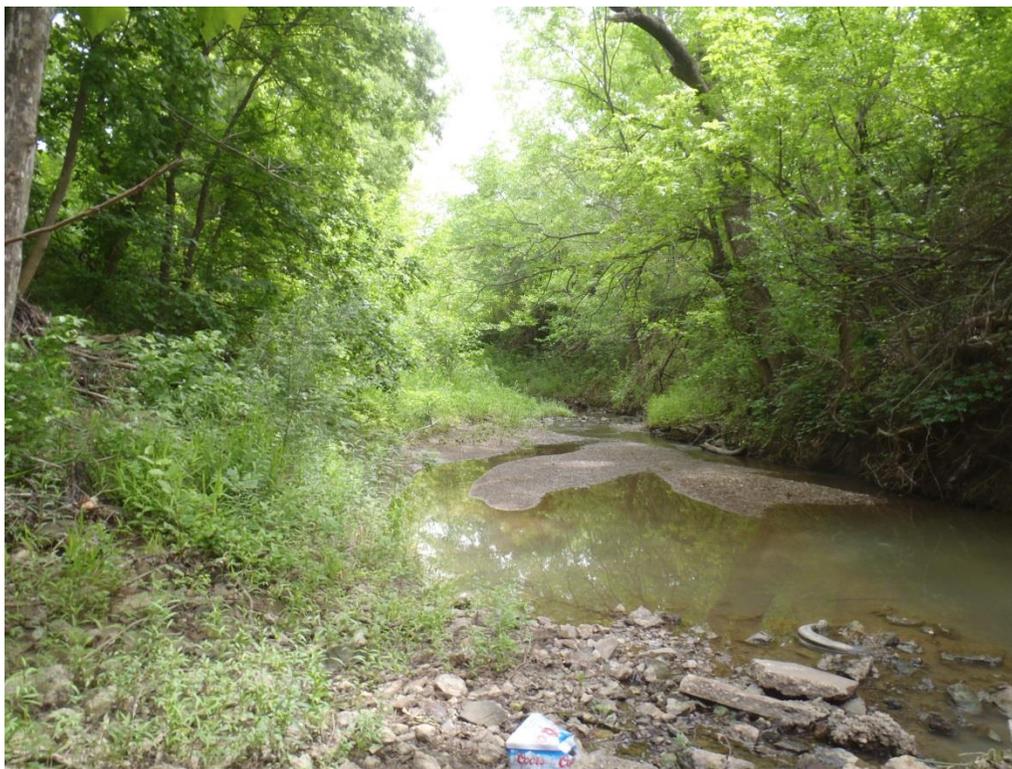
Iron Ore Creek at site IO06 was surveyed on May 17 and July 11, 2014. Access to this location was easy, because it occurred at a road crossing with a bridge over the stream. There were no private property fences hindering access (one side of the bridge has a barbed wire fence with a “No Trespassing” sign, but this fence was not continuous to the bridge). However, access into the stream was difficult everywhere due to steep banks, dense vegetation, and slick mud, except for moderately difficult access (steep concrete embankment) at the bridge. There was some concrete and rip rap at the immediate bridge with cobble, gravel, silt, sand, and mud/clay at varying points throughout the reach. In addition, this site had dense vegetation and steep banks along the reach and one log jam obstruction at the bridge. Figure 3.14 depicts the appearance of the site.

Figure 3.14 Photograph of Site IO06, taken May 17, 2014. Downstream view at 0-m transect.

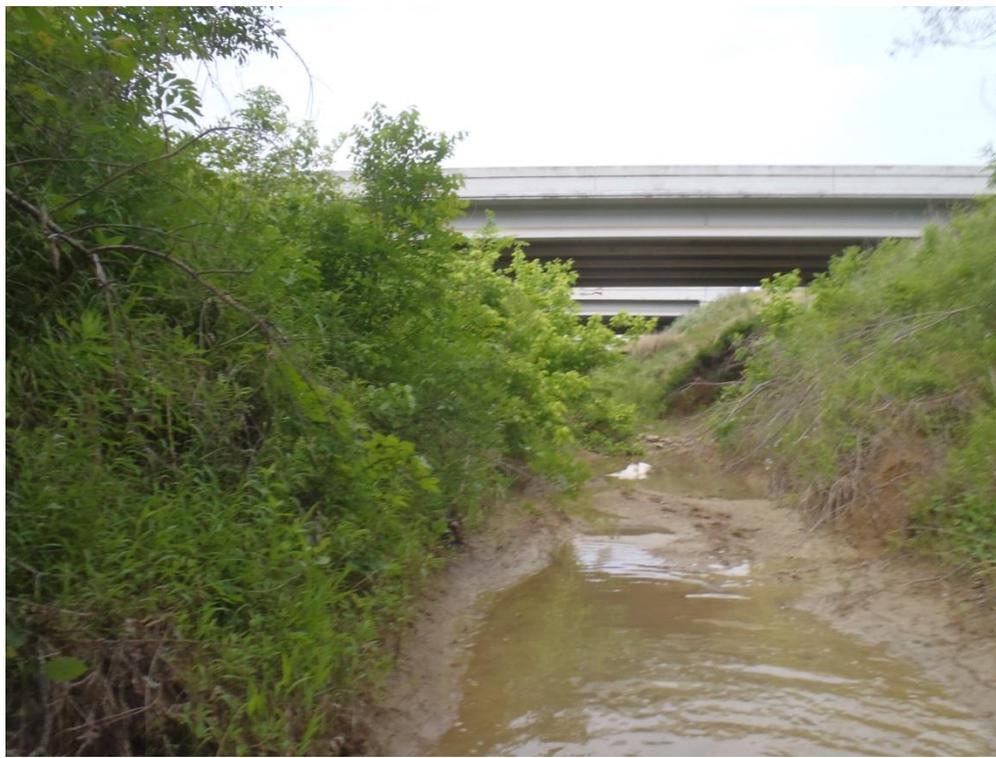
at points. Algae cover was absent during the first survey, but common during the second (Tables 3.9 and 3.20). Aquatic vegetation, primarily cattails and reeds were common to abundant. The color of the water was clear on Trip 1 and brown on Trip 2 with some foam and scum on the surface. Bird nests were observed under the bridge as well as two snakes. Tracks from felines and raccoons were observed, in addition to bird feces. Garbage such as plastics, aluminum cans, glass bottles, papers, and foam were common at the bridges, but rare along the reach. Large items, such as tires, were seen throughout the reach (Tables 3.9 and 3.10). There were no signs of human recreation.

Figure 3.16 Photograph of Site IO07, taken on May 17, 2014. Upstream view 0-m transect.

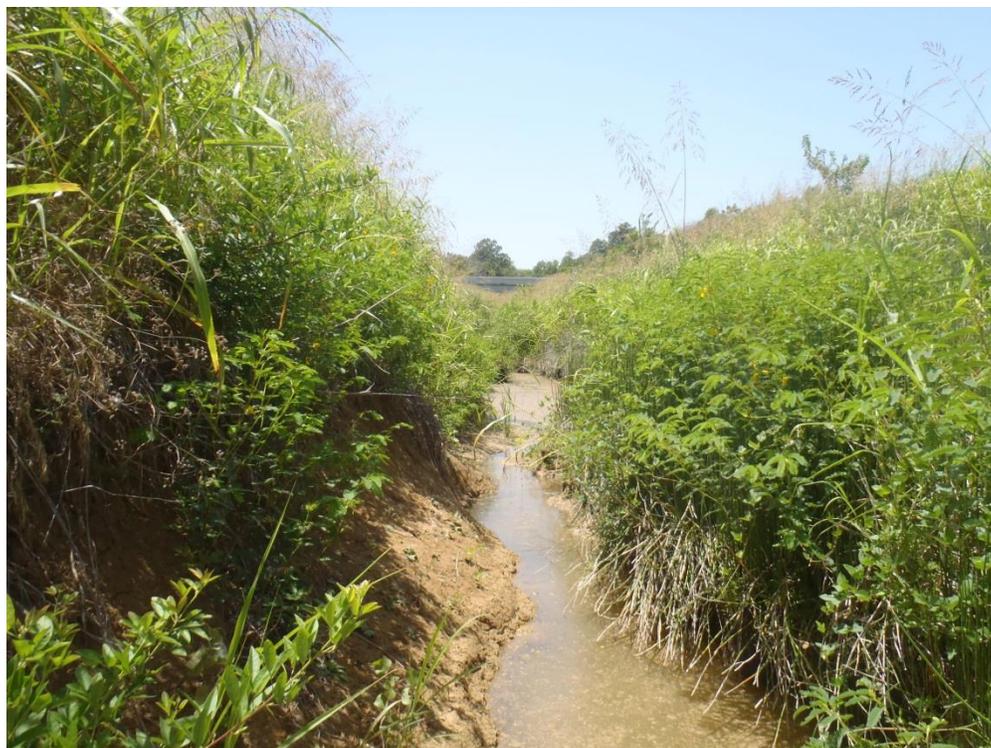
Figure 3.17 Photograph of IO07, taken on July 11, 2014. Upstream view at 150-m transect.

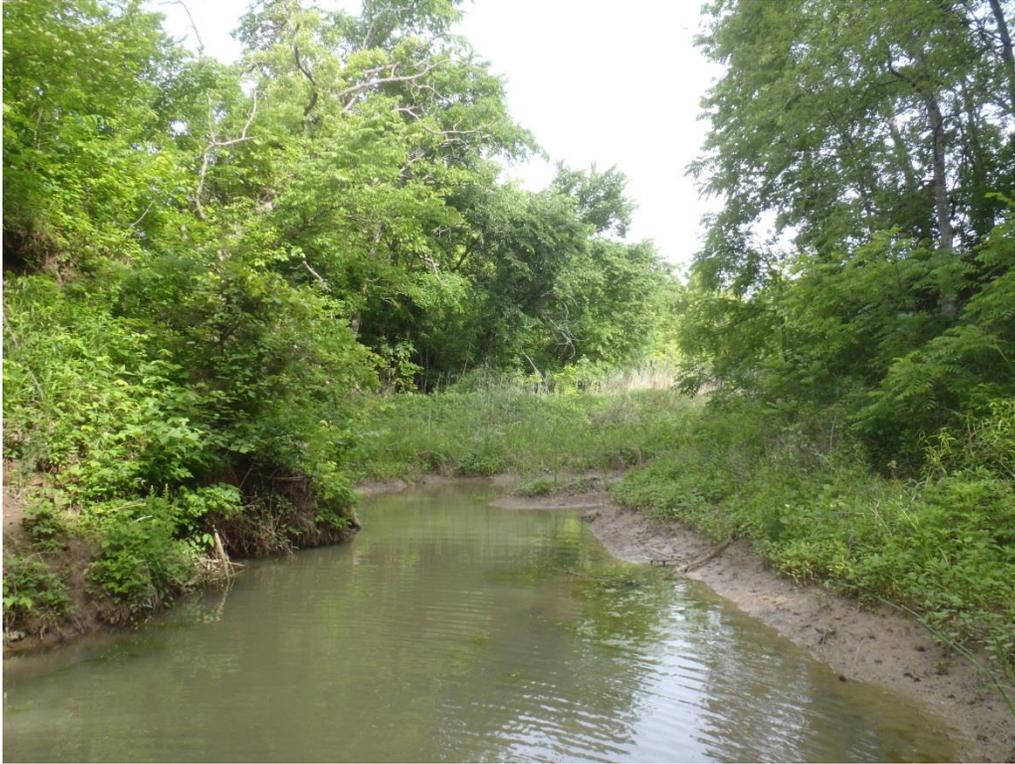
Figure 3.18 Photograph of IO08, taken on May 17, 2014. Upstream view at 150-m transect.

The stream channel was naturally vegetated with grass, forbs, and trees within the reach. Banks were moderately steep, with some areas sloughing off, making travel up the banks difficult. There was some rare algae cover and some rare aquatic vegetation, cattails and reeds, at both surveys. The color of the water body was clear for Trip 1 and Trip 2 with some foam and scum on the surface. No bird nests were observed under the bridge. Tracks from feral hogs and raccoons were observed, in addition to bird feces. During the second survey, two deer were observed in the stream bed. Common garbage such as plastics, aluminum cans, glass bottles, bricks, and wood debris were common at the bridge, but rare along the reach. Large items, such as tires, trash bags, a ceramic toilet, and a TV, were seen throughout the reach (Tables 3.9 and 3.10). There were no signs of human recreation.

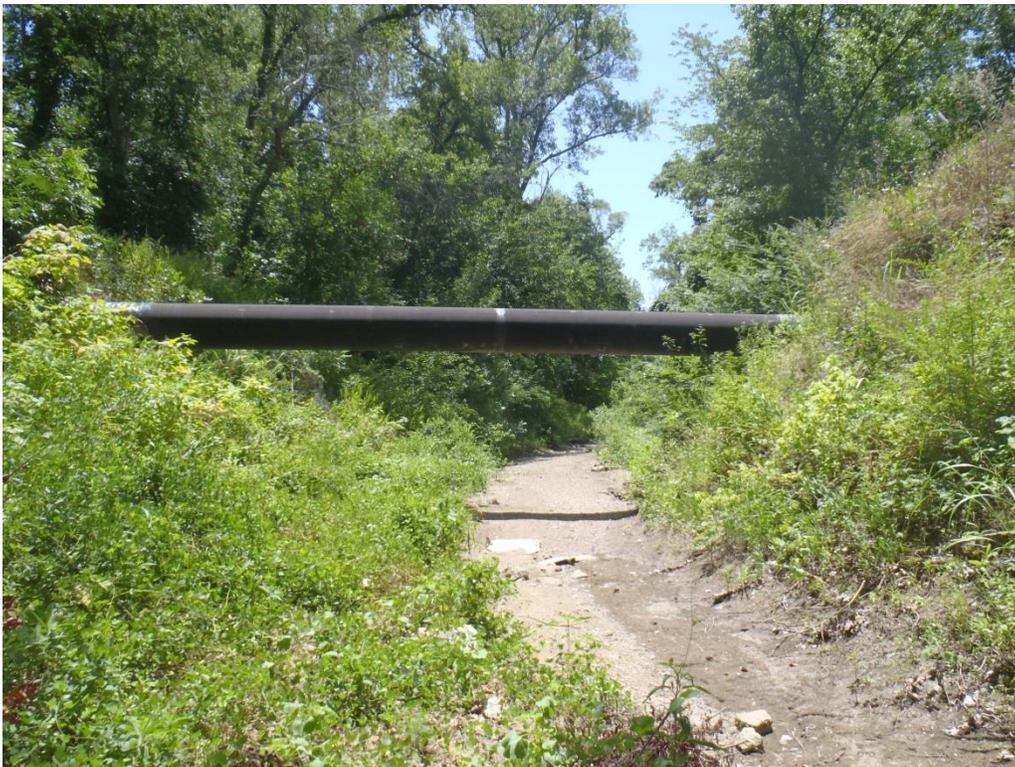
Figure 3.19 Photograph of Site IO08, taken on July 11, 2014. Downstream view at 0-m transect.

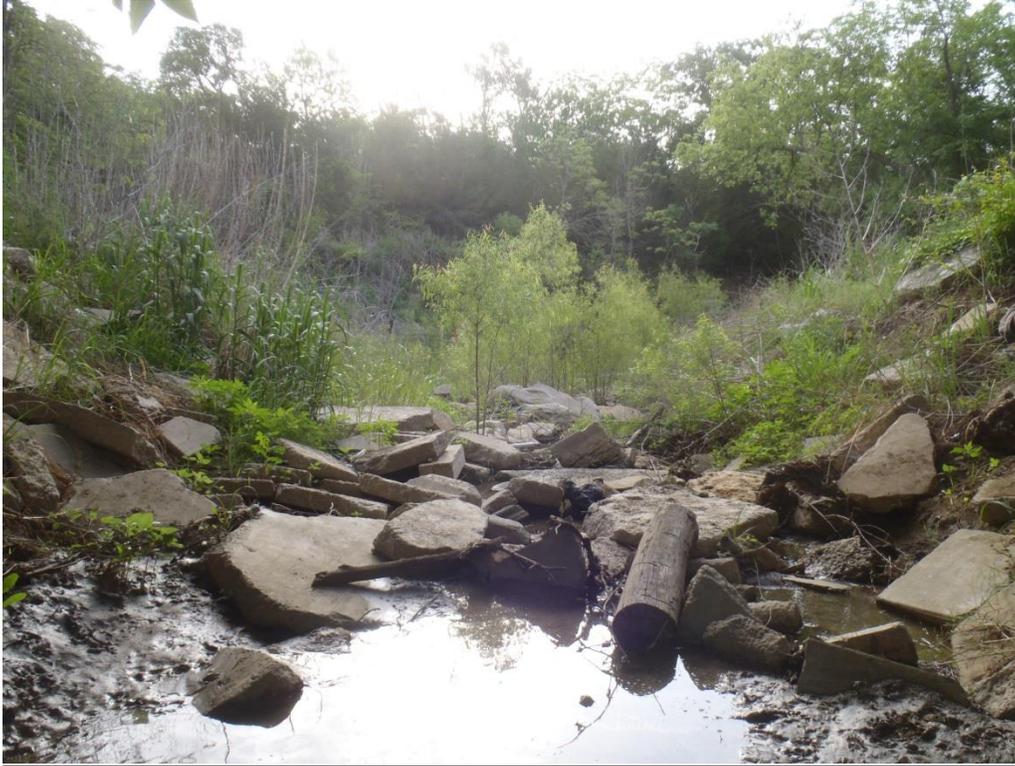
The stream channel was naturally vegetated with grass, forbs, and trees within the reach. Banks were moderately steep, with some areas sloughing off, making travel up the banks difficult. There was no algae cover and some (rare) aquatic vegetation found during both surveys. The color of the water body was clear for Trip 1, while the creek was dry during Trip 2. Some bird nests were observed under the bridge. Tracks from canine, deer, feral hog, and raccoons were observed, in addition to bird feces. Typical garbage such as plastics, aluminum cans, glass bottles, bricks, and wood debris were rare at the bridge with very little bank garbage along the reach. There was a single tire throughout the reach (Tables 3.9 and 3.10). There were no signs of human recreation.

Figure 3.20 Photograph of site IO09, taken on May 17, 2014. Downstream view at 0-m transect.

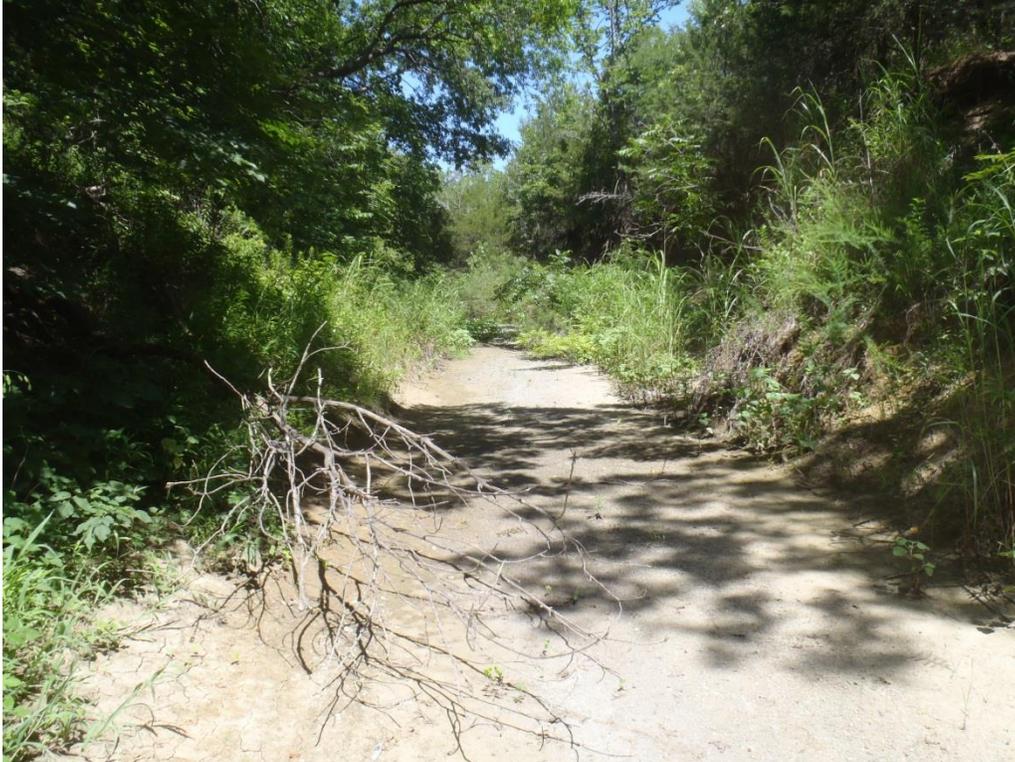
Figure 3.21 Photograph of site IO09, taken on July 11, 2014. Upstream view at 150-m transect.

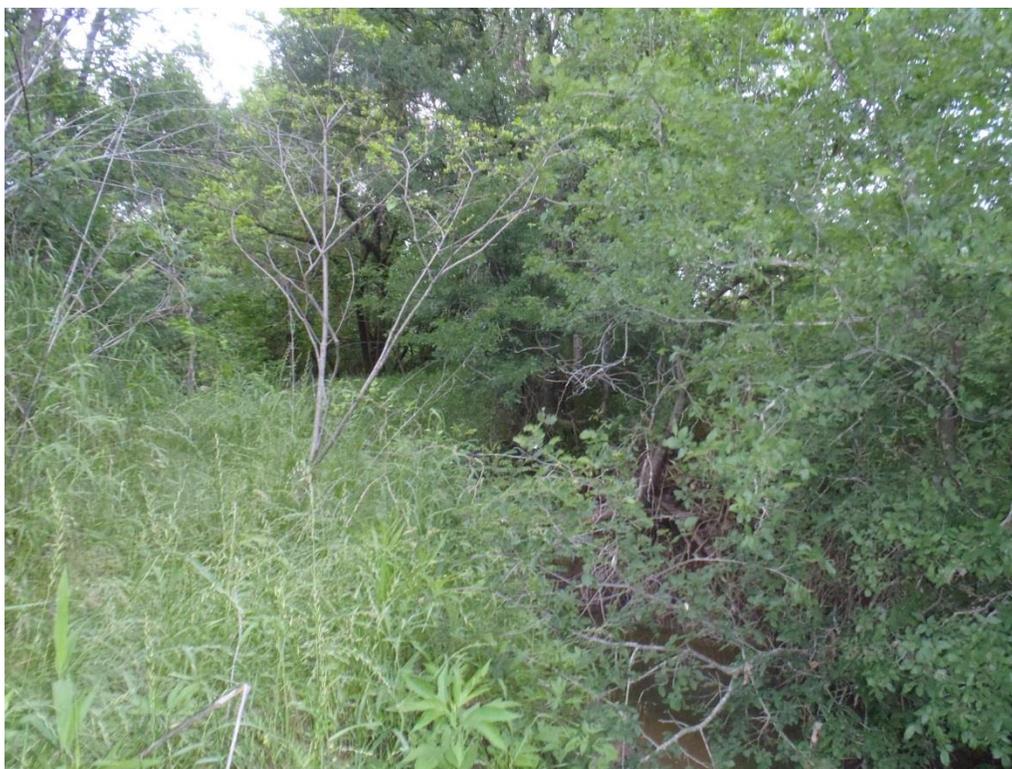
Figure 3.22 Photograph of IO10, taken on May 16, 2014. Upstream view at 150-m transect.

The stream channel was naturally vegetated with grass, forbs, and trees within the reach. Banks were moderately steep and heavily vegetated in parts. There was no algae cover and no aquatic vegetation noted during either survey (Tables 3.9 and 3.10). The color of the water body was clear for Trip 1, while there was no water during Trip 2. No bird nests were observed under the road/culverts but were observed throughout the reach. Tracks from cattle and raccoons were observed, in addition to bird feces. Common garbage such as plastics, aluminum cans, and glass bottles were common at the bridge, but rare along the reach. Several tires were observed throughout the reach. There were no signs of human recreation.

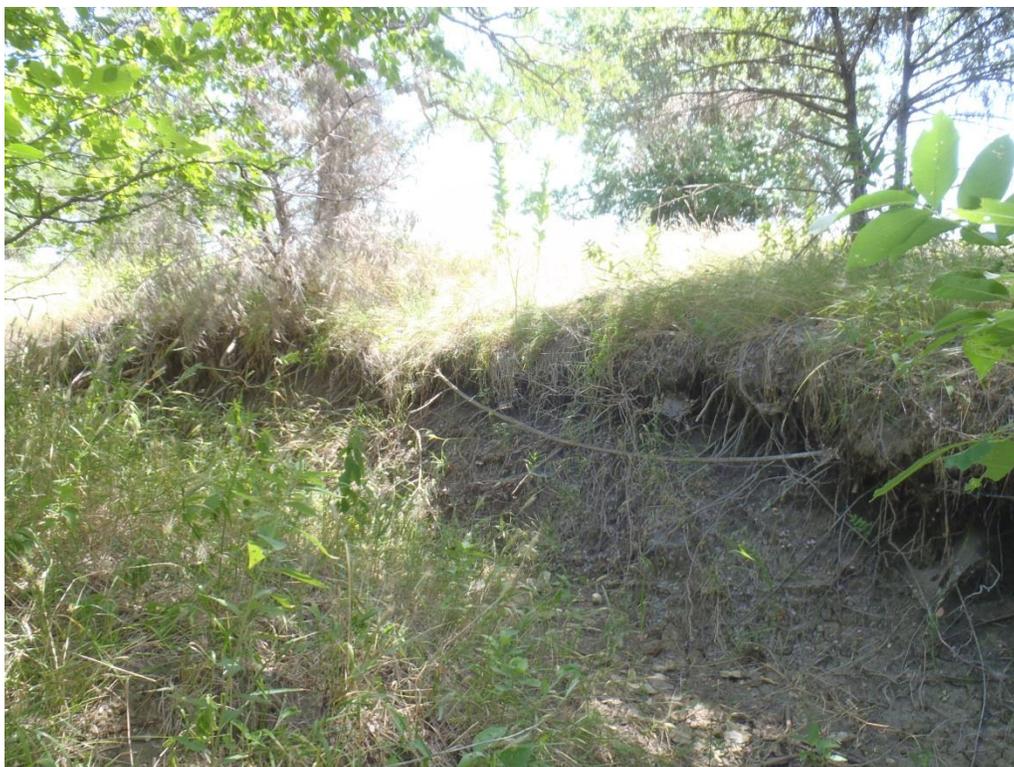
Figure 3.23 Photograph of IO10, taken on July 11, 2014. Upstream view at 300-m transect.

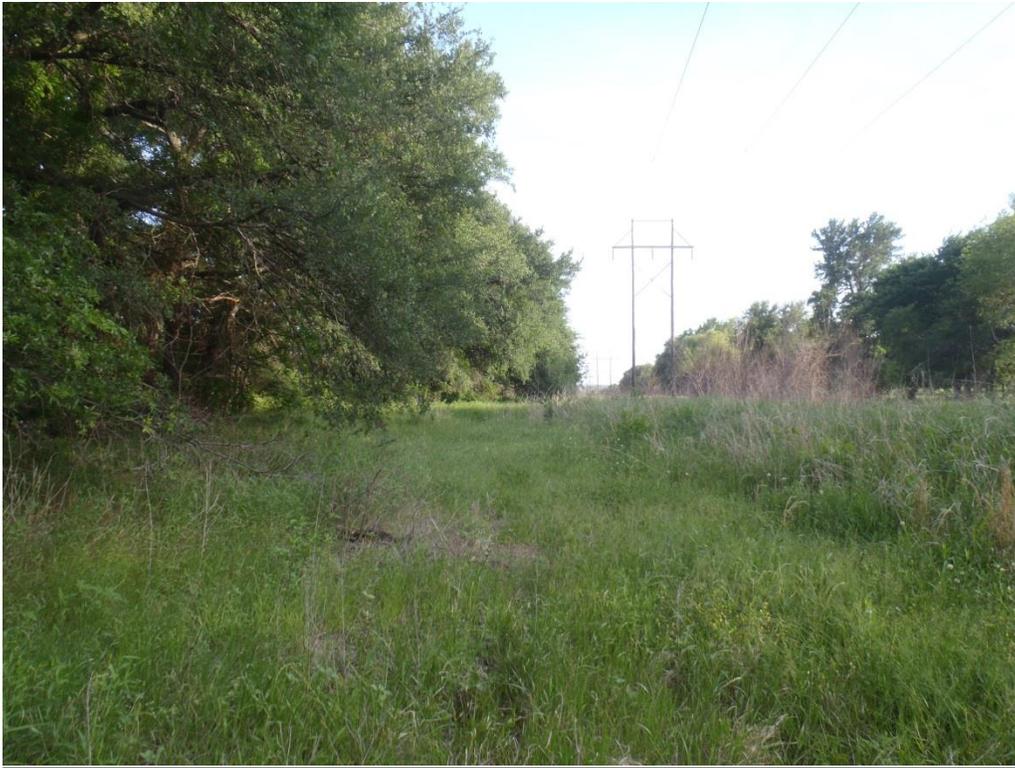
Figure 3.24 Photograph of site IO11, taken on May 16, 2014. Downstream view at 300-m transect.

The stream was wadeable as there was very limited water. Dry conditions were noted during both surveys (Table 3.6). No substantial pools were encountered within the reach. Overall, the stream had an average width of 0.0 m for Trip 1 and Trip 2 under dry conditions (Tables 3.7 and 3.8).

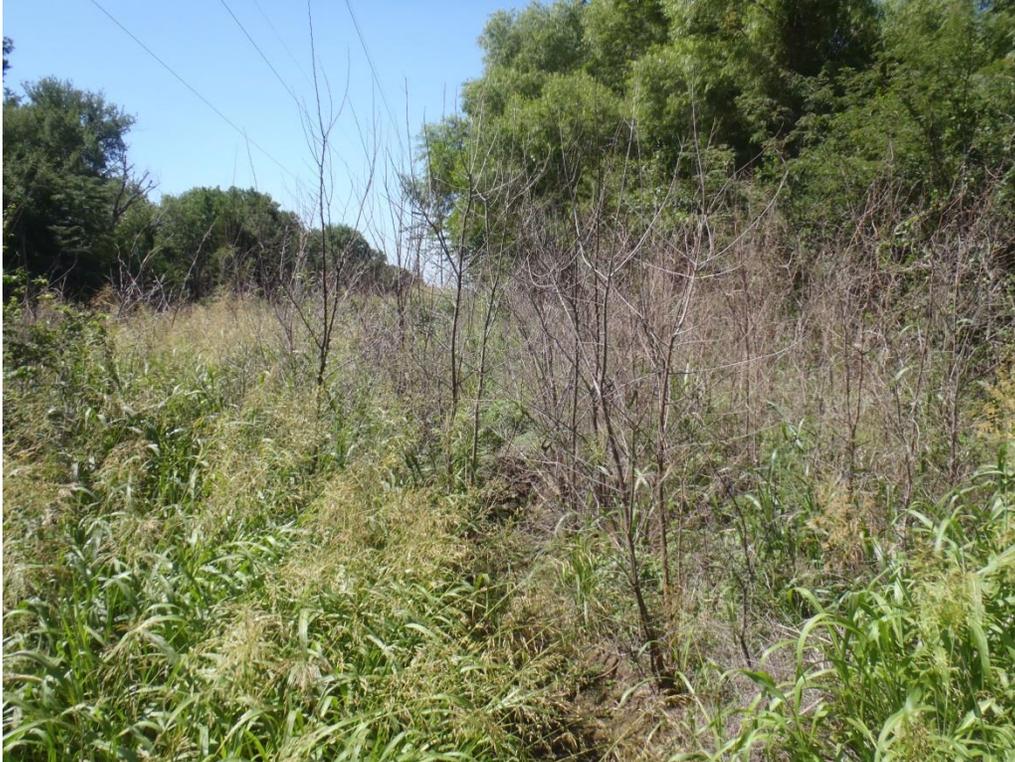
Figure 3.25 Photograph of IO11, taken on July 11, 2014. Downstream view at 180-m transect.

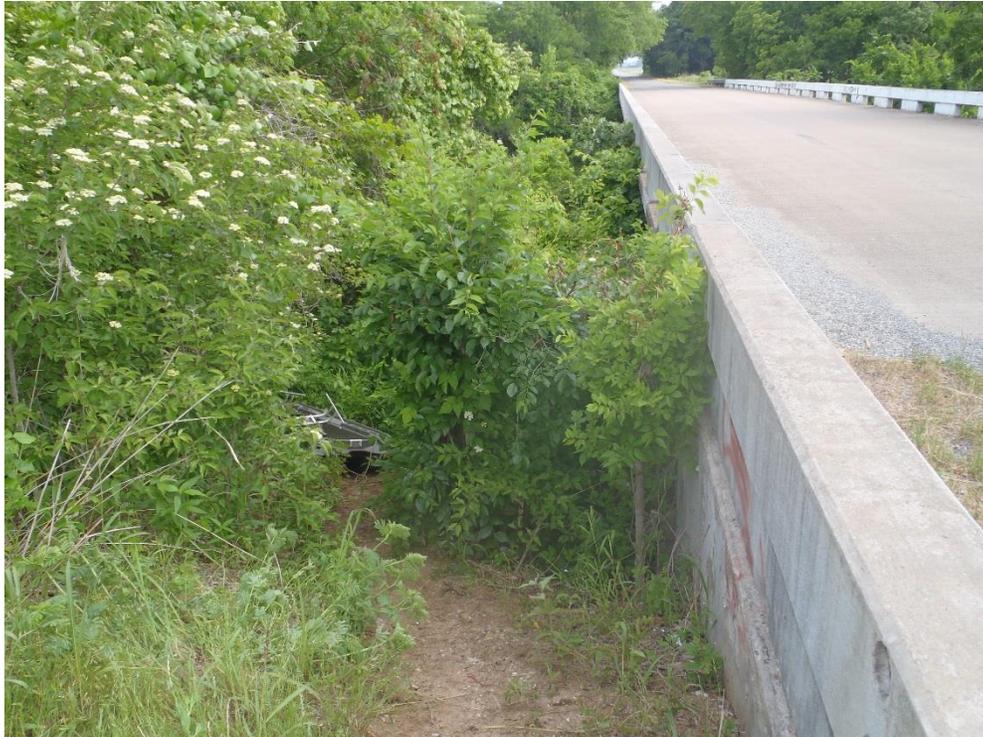
Figure 4.3 Photograph of Choctaw Creek at Site CH01, taken May 18, 2014. Footpath leading down from the side of the bridge. TIAER boat in photo.

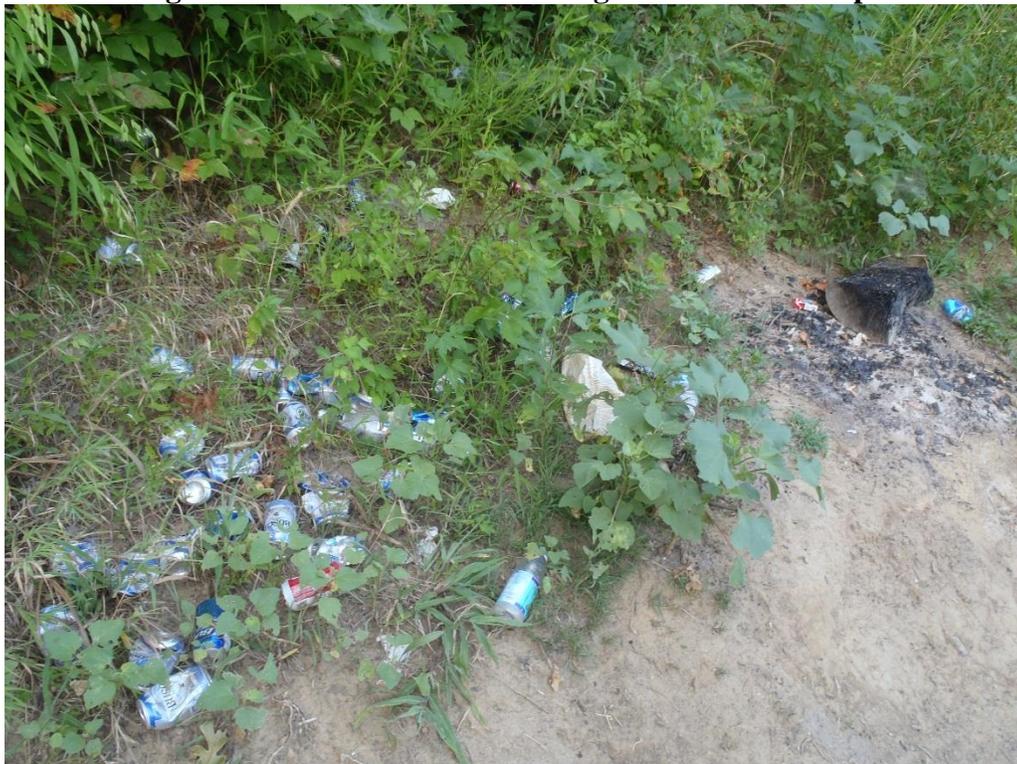
Figure 4.4 Photograph of Choctaw Creek at Site CH01, taken July 12, 2014, of beverage cans and remnants of a campfire.

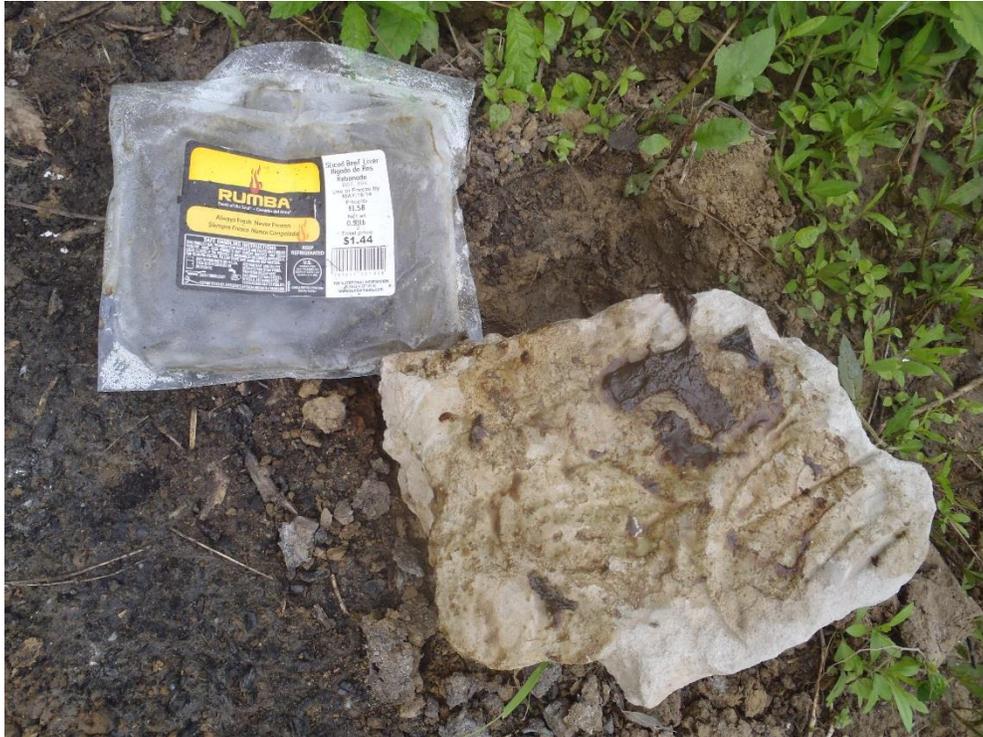
Figure 4.5 Photograph of Choctaw Creek at Site CH01, taken May 18, 2014. Discarded fishing bait in photo.

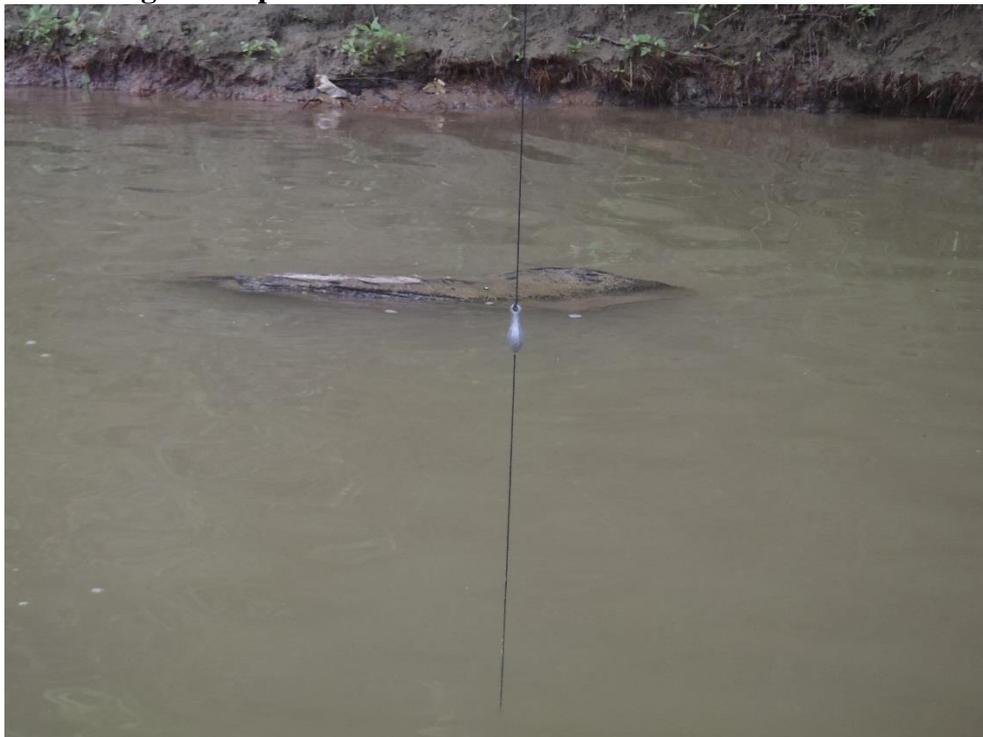
Figure 4.6 Photograph of Choctaw Creek at Site CH01, taken May 18, 2014. Trotline hanging from log in stream channel.

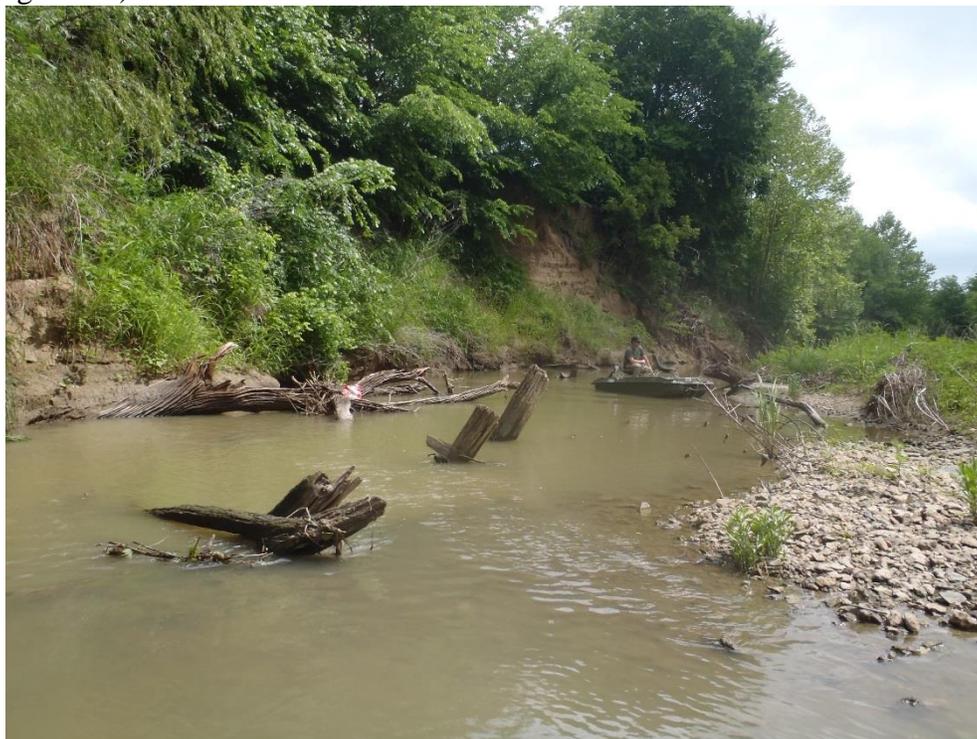
Choctaw Creek at Site CH02 was surveyed on May 18 and July 12, 2014. Access to this site was difficult as it occurred approximately 0.5 mile from a public road onto private property then through two gated pastures. Access into the stream was difficult, because the entry point had nearly vertical slopes. Although water depths along the majority of this site did not necessitate a boat, one was used, because banks dropped abruptly approximately 0.5 m down to the water. Stepping off the banks into the water had unknown results and exiting the creek from a wading position would be difficult to impossible. The boat was lowered down to this site by a rope tied to a vehicle. Once in the stream, navigation was simple. The inside bends at this site had gently sloping banks, from which access to the water would be easy. Left banks were cut resulting in steep to vertical bank structure. Left and right banks were forested immediately past the waterline. A pecan orchard existed on the right bank and improved pasture on the left bank. The primary substrate at this site was silty mud-clay on the outside bends of the creek and gravel and some plate rock on the shallower inside bends (Tables 4.5). Flood debris was encountered at the 300-m transect (Figure 4.7).

Figure 4.7 Photograph of Choctaw Creek at Site CH02, taken May 18, 2014. Downstream view at the 300-m transect. Note steep forested cut banks, gravelly inside bend and flood debris. TIAER staff in photo.

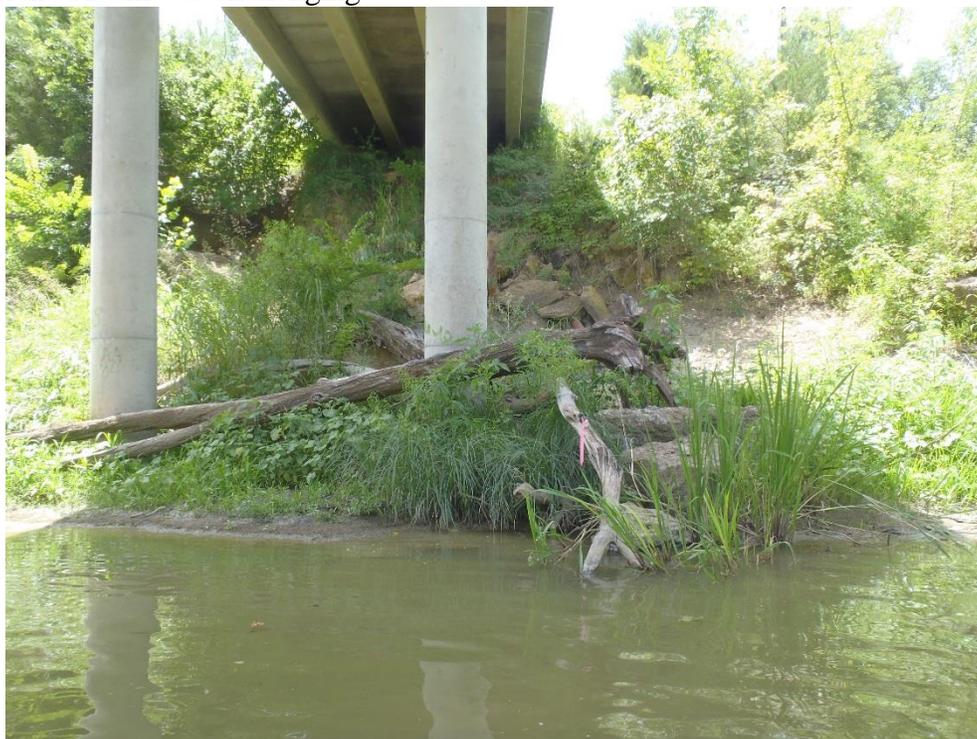
Choctaw Creek at Site CH03 was surveyed on May 18 and July 12, 2014. Access to this site was public from the right of way next to the bridge. Entering the creek was difficult, because it required climbing down a steep bank over large boulders (Figure 4.9). Banks were generally steep with forest/shrub vegetation including willow and sycamore trees. Outside the creek channel, the landscape opened up to improved and native pastures. Once in the creek, the observed primary substrate was a combination of sand, silt, mud, and clay where flow was slow, but the substrate was gravelly in the riffles (Table 4.5). There were some areas of swift moving water where standing in the stream was challenging.

Figure 4.9 Photograph of Choctaw Creek at Site CH03, taken July 12, 2014. Right bank view at the 300-m transect. Note tall, steep banks.

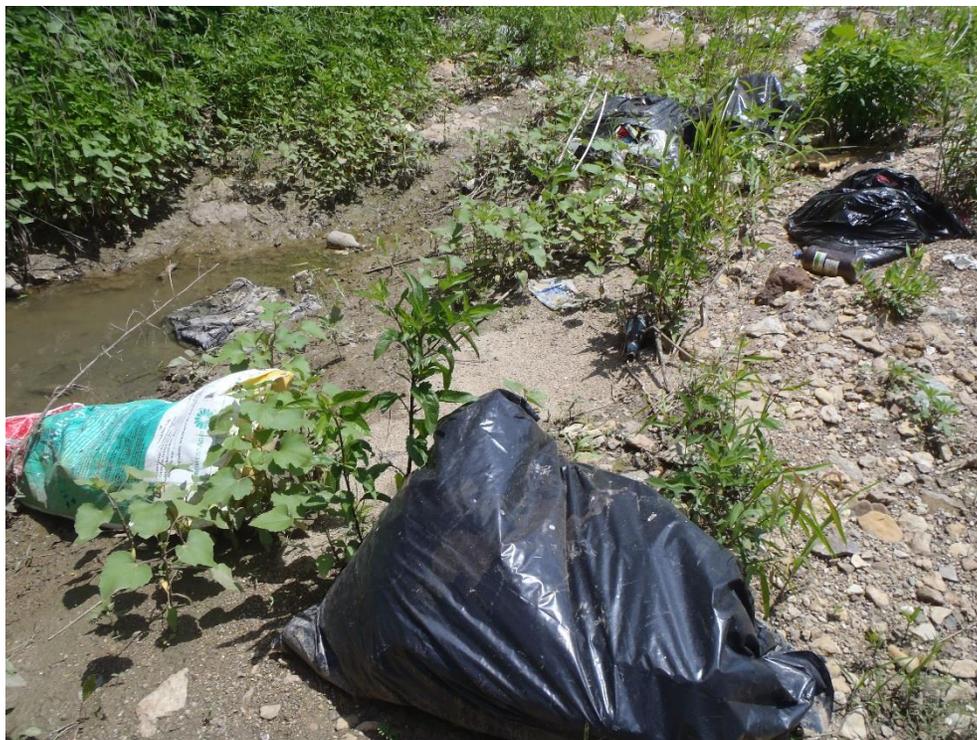
Figure 4.11 Photograph of Choctaw Creek at Site CH03, taken May 18, 2014. Photo of trash bags containing household garbage.

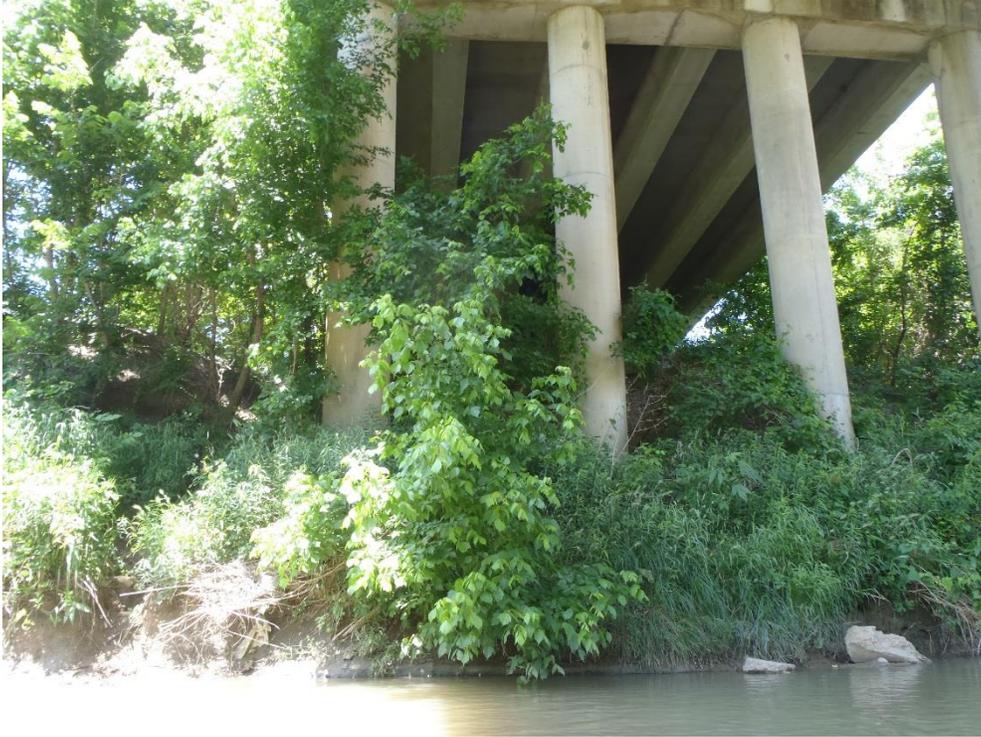
Figure 4.12 Photograph of Choctaw Creek at Site CH04, taken May 18, 2014. Left bank view at the 150-m transect, also the access site. Note dense woody bank vegetation.
