Recreational Use Attainability Analysis for Iron Ore (0202K), Choctaw Creek (0202F), Bois D' Arc Creek (0202A), Smith Creek (0202G), and Mud Creek (0201A) in the Red River Basin

Prepared for:
Texas State Soil and Water Conservation Board
Project 14-52

Texas Institute for Applied Environmental Research
Tarleton State University
Stephenville, Texas

TR 1504
October 2015

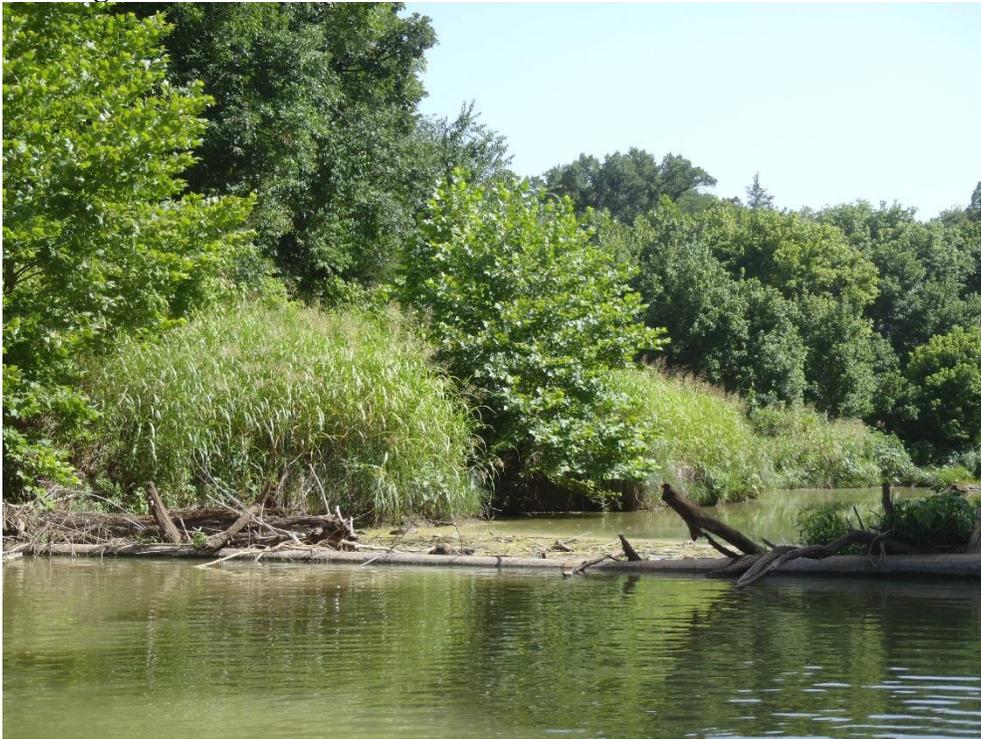
Figure 4.13 Photograph of Choctaw Creek at Site CH04, taken July 12, 2014. Photo of upstream view at utility pipe obstruction with associated debris.

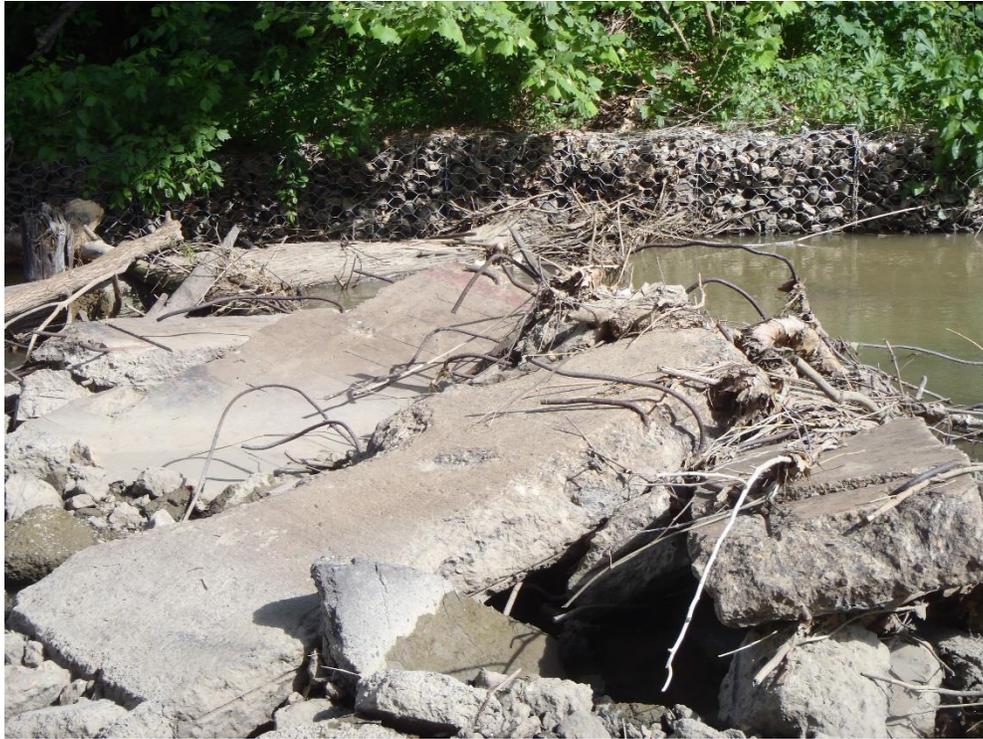
Choctaw Creek at Site CH05 was surveyed on May 18 and July 13, 2014. Access to this site was public and easy by driving down the right of way and parking under the bridge. A footpath under the bridge led down to the water. Beneath the bridge were large amounts of various types of concrete debris with rusty re-bar and steel protruding out (Figure 4.15). This made accessing the creek under the bridge hazardous as a trip or fall could easily result in severe abrasions or impalement. Additionally, remnants of I-beam supports from the old bridge were still in place and cut off approximately 1 m above ground surface. The primary substrate was a hard packed mud/clay that was slick and perforated with deep holes into which one could easily step and stumble (Table 4.5). Thick woody and herbaceous bank vegetation existed throughout the survey reach including poison ivy. Some non-wadeable places along the survey made use of a boat a requirement. Deploying the boat required lowering it down through tall Johnsongrass down a steep bank into flowing water using a rope tied to the field vehicle, which also served to retrieve the boat from the channel.

Figure 4.15 Photograph of Choctaw Creek at Site CH05, taken May 18, 2014. Rebar and concrete obstructions at bridge.

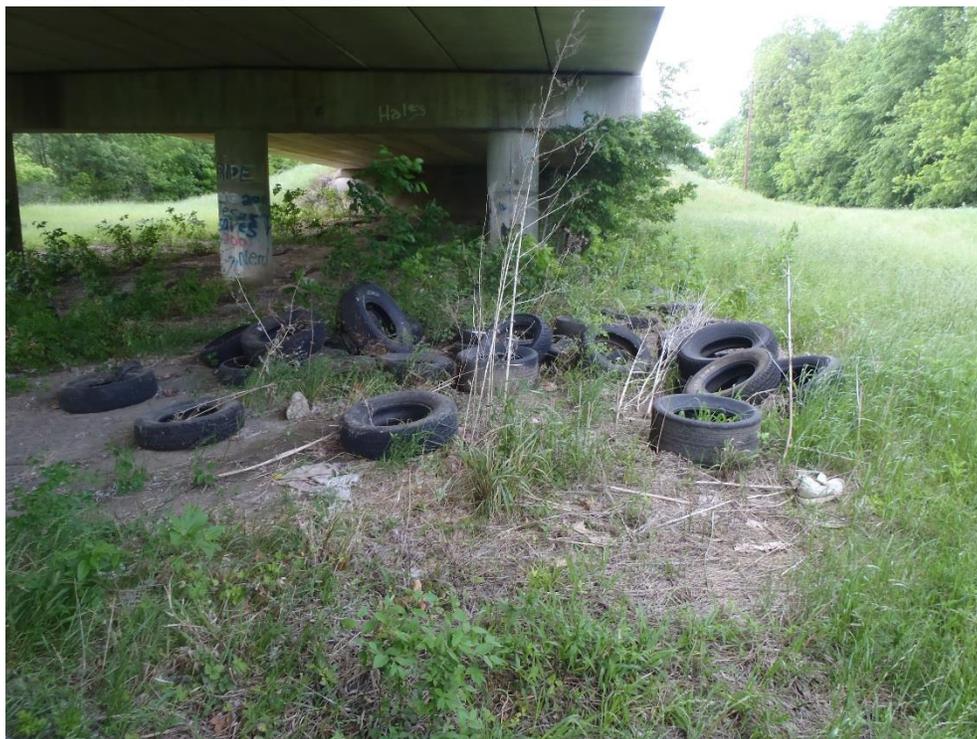
Figure 4.17 Photograph of Choctaw Creek at Site CH05, taken May 18, 2014. Tires and graffiti under bridge.

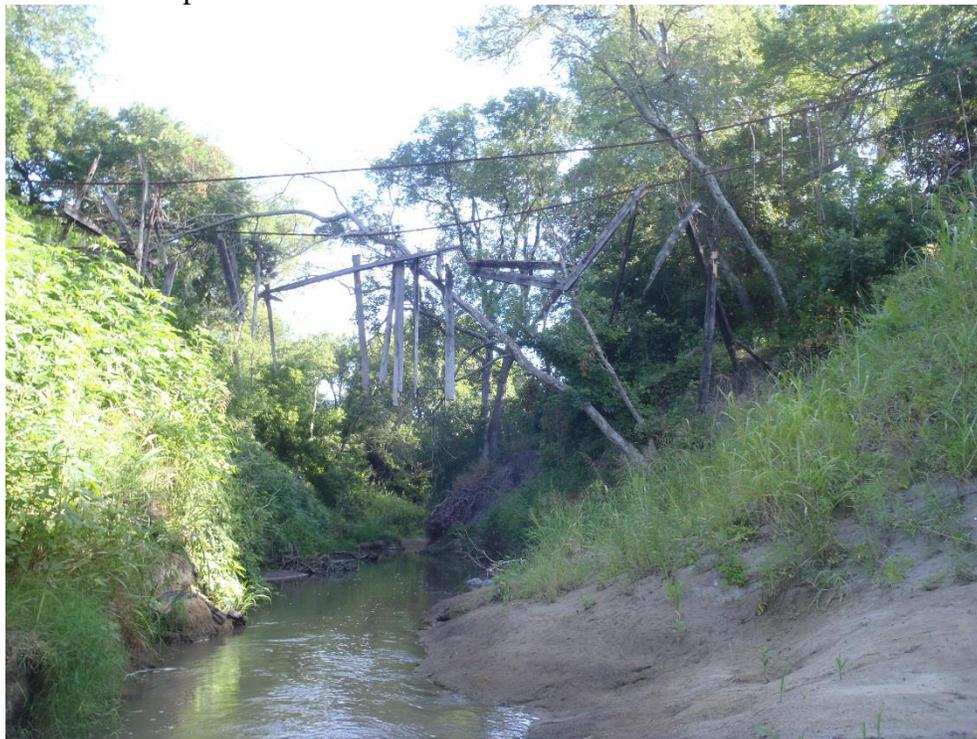
Choctaw Creek at Site CH06 was surveyed on May 18, 2014 and July 13, 2014. Access to this site was public at the highway right-of-way. Getting into the water was difficult. Submerged riprap, concrete, garbage and other unknown objects created a walking/wading hazard at the bridge. Banks were steep and densely vegetated with tall grasses and weeds. Some banks were denuded and eroding. Native and improved grass pastures existed beyond the forested riparian area. Remains of a cable and wood bridge suspended across the creek at approximately the 150-m transect were encountered (Figure 4.18). Boards from the old bridge hung, swinging over the channel creating a potential hazard of falling debris.

Figure 4.18 Photograph of Choctaw Creek at Site CH06, taken July 13, 2014. Downstream view near the 150-m transect. Note old suspension bridge remains, steep vegetated banks.

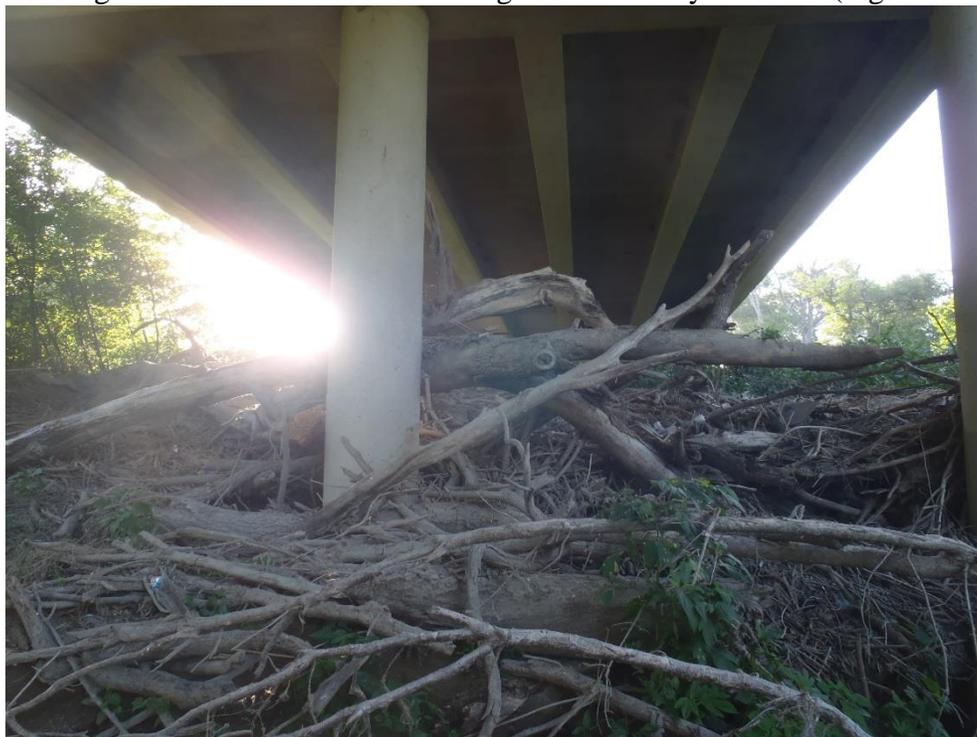
Choctaw Creek at Site CH07 was surveyed on May 18 and July 13, 2014. Access to this site was public at the bridge. The bridge was approximately a quarter mile long, and parking, where the terrain was reliably solid, was difficult to find. There was an abundance of large flood debris accumulated under the bridge and partially submerged riprap, concrete, and rebar (Figure 4.19). These hindrances along with steep banks at the bridge made access difficult. The corridor was a combination of forest and shrub vegetation with native and improved grass pastures beyond the riparian area. Some of the banks were eroded and free of established vegetation. The dominant substrate was a soft combination of silt, mud and clay, which caused significant sinking when walking through the channel in addition to deep holes the size of post holes (Table 4.5). Two obstructions of log debris were encountered throughout the surveyed stretch (Figure 4.20).

Figure 4.19 Photograph of Choctaw Creek at Site CH07, taken July 13, 2014. Flood debris beneath bridge.

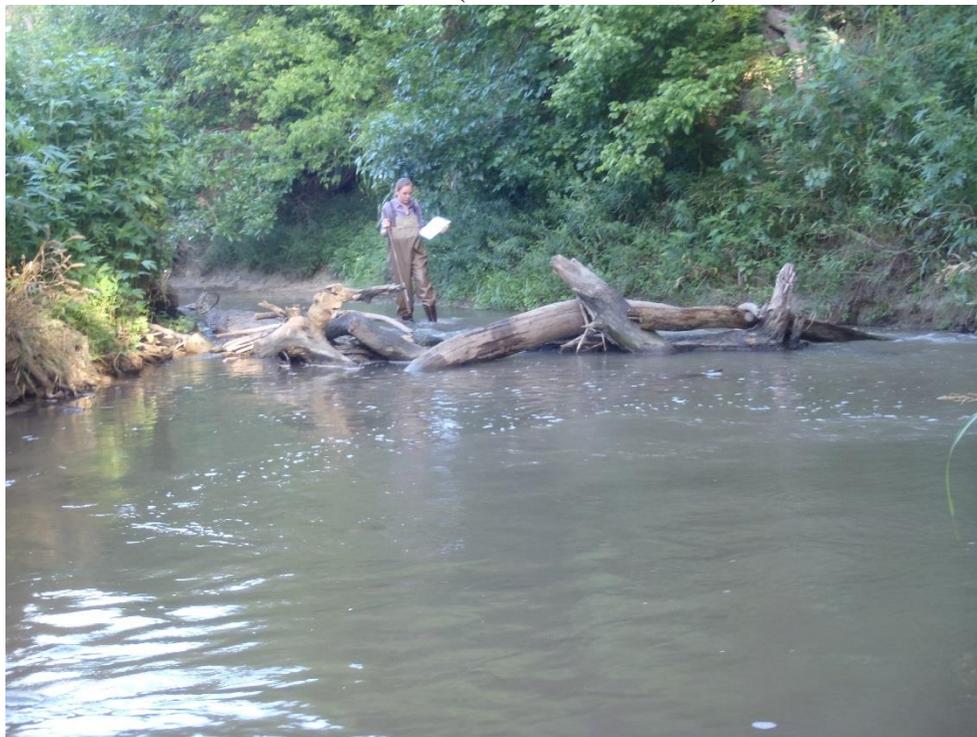
Figure 4.20 Photograph of Choctaw Creek at Site CH07, taken July 13, 2014. Log obstruction. TIAER staff in photo.

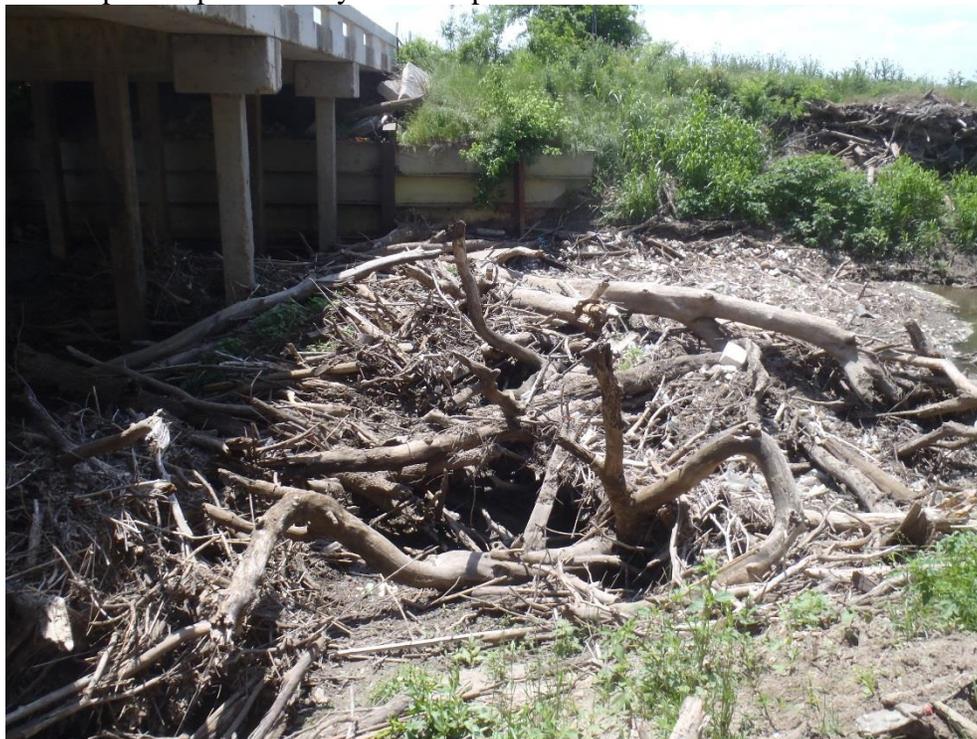
Choctaw Creek at Site CH08 was surveyed on May 18 and July 12, 2014. Access to the site was simple as it occurred at a road crossing. However, entering the channel to complete the survey was moderately difficult because banks were steep and densely vegetated. An extremely large amount of flood debris had accumulated under the bridge creating a massive log obstruction (Figure 4.21).

Figure 4.21 Photograph of Choctaw Creek at Site CH08, taken May 18, 2014. Left bank view at the 0-m transect. Note large accumulation of debris under bridge.

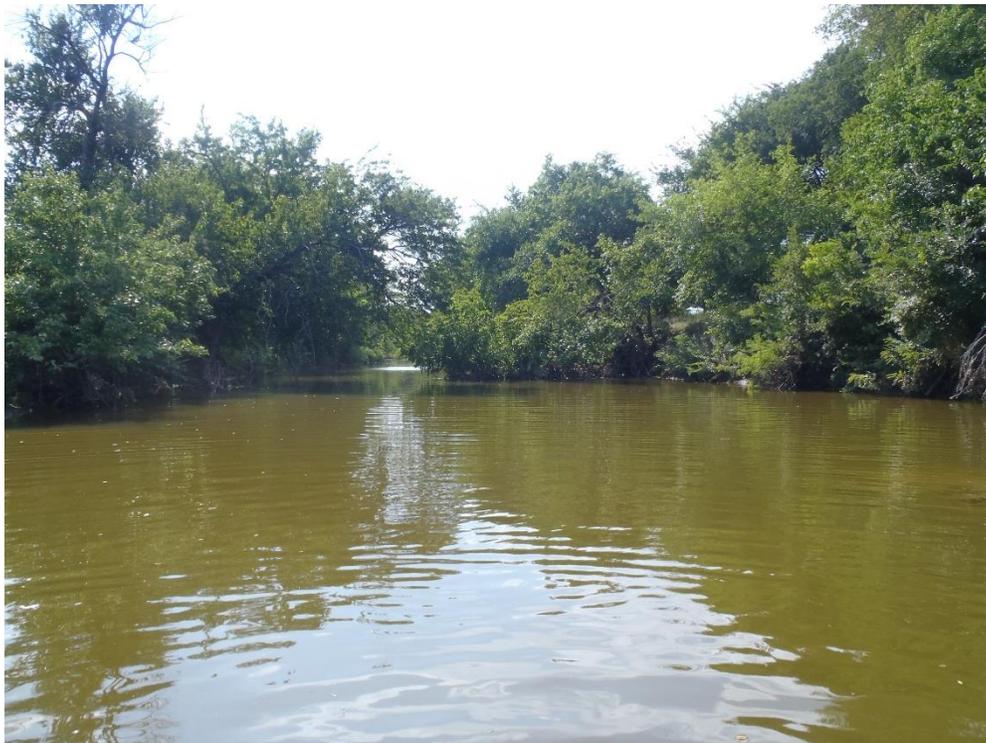
Water conditions changed minimally from one survey to the next (Tables 5.9 and 5.10). The water surface was clear and the color was brown (Figure 5.51). The bottom was half fine sediment and half solid rock (Figure 5.50). Aquatic vegetation and algae cover were common and no odor was detected during the first survey. During the second survey, aquatic vegetation increased to abundant, algae became more rare, and odor remained absent. Wildlife observed included small fish, frogs, and turtles. Tracks observed included raccoon, cattle, and water bird. A snakeskin, bird feathers, bird droppings, and cow manure were also seen in the stream. Garbage was rare overall; however, some items were seen including a glass bottle and an old appliance. Some ATV tracks were observed that crossed the creek, but no other signs of human recreation were observed at this location.

Figure 5.51 Photograph of Site BA17, taken June 16, 2014. Upstream view at 300-m transect.

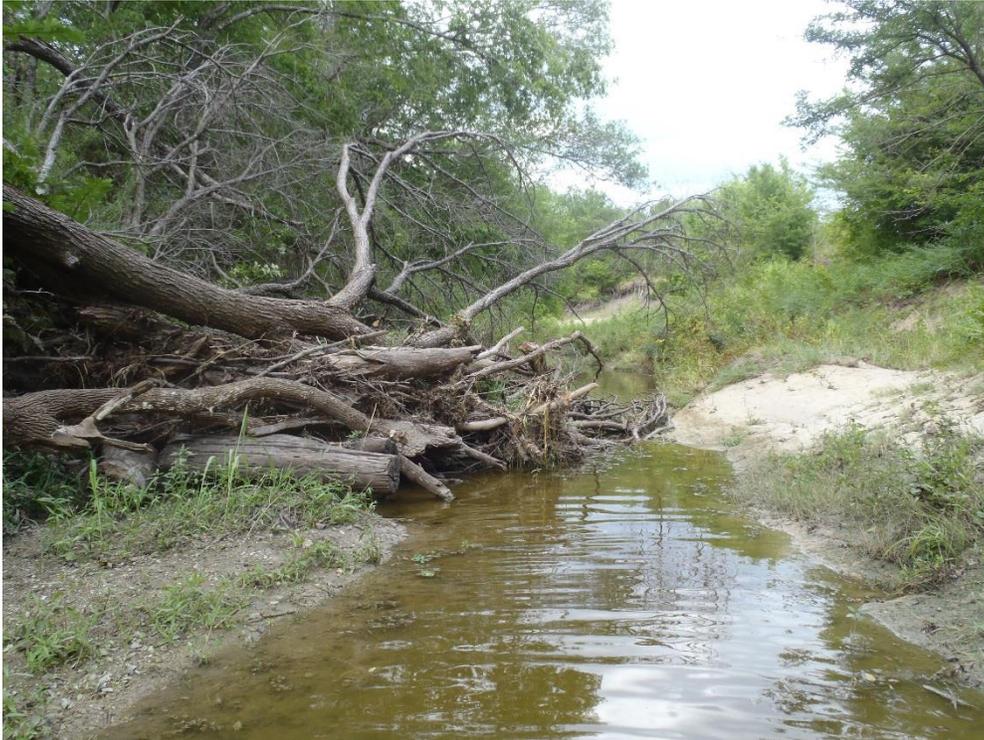
Bois D' Arc Creek at Site BA18 was surveyed on June 16 and August 9, 2014. Access to this site required landowner permission to enter through a closed gate and drive approximately 0.5 miles down a pasture road. Once at the site, access into the channel was moderately difficult because banks were steep and eroding. The left bank was densely forested and the right bank was vegetated with improved pasture (Table 5.5). One log obstruction was observed at the 210-m transect (Figure 5.52).

Figure 5.52 Photograph of Site BA18, taken August 9, 2014. Log obstruction at 210-m transect.

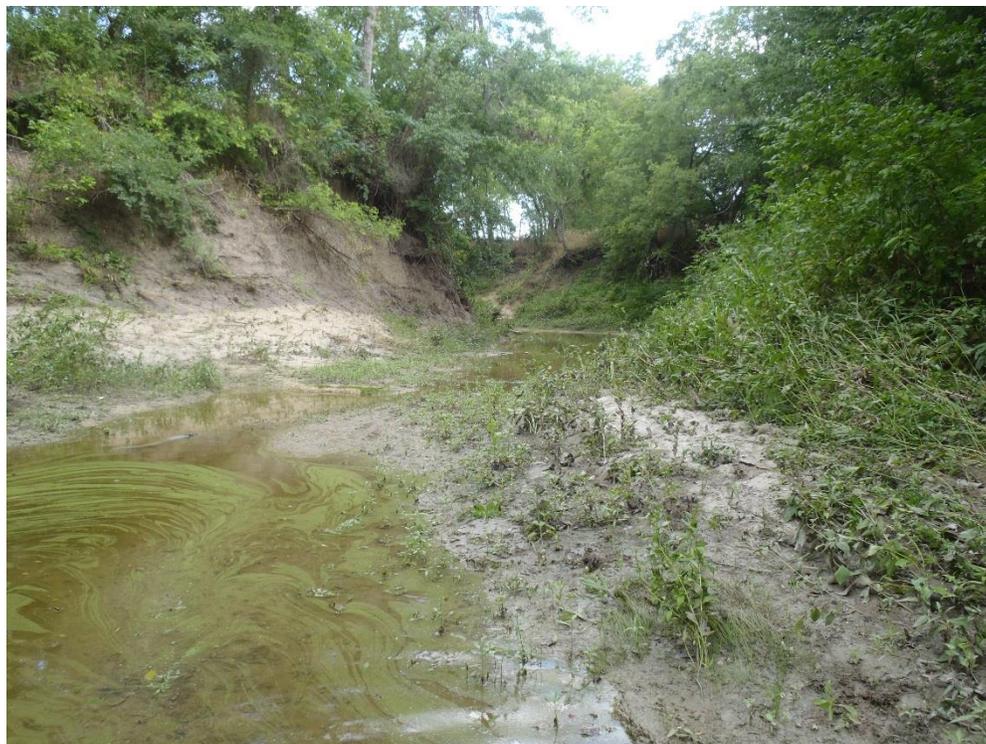
Stream aesthetics for both surveys are summarized in Tables 5.9 and 5.10. During the first survey aquatic vegetation and odor were common, while algae cover was abundant. However, during the second survey, while algae cover remained the same, aquatic vegetation was rare and the odor was absent (Figure 5.53). The water surface was clear with a brown coloration during both surveys. The primary substrate was a cobble/mud/clay with bottom deposits of fine sediment and rocks.

Figure 5.53 Photograph of Site BA18, taken August 9, 2014. Downstream view at 300-m transect.

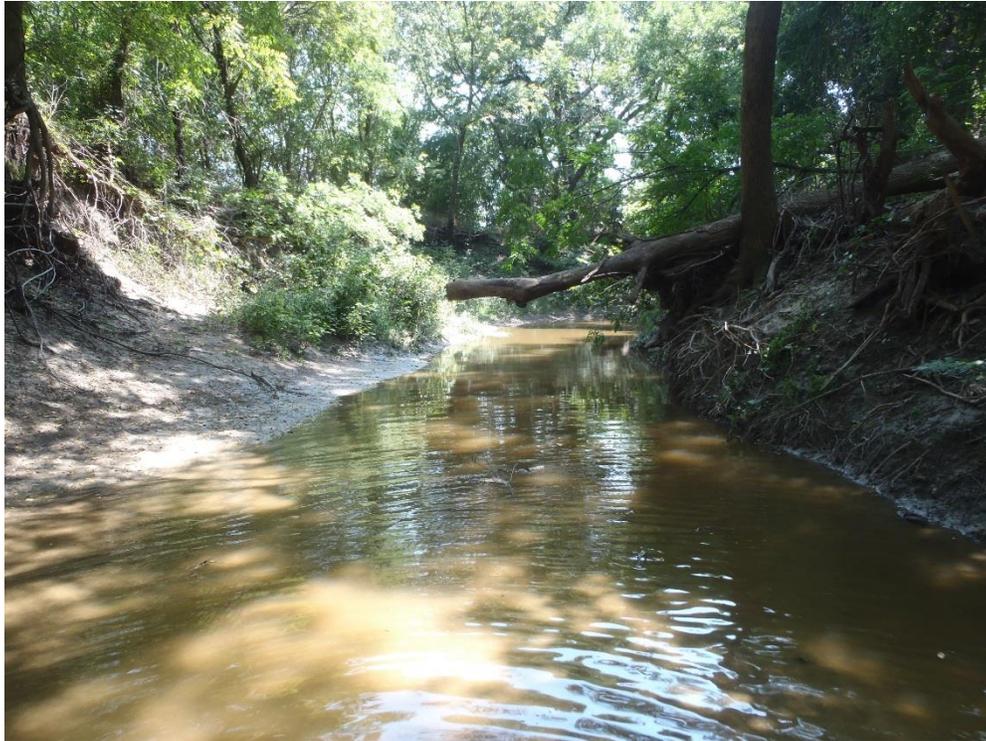
Stream aesthetics are described for both surveys in Tables 5.9 and 5.10. A pool was encountered during the first survey from the 0-m transect to the 190-m transect. The widest point of the pool was 8.5 m. The pool depth was 1 m. During the first survey aquatic vegetation and algae cover were absent; however, algae appeared common during the second survey. An odor was rarely encountered during the first survey; however, was non-existent during the second. The color of the water during the first survey was brown with scum on the surface. During the second survey though, the color appeared green and the surface was clear (Figure 5.55). The bottom deposit was a fine sediment.

Figure 5.55 Photograph of Site BA19, taken August 8, 2014. Upstream view at 0-m transect.

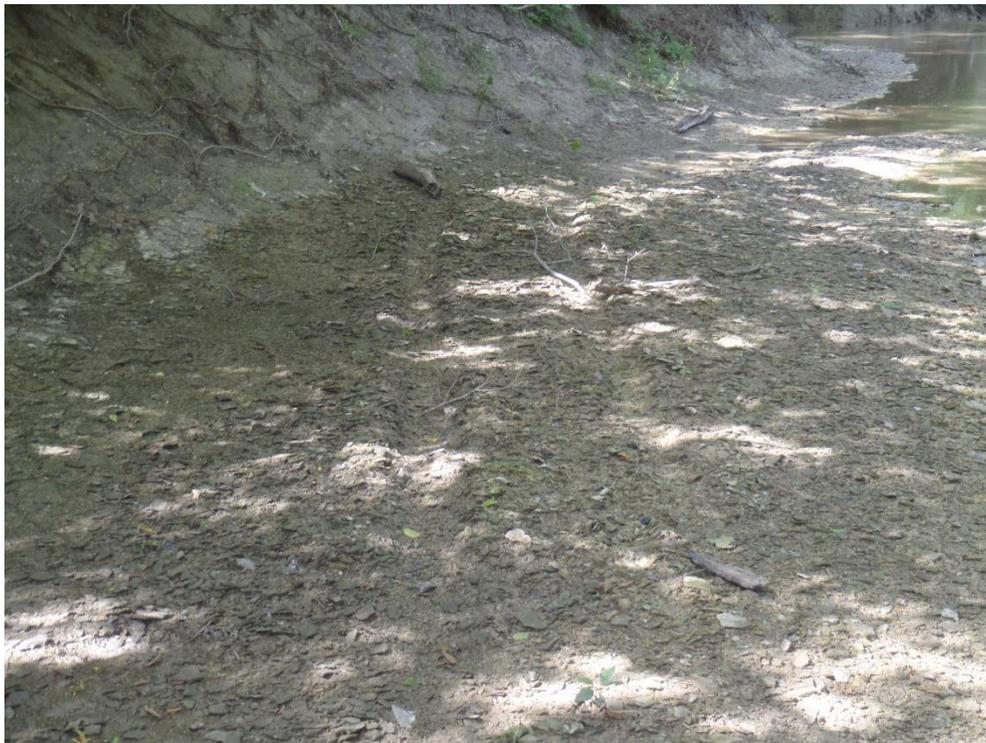
Evidence of wildlife presence was observed during both surveys. Small fish, clam, turtle, and a snake were observed in the stream. Raccoon, feral hog, canine, and armadillo tracks were also seen. Fecal material from birds and feral hogs were noted as well as a snake skin and crawfish burrows. Large and small garbage were commonly seen during the first survey but were rare during the second. No bank garbage was observed (Tables 5.9 and 5.10). Among the garbage seen were plastic bags, glass, scrap metal, a 55 gallon plastic barrel, a television set, tires, a trap and a grill. ATV tracks were observed in the stream during the first survey (Figure 5.56). No other evidence of human recreation was observed at this site.

Figure 5.56 Photograph of Site BA19, taken June 17, 2014. ATV tracks.

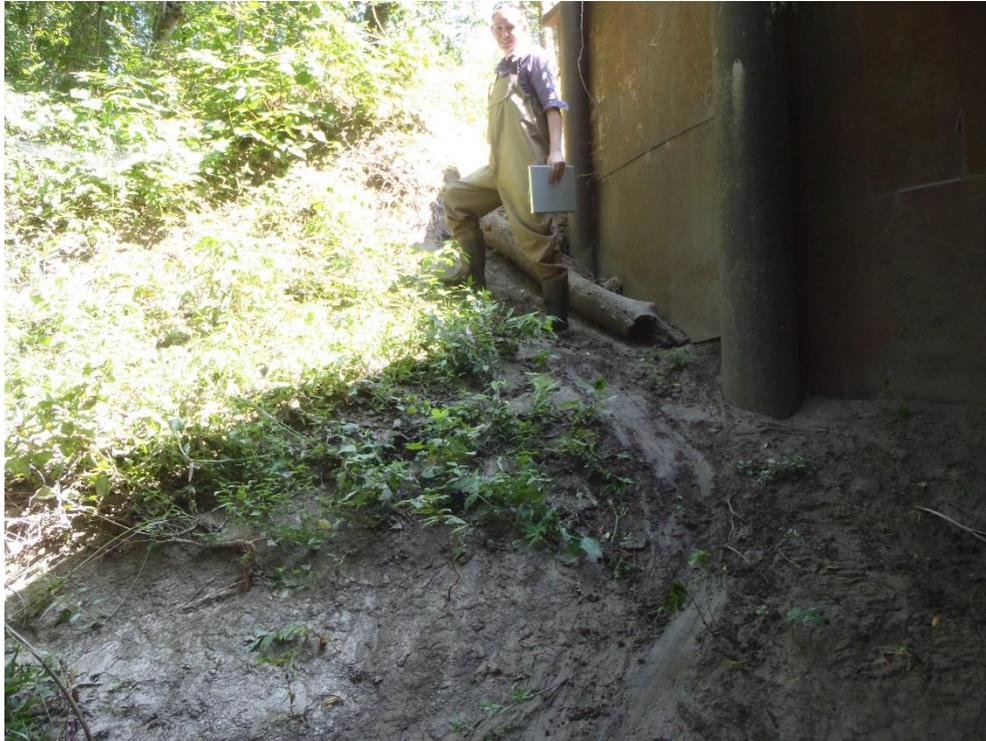
Bois D' Arc Creek at Site BA 20 was surveyed on June 17 and August 8, 2014. Access to this site was difficult as it was public at the bridge only with a private property fence restricting further access (Table 5.6). Landowner permission was required to complete the survey. Banks were steep, eroding, and slick (Figure 5.57). Debris in the channel, deep mud, and poison ivy also contributed to difficult access. During the second survey water levels were slightly lower, which made navigating the creek less difficult once in the stream. Stream banks were vegetated with large trees and some understory with improved pasture visible beyond the trees (Tables 5.5).

Figure 5.57 Photograph of Site BA20 taken August 8, 2014. Access at bridge crossing. Note steep, muddy, slick banks. TIAER staff in photo.

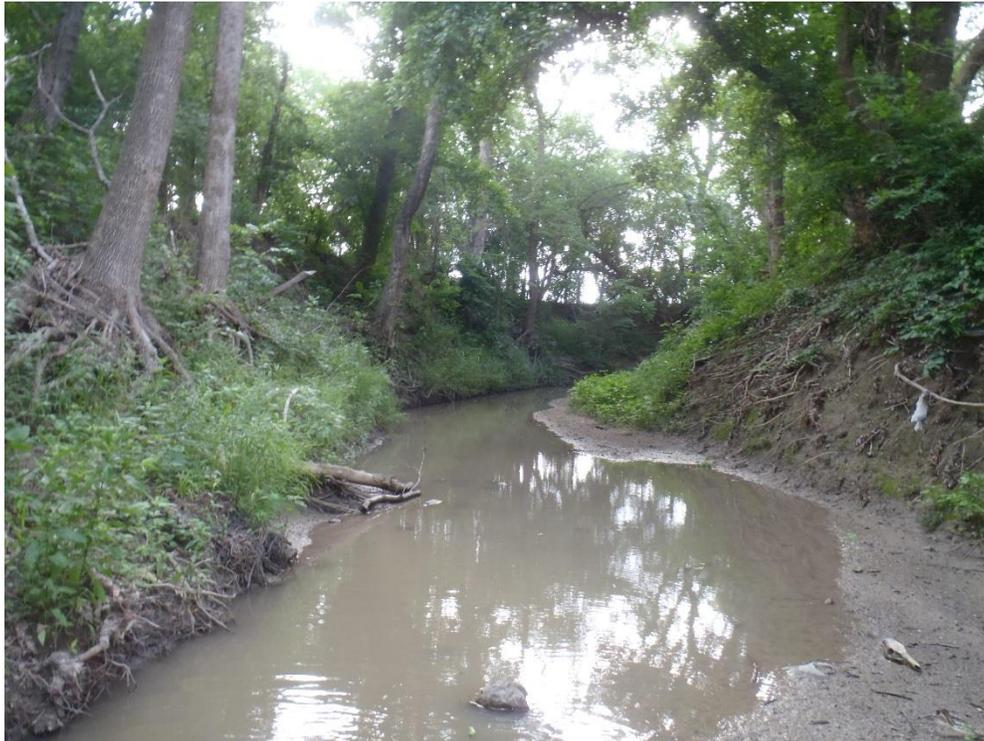
Figure 5.58 Photograph of Site BA20, taken June 17, 2014. Downstream view at the 150-m transect. Note steep banks, feral hog skull and bank/corridor conditions.

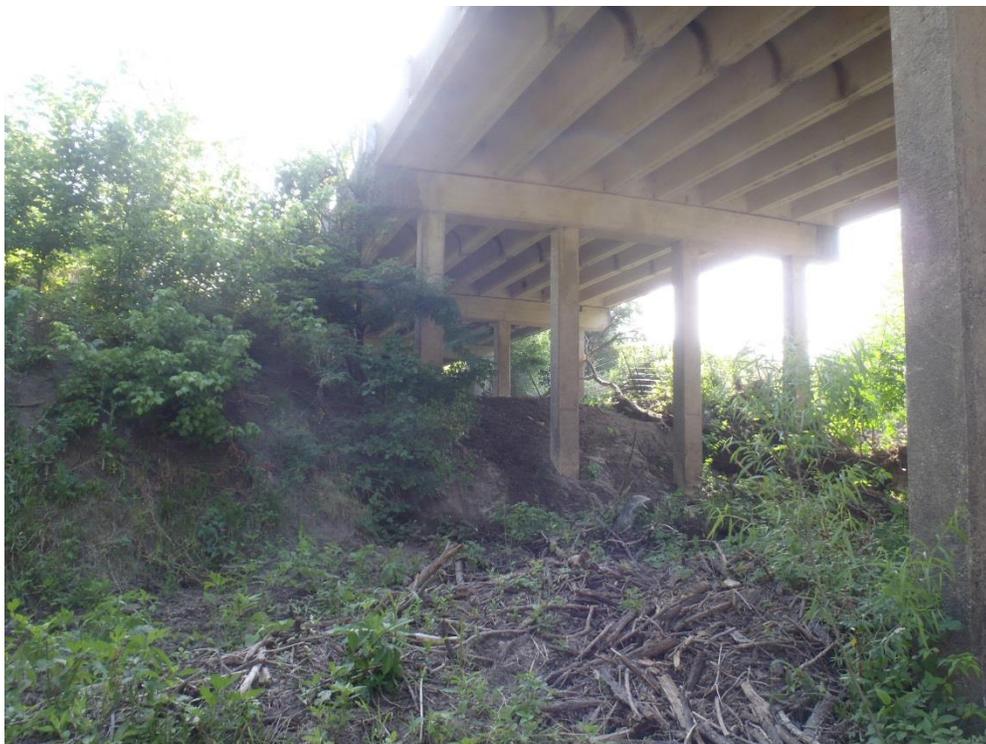
Bois D' Arc Creek at Site BA21 was surveyed June 16 and August 8, 2014. Access to this site was public at the bridge only and moderately difficult (Table 5.6). A private property fence restricted access to the channel and required landowner permission to conduct the survey (Figure 5.59). Steep banks, poison ivy, log jams and additional debris in the channel also contributed to difficulty in navigating the streambed (Figure 5.60). The vegetation immediately at the edge of the creek was forest but opened up to improved pasture beyond. The primary substrate was a mix of sand, silt, mud, and clay which made walking in the stream challenging (Tables 5.5 and 5.6).

Figure 5.59 Photograph of Site BA21, taken June 16, 2014. Right bank view at the 300-m transect. Note access at bridge and private property fence.

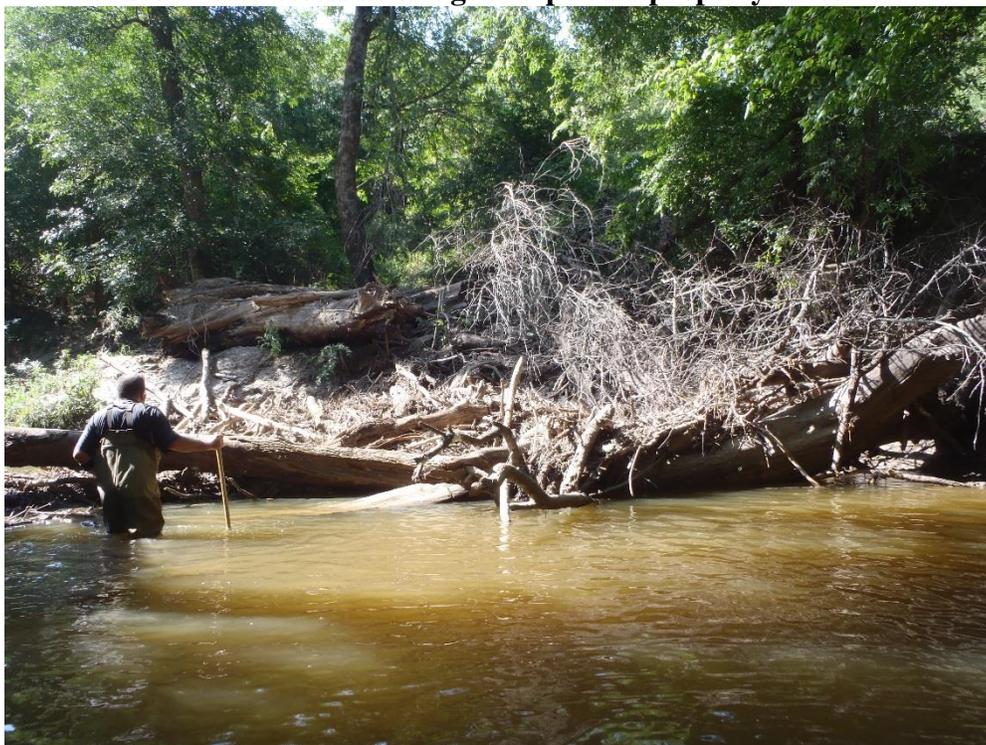
Figure 5.60 Photograph of Site BA21, taken August 8, 2014. Large log jam obstructing access through creek. TIAER staff in photo.

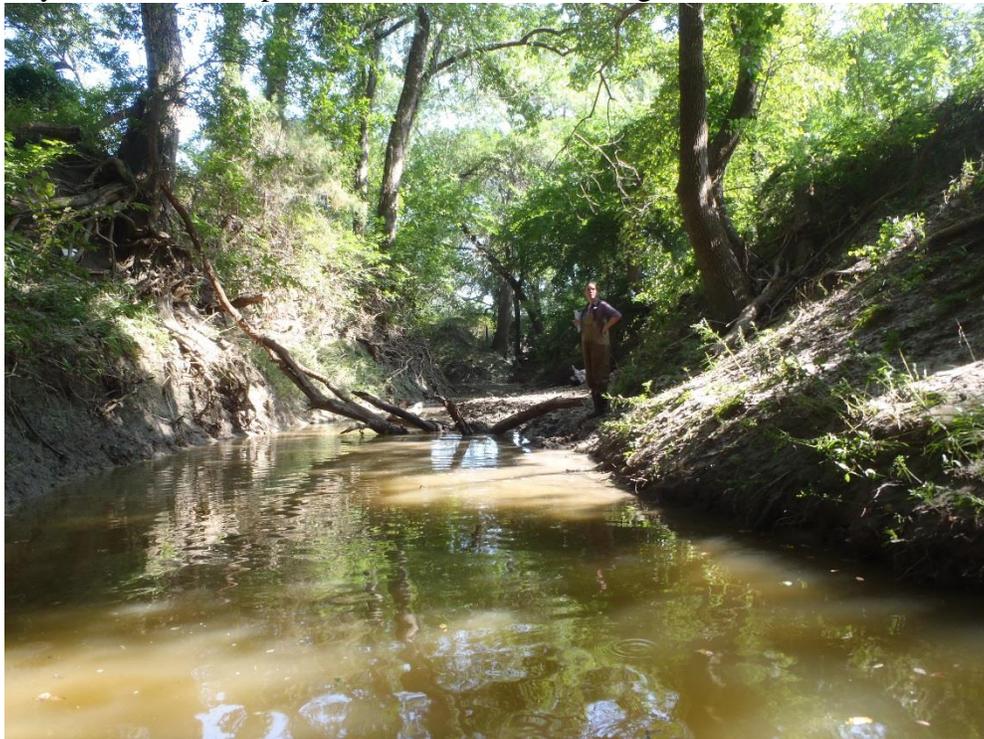
Figure 5.61 Photograph of Site BA21, taken August 8, 2014. Downstream view at the 0-m transect. TIAER staff in photo.

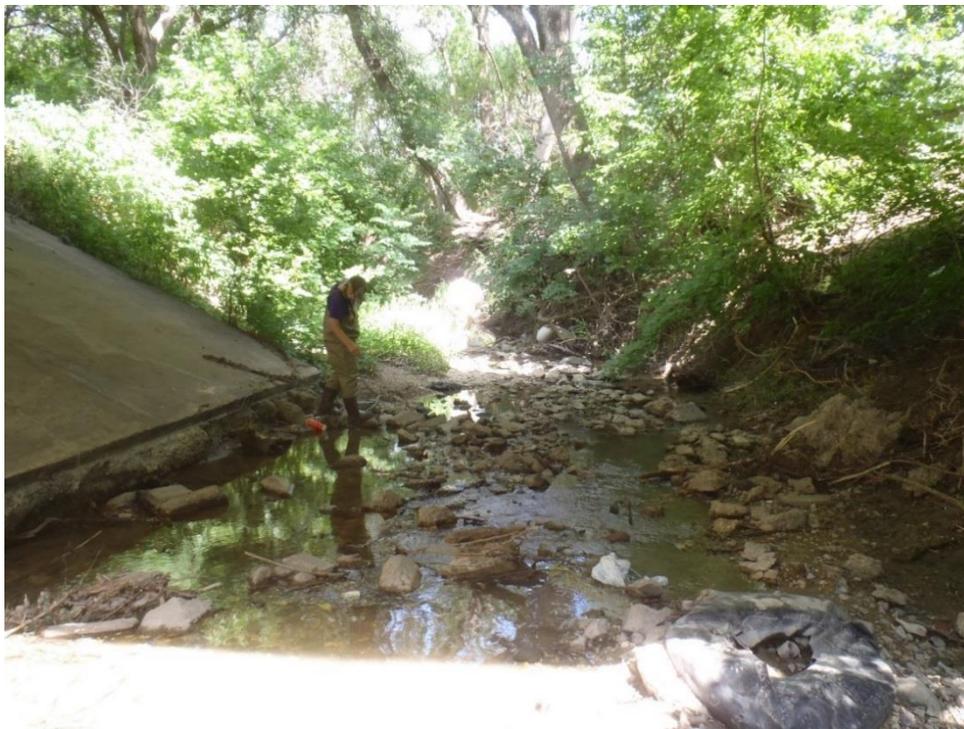
Bois D' Arc Creek, at Site BA23, was surveyed June 16 and August 8, 2014. Access to this site was public at the bridge crossing. A fence was observed on the right bank but did not affect access into or through the creek. The dominant substrate was a combination of sand, silt, mud, clay gravel and bedrock (Figure 5.64). The corridor was densely wooded and opened up to pasture beyond the riparian area. Banks were steep and, along some stretches, were denuded and eroding (Table 5.5). Rip rap, concrete, and areas of soft mud created unstable and varying terrain, which made navigation difficult overall. This site was wadeable and flow appeared normal during both surveys (Tables 5.7 and 5.8). Average thalweg depths were 0.3 m. Widths remained within about 1 m from one survey to the next and the typical width was 3.5 m.

Figure 5.64 Photograph of Site BA23, taken June 16, 2014. Downstream view at the 0-m transect. Note garbage under bridge and combination substrate. TIAER staff in photo.

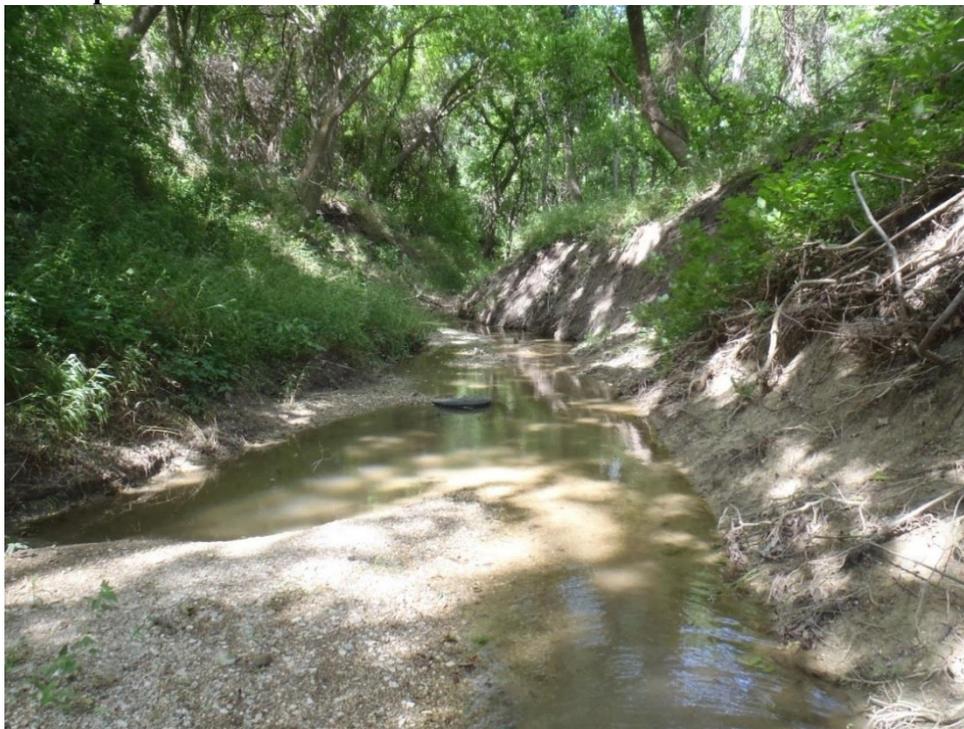
Figure 5.65 Photograph of Site BA23, taken June 16, 2014. Downstream view at the 300-m transect. Note clarity of water surface, steep eroding banks and bank vegetation.

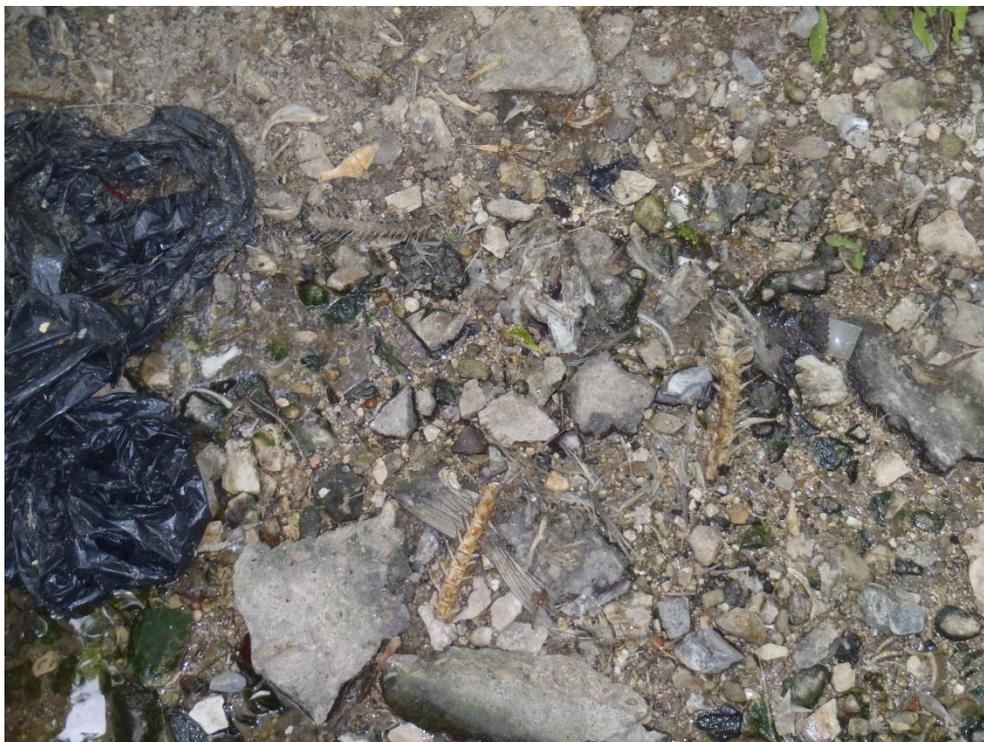
Figure 5.66 Photograph of Site BA23, taken June 16, 2014. Note fish carcasses.

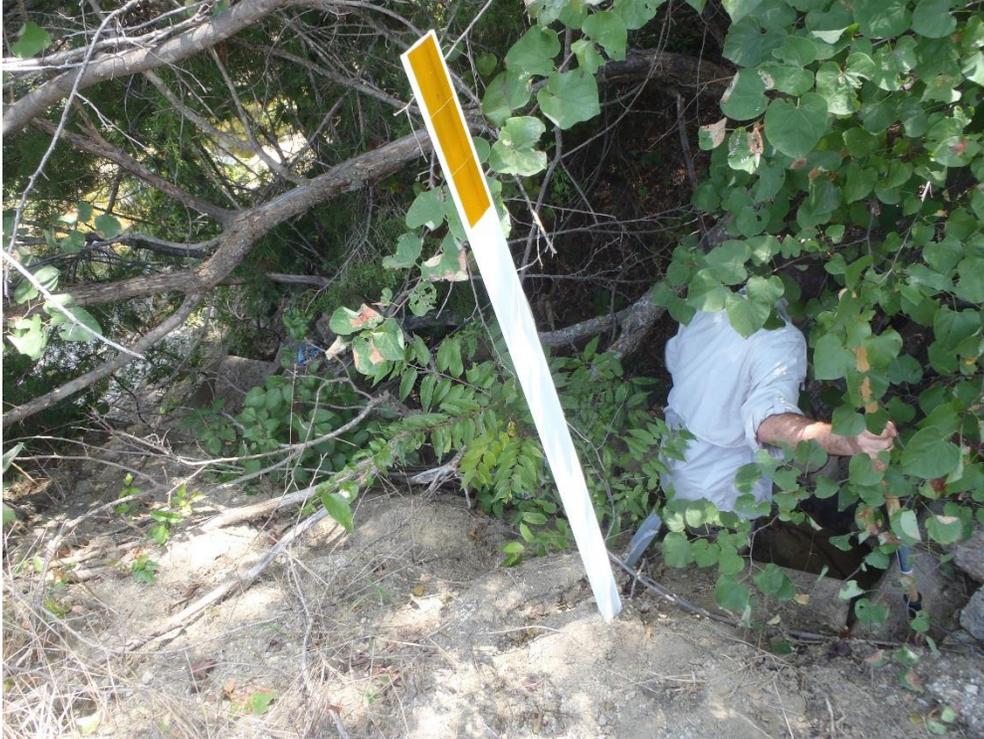
Figure 5.67 Photograph of Site BA24, taken August 8, 2014. Access point at bridge. TIAER personnel in photo.

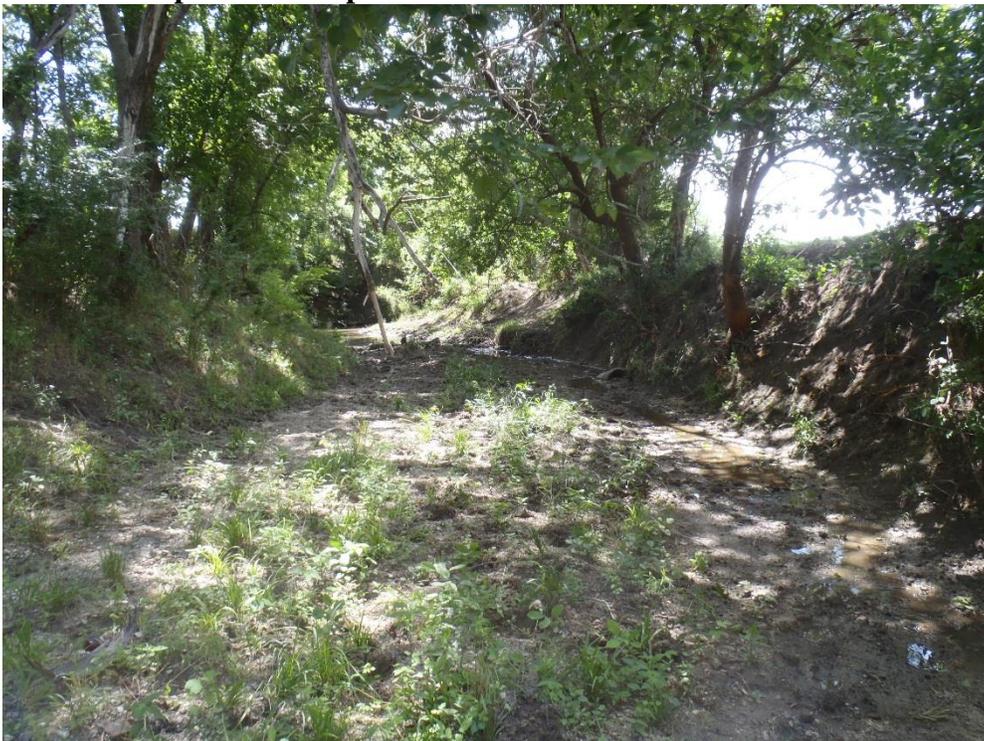
Figure 5.68 Photograph of Site BA24, taken June 16, 2014. Upstream view at the 300-m transect.

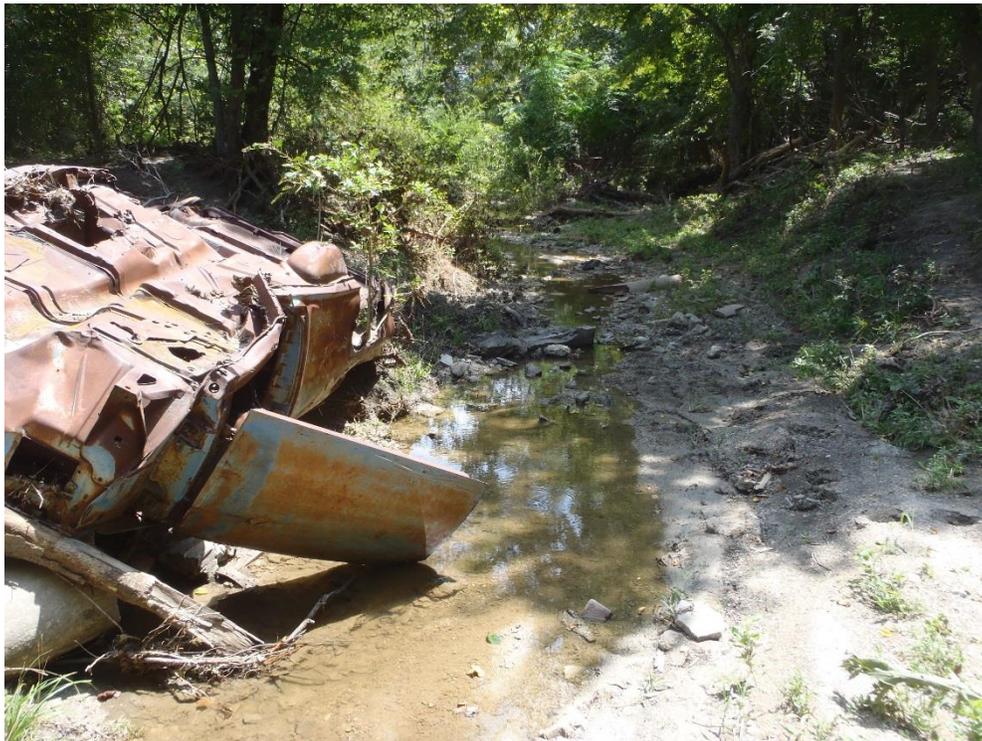
Wildlife encountered during the surveys included a snake and a water dependent bird (Tables 5.9 and 5.10). Livestock/wildlife trails entered the channel at numerous locations along the survey stretch. Tracks of raccoon and cattle were seen in the mud as well as cattle manure and bird droppings. Large garbage was common to abundant during the two surveys and took the form of an entire vehicle frame and a water heater (Figure 5.69). Other garbage was rarely encountered but included tires, a television set, glass bottles, aluminum cans, general plastics, and other typical road garbage. No evidence of human recreation was observed at this site.

Figure 5.69 Photograph of Site BA24 taken August 8, 2014. Note large garbage in form of vehicle frame.

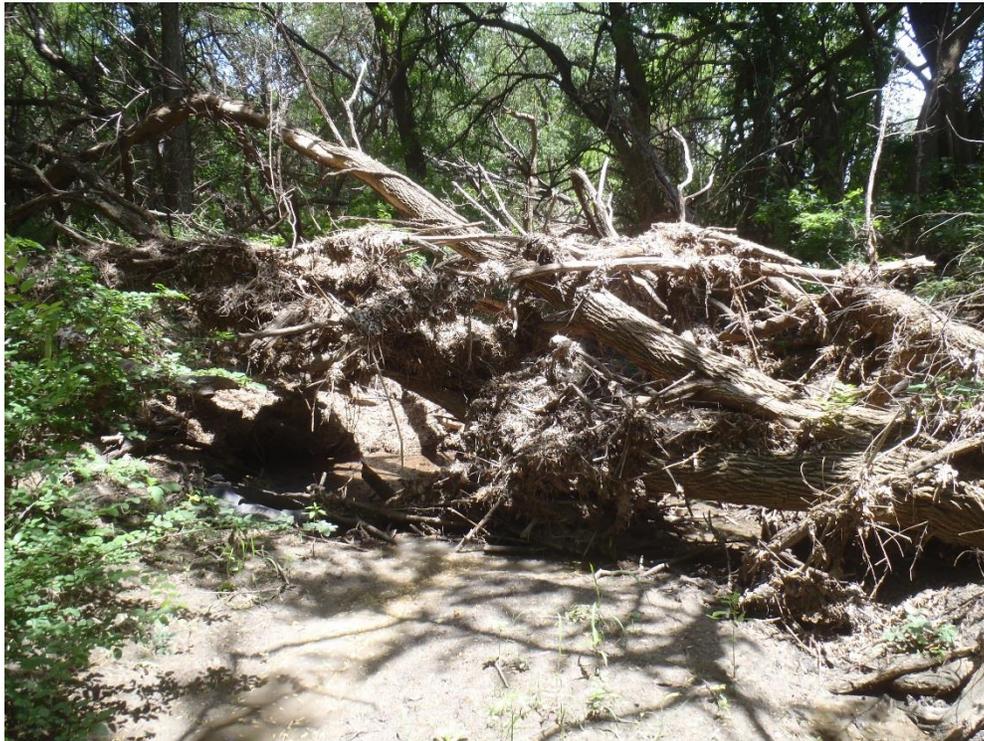
cultivated pastures beyond the riparian area (Table 5.5). Debris in the channel was abundant. Four significant log jams that hindered travel through the creek were encountered during both surveys (Figure 5.70).

Figure 5.70 Photograph of Site BA26, taken June 16, 2014. Large log obstruction.

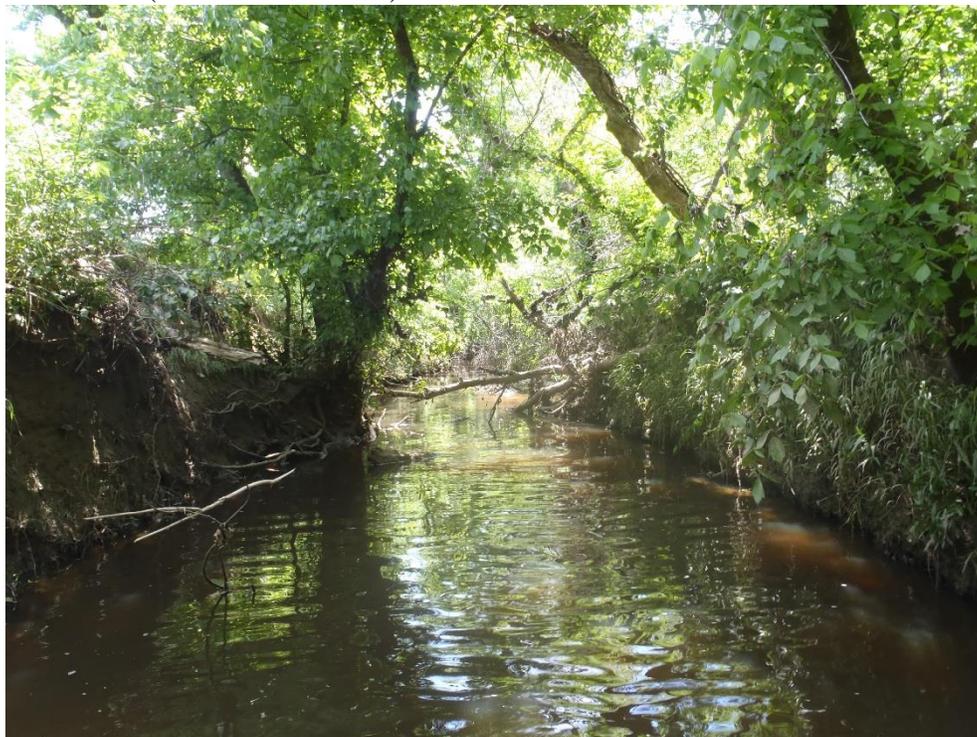
Figure 6.3 Photograph of Site SM01, taken May 16, 2014. Upstream view of the 150-m transect.

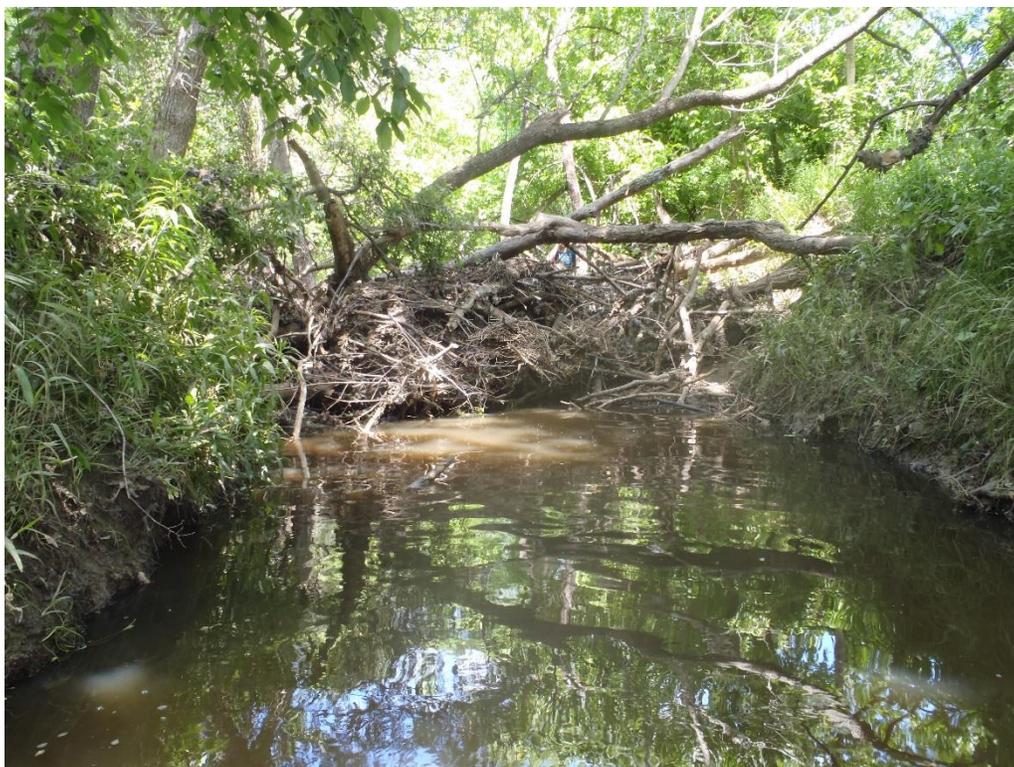
Figure 6.4 Photograph of Site SM01, taken May 16, 2014. Downstream view at 180-m transect. Note log obstruction, dense vegetation and steep banks.
