Recreational Use Attainability Analysis for Iron Ore (0202K), Choctaw Creek (0202F), Bois D' Arc Creek (0202A), Smith Creek (0202G), and Mud Creek (0201A) in the Red River Basin

Prepared for:
Texas State Soil and Water Conservation Board
Project 14-52

Texas Institute for Applied Environmental Research
Tarleton State University
Stephenville, Texas

TR 1504
October 2015

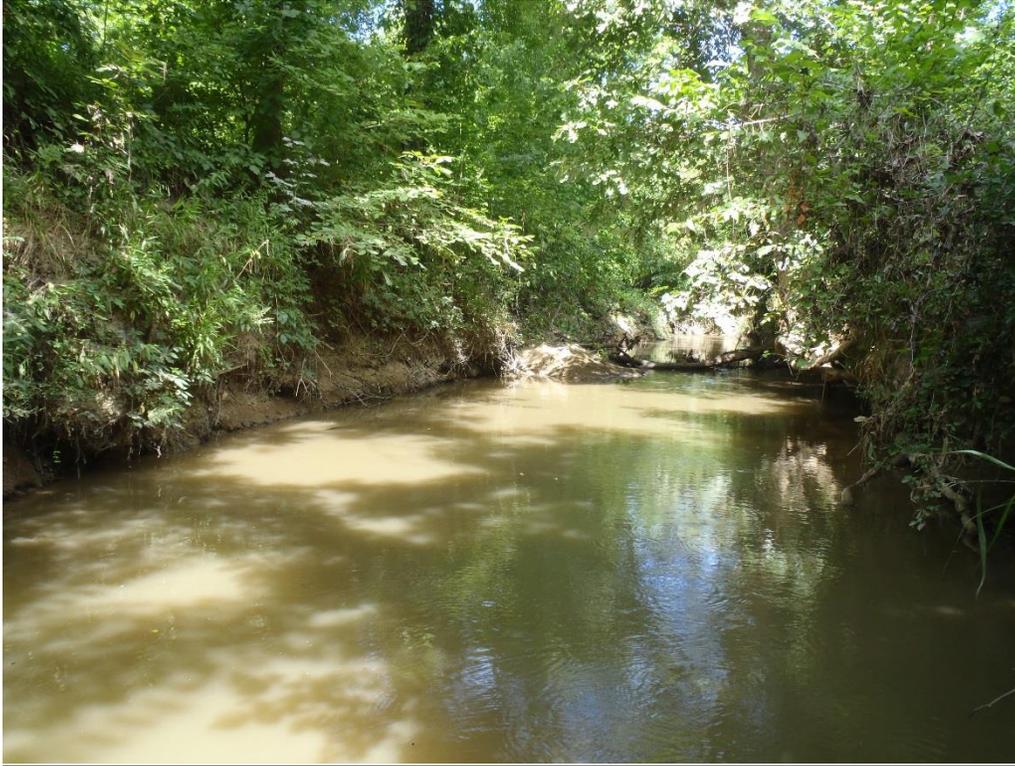
Figure 6.5 Photograph of Site SM02, taken on July 11, 2014. Upstream view at 150-m transect.

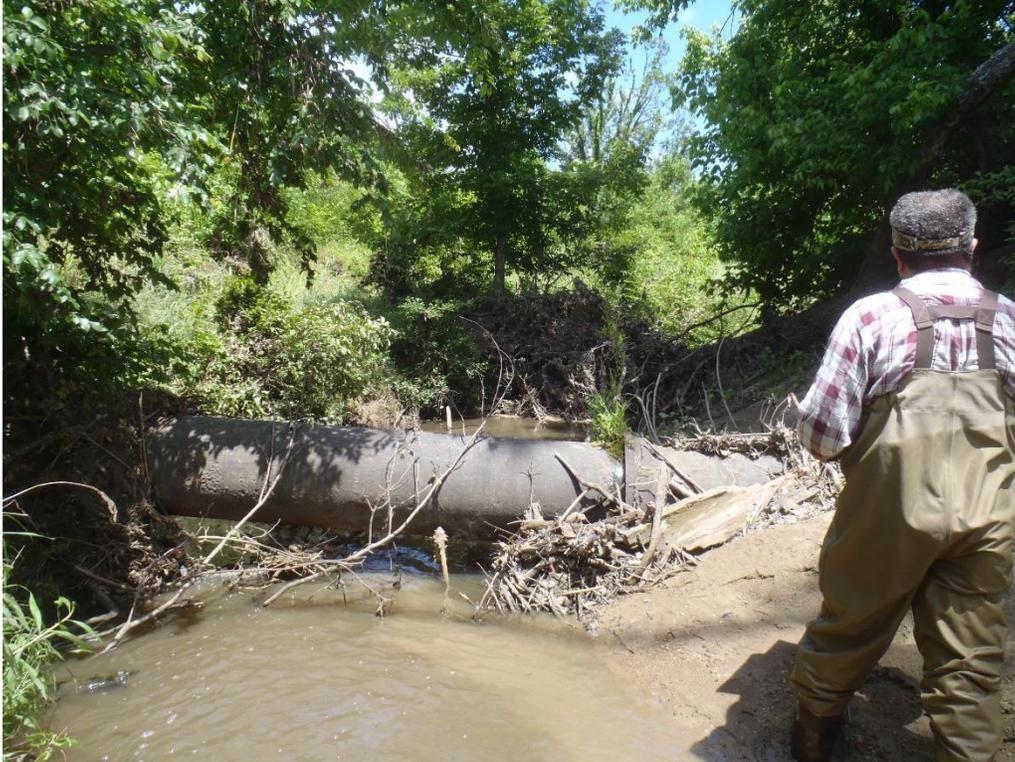
Figure 6.6 Photograph of Site SM02, taken May 16, 2014. Large utility pipe obstruction and TIAER personnel.

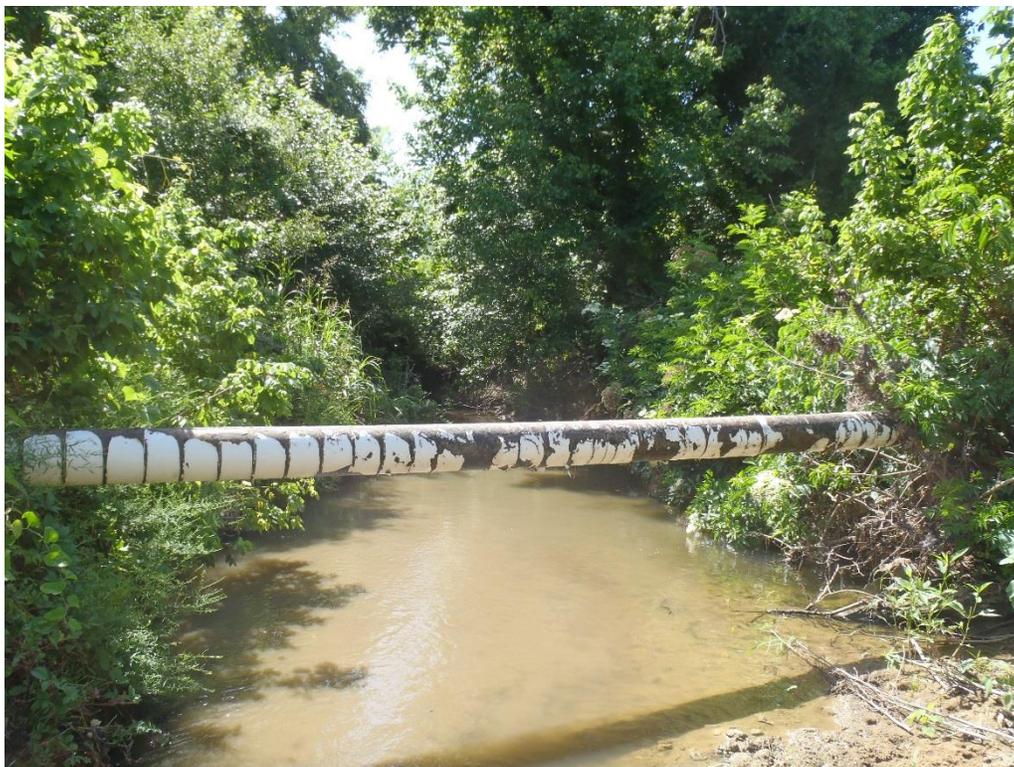
Figure 6.7 Photograph of Site SM02, taken July 11, 2014, of large utility pipe.

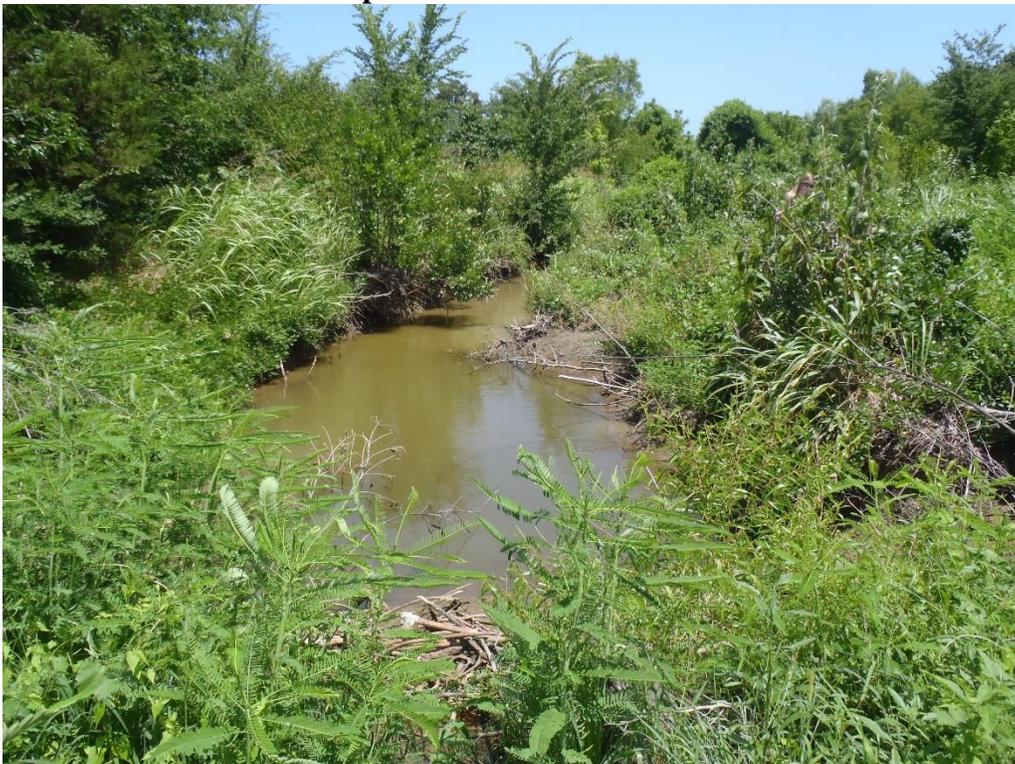
Smith Creek at site SM03 was surveyed on May 16 and July 11, 2014. Access to this site was easy as it was located at a public road crossing. However, access into the stream was moderately difficult due to dense vegetation and deep mud (Table 6.5 and Figure 6.8). Travel down the stream was difficult because water depths approached 1 m deep in places, the bottom was muddy and banks were densely vegetated (Figure 6.9).

Figure 6.9 Photograph of SM03, taken on July 11, 2014. Downstream view at 300-m transect. Note significant corridor vegetation.

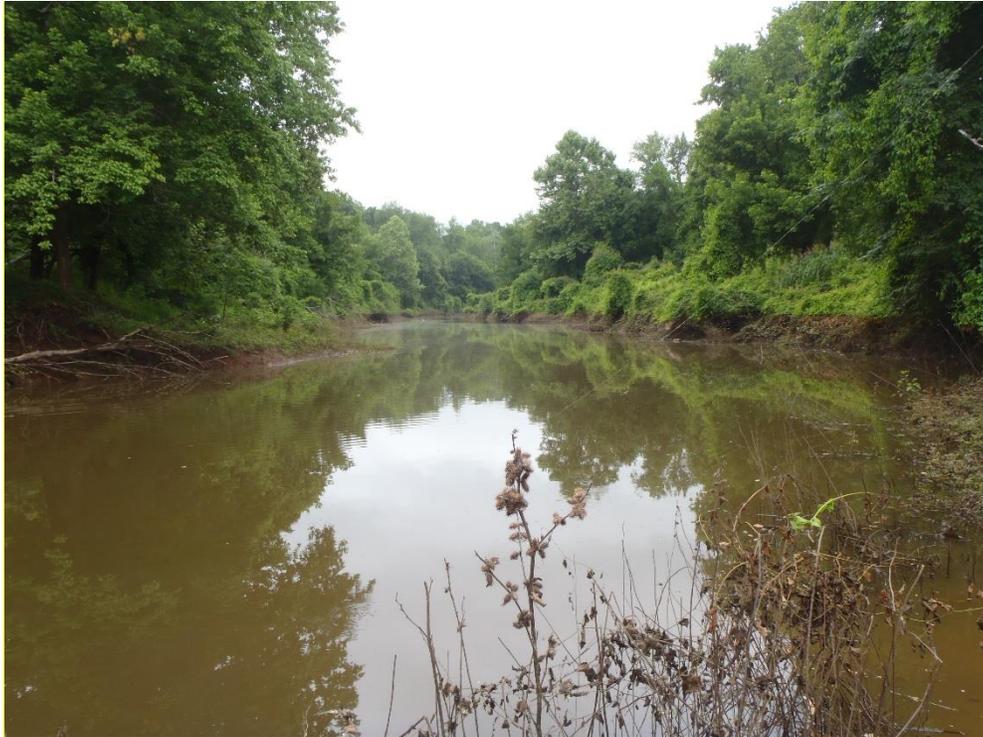
Figure 7.3 Photograph of Mud Creek Site MU01, taken on June 19, 2014. Downstream view at the 300-m transect. Note high-water mark.

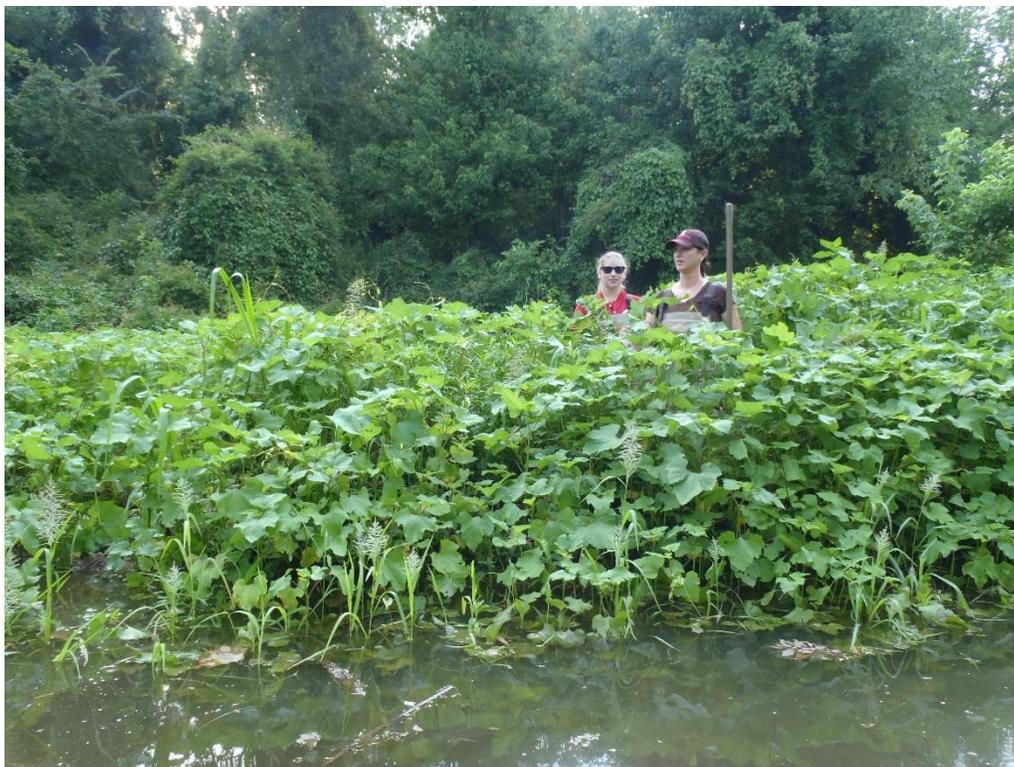
Mud Creek at Site MU01 was surveyed on June 19 and August 8, 2014. Access to this site was difficult because it was located approximately 3.5 miles from a public road on private property. Access into the stream was also difficult due to thick vegetation and long distance from the public road. Although there was an all-terrain-vehicle trail that was used to access the site, recent rains caused the ATV trails to hold water resulting in more difficult travel to this site. Site MU01 was originally selected because it exists on a cooperatively owned recreational property where recreation in the creek was likely to occur. The landowner indicated water levels at this stretch of the creek were typically wadeable during the time summer surveys would be conducted. Additionally, when reconnaissance was conducted in the spring, the trails leading to the site were dry and the density of vegetation at the time of site selection was minimal. During the surveys, the banks were overgrown by dense herbaceous cover, which was too thick to navigate on foot, therefore, only 90 m (4 transects) were surveyed (Figure 7.5).

Figure 7.5 Photograph of Mud Creek Site MU01, taken on August 8, 2014. Right bank view at the 300-m transect. Note tall vegetation growing into water and access point behind TIAER staff.

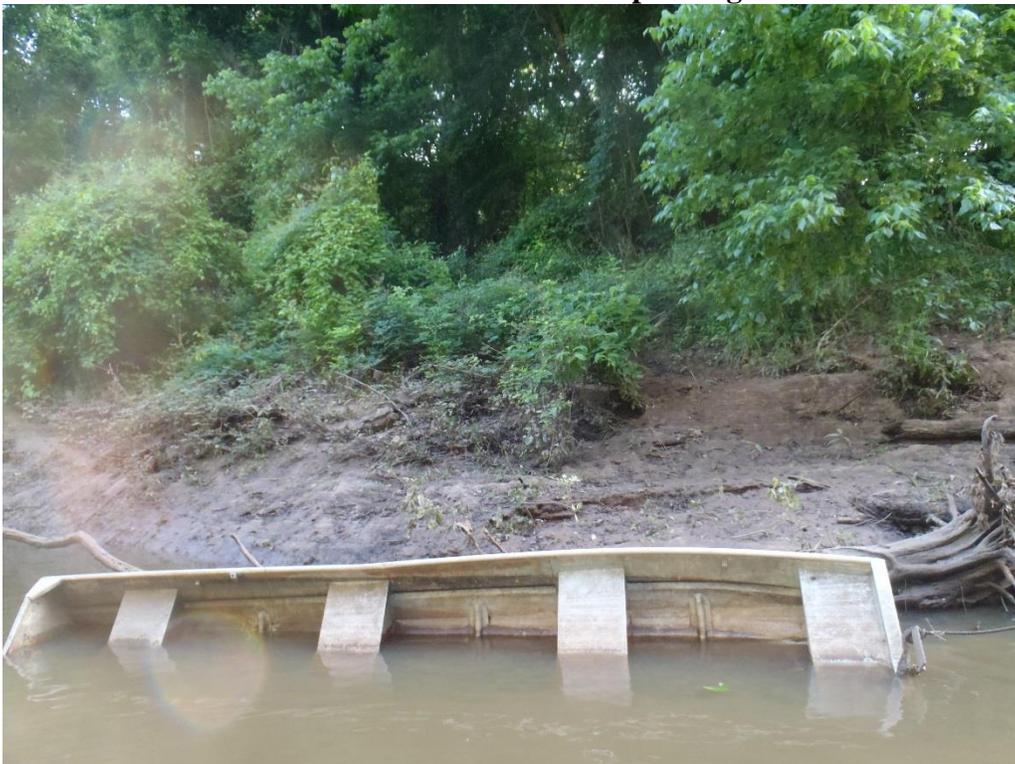
wallows were observed along with bird droppings. Garbage was rare but did include glass bottles, cans, various metals, a boot, and other small trash (Tables 7.9 and 7.10). Remnants of the old county bridge were observed (Figure 7.6). An aluminum boat tied to a cross-tie that spanned the creek was present during both surveys (Figures 7.7 and 7.8). No other signs of human recreation were observed.

Figure 7.8 Photograph of site MU02, taken June 18, 2014. Right bank view at 150-m transect. Note overgrown banks and aluminum boat.

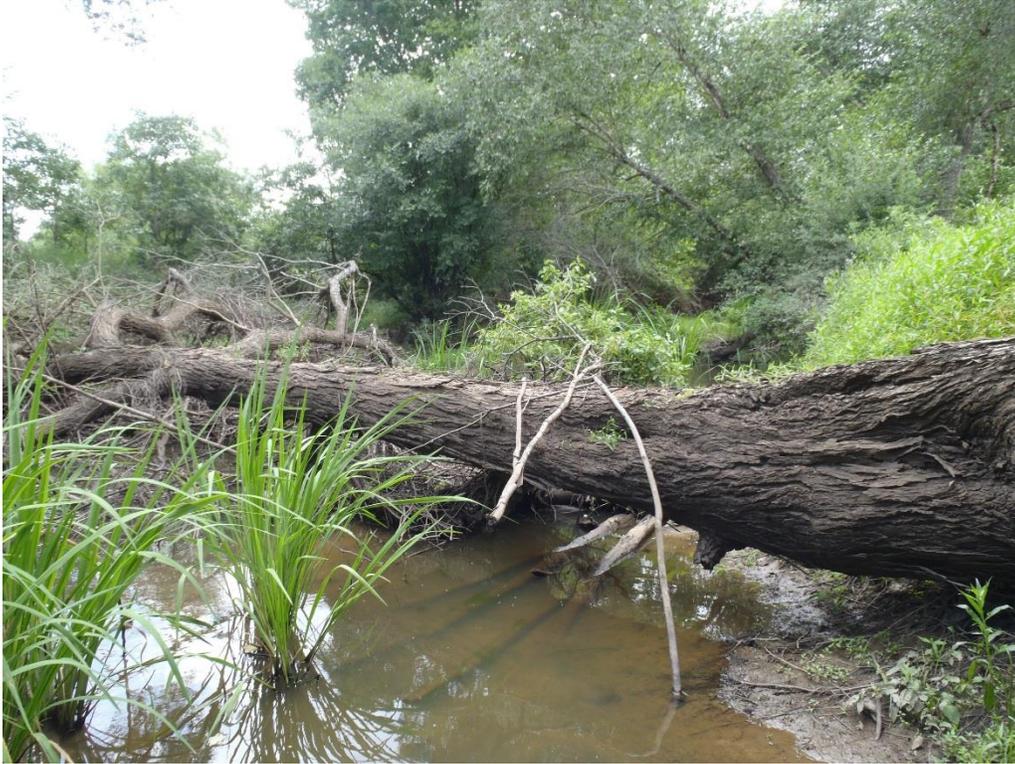
Figure 7.10 Photograph of MU03, taken on August 7, 2014, of large log obstruction.

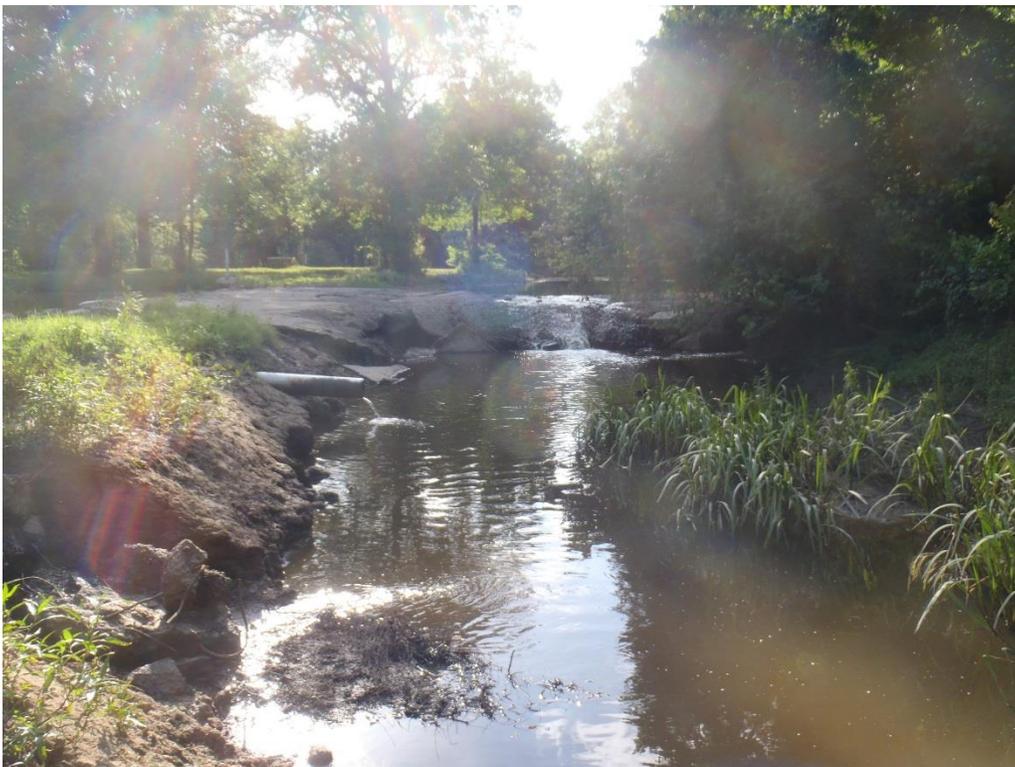
The stream was wadeable with a typical average width of approximately 6.5 m during both surveys, and thalweg depths of 0.7 m during the first survey and 0.4 m during the second survey. The stream appeared to have normal flow during both surveys (Tables 7.6, 7.7 and 7.8). A substantial pool was encountered at approximately 200 m that measured 70 m long, 16 m wide and was greater than 1.5 m deep during the first survey. During the second survey the pool had reduced to 13 m long, 11 m wide but was still greater than 1.5 m deep. A low water crossing with culverts was encountered just beyond the 300-m transect on private property that caused some water to be impounded (Figure 7.11).

Figure 7.11 Photograph of Site MU03, taken June 18, 2014. Upstream view at 300-m transect and low water crossing with culverts on private property.

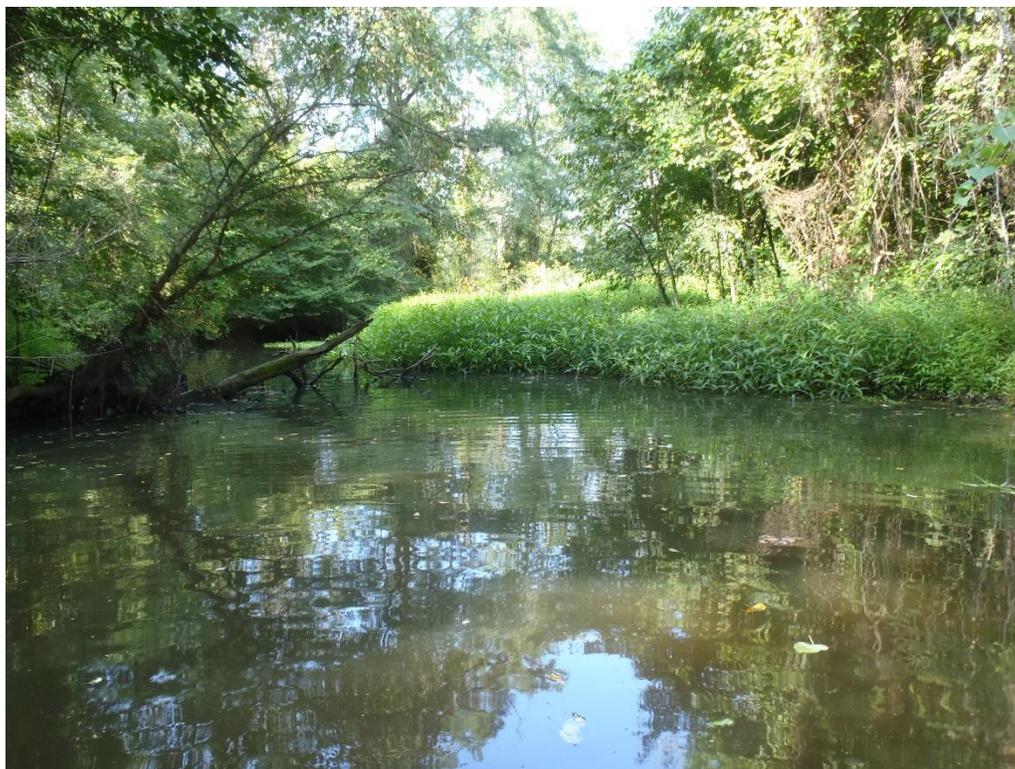
Figure 7.12 Photograph of Site MU04, taken August 8, 2014. Upstream view at 0-m

transect. Note dense vegetation on left and right banks.

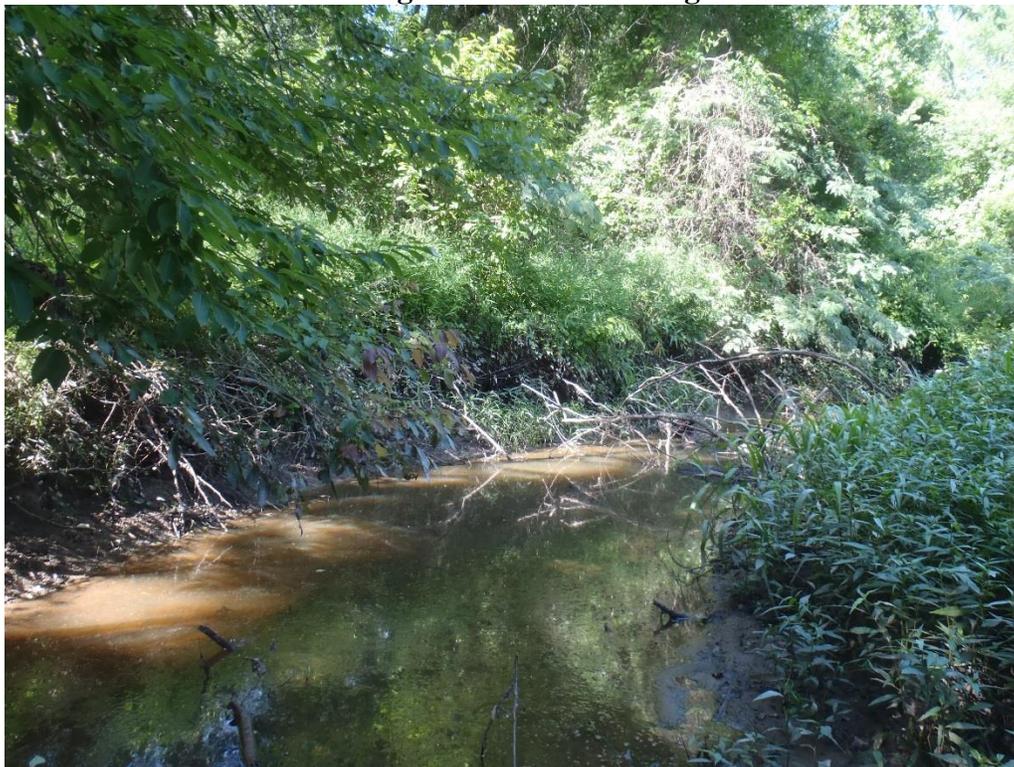
Mud Creek at Site MU04 was surveyed on June 18 and August 8, 2014. This site is publically accessible at the bridge crossing but access down to the water required landowner permission to cross over a private property fence line (Table 7.5). Travel through the channel was difficult as well because of steep slopes and dense forest vegetation and the deep, muddy bottom. Submerged trees and debris contributed to difficult travel in the stream (Figure 7.13).

Figure 7.13 Photograph of MU04, taken on June 18, 2014. Downstream view of the 150-m transect. Note dense bank vegetation and debris in stream.

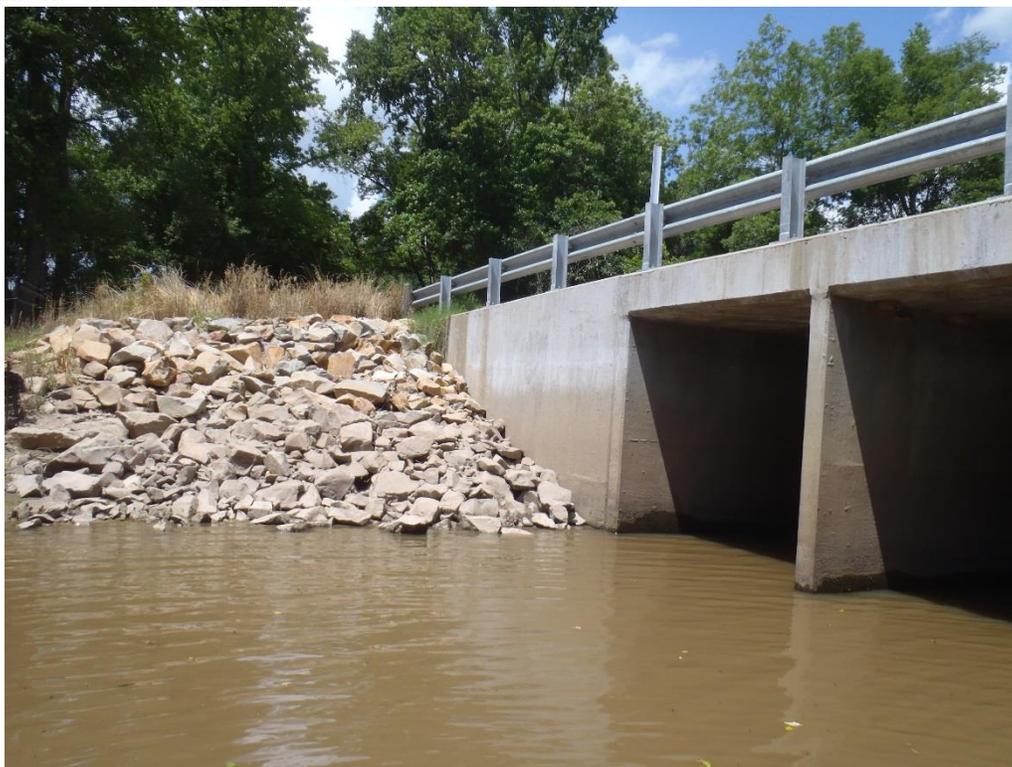
Figure 7.16 Photograph of MU06, taken on June 18, 2014. Left bank view of 300-m transect. Note public access at bridge and large rip-rap.

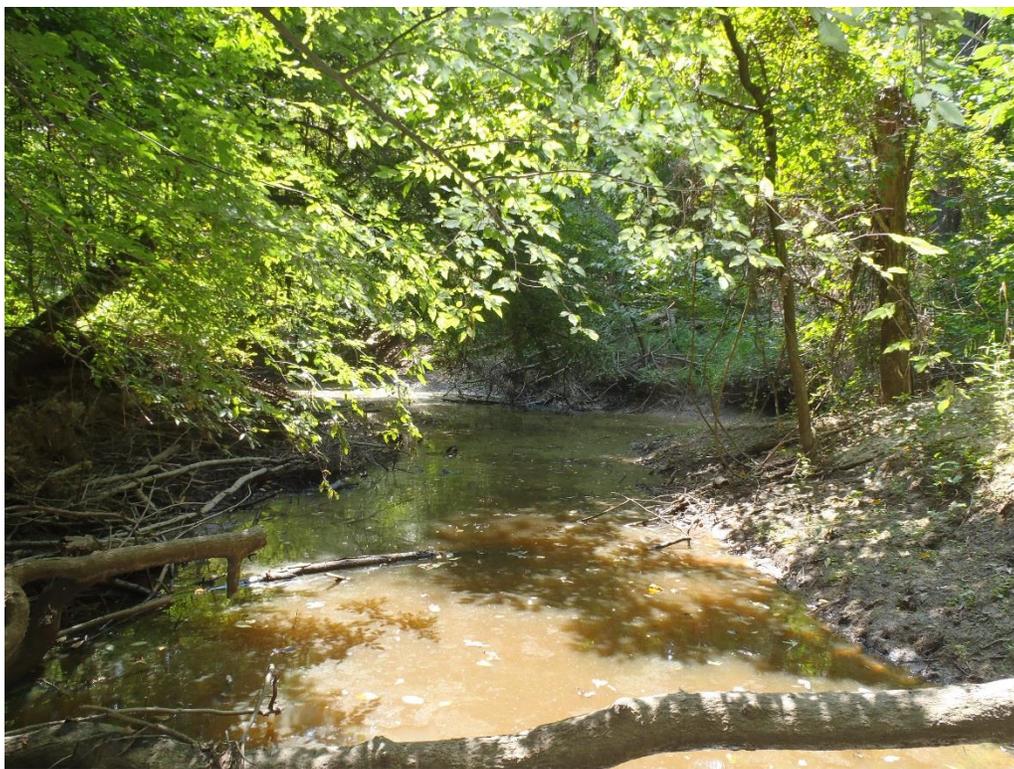
Figure 7.18 Photograph of Site MU06, taken August 8, 2014. Downstream view at 0-m. Note forested banks and debris in channel.

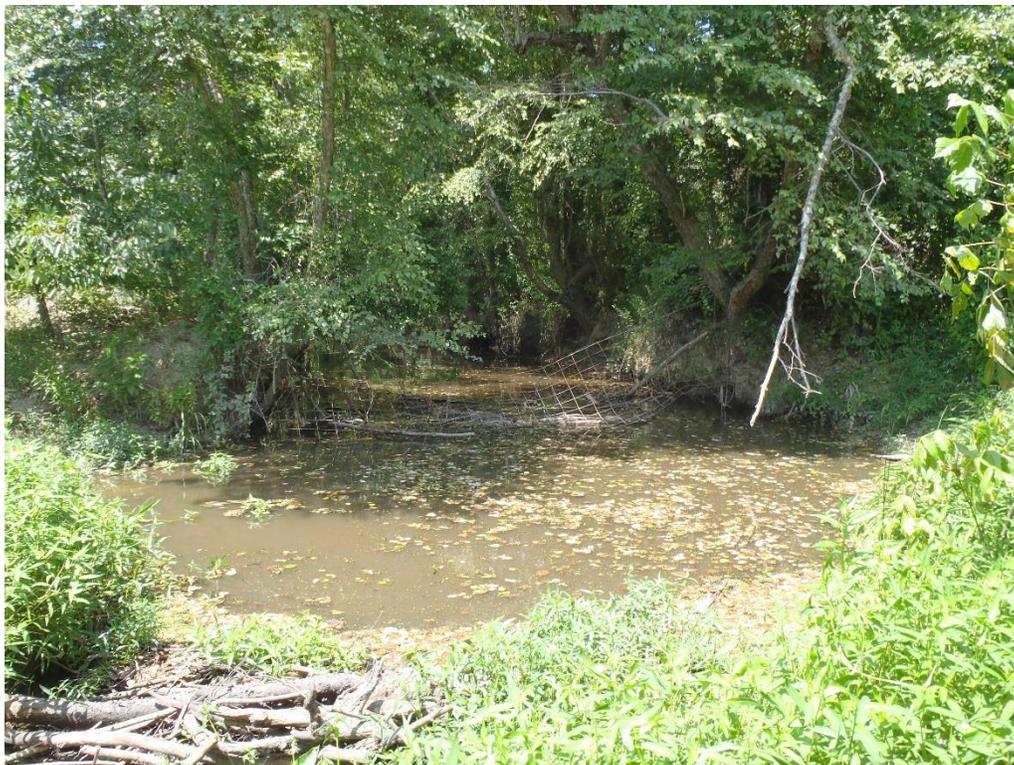
MU08 was surveyed on June 18 and August 8, 2014. This site was publically accessible but only at the bridge crossing. Private property fences hindered further access both upstream and downstream and required landowner permission to cross (Figure 7.22). Once in the channel travel through the corridor was moderately easy with some deep mud and steep slopes making climbing out of the channel more difficult (Figure 7.23).

Figure 7.22 Photograph of MU08, taken on August 8, 2014. Upstream view at 300-m transect. Note private barbed wire fence line and algae on water surface.

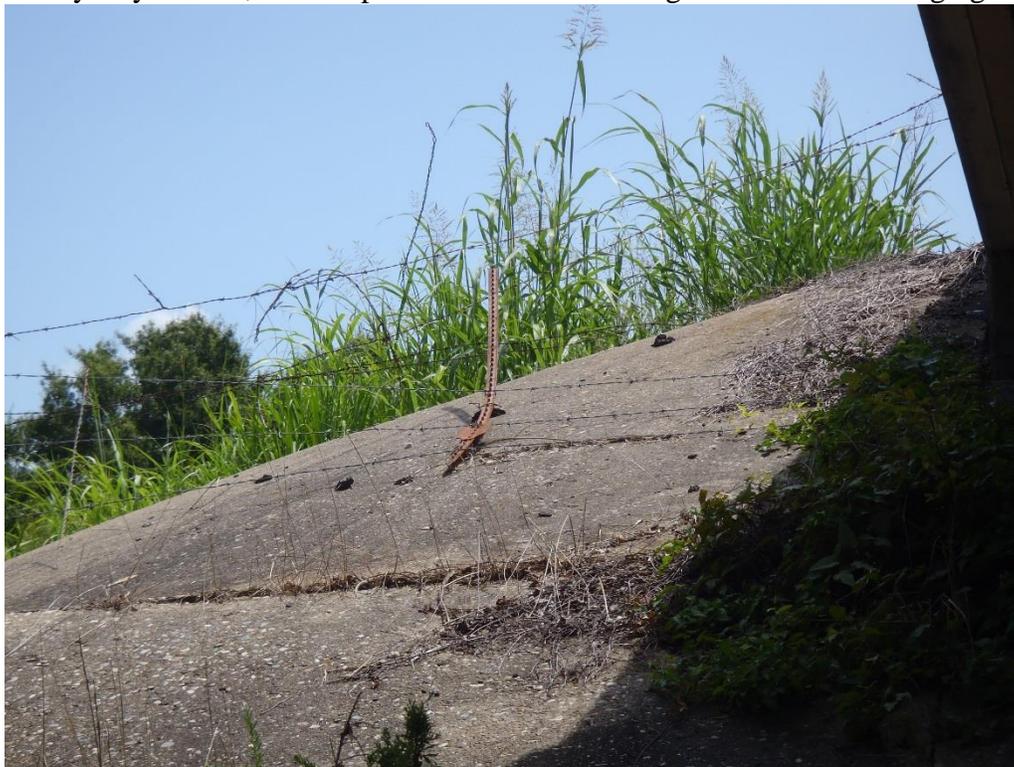
Figure 7.25 Photograph of site MU09, taken on August 8, 2014, of private property fence preventing foot traffic from roadside. This existed at all four points around bridge.

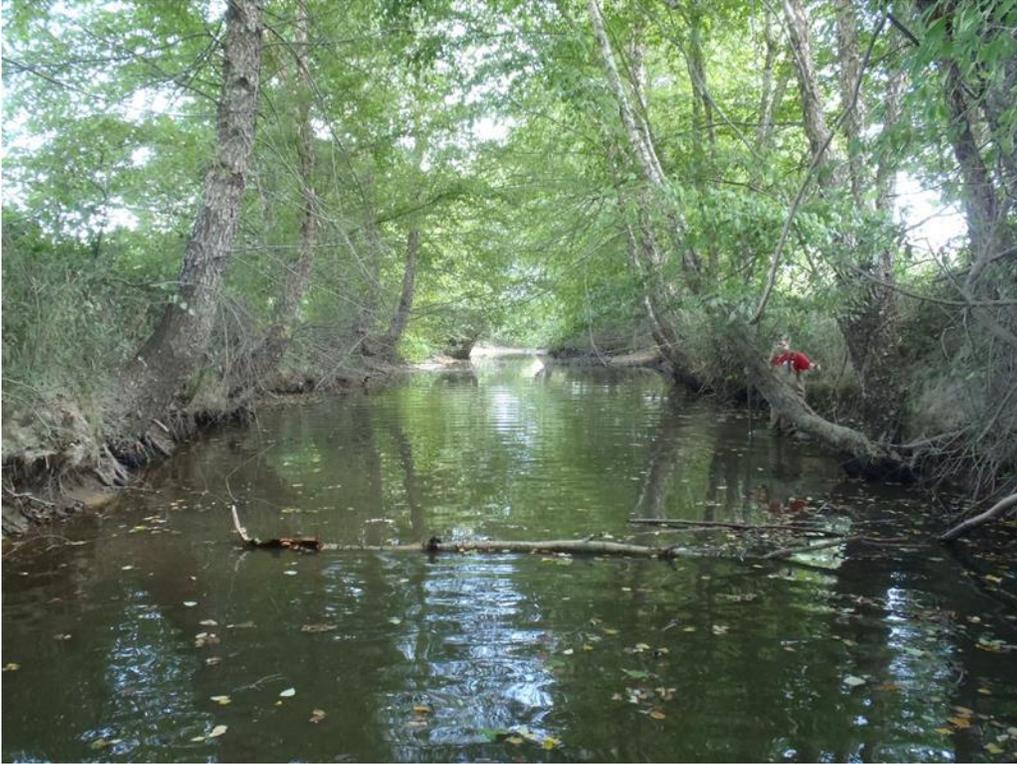
Figure 7.26 Photograph of site MU09, taken on August 8, 2014. Downstream view at 0-m transect. Note the steep banks, water levels and debris. TIAER staff in photo.

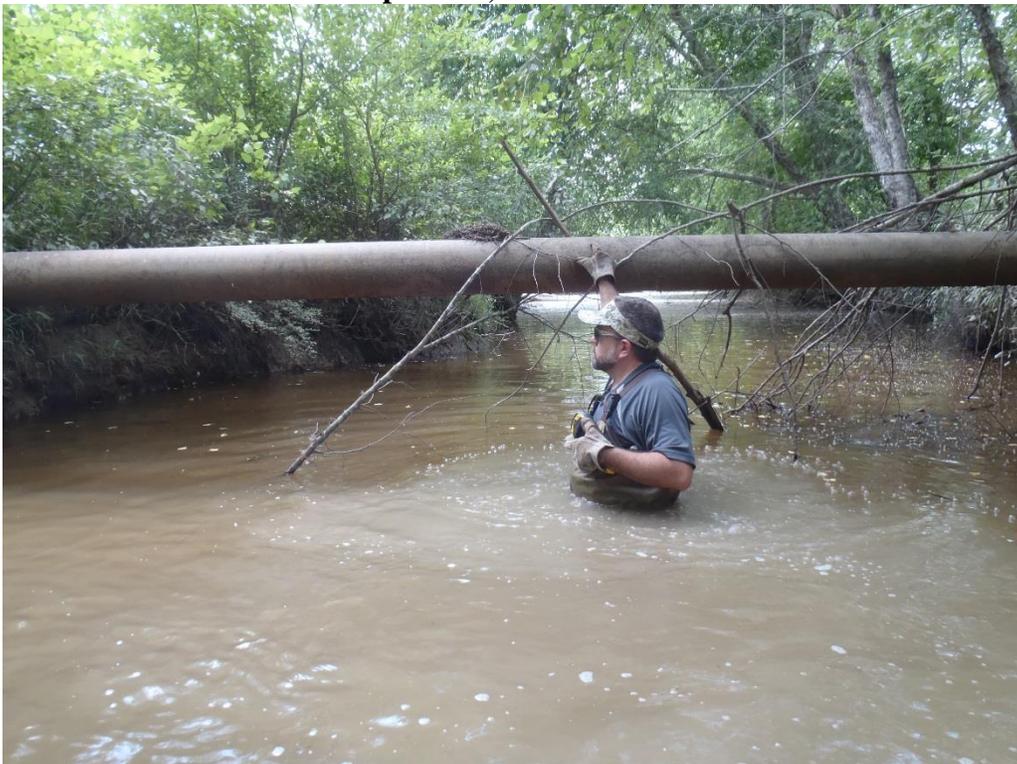
Figure 7.27 Photograph of site MU09, taken on June 18, 2014. Pipeline obstruction bisecting the creek. TIAER personnel in photograph.

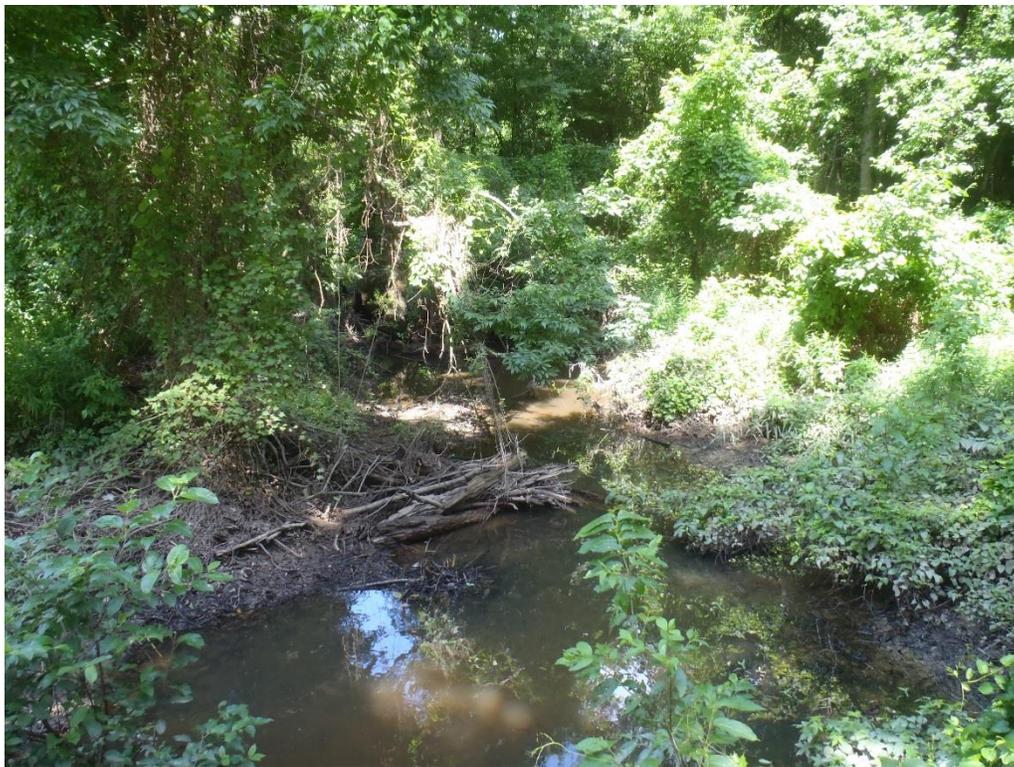
This site was wadeable (Figures 7.28 and 7.29). Average thalweg depths for the two surveys were 0.3 m and 0.11 m, respectively (Table 7.6). Flow appeared low during the first survey and no flow was observed during the second. Typical average widths for the two surveys were both 2.5 m; however, a maximum width of 9 m was recorded during the first survey and only 4.5 m maximum during the second (Tables 7.7 and 7.8). Two pools were recorded as well. One measured 30 m long, 9 m wide and 0.6 m deep and the other measured 50 m long, 5 m wide and 0.6 m deep.

Figure 7.28 Photograph of MU10, taken on June 18, 2014. Upstream view at the 150-m transect from road crossing.

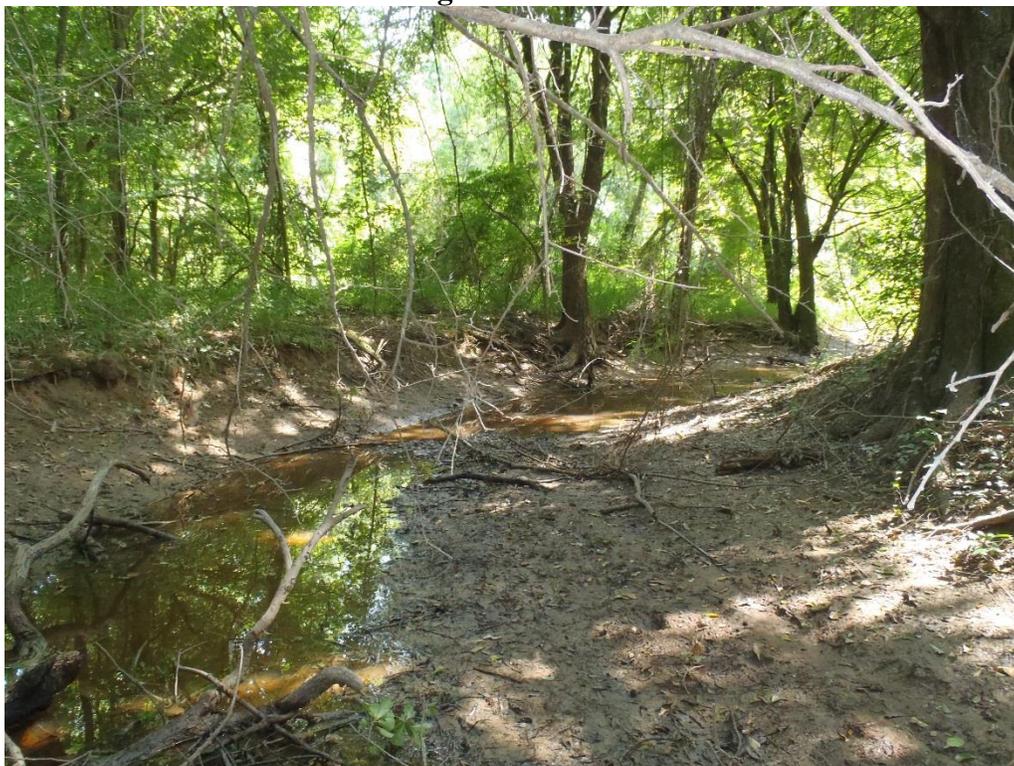
Figure 7.29 Photograph of MU10, taken on August 8, 2014. Downstream view at 300-m transect. Note lack of water, muddy substrate, dense vegetation, and debris.

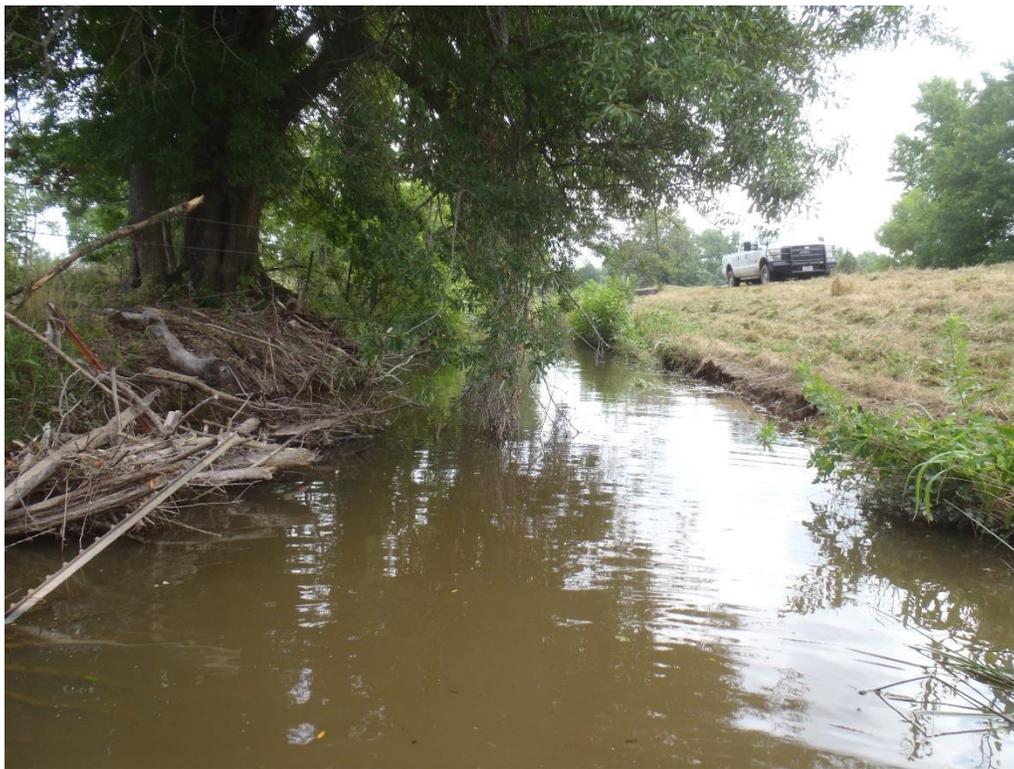
MU11 was surveyed on June 18 and August 8, 2014. Access to this site was easy because it occurred at a road crossing and the stream ran parallel to the road for approximately 75 m (Figure 7.30). However, the channel was fenced both upstream and downstream from the bridge. Access down the stream was moderately easy after acquiring landowner permission to cross a fence that bisected the creek. The dominant substrate was gravel with some mud/clay deposited in places which made wading a challenge at times. There was some rip rap and concrete at the bridge that was difficult to navigate through. A few log jams existed along the surveyed stretch as well. Streambanks were steep and densely vegetated with native shrubs and herbaceous plants, including poison ivy, with some scattered trees. Beyond both right and left banks exists improved pastureland.

Figure 7.30 Photograph of site MU11, taken June 18, 2014. Downstream view at 300-m transect. Note public access availability from road.
