Recreational Use Attainability Analysis for
Kickapoo Creek in Henderson County (0605A),
the Neches River Above Lake Palestine (0606),
Prairie Creek (0606A), Mud Creek (0611C), and
West Mud Creek (0611D)
in the Neches River Basin

Prepared for:
Texas State Soil and Water Conservation Board
Project 14-52

Texas Institute for Applied Environmental Research
Tarleton State University
Stephenville, Texas

TR1503
September 2015

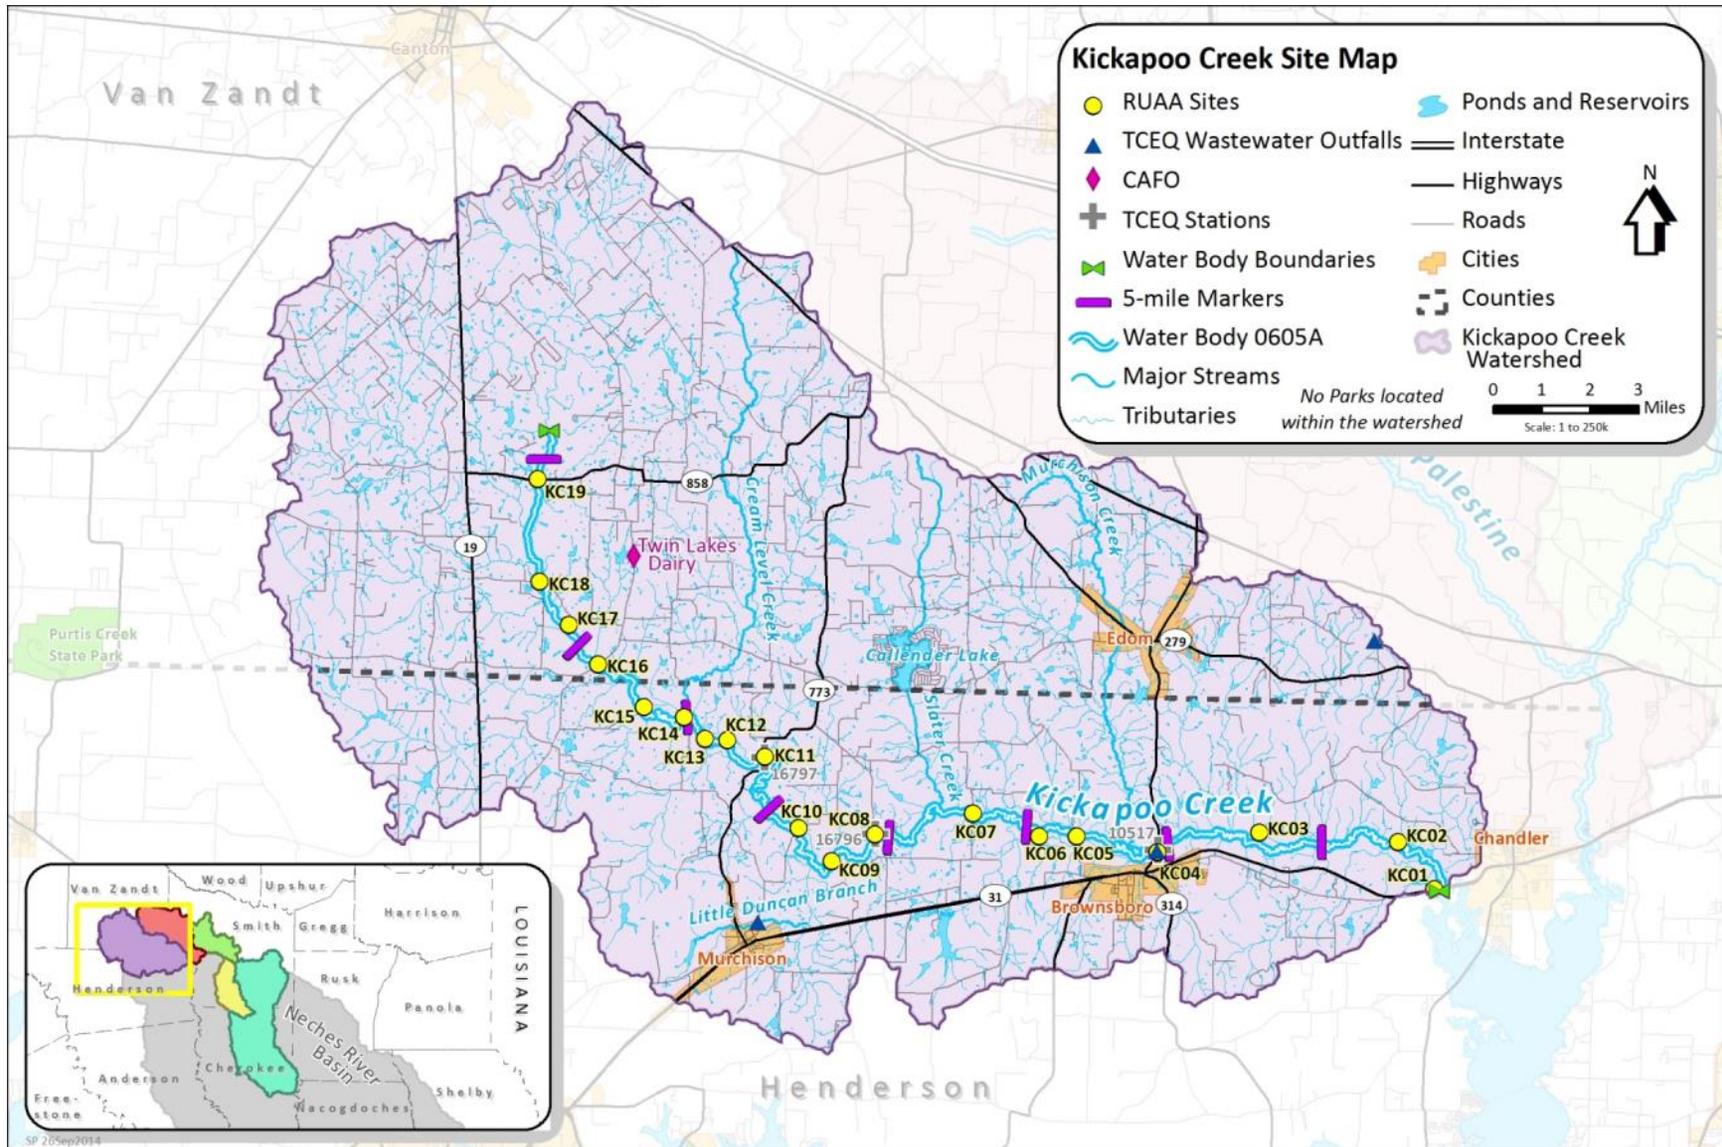
Figure 3.1 Overview of Kickapoo Creek in Henderson County watershed and RUA sites.

Kickapoo Creek in Henderson County (0605A) is 41 river miles long indicating a goal of 25 sites (3 sites per 5 miles of river) for the RUAA survey (Figure 3.1). With the help of cooperating stakeholders, TIAER was able to establish a total of 19 sampling stations along Kickapoo Creek (Table 3.2). Although the optimum number of sampling stations was 25 following the RUAA guidelines, acceptance of using only 19 stations was sought and granted from TCEQ.

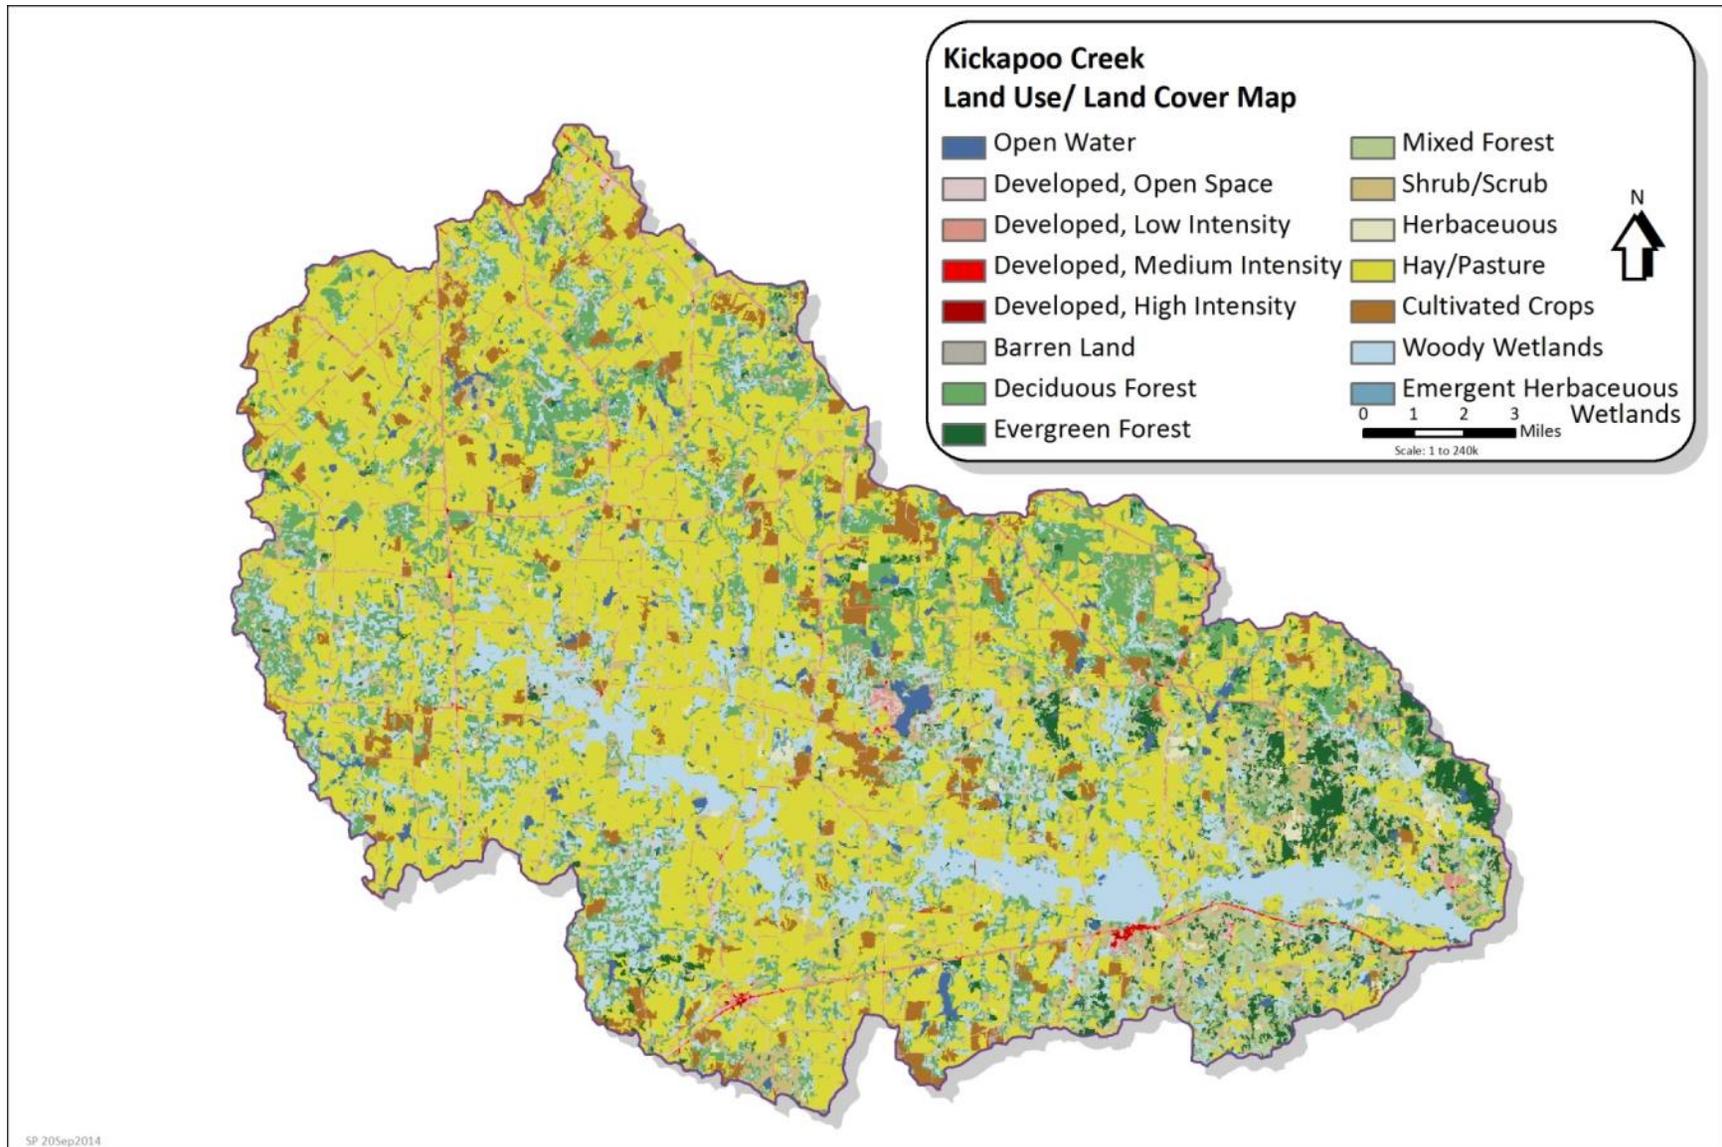
Figure 3.2 Land use/land cover for the Kickapoo Creek in Henderson County watershed. Source: 2011 National Land Cover Database (USGS, 2013).

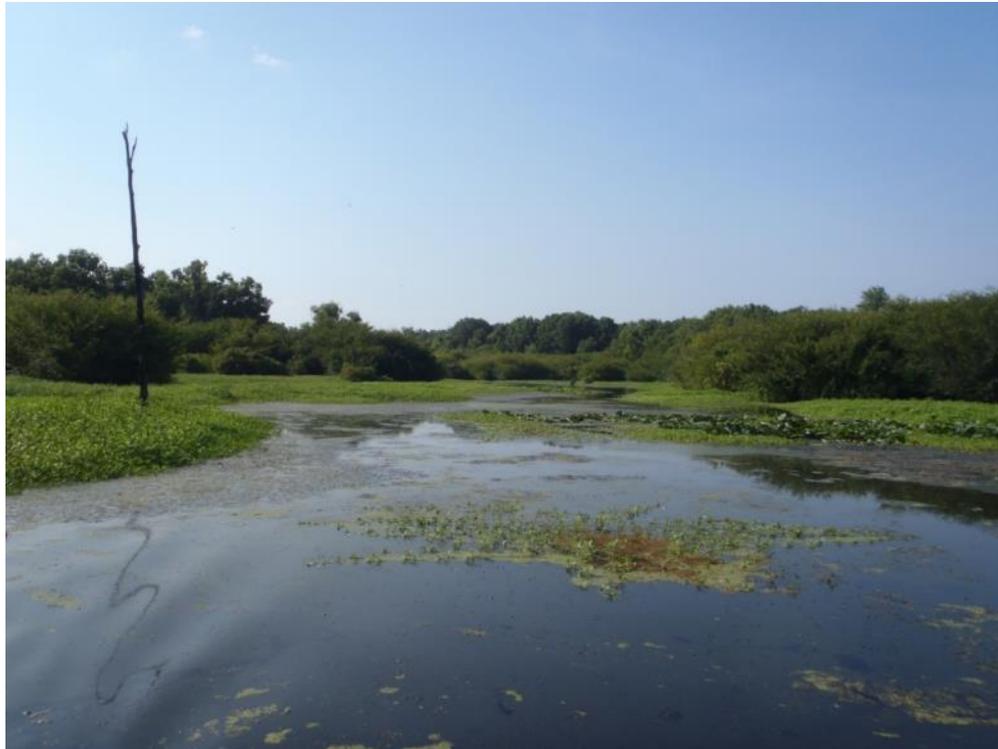
Figure 3.4 Photograph of Kickapoo Creek Site KC01 taken on July 25, 2014. The upstream view of the 0-m transect.

Kickapoo Creek at Site KC01 was visited on July 25 and August 22, 2014. This site was located at the bridge crossing on State Highway 31, west of Chandler, Texas in Henderson County, and was publically accessible from the bridge crossing. The site is located in a forest dominated corridor (Table 3.5). At the site, access to the stream was easy from the northwest side of the bridge crossing. The easy access was due to the presence of a cleared dirt pathway that was large enough to accommodate a vehicle (Figure 3.3). Additionally, the pathway led to a small dirt boat ramp that was adequate for launching a small boat. Access elsewhere along the reach would have likely been difficult due to dense vegetation and fenced private property. Figures 3.4 and 3.5 depict the appearance of the site during each of the surveys.

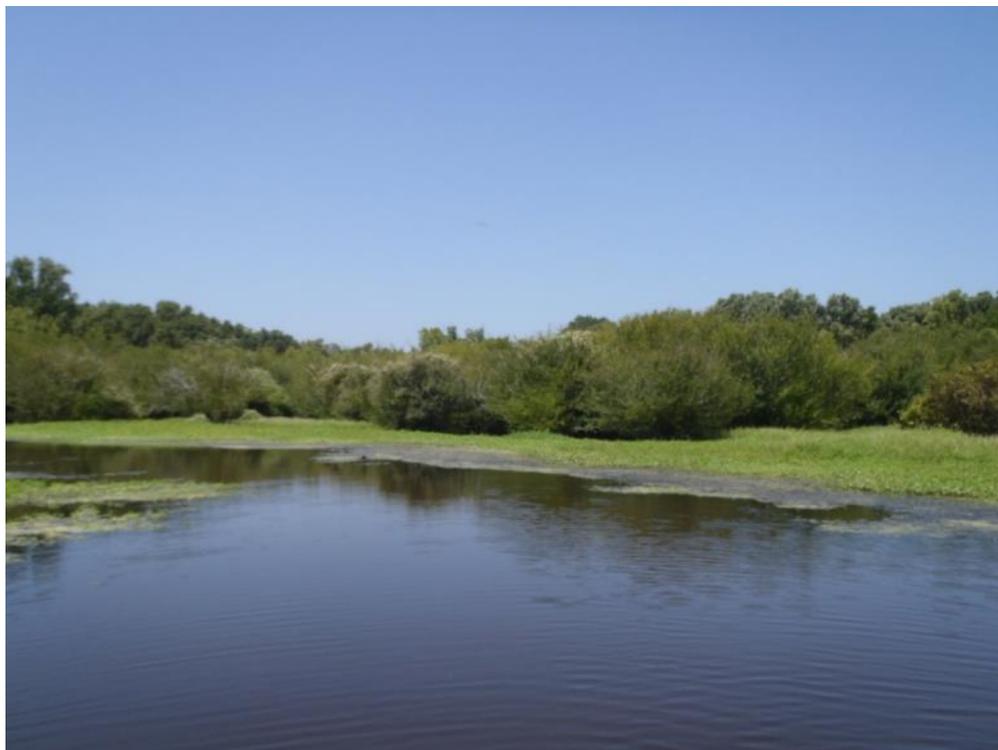
Figure 3.5 Photograph of Kickapoo Creek Site KC01 taken on August 22, 2014. The upstream view of the 150-m transect.

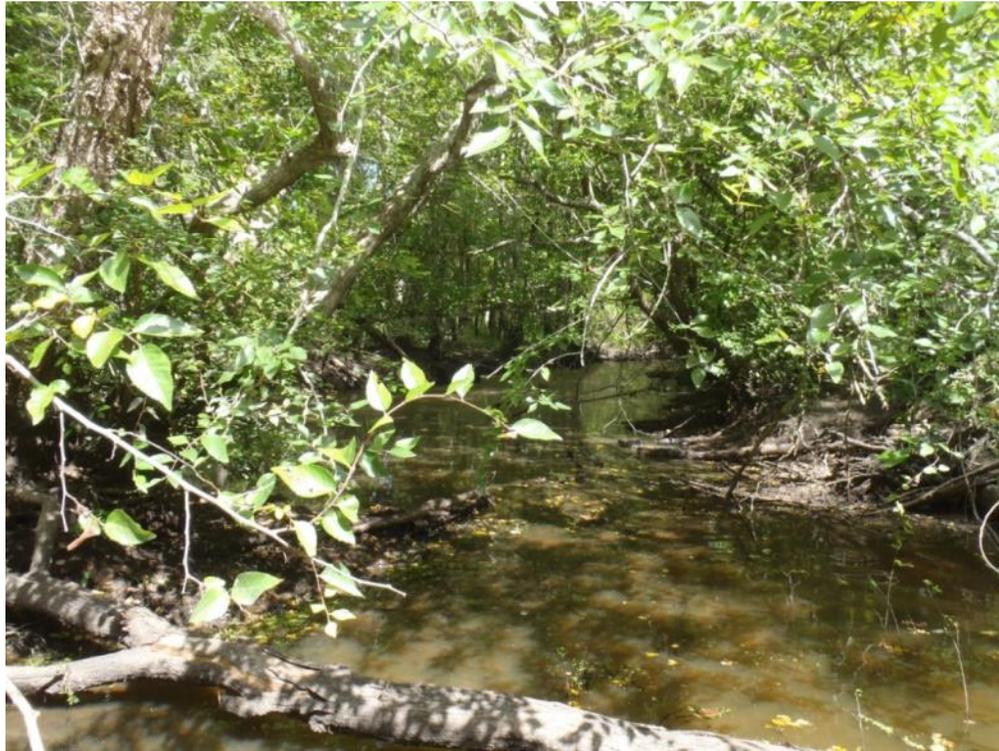
Figure 3.6 Photograph of Kickapoo Creek Site KC02 taken on July 26, 2014. The downstream view of the 300-m transect.

Kickapoo Creek at site KC02 was visited on July 26 and August 29, 2014. This site was located west of Chandler, Texas in Henderson County. Site KC02 was accessible only through private lands that were fenced with a gate that could be locked. With landowner permission, TIAER personnel entered private property over a cattle guard and drove approximately one-half mile through the pasture and a second gate to reach the site. The corridor was forested along both banks (Table 3.5). At the site, access to the stream was easy via gentle sloping banks and little to no understory vegetation (Table 3.6). Figures 3.6 and 3.7 depict the site during each of the surveys.

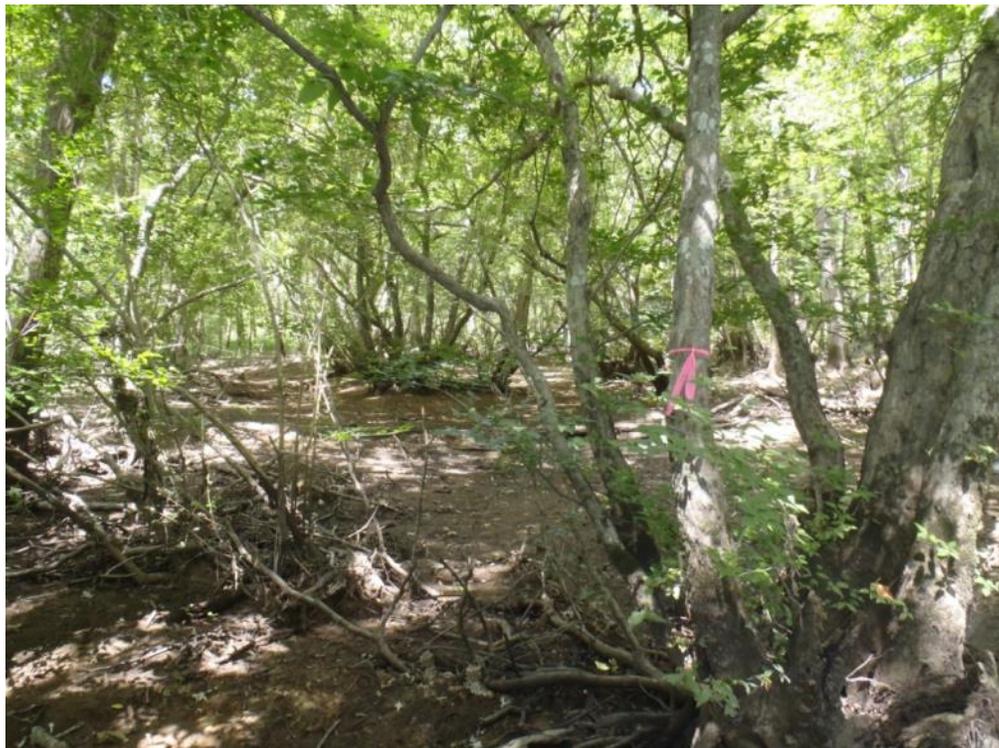
Figure 3.7 Photograph of Kickapoo Creek Site KC02 taken on August 22, 2014. The upstream view of the 150-m transect.

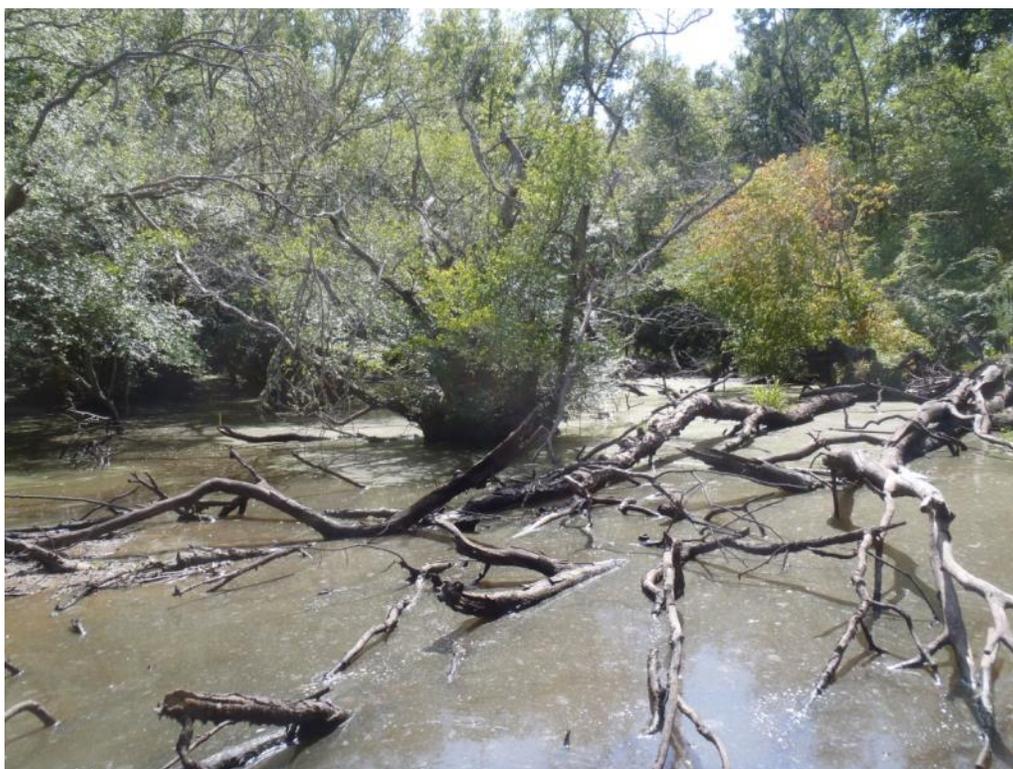
Figure 3.8 Photograph of typical obstructions encountered on Kickapoo Creek Site KC03 taken on July 26, 2014, the upstream view of the 300-m transect.

Kickapoo Creek at Site KC03 was visited on July 26 and August 22, 2014. This site was located west of Chandler, Texas in Henderson County, and was accessible only through private lands that were fenced. With landowner permission, TIAER personnel entered private property and drove approximately 0.9 miles on a pasture road and then walked an additional 0.35 miles along an ATV path to reach the site. The stream corridor was forested (Table 3.5), and access to the stream was difficult due to dense vegetation and muddy stream banks as shown in Figures 3.8 and 3.9 during each survey.

Site KC03 was wadeable for the entire 300-m reach length. Average thalweg was 0.30 m during both surveys (Table 3.6). During both surveys, TIAER personnel encountered downed timber and log jams throughout the reach that made wading difficult (e.g., Figure 3.8). Kickapoo Creek at this location did not have a well-defined stream channel at the time of the surveys, but rather had numerous small channels that were separated by dry land. The inability to accurately discern the true stream width led to the resulting “unknown” widths recorded in Tables 3.7 and 3.8.

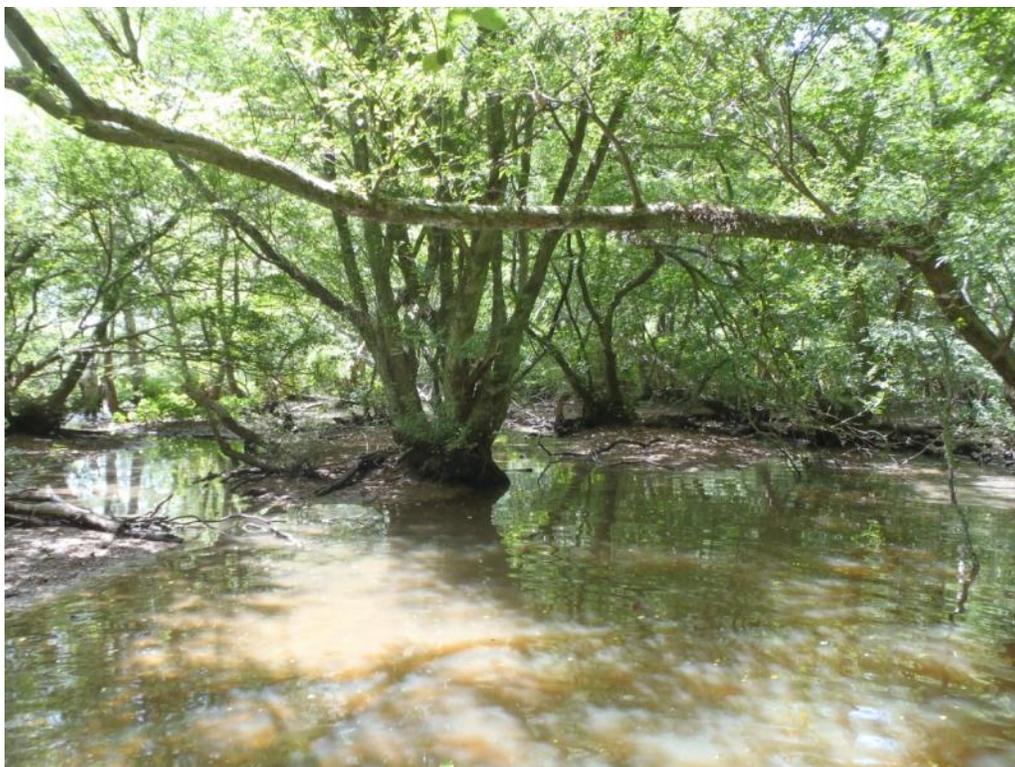
Figure 3.9 Photograph of Kickapoo Creek Site KC03 taken on August 22, 2014, the upstream view of the 0-m transect.

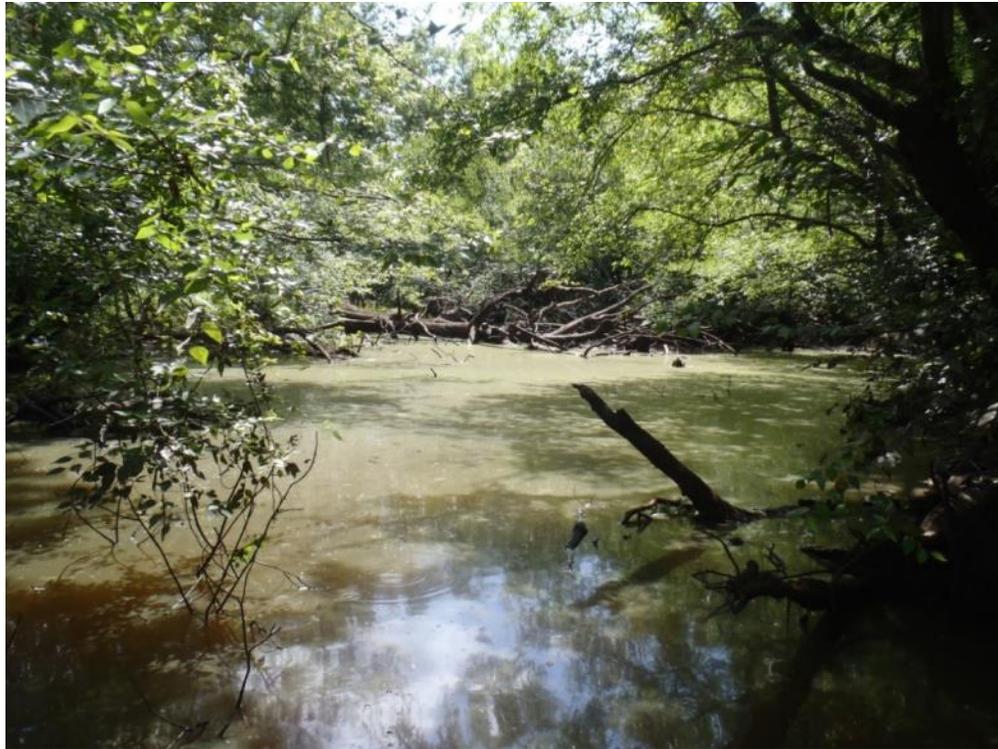
Figure 3.10 Photograph of Kickapoo Creek Site KC04 taken on July 26, 2014, the upstream view of the 150-m transect.

Kickapoo Creek at Site KC04 was visited on July 26 and August 22, 2014. This site was located north of Brownsboro, Texas in Henderson County, and was publicly accessible at the bridge crossing of FM 314. Private property upstream and downstream of this bridge crossing was unfenced. With landowner permission, TIAER personnel parked underneath the bridge and walked along an ATV path to reach the stream. The stream corridor was forested on both sides (Table 3.5), and access to the stream was easy due to gently sloping banks with little to no understory vegetation (Table 3.6). The general appearance of the creek at this location is shown in Figures 3.10 and 3.11.

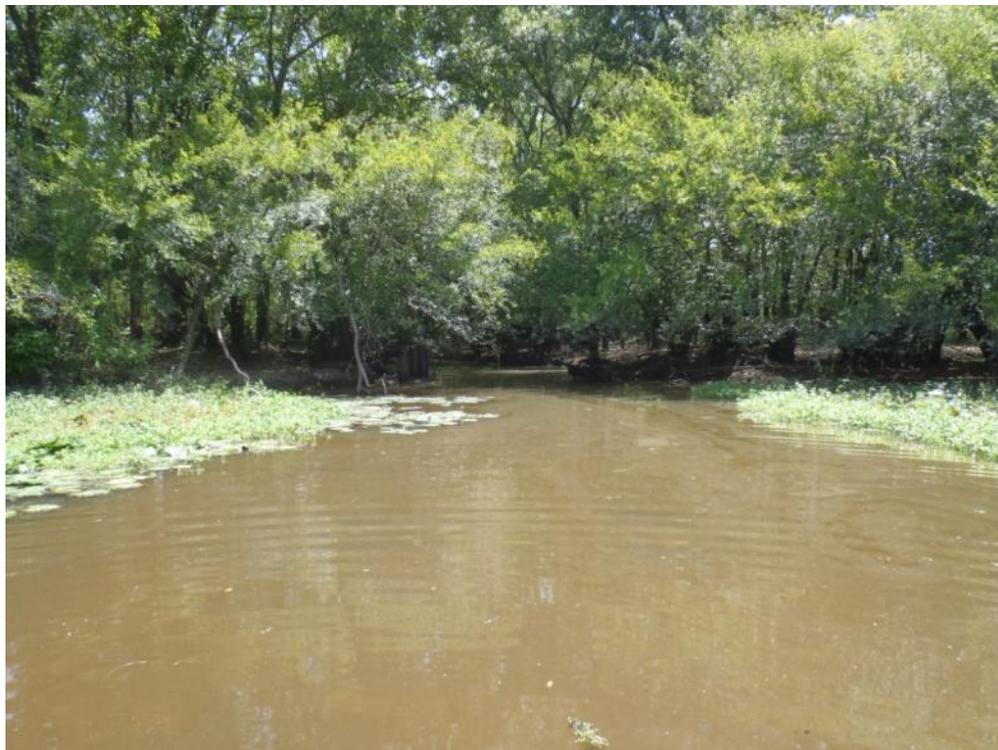
Figure 3.11 Photograph of Kickapoo Creek Site KC04 taken on August 22, 2014, the downstream view of the 300-m transect.

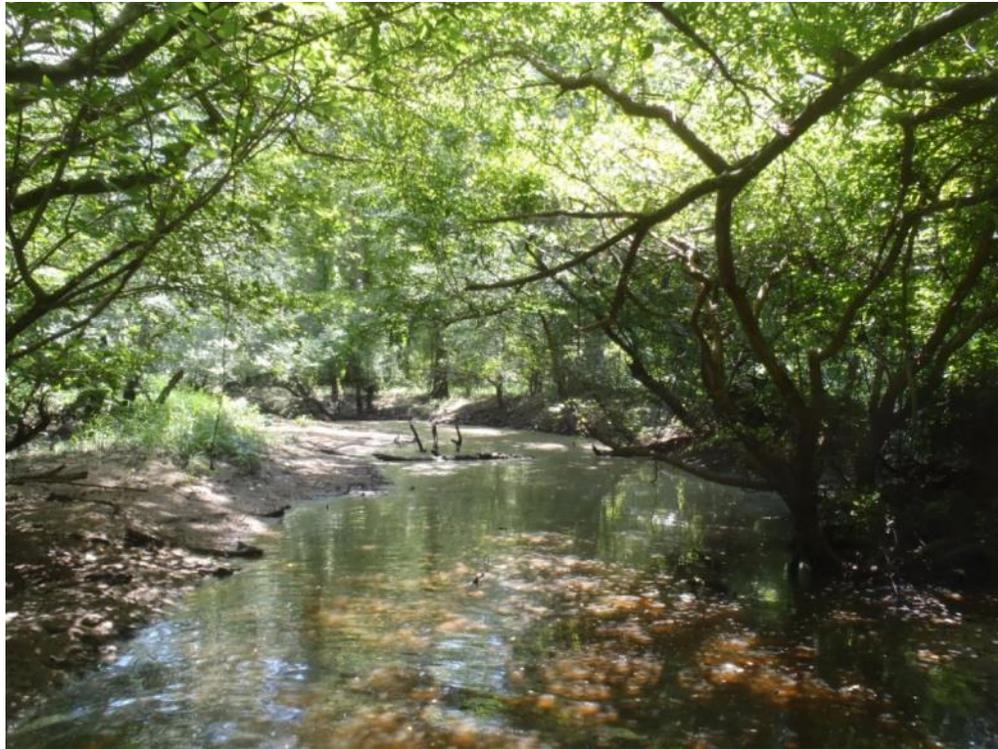
Figure 3.12 Photograph of Kickapoo Creek Site KC05 taken on July 26, 2014, the downstream view of the 0-m transect.

Kickapoo Creek at Site KC05 was visited on July 26 and August 22, 2014. This site was located northwest of Brownsboro, Texas in Henderson County. It was publicly accessible at the bridge and the private property upstream and downstream of the bridge crossing was unfenced (landowner permission was granted for TIAER field crew to access the stream). The stream corridor was forested on both sides (Table 3.5), and access to the stream was moderately easy (Table 3.6). The general appearance of the site during each survey is shown in Figures 3.12 and 3.13).

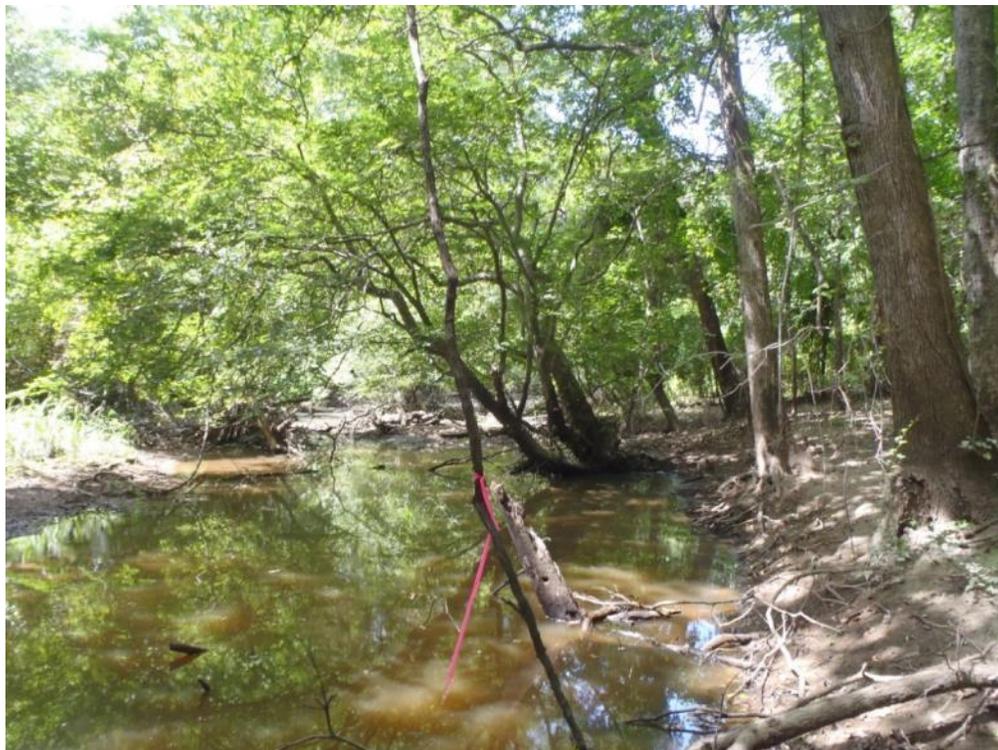
Figure 3.13 Photograph of Kickapoo Creek Site KC05 taken on August 22, 2014, the upstream view of the 150-m transect.

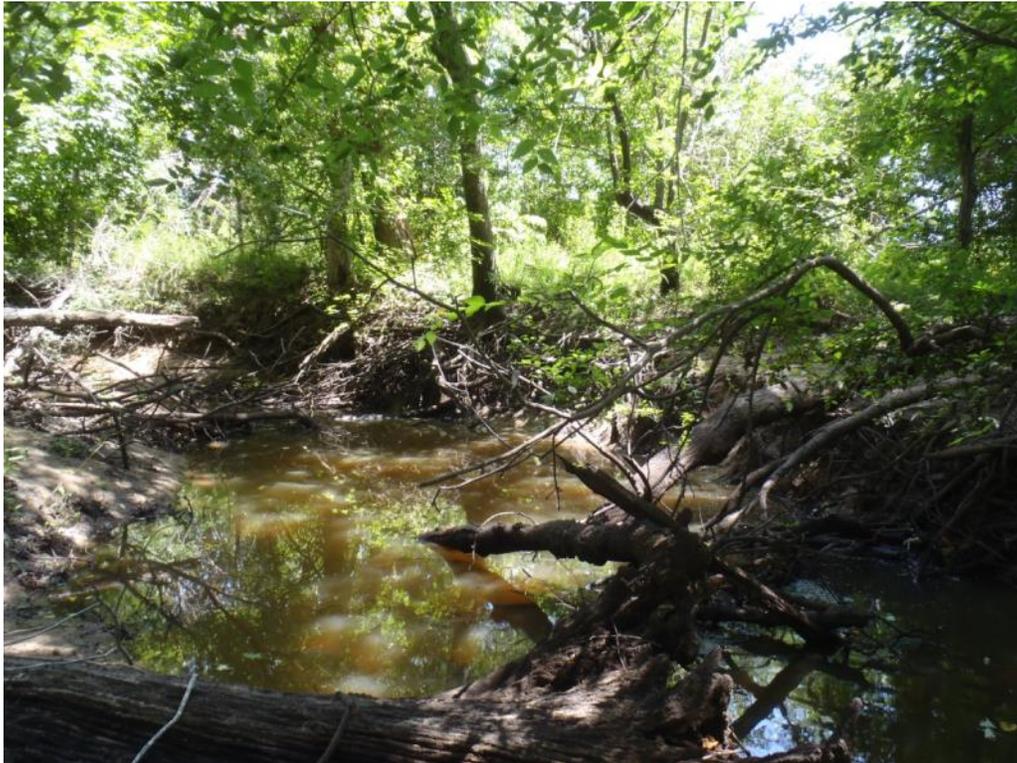
Figure 3.14 Photograph of Kickapoo Creek Site KC06 taken on July 26, 2014, the downstream view of the 0-m transect.

Kickapoo Creek at Site KC06 was visited on July 26 and August 22, 2014. This site was located northwest of Brownsboro, Texas in Henderson County, and was accessible only through private lands that were fenced and had two locked entrances. With landowner permission, TIAER personnel entered private property through the first entrance and drove one-quarter mile to a second locked gate. Once through the second gate, TIAER personnel drove approximately three-quarter mile through pasture land to reach the site. The stream corridor had primarily forest on the left bank of the reach and pasture on the right bank of the reach (Table 3.5). At the site, access to the stream was moderately easy (Table 3.6), although at other locations along the reach, access to the stream was more challenging due to steep banks and dense vegetation. Figures 3.14 and 3.15 depict the general appearance of the site during each of the surveys.

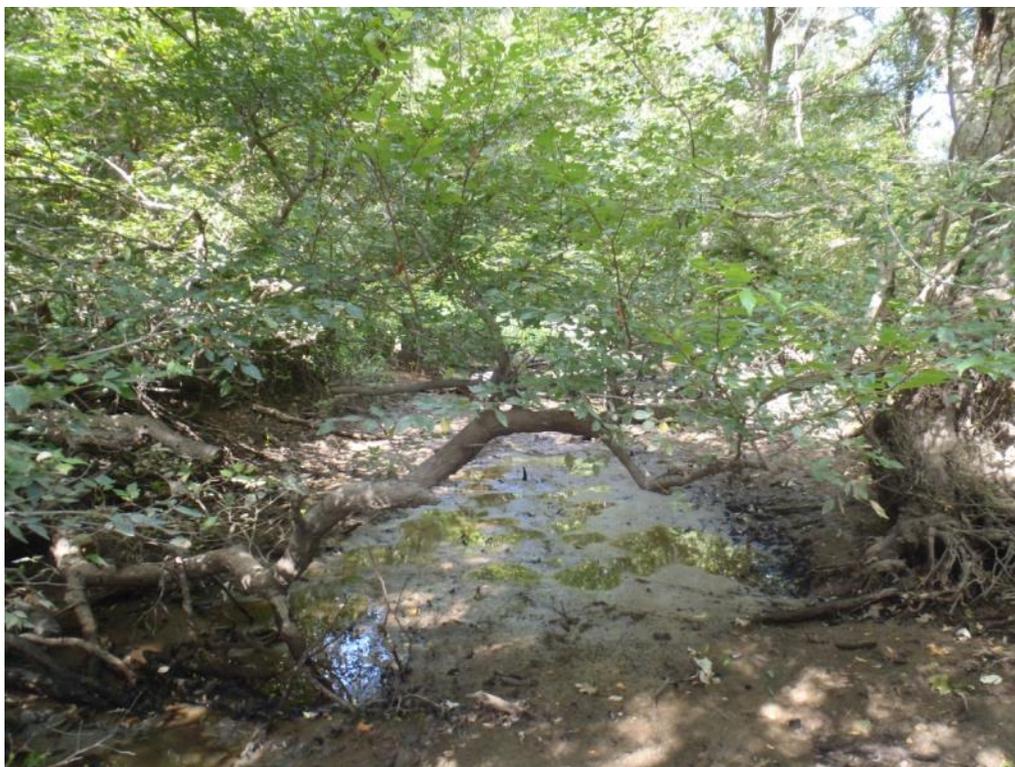
Figure 3.15 Photograph of Kickapoo Creek Site KC06 taken on August 22, 2014, the downstream view of the 150-m transect.

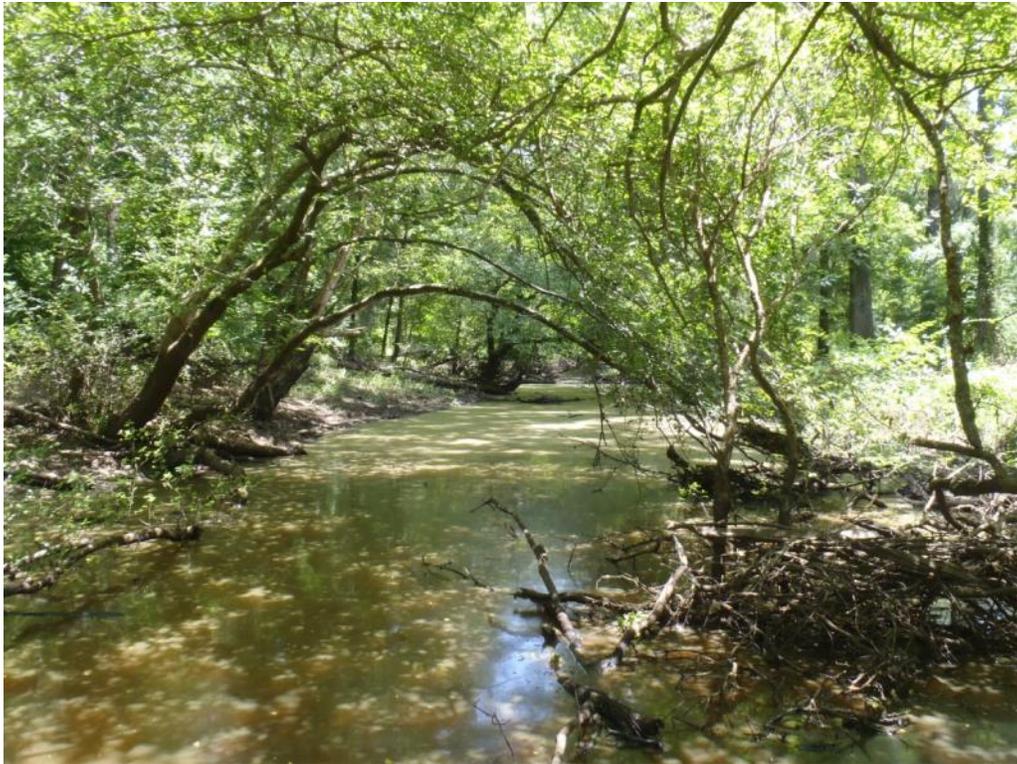
Figure 3.16 Photograph of Kickapoo Creek Site KC07 taken on July 26, 2014, the downstream view of the 0-m transect.

Kickapoo Creek at Site KC07 was visited on July 26 and August 22, 2014. This site was located northwest of Brownsboro, Texas at the crossing of Henderson County Road 3520. Site KC07 was only publicly accessible at the bridge crossing as private property fencing occurred upstream and downstream of the bridge crossing. With landowner permission, TIAER personnel entered private property through the fence and conducted the 300 m survey downstream of the bridge crossing. The stream corridor is forested for the entire length of the reach (Table 3.5). Access to the creek was moderately difficult due to thick vegetation and steep banks at the bridge crossing (Table 3.6). Away from the bridge crossing, access to the stream was easier with more gently sloping banks, but these locations were on private property, which would limit access to these locations. The general appearance of the creek at Site KC07 is depicted in Figures 3.16 and 3.17.

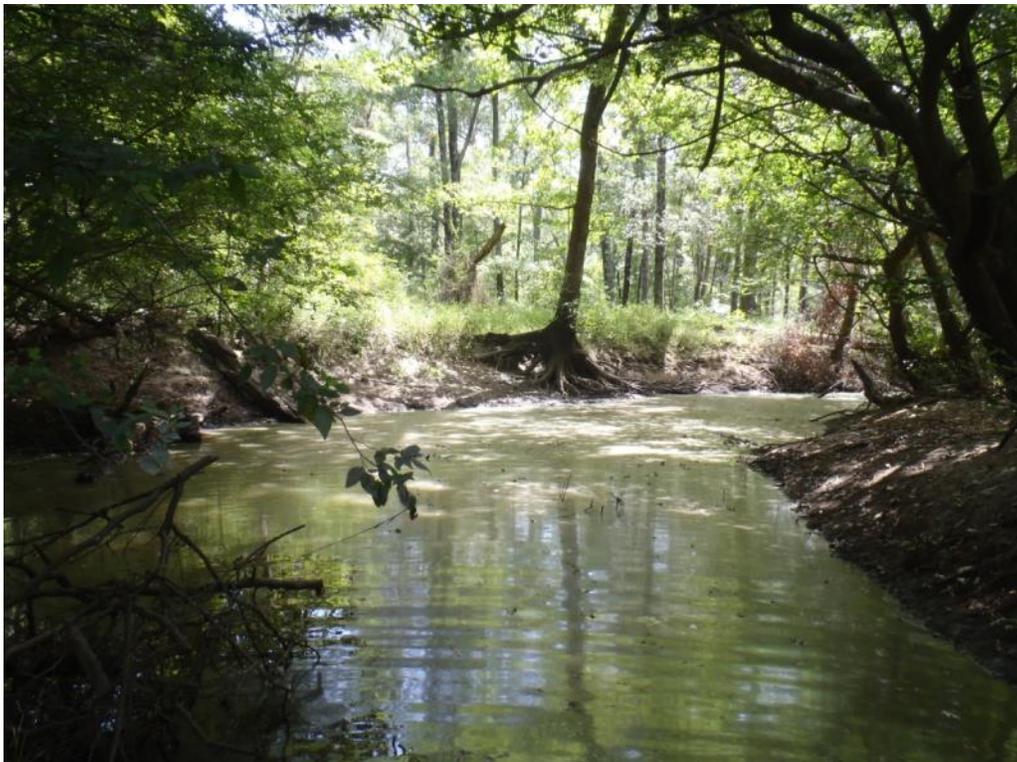
Figure 3.17 Photograph of Kickapoo Creek Site KC07 taken on August 22, 2014, the downstream view of the 150-m transect.

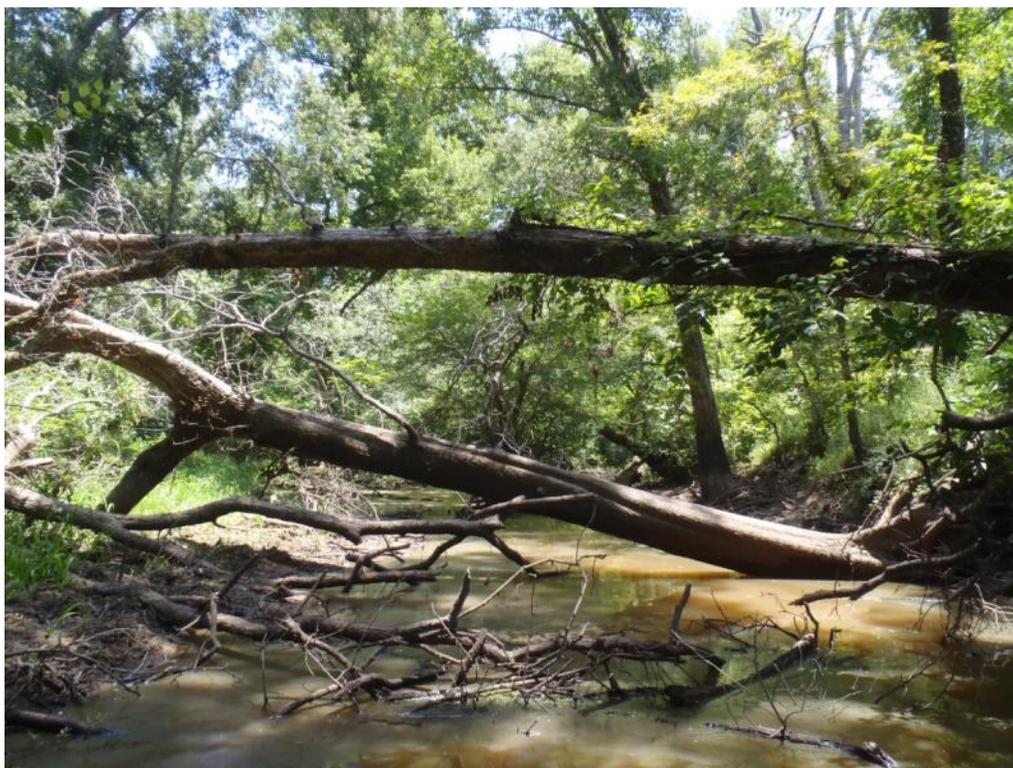
Figure 3.18 Photograph of typical obstructions at Kickapoo Creek Site KC07 taken on July 26, 2014.

Site KC07 was wadeable for the entire 300-m reach length. Average thalweg was 0.3 m during both surveys (Table 3.6), and shallow water depths with the silt substrate made wading in the stream channel easy. Parts of the stream were dry during both surveys. Widths of the stream ranged from a minimum of 0.0 m during both surveys to a maximum of 17 m during the first survey (Tables 3.7 and 3.8). One pool was identified at the bridge crossing and went upstream beyond the survey reach. The pool was identified during each survey. The dimensions for the first survey are provided in Table 3.12 with dimensions for the second survey in Table 3.13. There were several tree obstructions and some overhanging trees during both surveys that made traversing the streambed sometimes challenging (Figure 3.18).

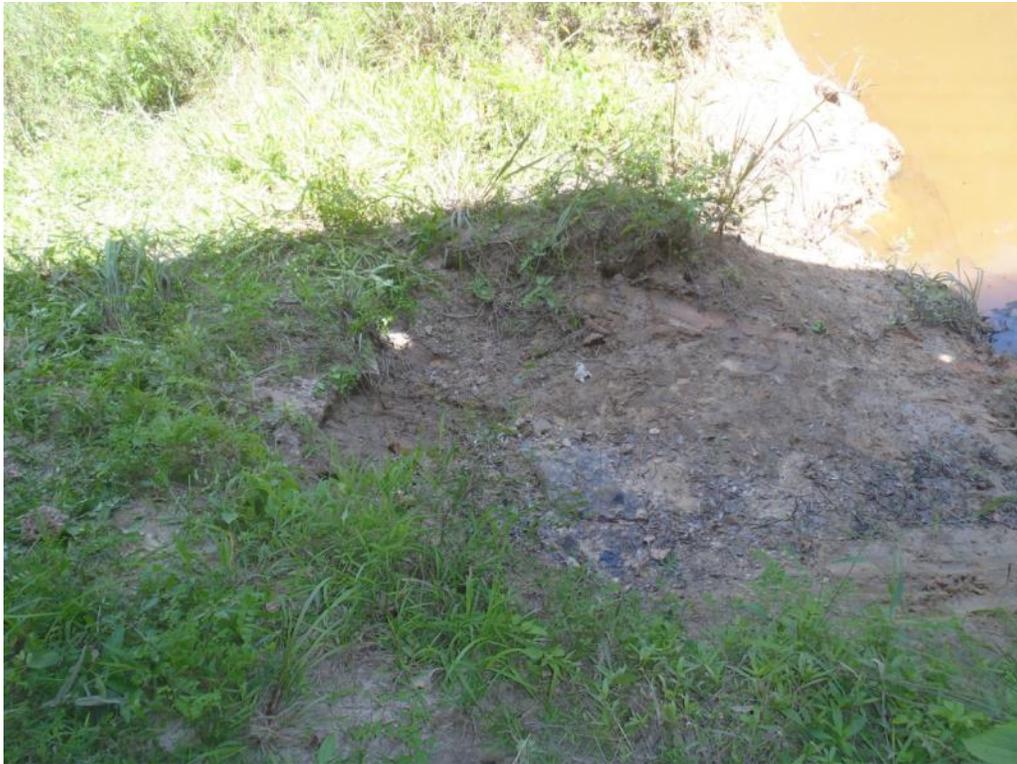
Figure 3.19 Photograph of dirt boat ramp on Kickapoo Creek KC08 taken on July 26, 2014.

Kickapoo Creek at Site KC08 was visited on July 26 and August 22, 2014. This site was located northeast of Murchison, Texas in Henderson County, and was only publicly accessible at the FM 1803 bridge crossing. There was a narrow dirt path along the road right-a-way that went to the creek, but private property fencing otherwise limited access to the creek at this location. To access the site, TIAER personnel drove along this dirt path on the northwest side of the bridge and parked under the bridge. The site is located in a forest dominated corridor (Table 3.5). At the site, access to the stream was moderately easy (Table 3.6). At other locations throughout the reach, access to the stream would be more challenging due to steep banks, tree obstructions, and dense vegetation. Figures 3.19 and 3.20 depict the appearance of the site during each of the surveys.

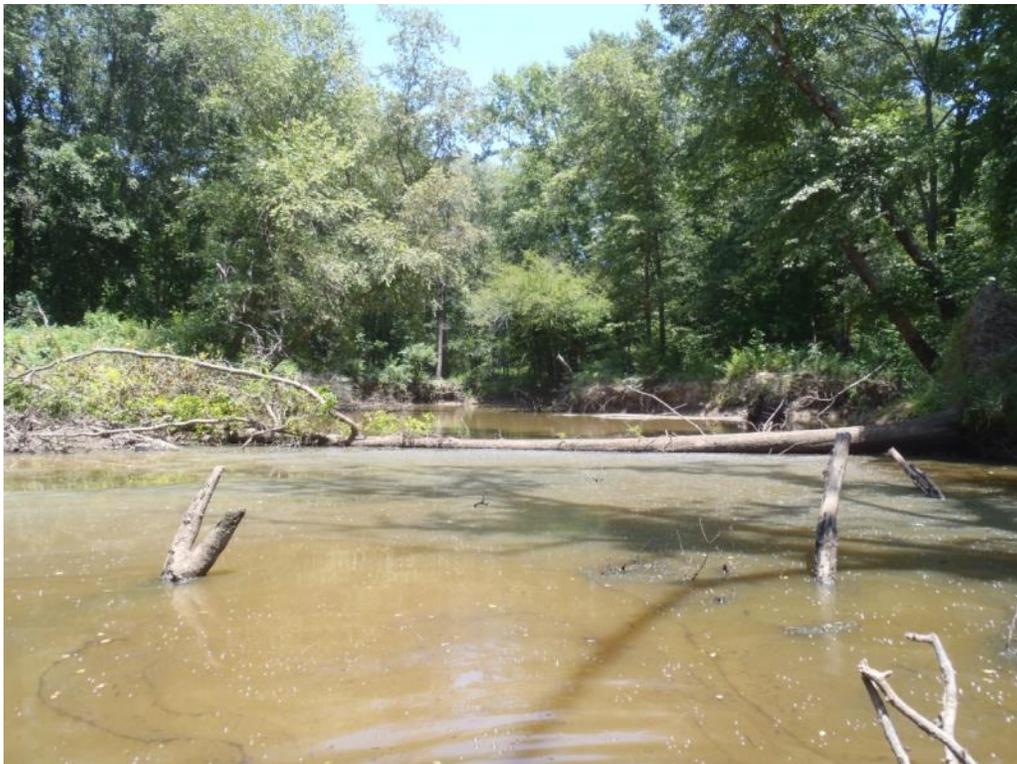
Figure 3.20 Photograph of Kickapoo Creek Site KC08 taken on July 26, 2014, the downstream view of the 0-m transect.

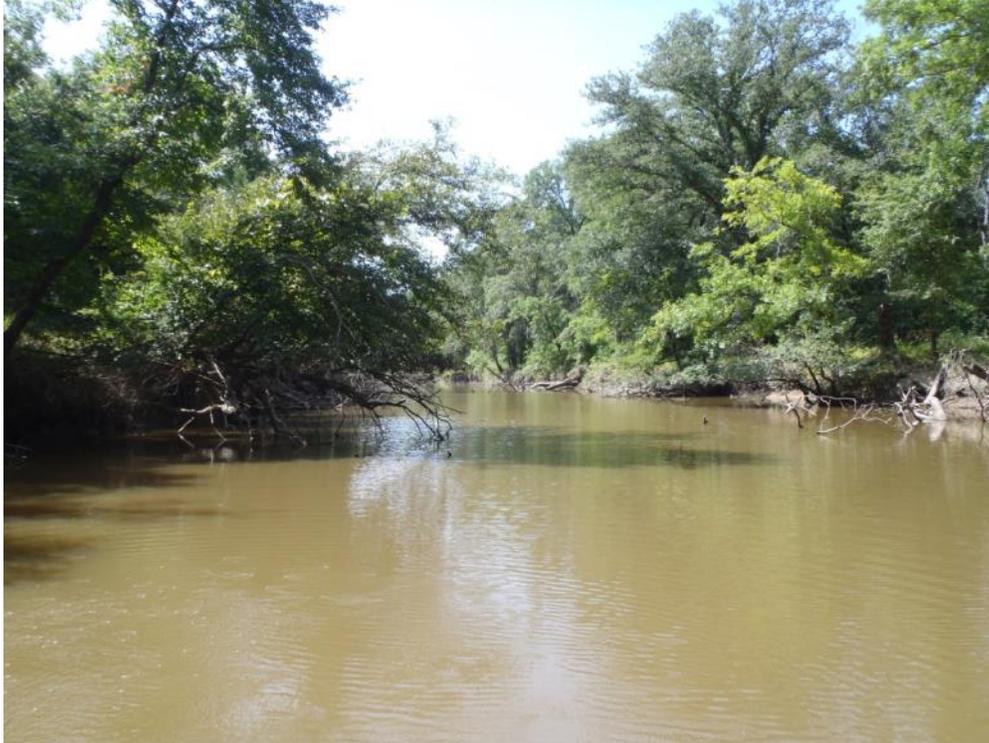
Figure 3.21 Photograph of Kickapoo Creek Site KC08 taken on August 22, 2014, the upstream view of the 150-m transect.

Site KC08 was not wadeable for the entire 300-m reach length. To traverse the reach TIAER personnel launched a small boat via a makeshift dirt boat ramp that was located at the northeast side of the bridge crossing (Figure 3.21). Average thalweg was greater than 1.5 m during both surveys (Table 3.6). During each survey, numerous log jams and other woody debris were encountered within the reach. A log jam at the 0-m transect was significant enough to restrict travelling any further downstream. Stream widths ranged from 18 m to 26 m during both surveys (Tables 3.7 and 3.8).

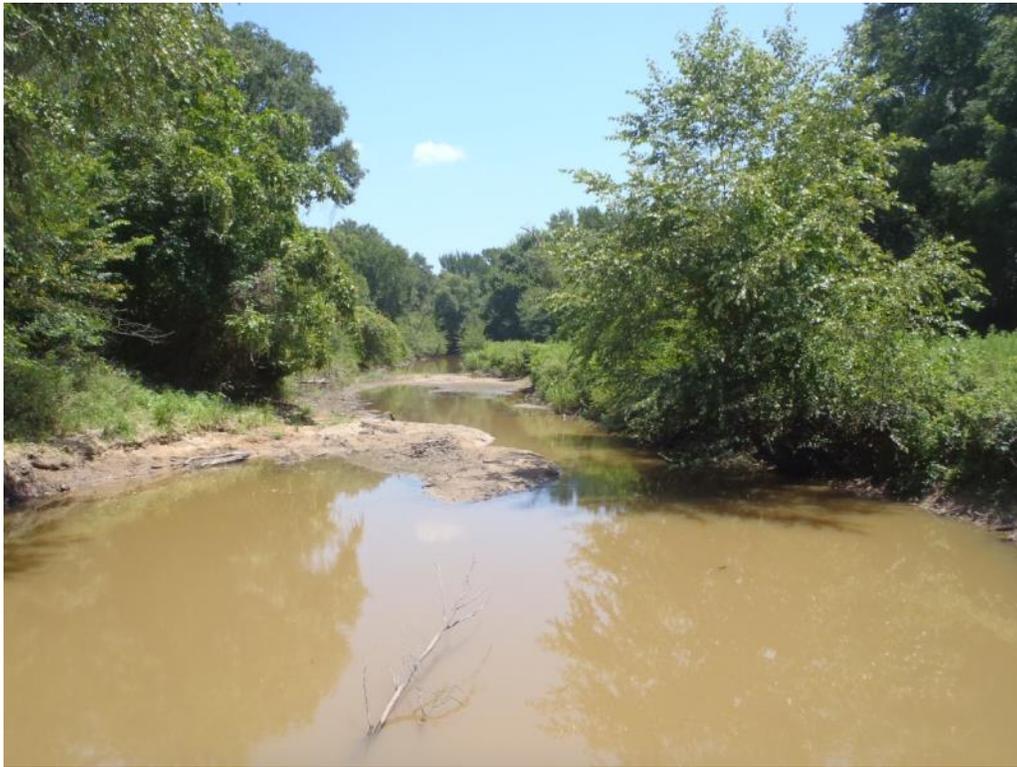
Figure 3.22 Photograph of Kickapoo Creek Site KC09 taken on July 26, 2014 the downstream view of the 300-m transect.

The stream corridor had forest and pasture on both sides (Table 3.5). Access to the stream was moderately easy due to the presence of a low water crossing at the 300-m transect (Table 3.6). The general appearance of Kickapoo Creek at KC09 is shown in Figures 3.22 and 3.23.

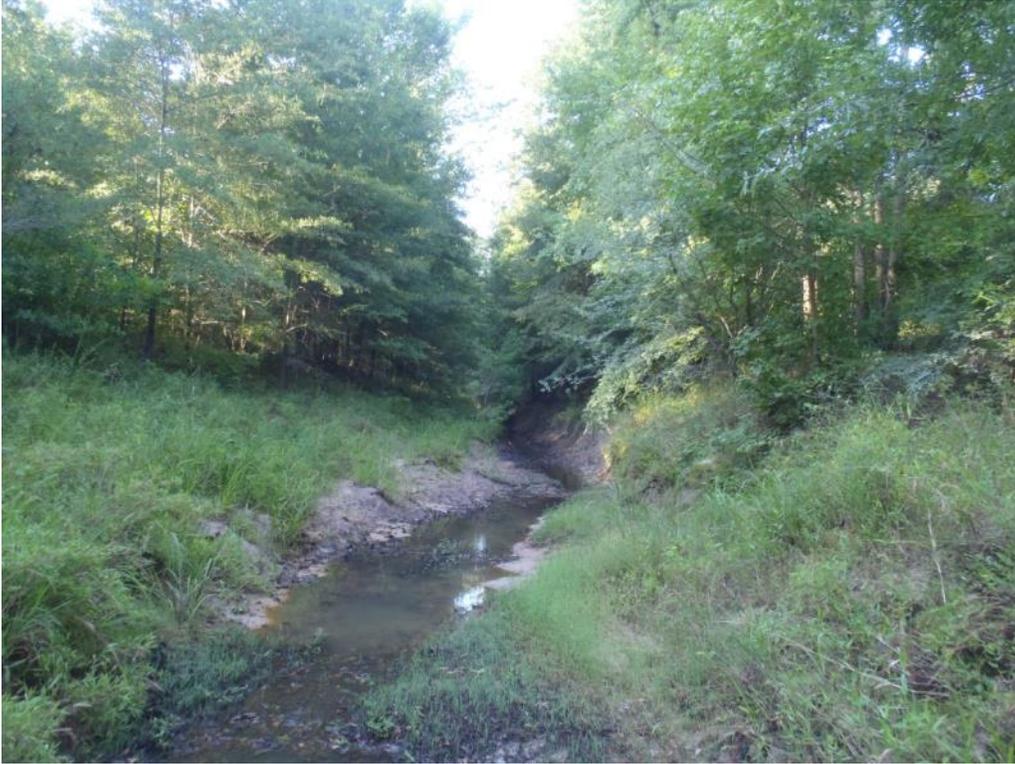
Figure 3.50 Photograph of Kickapoo Creek Site KC19 taken on July 26, 2014, the downstream view of the 0-m transect.

Kickapoo Creek at Site KC19 was visited on July 26 and August 22, 2014. This site was located northwest of Murchison, Texas in Van Zandt County, and was publically accessible only at bridge crossing of FM Road 858. Forest and pasture were noted along both sides of the stream corridor (Table 3.5). Access to the stream was moderately easy due to gently sloping banks at the bridge crossing. Access at other locations along the reach would be difficult due to dense vegetation (Table 3.6). The general appearance of the reach at Site KC19 is shown in Figures 3.50 and 3.51.
