Recreational Use Attainability Analysis for
Kickapoo Creek in Henderson County (0605A),
the Neches River Above Lake Palestine (0606),
Prairie Creek (0606A), Mud Creek (0611C), and
West Mud Creek (0611D)
in the Neches River Basin

Prepared for:
Texas State Soil and Water Conservation Board
Project 14-52

Texas Institute for Applied Environmental Research
Tarleton State University
Stephenville, Texas

TR1503
September 2015

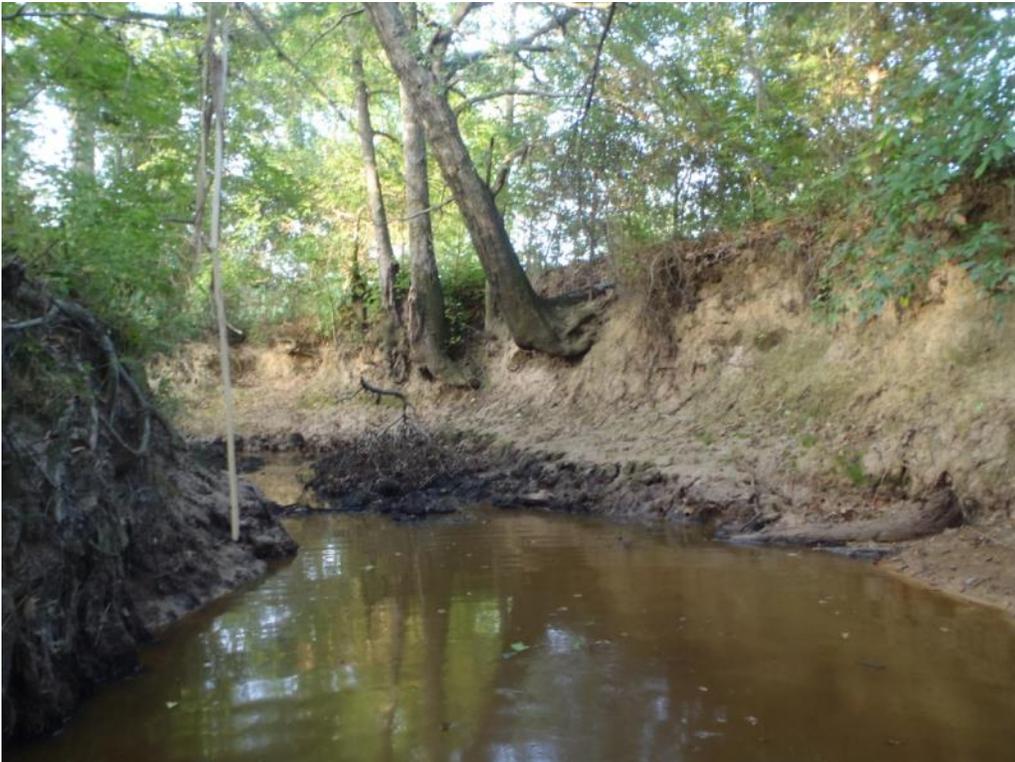
Figure 3.51 Photograph of Kickapoo Creek Site KC19 taken on August 22, 2014, the downstream view of the 150-m transect.

Kickapoo Creek at Site KC19 was visited on July 26 and August 22, 2014. This site was located northwest of Murchison, Texas in Van Zandt County, and was publically accessible only at bridge crossing of FM Road 858. Forest and pasture were noted along both sides of the stream corridor (Table 3.5). Access to the stream was moderately easy due to gently sloping banks at the bridge crossing. Access at other locations along the reach would be difficult due to dense vegetation (Table 3.6). The general appearance of the reach at Site KC19 is shown in Figures 3.50 and 3.51.

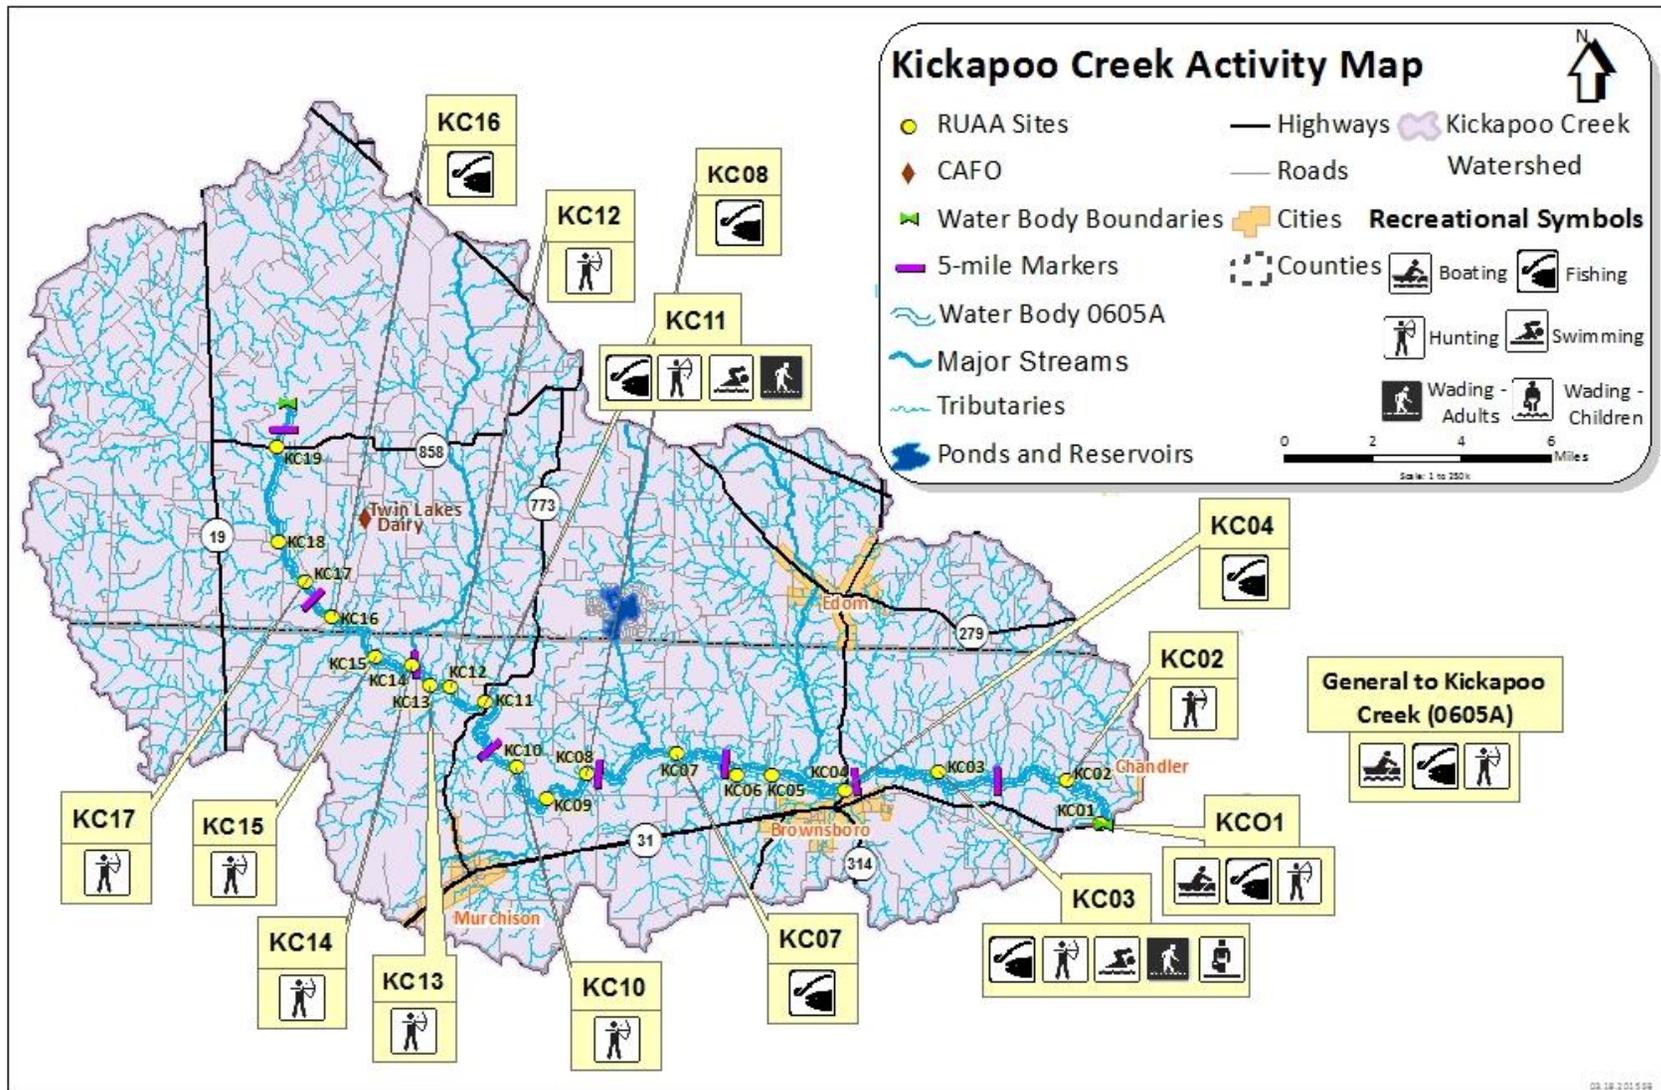
Figure 3.52 Summary of observed and interviewed human activities on Kickapoo Creek. Fishing and kayaking were the only recreational activities observed during field surveys or site visits.

Recreational activities observed and reported in interviews are summarized in Figure 3.52. Overall RUAAs findings are summarized in the form below.

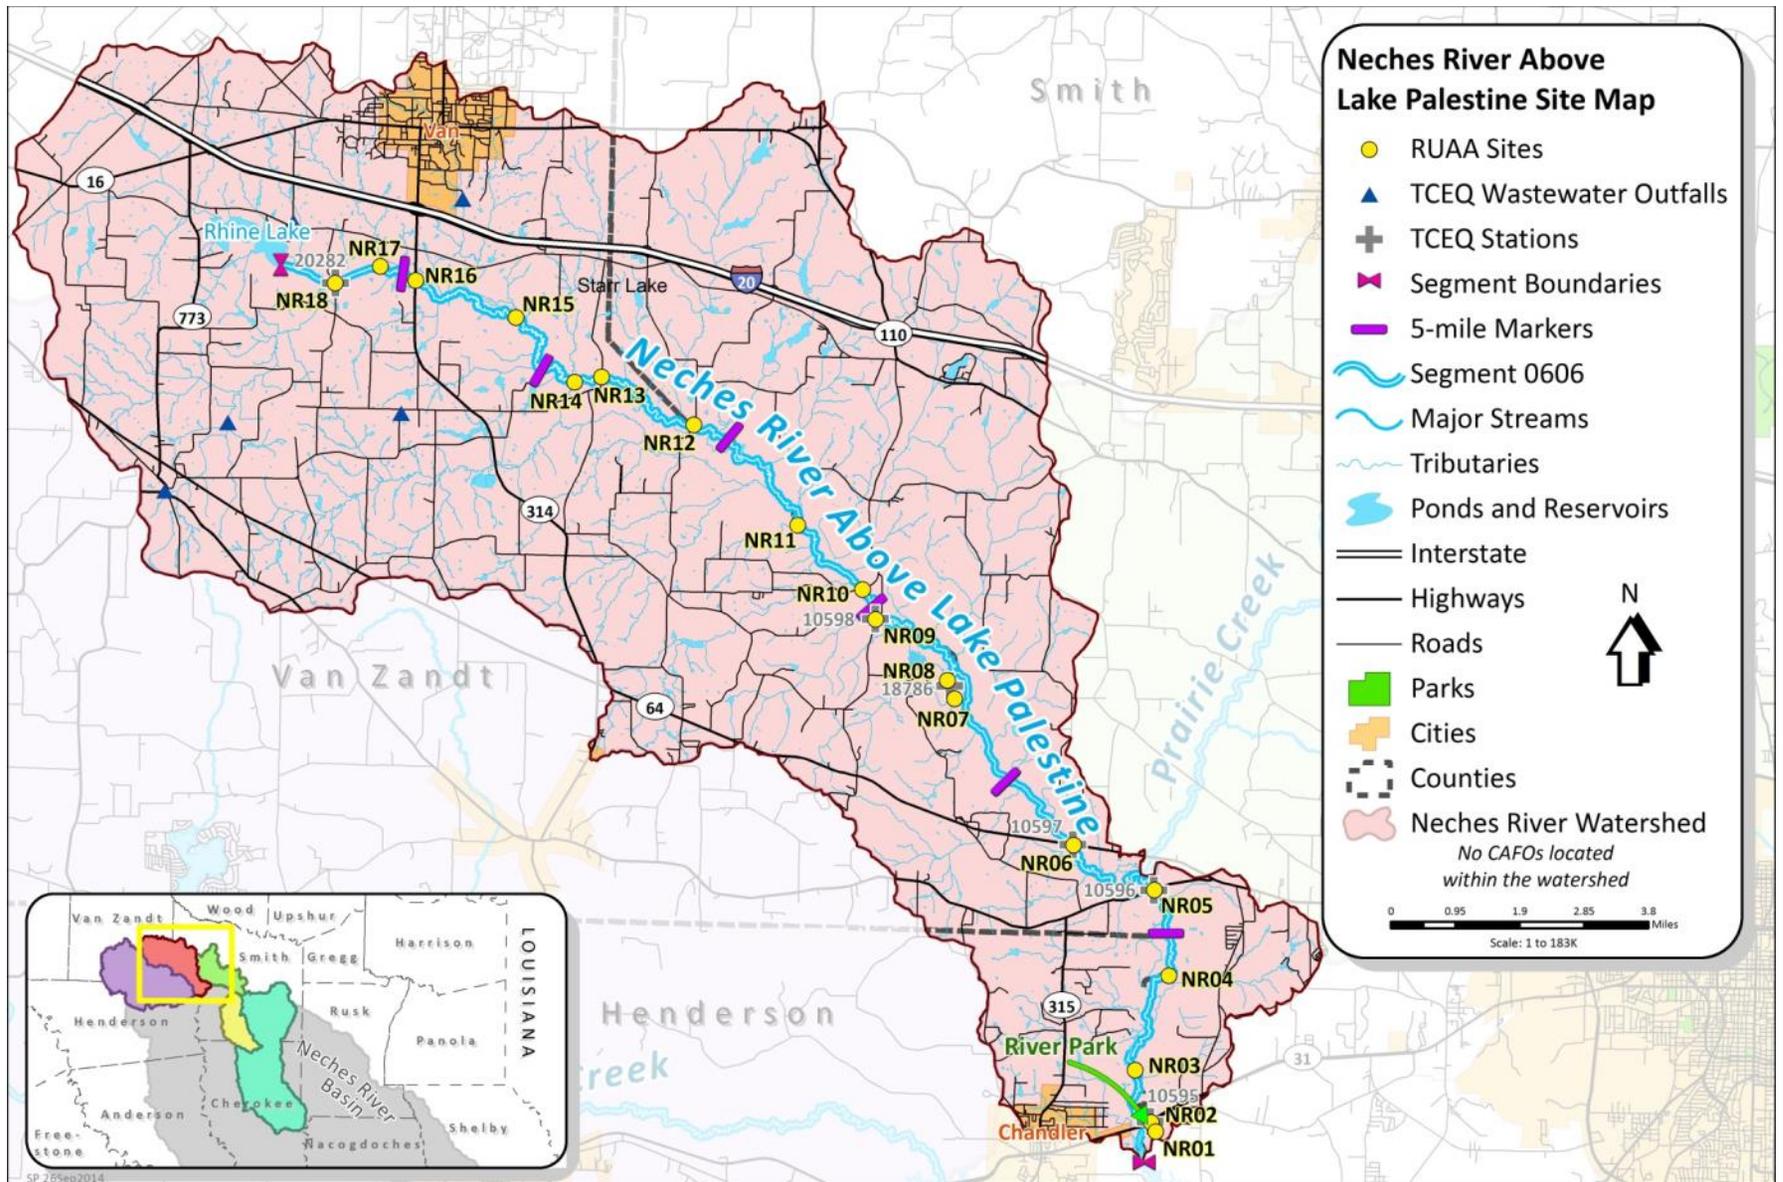
Figure 4.1 Overview of the Neches River Above Lake Palestine watershed and RUAA sites.

The Neches River Above Lake Palestine is 33 miles long and therefore indicated a goal of 20 sites (3 site per 5 miles of river for the RUAA survey (Figure 4.1). With the help of cooperating stakeholders, TIAER was able to establish a total of 18 survey sites along Segment 0606 (Table 4.2). Although the optimum number of sampling stations would have been 20 following the RUAA guidelines, acceptance of using only 18 sites was sought and granted from TCEQ. Although 18 sites were initially established, when making arrangements to conduct the first survey, landowners for Site NR04 decided not to allow access to the stream through their property, so no field surveys were conducted at this location. Also, at Site NR15 only the first survey was conducted and not the second as the landowner was unavailable to escort TIAER personnel on his property and would not allow access without his presence.

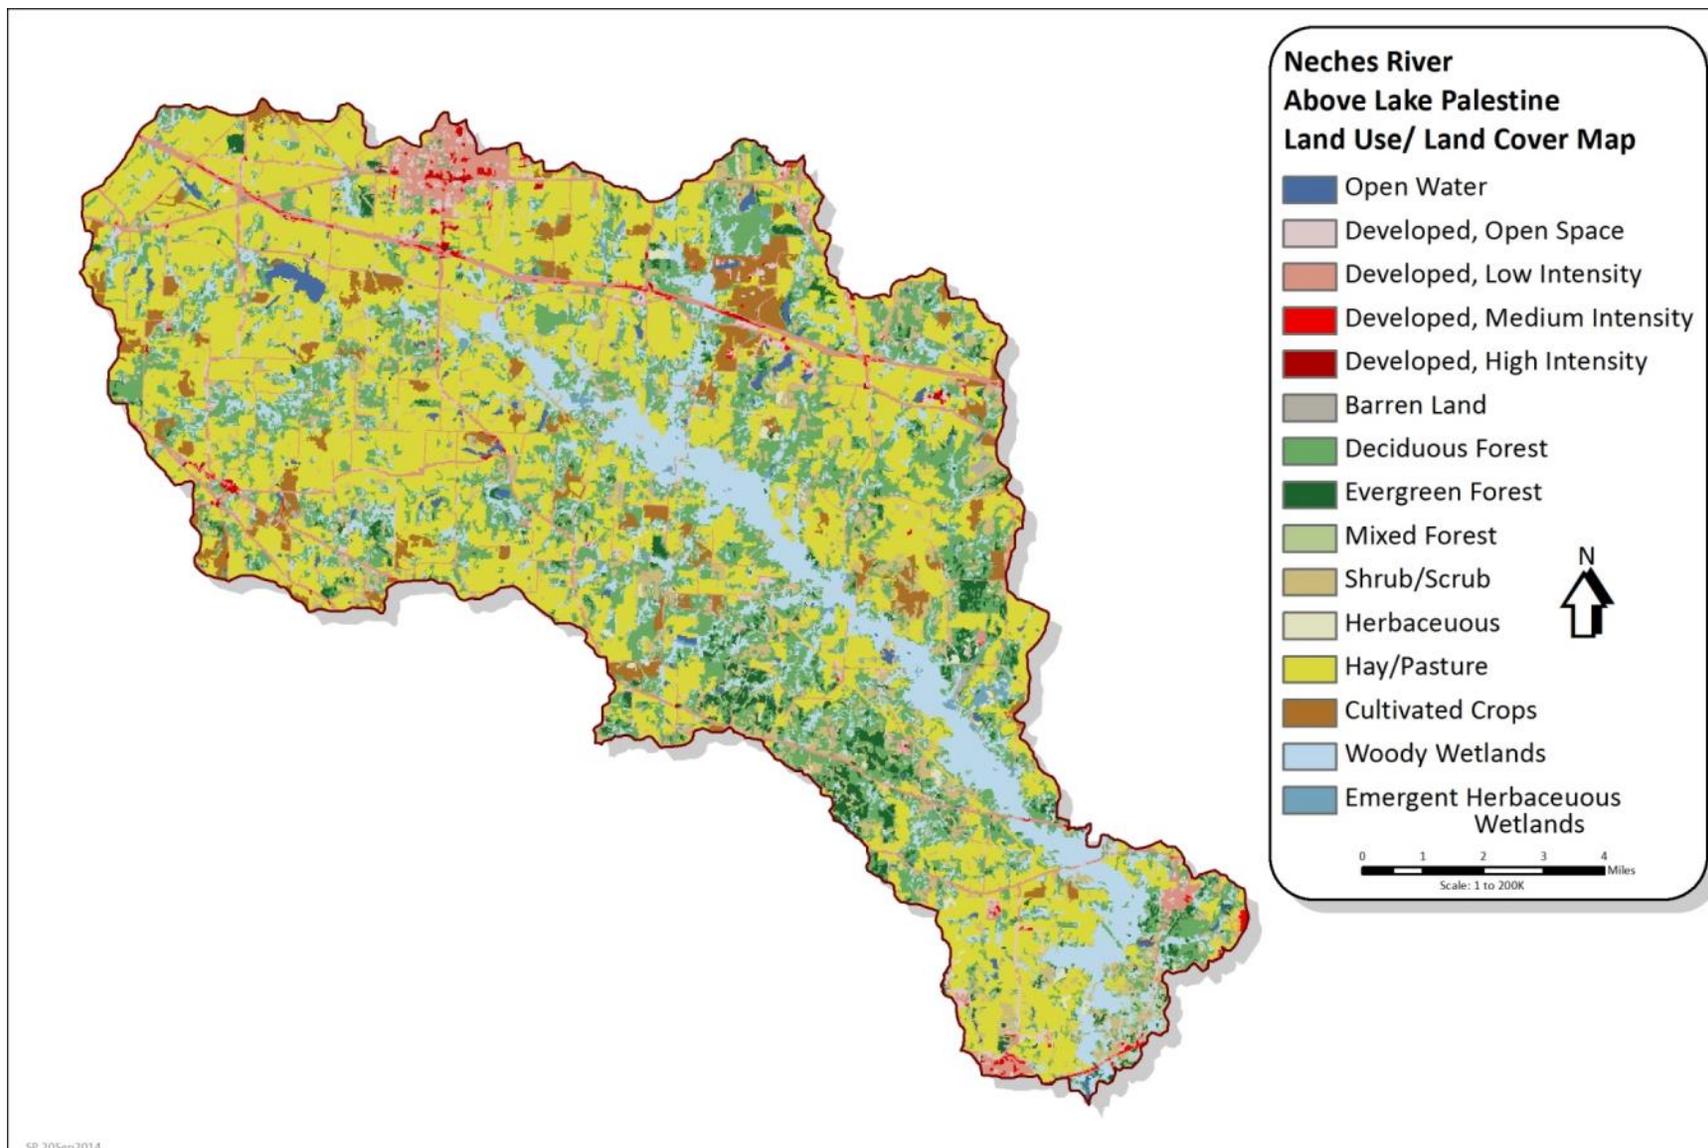
Figure 4.2 Land use/land cover for the Neches River Above Lake Palestine watershed. Source: 2011 National Land Cover Database (USGS, 2013).

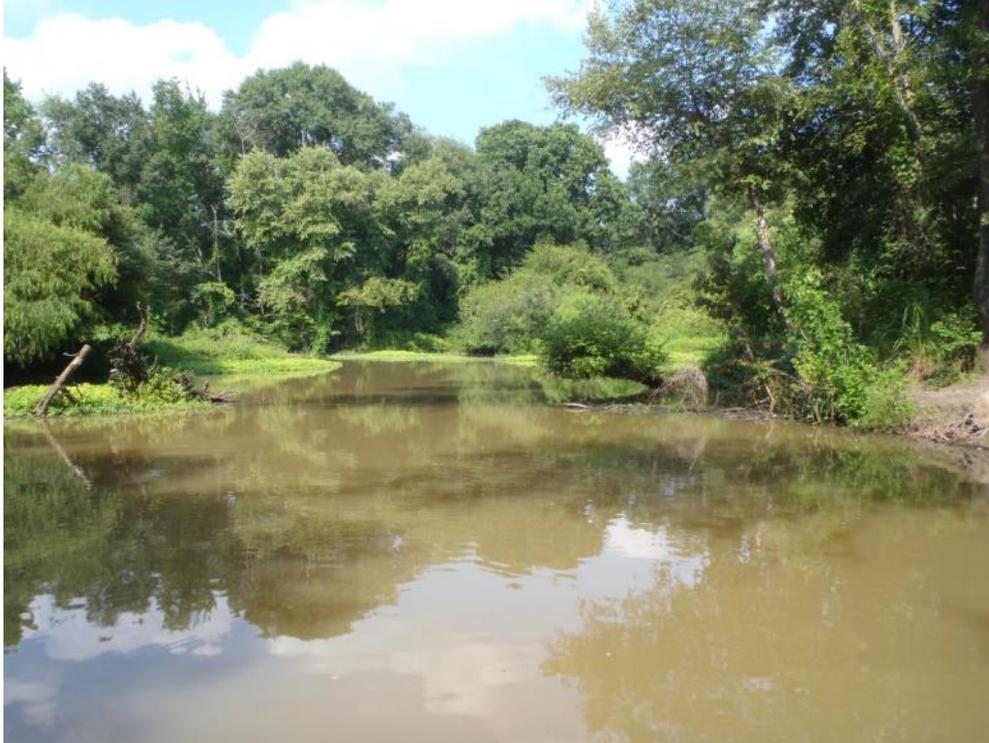
Figure 4.4 Photograph of Neches River Site NR01 taken on July 25, 2014. The downstream view of the 300-m transect.

Neches River at Site NR01 was visited on July 25 and August 22, 2014. This site was located approximately 250 meters south of State Highway 31, east of Chandler, Texas on the border between Smith and Henderson Counties. Three methods of accessing this site were available. One option required driving approximately 0.40 miles and walking approximately 0.30 miles through private lands that were locked and fenced. A second option allowed for utilizing a publicly accessible boat ramp at the City of Chandler River Park near the State Highway 31 bridge crossing and boating downstream approximately 0.20 miles to the site. The third option for accessing this site was to launch a boat on Lake Palestine and travel up the Neches River to the site. TIAER personnel accessed the site during both surveys by utilizing the upstream public boat ramp at the City of Chandler River Park. The location of the boat ramp also provided paved parking locations on both sides of State Highway 31 along with covered picnic areas associated with the River Park (Figure 4.3). Forest dominated the stream corridor (Table 4.5), and access to the stream was moderately easy, due to the well maintained boat ramp and ample parking space (Table 4.6). The general appearance of the site during each survey is shown in Figures 4.4 and 4.5.

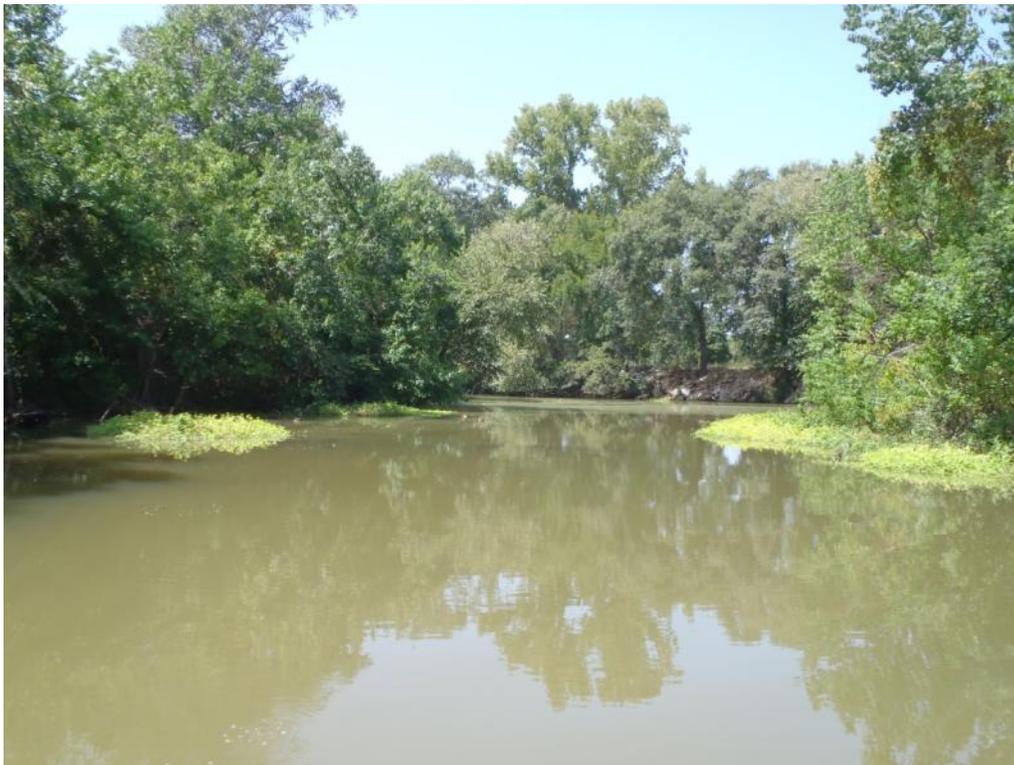
Figure 4.5 Photograph of Neches River Site NR01 taken on August 22, 2014. The downstream view of the 0-m transect.

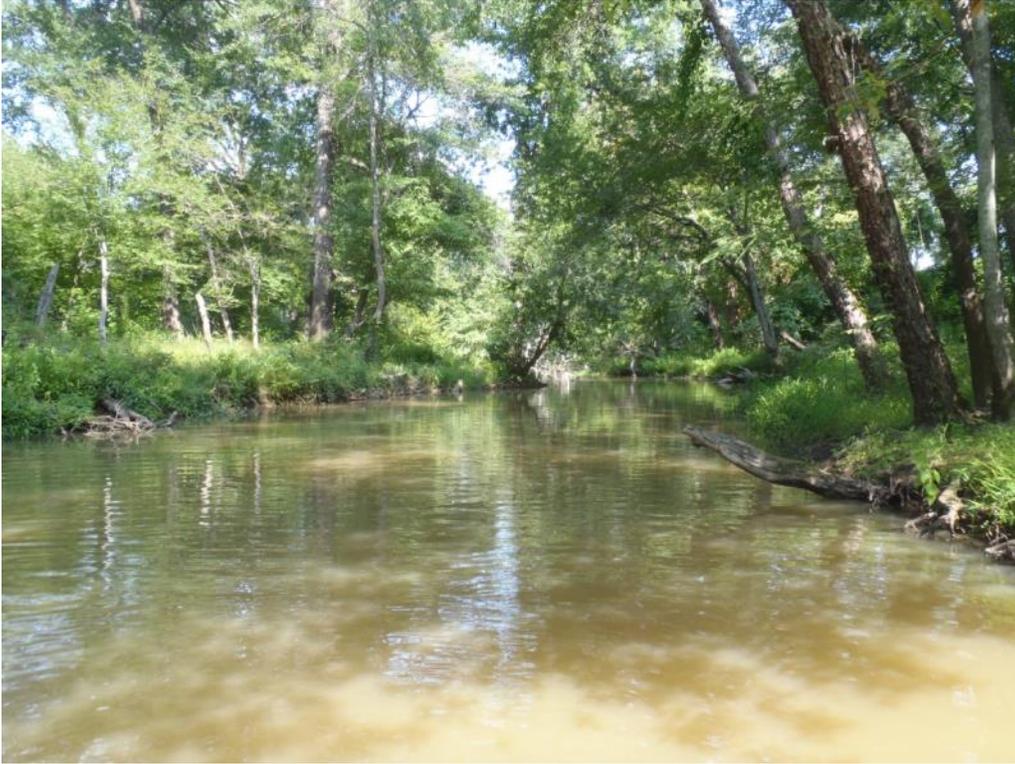
Figure 4.6 Photograph of Neches River Site NR02 taken on July 25, 2014. The downstream view of the 300-m transect.

Neches River at Site NR02 was visited on July 25 and August 22, 2014. This site was located at the bridge crossing on State Highway 31, east of Chandler, Texas, on the border between Smith and Henderson Counties. Site NR02 was publicly accessible at the bridge crossing with unfenced private property upstream and downstream of the crossing. A concrete public boat ramp was available at this location along with ample parking spaces on both sides of the highway. Additionally, a covered picnic/rest area was located near the boat ramp along with a concrete walking path that passed under the highway bridge crossing. TIAER personnel accessed the reach by deploying a small boat via the public boat ramp during both surveys. The area immediately at the bridge crossing was mowed, while the remainder of the stream corridor was forested. Access to the stream was easy near the bridge crossing due to the availability of a boat ramp and the concrete walking path; however access was moderately easy elsewhere due to moderately dense vegetation and slightly steep banks (Table 4.6). The general appearance of the reach at NR02 is shown in Figures 4.6 and 4.7.

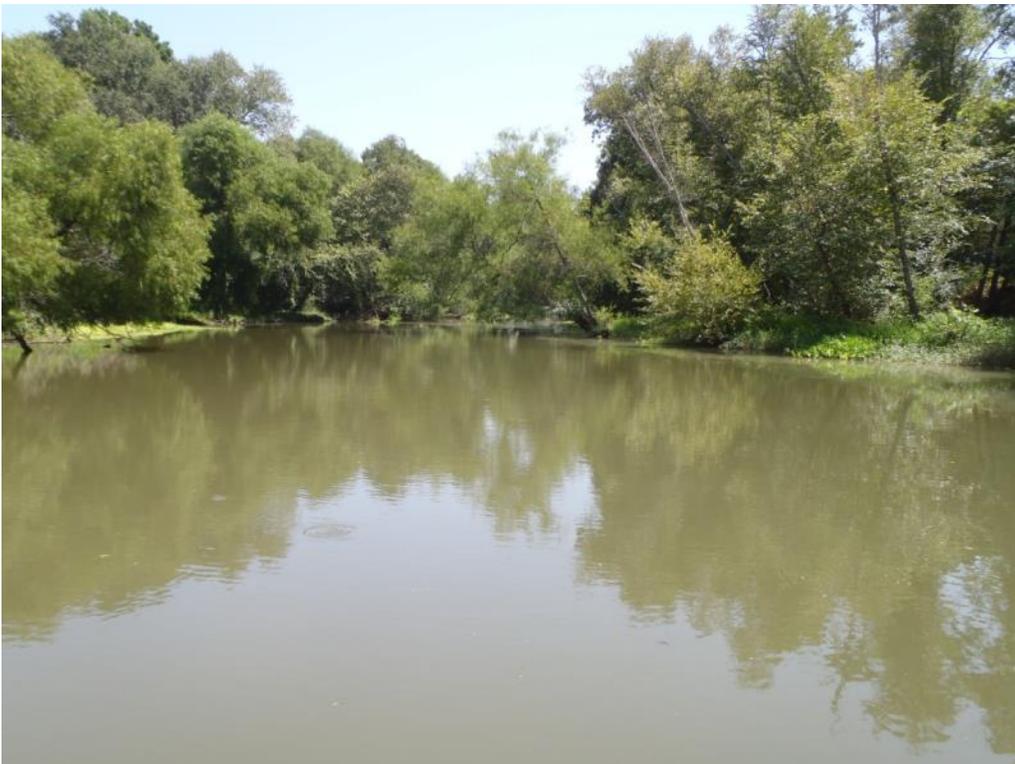
Figure 4.7 Photograph of Neches River Site NR02 taken on August 22, 2014. The downstream view of the 0-m transect.

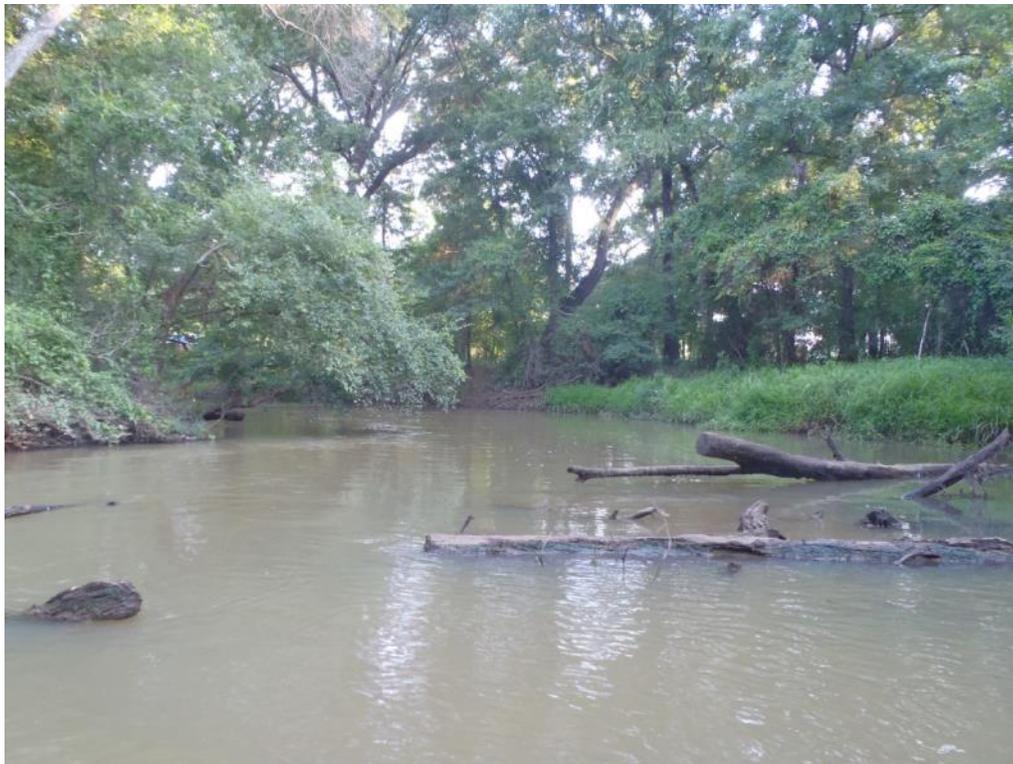
Figure 4.8 Photograph of Neches River Site NR03 taken on July 25, 2014, the downstream view of the 300-m transect.

Neches River at Site NR03 was visited on July 25 and August 22, 2014. This site was located northeast of Chandler, Texas, on the border between Smith and Henderson Counties. Site NR03 was only accessible through private lands that were fenced with cattle guards and a locked gate. With landowner permission, TIAER personnel entered private property through a locked gate and over two cattle guards and drove approximately 0.8 miles on a gravel then pasture road to reach the site. The right-bank of the stream corridor was primarily pasture and the left-bank primarily forest (Table 4.5). Steep banks throughout the reach made access to the stream moderately difficult (Table 4.6). The general appearance of the reach is shown in Figures 4.8 and 4.9.

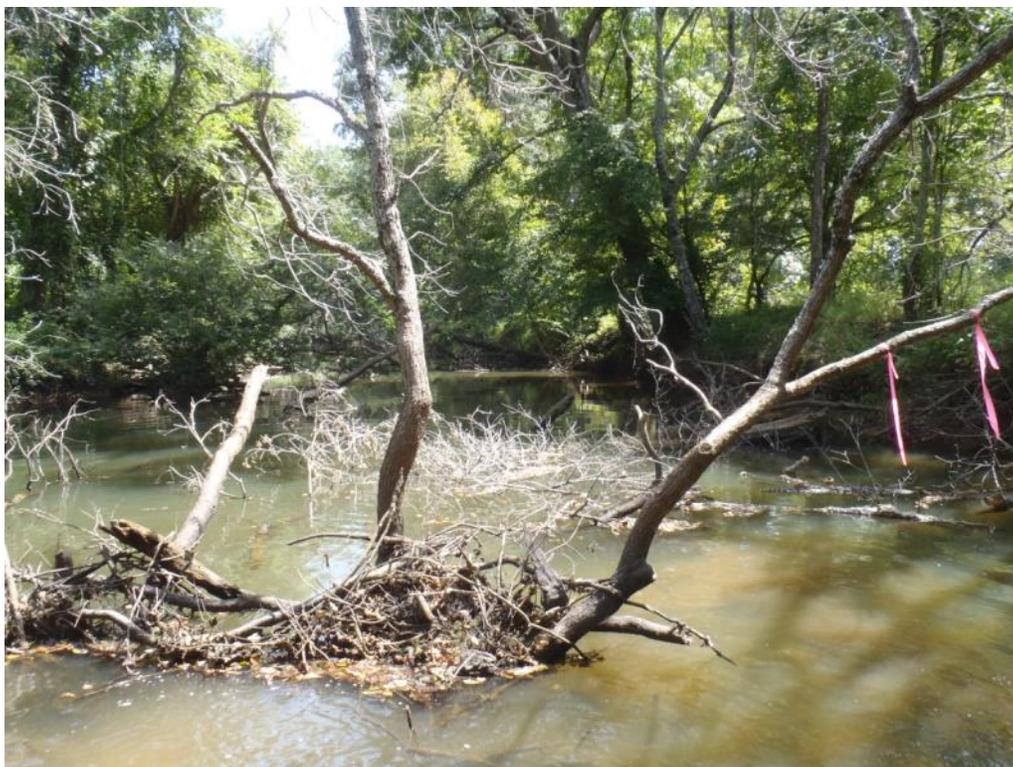
Figure 4.9 Photograph of Neches River Site NR03 taken on August 22, 2014, the downstream view of the 0-m transect.

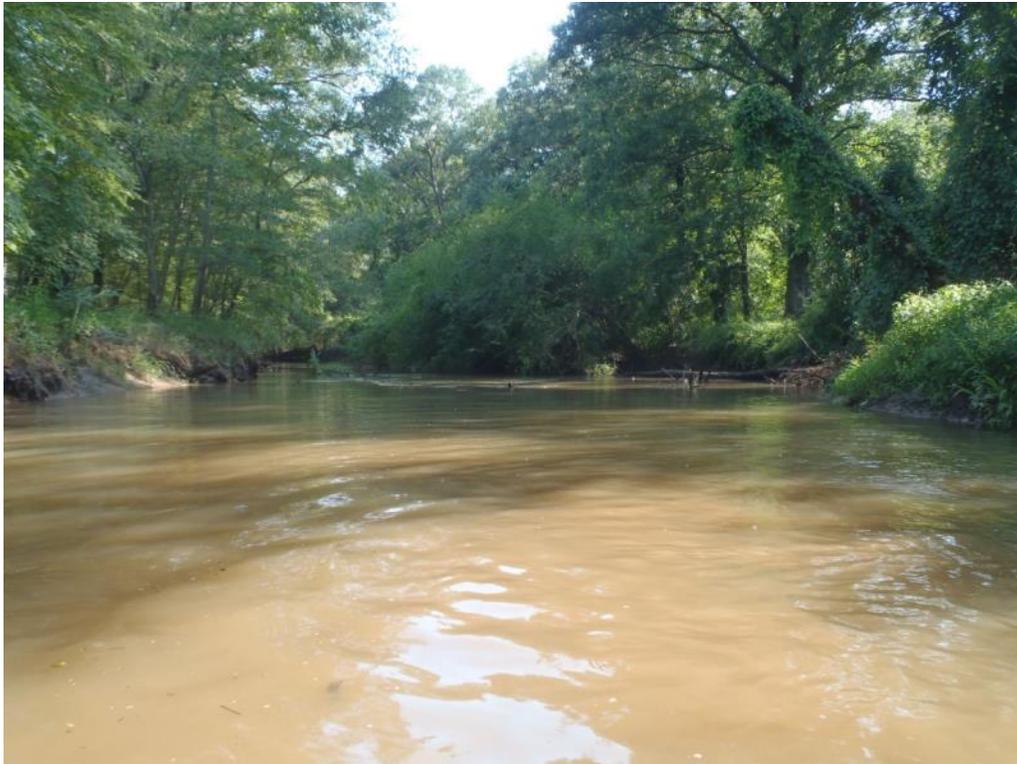
Figure 4.10 Photograph of Neches River Site NR05 taken on July 25, 2014, the downstream view of the 150-m transect.

Neches River at Site NR05 was visited on July 25 and August 22, 2014. This site was located north of Chandler, Texas on the border between Smith and Van Zandt Counties. Site NR05 was publicly accessible only at the bridge crossing of State Highway 64. Private property was fenced upstream of the crossing and unfenced downstream of the crossing. With landowner permission, TIAER personnel parked in a private property entrance and entered the stream underneath the bridge. Shrubs dominated stream corridor along the left bank and forest along the right bank (Table 4.5). Access to the stream was moderately difficult due to steep muddy banks (Table 4.6). The general appearance of the river at this location is shown in Figures 4.10 and 4.11.

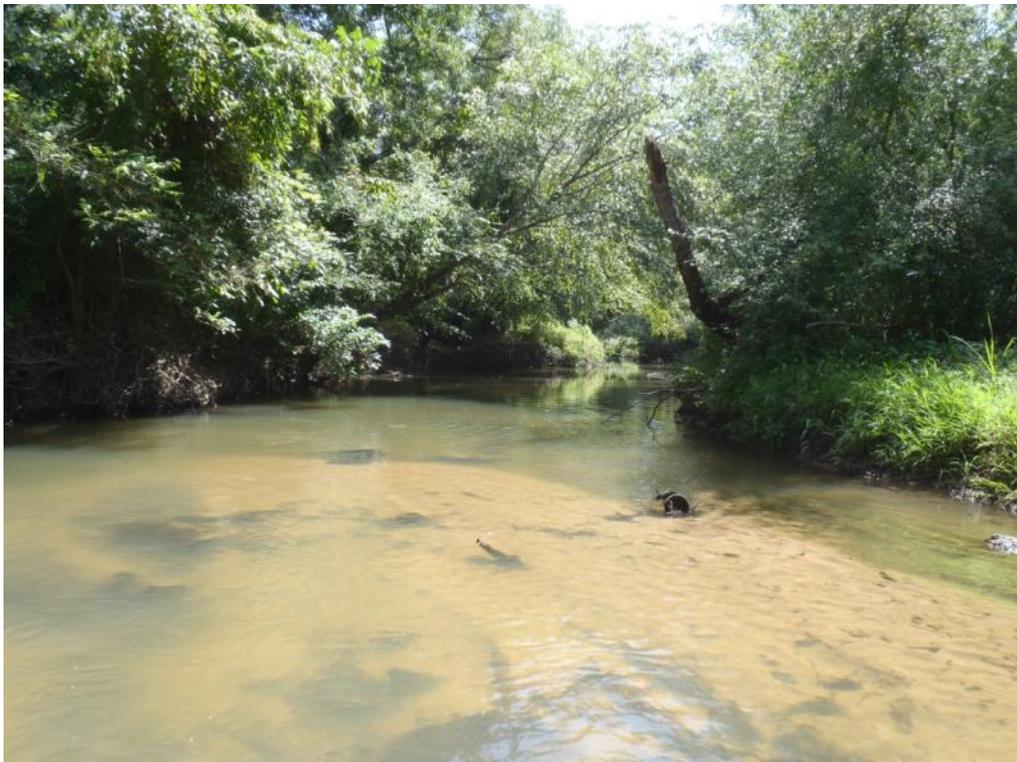
Figure 4.11 Photograph of Neches River Site NR05 taken on August 22, 2014, the downstream view of the 300-m transect.

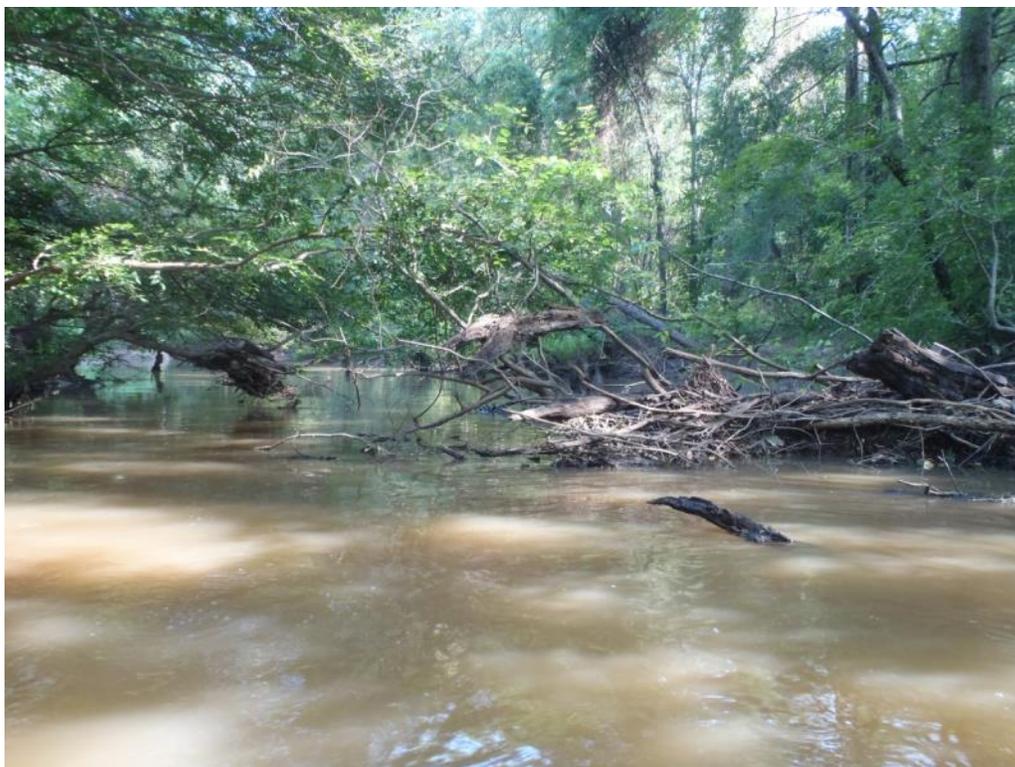
Figure 4.12 Photograph of Neches River Site NR05 taken on July 25, 2014, showing a typical timber obstruction.

Site NR05 was wadeable for the entire 300-m reach length. Average thalweg ranged from 1.0 m during the first survey to 0.7 m during the second survey (Table 4.6). During both surveys, the mud/clay substrate and timber obstacles made wading in the stream channel challenging. One of the log obstructions encountered is shown in Figure 4.12. Stream widths ranged from a maximum of 22 m to a minimum of 5.7 m (Tables 4.7 and 4.8).

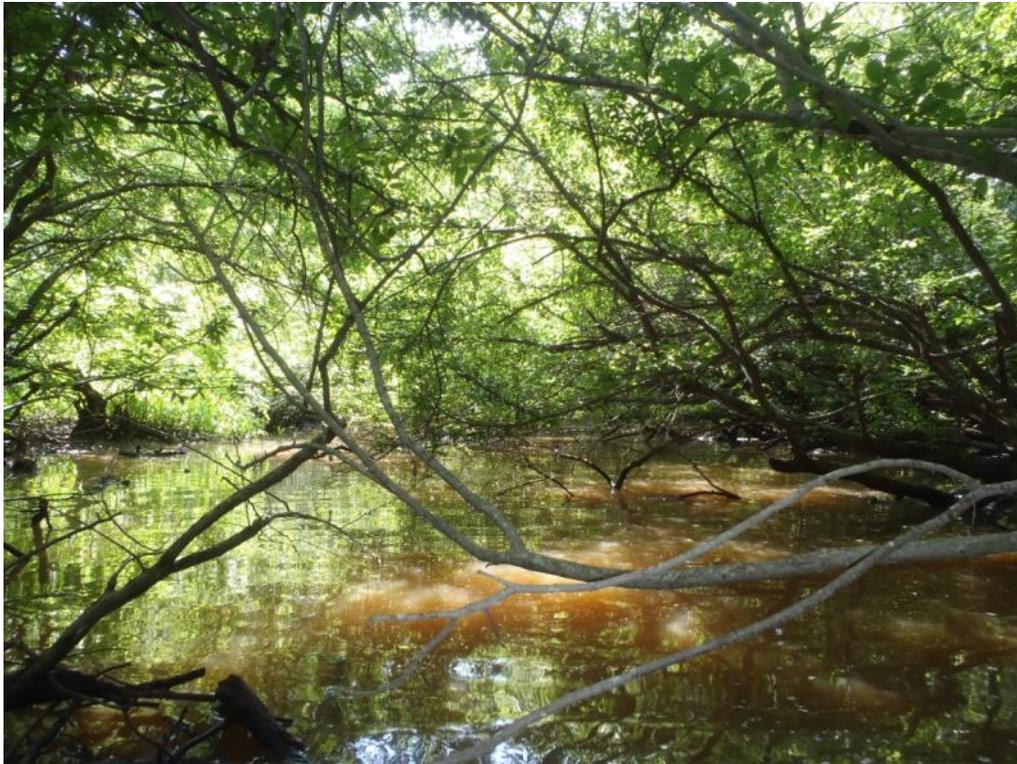
Figure 4.13 Photograph of Neches River Site NR06 taken on July 25, 2014, the upstream view of the 150-m transect.

Neches River at Site NR06 was visited on July 25 and August 23, 2014. This site was located at the bridge crossing State Highway 60 north of Chandler, Texas along the border between Smith and Van Zandt Counties. The site was publicly accessible only at the bridge, although private property was unfenced upstream and downstream of the road crossing. Forest dominated the stream corridor, although the area immediately at the bridge was mowed and maintained (Table 4.5). Access to the stream was moderately easy (Table 4.6) at the bridge crossing; however access at other locations throughout the reach were more challenging due to dense vegetation. Figures 4.13 and 4.14 depict the general appearance of the site during each survey.

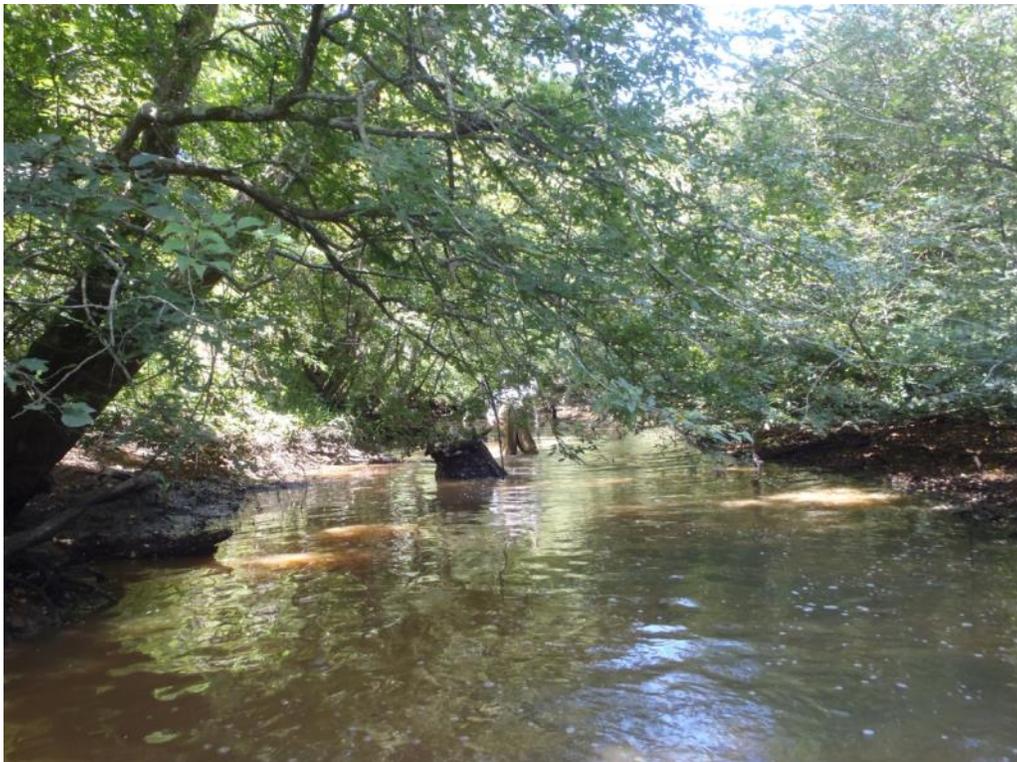
Figure 4.14 Photograph of Neches River Site NR06 taken on August 23, 2014, the upstream view of the 0-m transect.

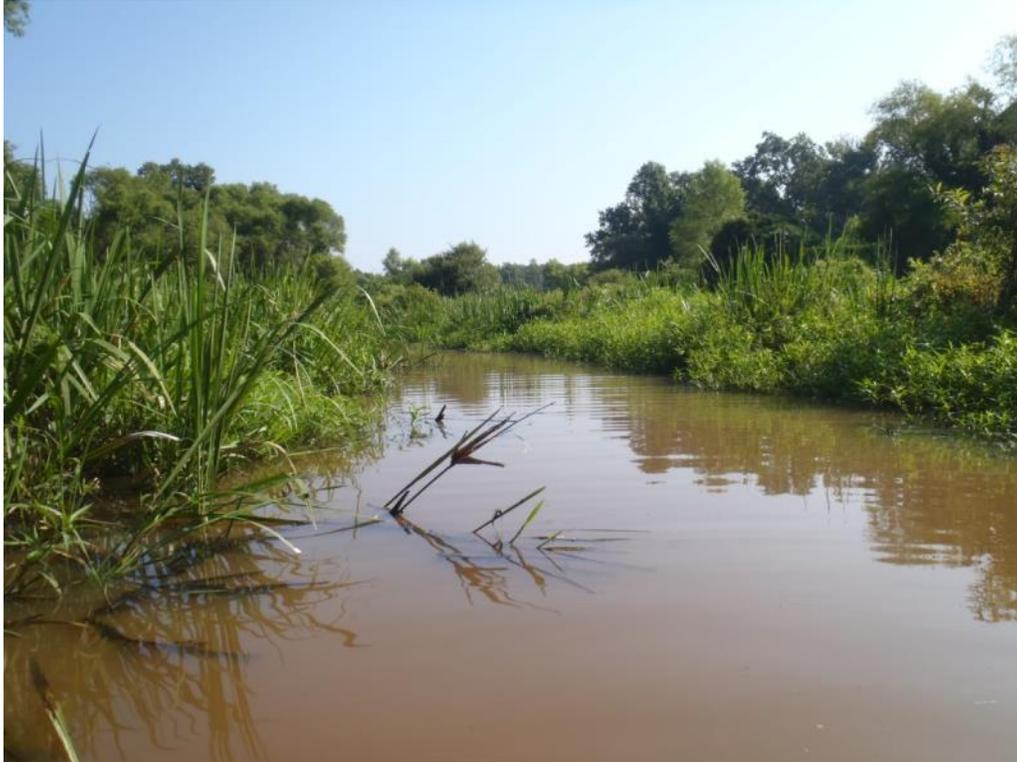
Figure 4.16 Photograph of Neches River Site NR07 taken on July 25, 2014, the upstream view of the 0-m transect.

Neches River at Site NR07 was visited on July 25 and August 23, 2014. This site was located north of Chandler, Texas on the border between Smith and Van Zandt Counties. This site was accessible only through private lands that were fenced. The entrance was a private road with a cattle guard and a gate that could be locked. With landowner permission, TIAER personnel entered private property and drove approximately 0.7 miles through a coastal pasture to reach a heavily wooded area. TIAER personnel then walked an additional 0.30 miles through the wooded area to Site NR07. The stream corridor was considered an herbaceous marsh for the entire length of the reach (Table 4.5). Access to the stream was moderately difficult (Table 4.6) due to the densely vegetated nature of the stream corridor (Figure 4.15). The general appearance of the stream during the surveys is shown in Figures 4.16 and 4.17.

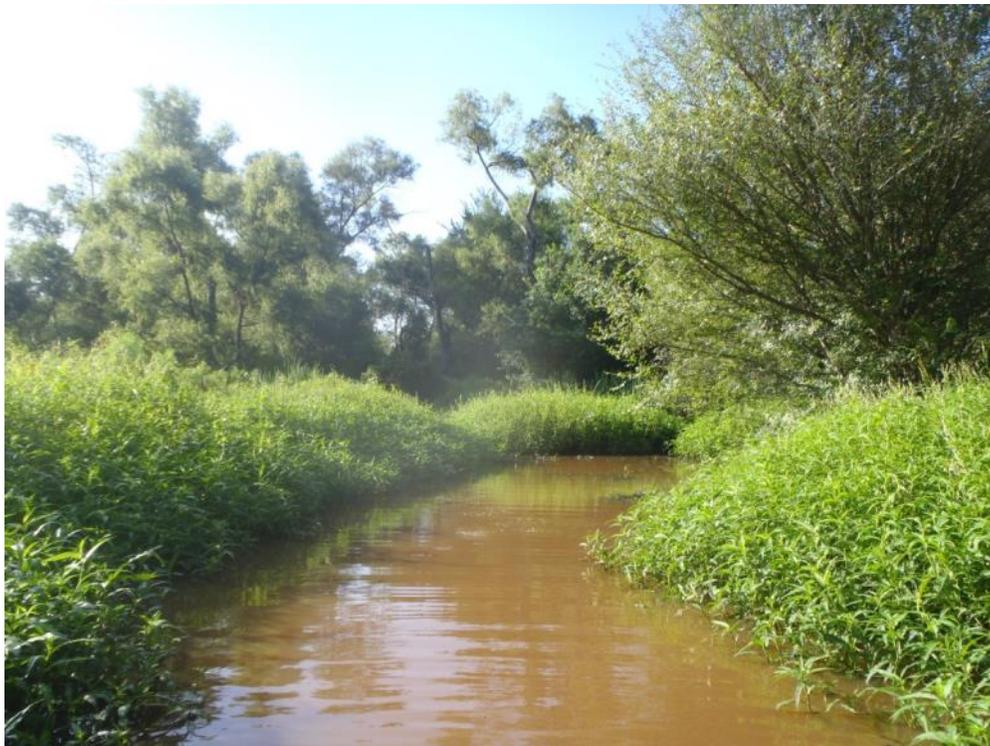
Figure 4.17 Photograph of Neches River Site NR07 taken on August 23, 2014, the downstream view of the 300-m transect.

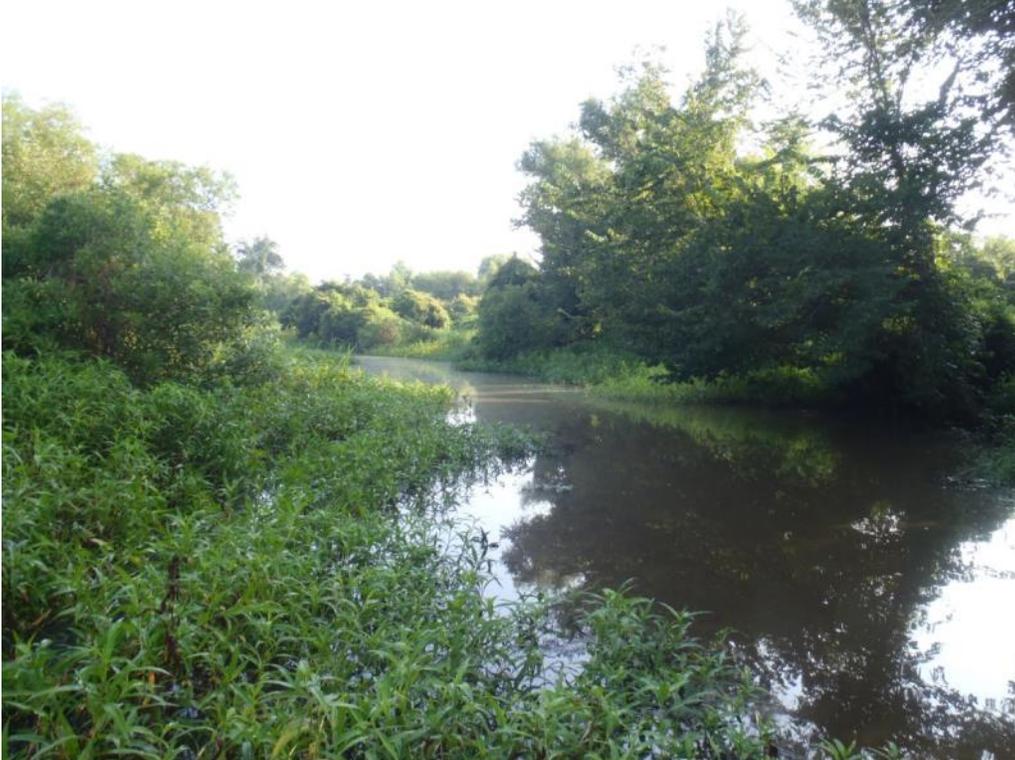
Figure 4.20 Photograph of Neches River Site NR08 taken on July 25, 2014 showing the upstream view of the 0-m transect.

Neches River at Site NR08 was visited on July 25 and August 23, 2014. This site was located north of Chandler, Texas on the border between Smith and Van Zandt Counties. Site NR08 was publicly accessible via tribal land maintained by The American Indian Cultural Society. The property is the site of the Battle of the Neches and contains a memorial to Cherokee Chief Bowles along with benches (Figure 4.18). A gravel parking area and trash receptacles were available near the memorial. TIAER personnel accessed the site by parking in the gravel parking area and walking approximately 0.15 miles on a mowed trail and then an additional 0.25 miles through a heavily vegetated forest area. The stream corridor was classified as an herbaceous marsh with some trees along each stream bank (Table 4.5). Access to the stream was difficult (Table 4.6) due to the dense vegetation and marsh conditions (Figure 4.19). The general appearance of the stream at Site NR08 is further depicted in Figures 4.20 and 4.21.

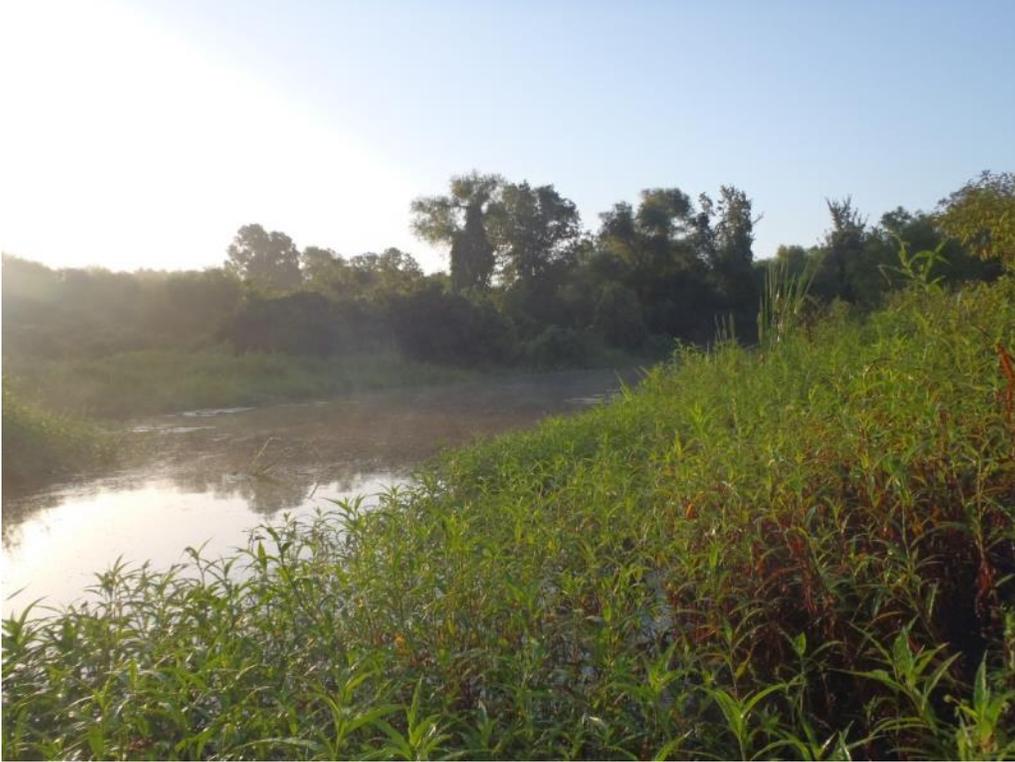
Figure 4.21 Photograph of Neches River Site NR08 taken on August 22, 2014 showing the downstream view of the 300-m transect.

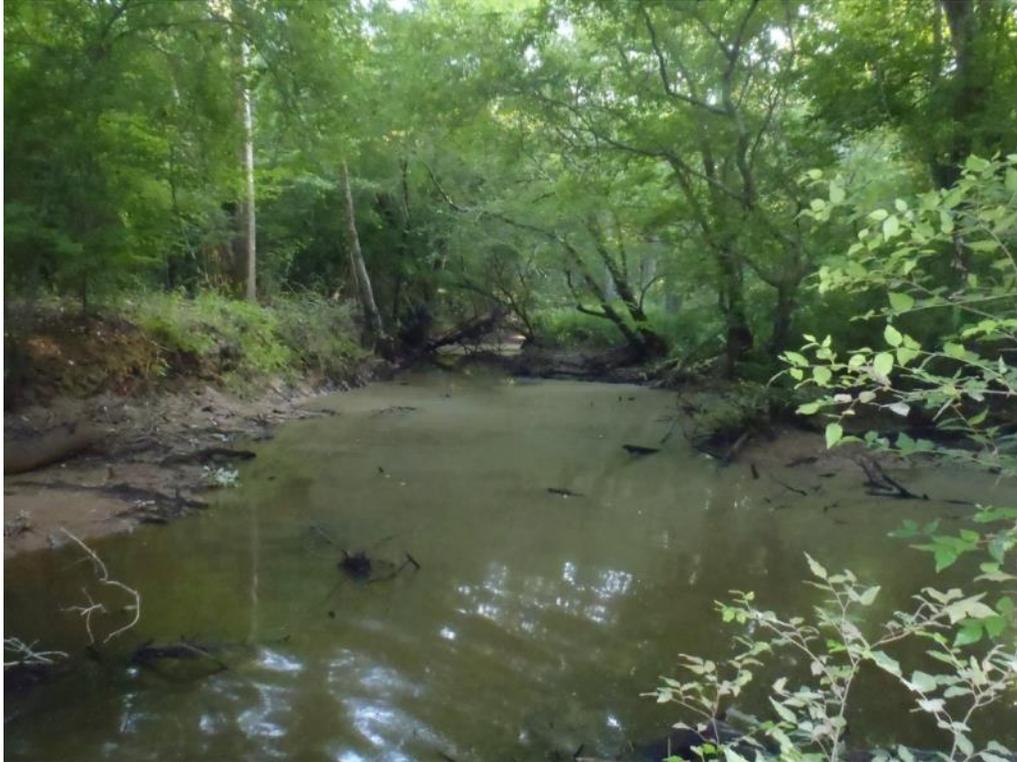
Figure 4.22 Photograph of Neches River Site NR09 taken on July 24, 2014, the upstream view of the 150-m transect.

Neches River at Site NR09 was visited on July 24 and August 23, 2014. This site was located at the culvert crossing on Van Zandt County Road 4915 (Smith County Road 420), north of Chandler, Texas at the border between Smith and Van Zandt Counties. The site was only publicly accessible at the culvert with fenced private property upstream and downstream of the crossing. TIAER personnel parked on the side of the county road and accessed the stream by down the culvert embankment. The site is located in a forest dominated corridor (Table 4.5). At the site, access to the stream was moderately difficult due to steep banks and dense vegetation. The general appearance of the stream is shown in Figures 4.22 and 4.23.
