Recreational Use Attainability Analysis for
Kickapoo Creek in Henderson County (0605A),
the Neches River Above Lake Palestine (0606),
Prairie Creek (0606A), Mud Creek (0611C), and
West Mud Creek (0611D)
in the Neches River Basin

Prepared for:
Texas State Soil and Water Conservation Board
Project 14-52

Texas Institute for Applied Environmental Research
Tarleton State University
Stephenville, Texas

TR1503
September 2015

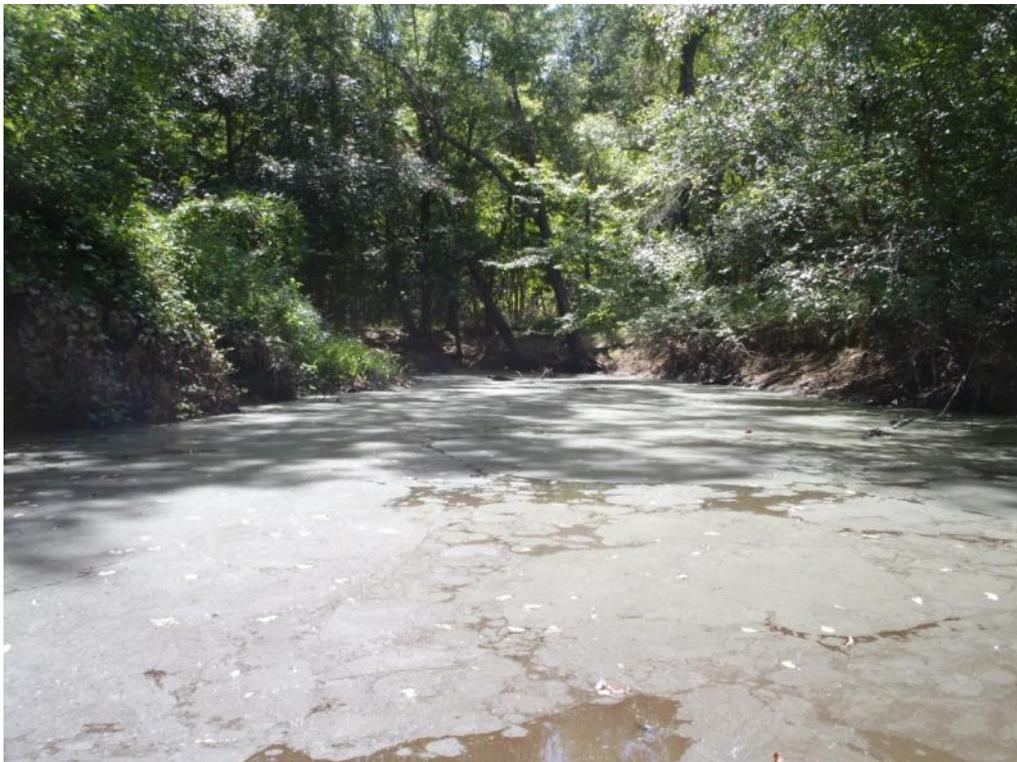
Figure 4.23 Photograph of Neches River Site NR09 taken on August 23, 2014, the downstream view of the 300-m transect.

Neches River at Site NR09 was visited on July 24 and August 23, 2014. This site was located at the culvert crossing on Van Zandt County Road 4915 (Smith County Road 420), north of Chandler, Texas at the border between Smith and Van Zandt Counties. The site was only publicly accessible at the culvert with fenced private property upstream and downstream of the crossing. TIAER personnel parked on the side of the county road and accessed the stream by down the culvert embankment. The site is located in a forest dominated corridor (Table 4.5). At the site, access to the stream was moderately difficult due to steep banks and dense vegetation. The general appearance of the stream is shown in Figures 4.22 and 4.23.

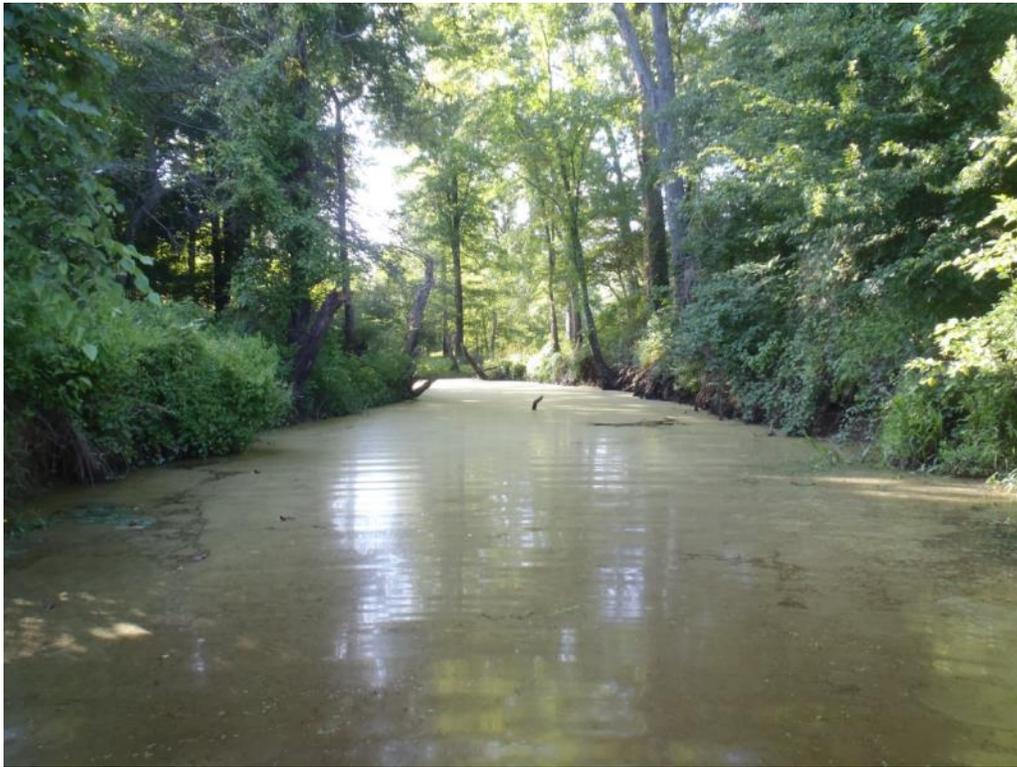
Figure 4.24 Photograph of Neches River Site NR10 taken on July 24, 2014, the upstream view of the 0-m transect.

Neches River at Site NR10 was visited on July 24 and August 23, 2014. This site was located north of Chandler, Texas on the border between Smith and Van Zandt Counties. The site was only publicly accessible at the culvert crossing on Van Zandt County Road 4931 (Smith County Road 421) and had fenced private property upstream and downstream of the culvert. With landowner permission, TIAER personnel entered the stream at the culvert and conducted the survey upstream. Forest bordered the corridor (Table 4.5). Access to the stream was moderately difficult due to dense vegetation and steep banks (Table 4.6). The general stream appearance is shown in Figures 4.24 and 4.25.

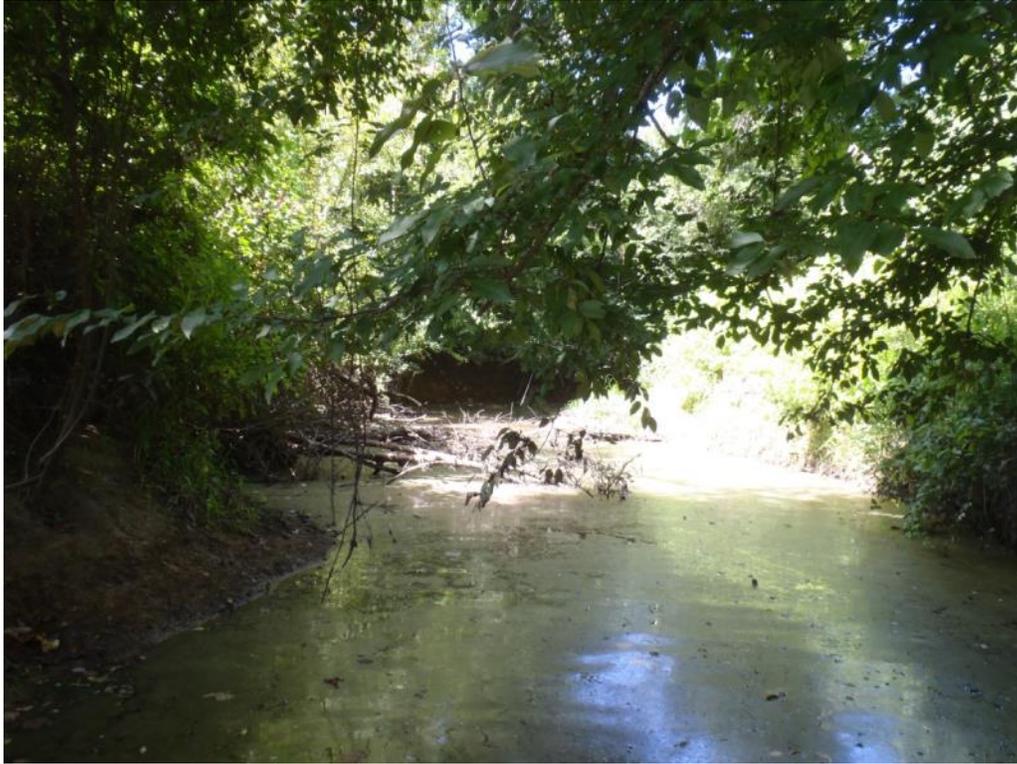
Figure 4.25 Photograph of Neches River Site NR10 taken on August 23, 2014, the upstream view of the 150-m transect.

Site NR10 was wadeable for the entire 300-m reach length, although the mud/clay substrate and numerous submerged tree obstacles made wading in the stream channel difficult. Average thalweg ranged from 0.8 m during the first survey to 0.7 m during the second survey (Table 4.6). Stream widths ranged from a maximum of 7.8 m to a minimum of 3.4 m, both encountered during the second survey (Tables 4.7 and 4.8). As depicted in Figure 4.25, log obstructions and overhanging trees were encountered during both surveys.

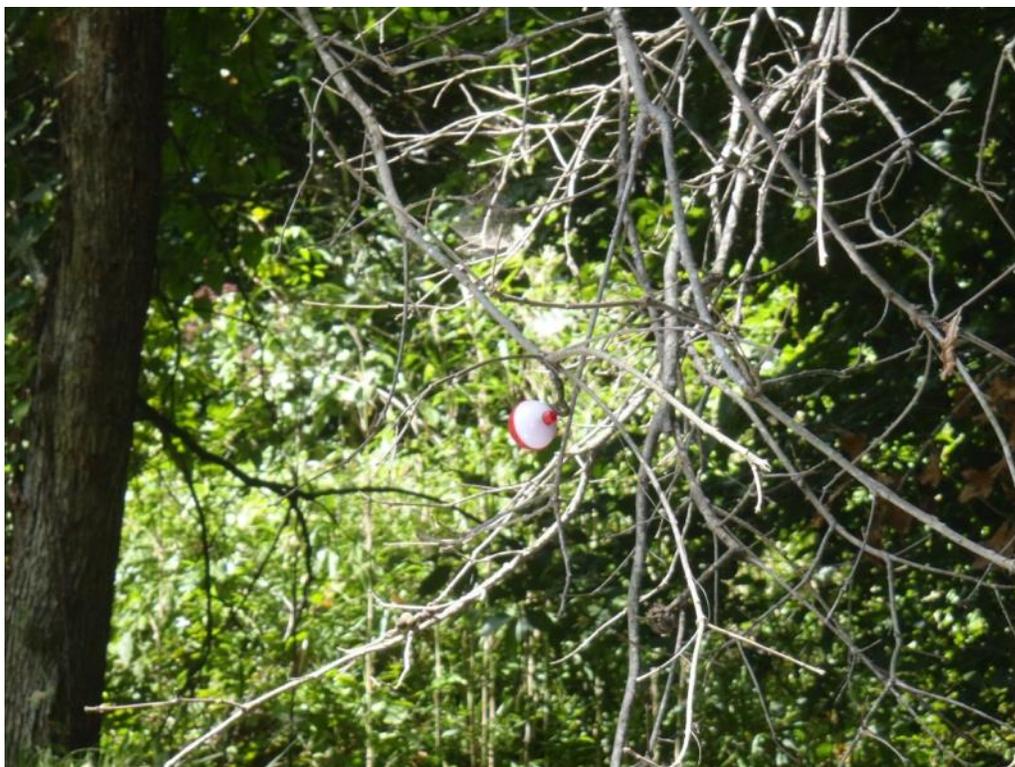
Figure 4.26 Photograph of Neches River Site NR10 taken on August 23, 2014 depicting the fishing bobber in an overhanging branch.

A river otter was observed during the first survey, but no other mammals or vertebrates during either survey (Tables 4.9 and 4.10). Tracks observed during each trip consisted of deer, raccoon, and feral hog. Bird feces were found throughout the reach during both surveys. Aquatic vegetation and algae were rarely observed. Water color was brown with a surface scum and commonly had an odor. Trash was rarely observed, but when encountered, consisted of typical plastics and an occasional tire, primarily at the culvert crossing. A fishing bobber found dangling in an overhanging branch was the only sign of recreational activity observed within the reach (Figure 4.26).

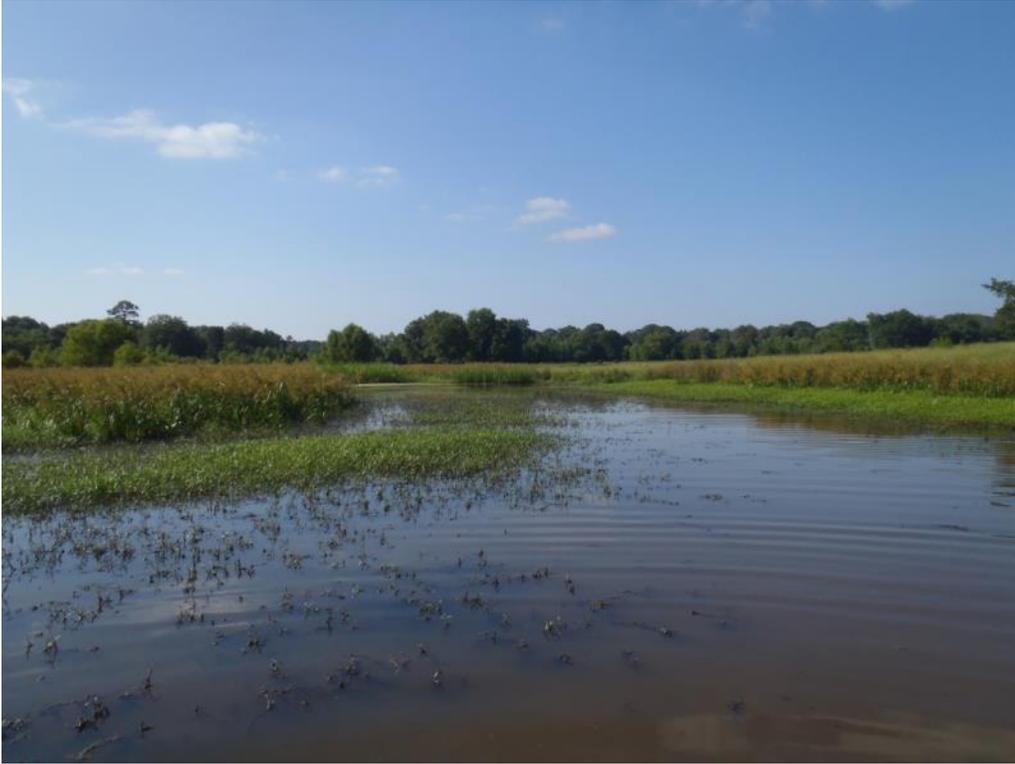
Figure 4.27 Photograph of Neches River Site NR11 taken on July 24, 2014, the upstream view of the 300-m transect.

Neches River at Site NR11 was visited on May 27 and July 29, 2014. This site was located southeast of Van, Texas on the border between Smith and Van Zandt Counties. The site was accessible only through private lands that were fenced with a cattle guard and potentially locked gate. With landowner permission, TIAER personnel entered private property over the cattle guard with a locked gate and drove approximately 0.6 mile through a pasture to reach the site. The site is located in a pasture dominated corridor along the left bank and a forest dominated corridor along the right bank (Table 4.5). The landowner stated that generally during the summer months, he uses his tractor and shredder to keep the stream channel mowed and maintained. He further stated that this year was significantly wetter than recent past years, and he was unable to mow the stream before our arrival. At the site, access to the stream was easy despite dense vegetation (Table 4.6). Figures 4.27 and 4.28 depict the appearance of the site during each of the surveys.

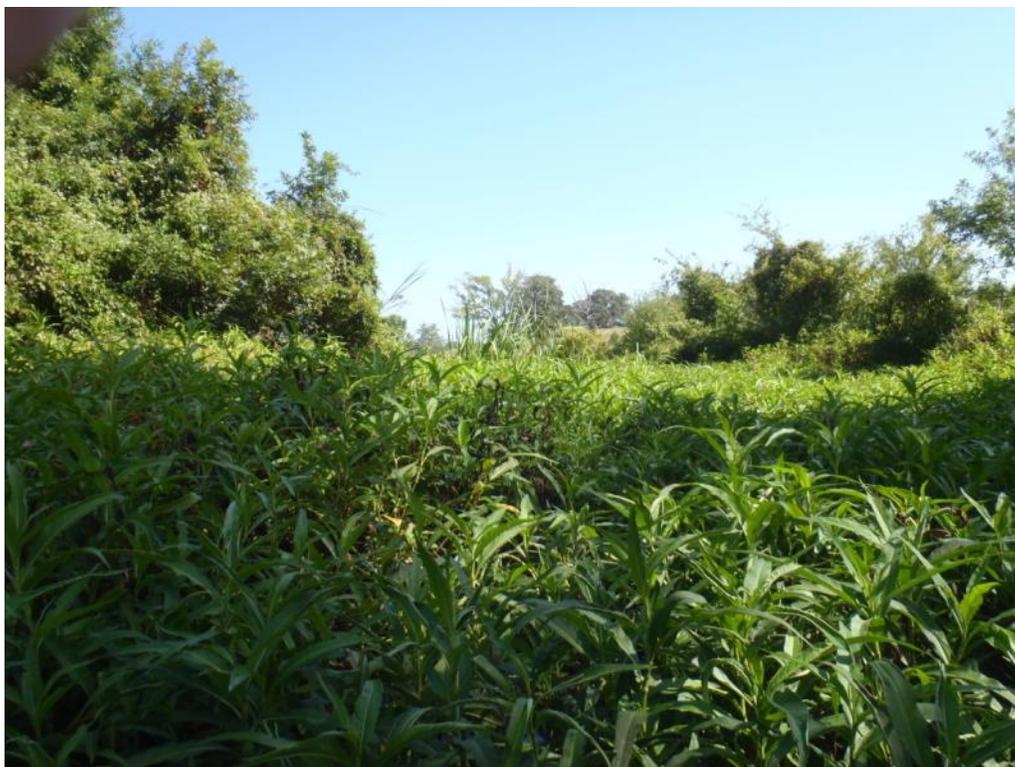
Figure 4.28 Photograph of Neches River Creek Site NR11 taken on August 23, 2014, the upstream view of the 0-m transect.

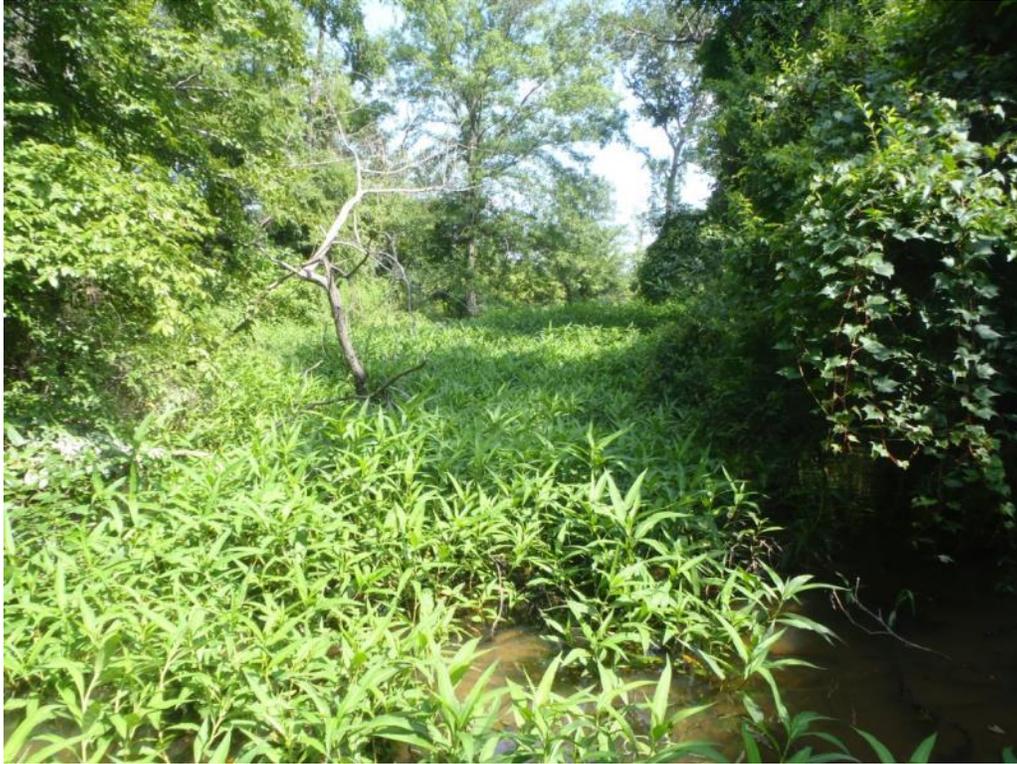
Figure 4.29 Photograph of Neches River Site NR12 taken on July 25, 2014, the upstream view of the 150-m transect.

Neches River at Site NR12 was visited on July 25 and August 23, 2014. This site was located southeast of Van, Texas on the border between Smith and Van Zandt Counties. This site was only publicly accessible at the area around the culvert road crossing on Van Zandt County Road 420 (Smith County Road 426). Properties upstream and downstream of the crossing were only partially fenced, but one no trespassing sign was observed and several trees were marked with purple paint indicating private property. With landowner permission, TIAER personnel entered stream at the culvert crossing and conducted the survey upstream of the crossing. Shrubs lined the left bank and forest the right bank of the stream corridor (Table 4.5). Access to the stream was moderately easy (Table 4.6), and Figures 4.29 and 4.30 depict the general appearance of the site during each survey.

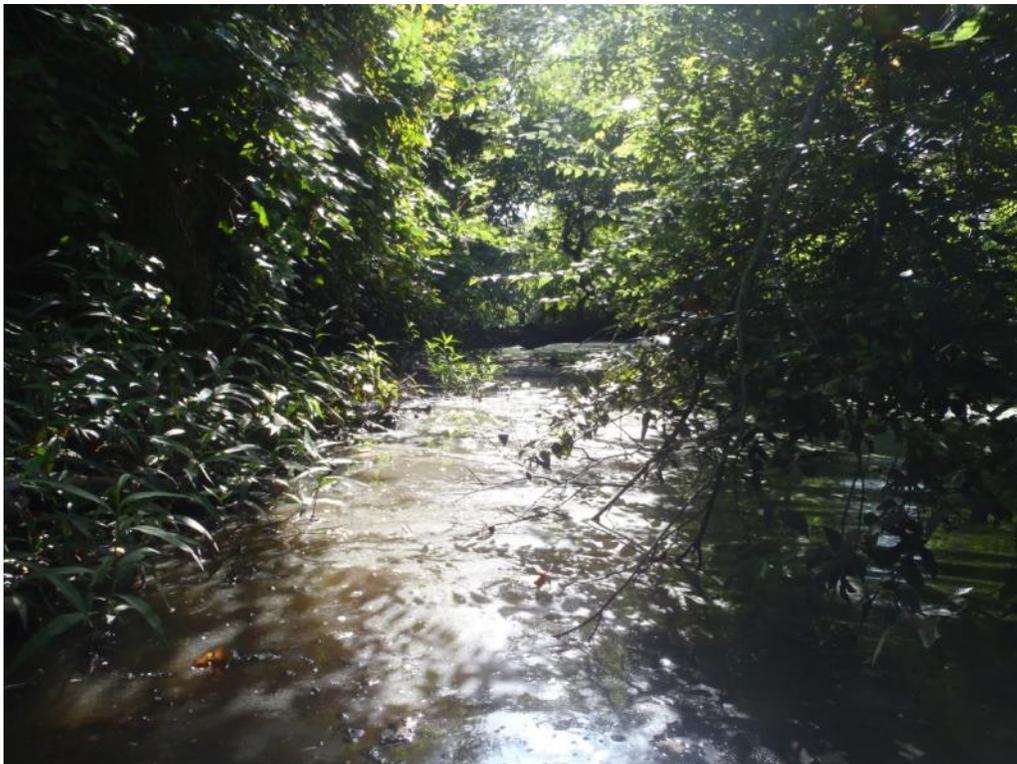
Figure 4.30 Photograph of Neches River Site NR12 taken on August 23, 2014, the downstream view of the 300-m transect.

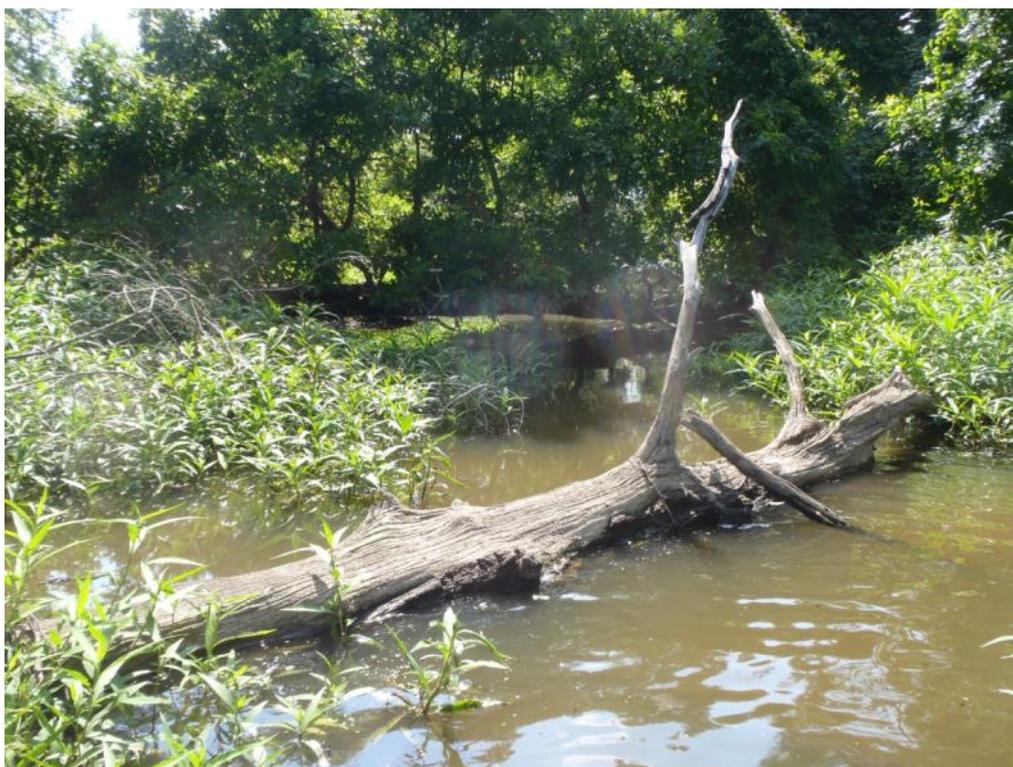
Figure 4.31 Photograph of Neches River Site NR12 taken on July 25, 2014 depicting a typical obstruction encountered during the field surveys.

Site NR12 was wadeable for the entire 300-m reach length, although the dense vegetation and primarily mud/clay substrate made wading challenging, despite relatively shallow water depths. Average thalweg depth was 0.5 m for each survey (Table 4.6). Stream widths ranged from a maximum of 9.0 m during the first survey to a minimum of 1.4 m during the second survey (Tables 4.7 and 4.8). Several log obstructions were encountered as were overhanging branches and dense vegetation, which could impede potential recreation (Figure 4.31).

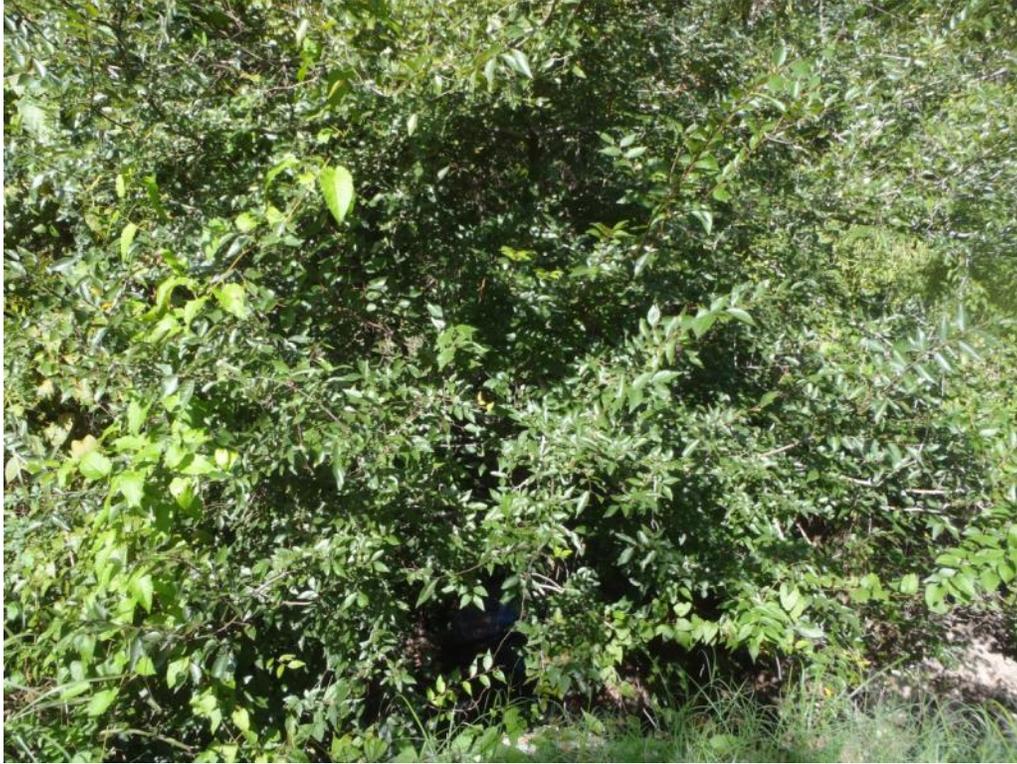
Figure 4.32 Photograph of dense vegetation at the Neches River culvert crossing on Van Zandt County Road 4912 taken on August 23, 2014.

Neches River at Site NR13 was visited on July 25 and August 23, 2014. This site was located at the culvert crossing on Van Zandt County Road 4912, southeast of Van, Texas in Van Zandt County. The site was only publicly accessible at the culvert with fenced private property upstream and downstream of the crossing. At the culvert crossing, dense vegetation (Figure 4.32) created

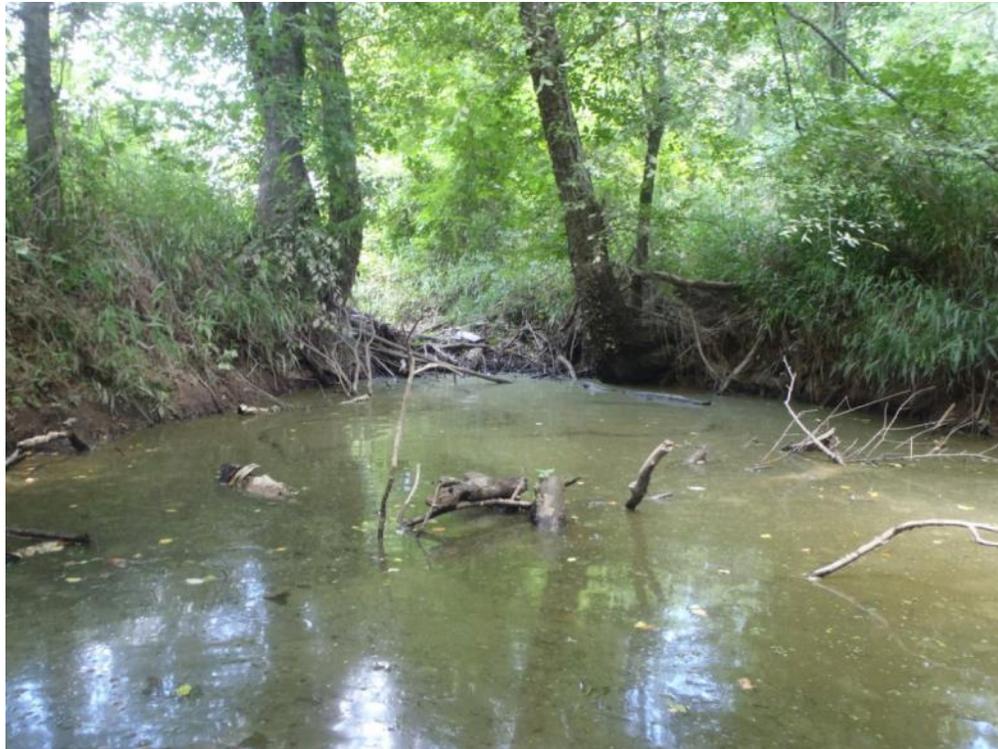
Figure 4.33 Photograph of Neches River Site NR13 taken on July 25, 2014, the upstream view of the 300-m transect.

more challenging access to the stream than what was available on the private property just upstream of the crossing. With landowner permission, TIAER personnel entered private property and drove approximately 0.30 miles down a mowed road and then walked an additional 100 m to reach the downstream portion of the 300-m reach. Forest was noted on both sides of the stream corridor (Table 4.5). Access to the stream was moderately difficult due to steep banks and dense vegetation (Table 4.6). The general appearance of the stream is shown in Figures 4.33 and 4.34.

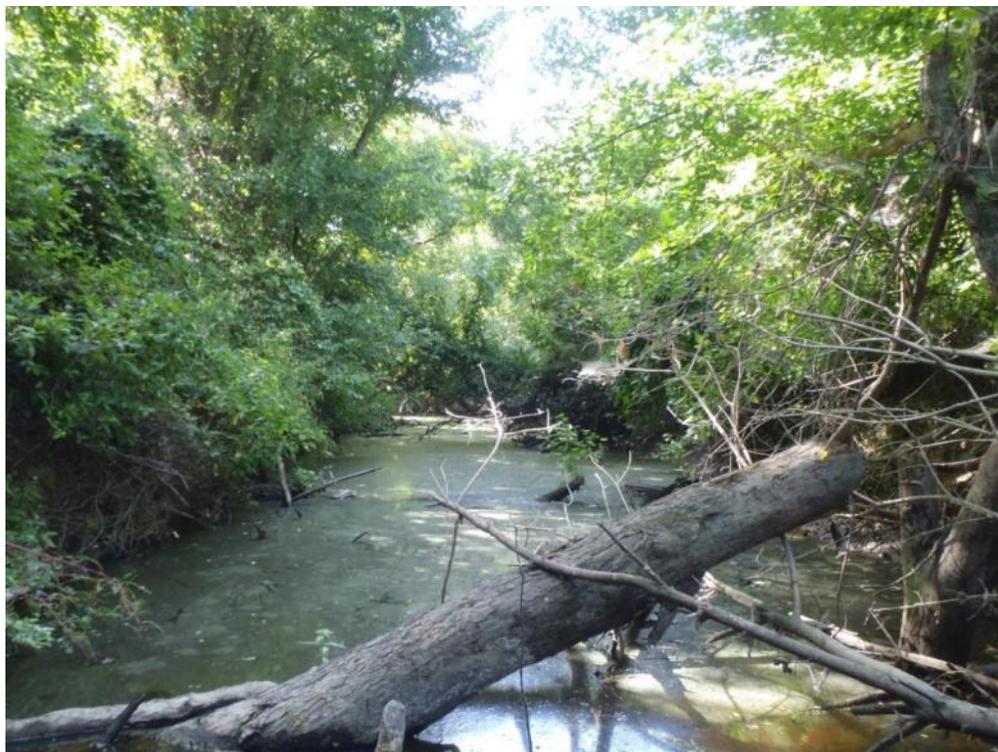
Figure 4.34 Photograph of Neches River Site NR13 taken on August 23, 2014, the downstream view of the 0-m transect.

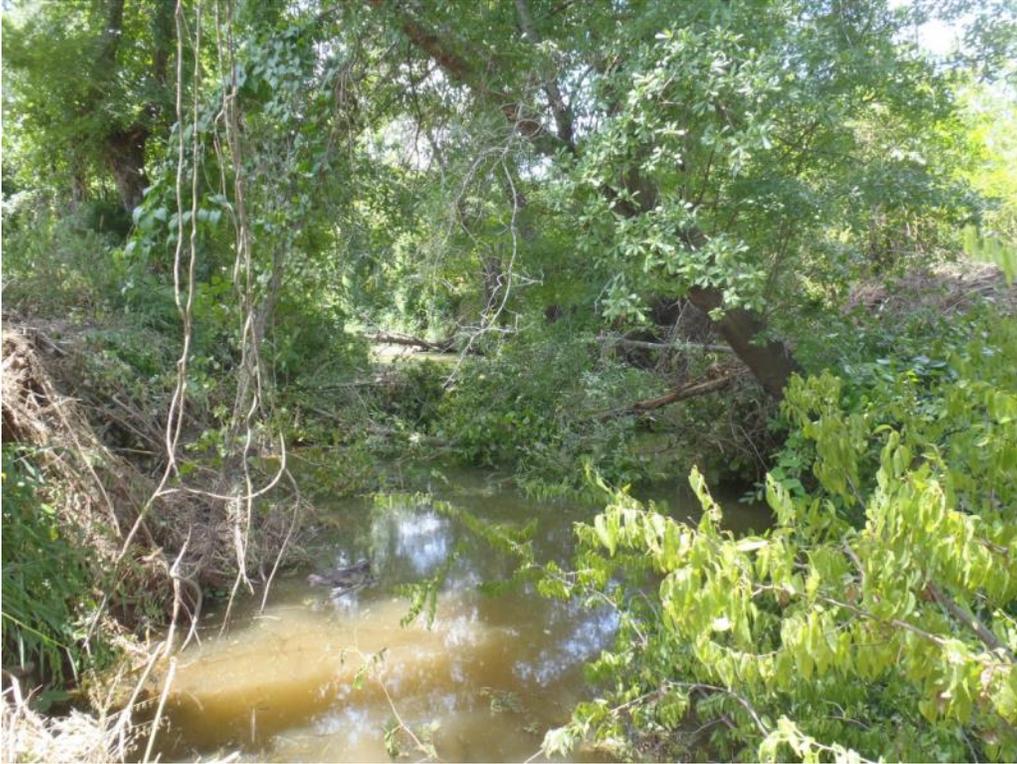
Figure 4.35 Photograph of Neches River Site NR14 taken on July 25, 2014, the upstream view of the 0-m transect.

Neches River at Site NR14 was visited on July 25 and August 23, 2014. This site was located on private property southeast of Van, Texas in Van Zandt County, and was only accessible, with landowner permission, through fenced private property. With landowner permission, TIAER personnel entered private property and drove approximately 0.30 miles on a mowed dirt road to reach the site. The most upstream portion of the site reach was located at a privately owned and maintained low-water crossing. Forest occurred along both sides of the stream corridor (Table 4.5). Access to the stream was easy at the low water crossing (Table 4.6). Figures 4.35 and 4.36 depict the general appearance of the site during each survey.

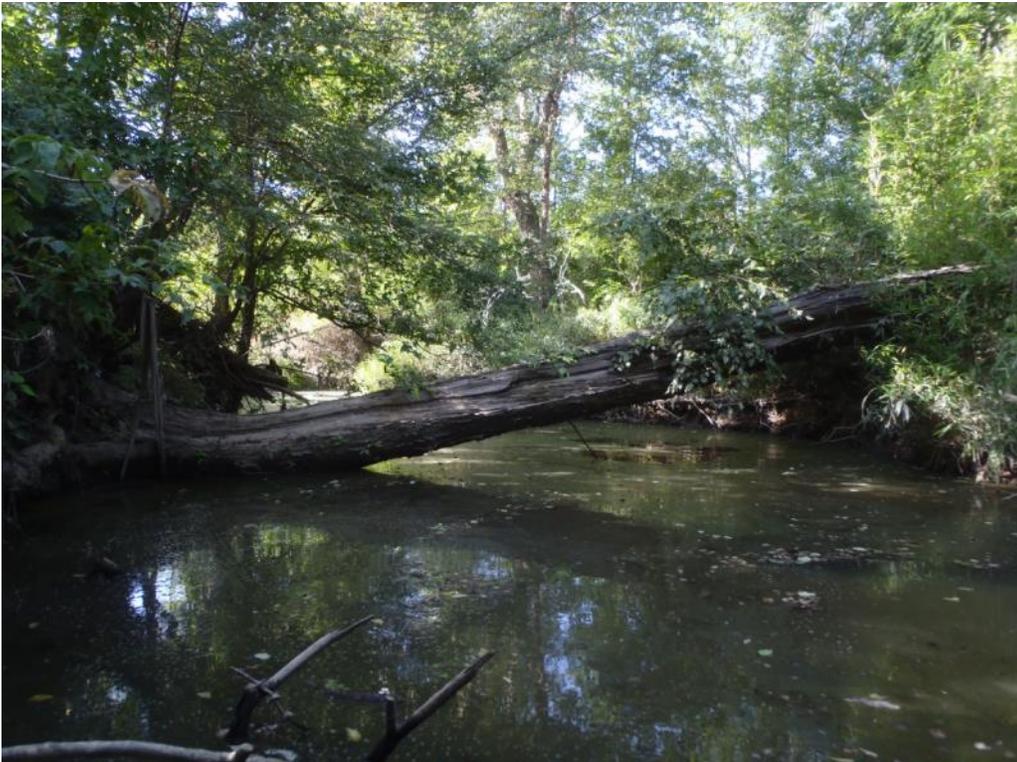
Figure 4.36 Photograph of Neches River Site NR14 taken on August 23, 2014, the upstream view of the 150-m transect.

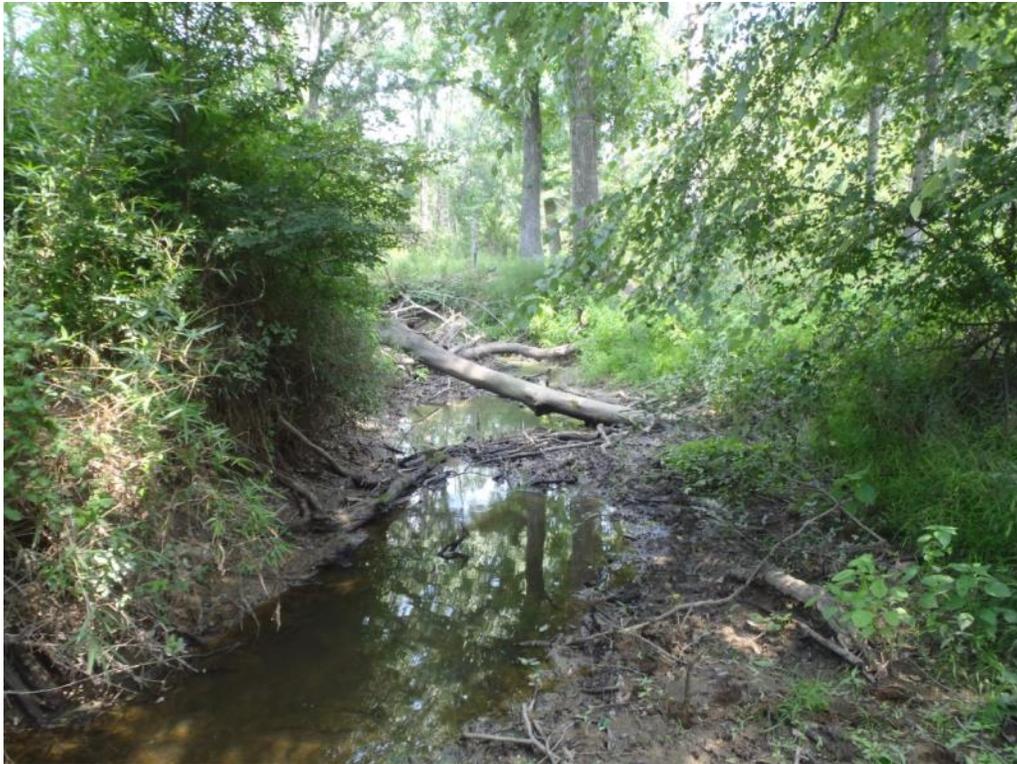
Figure 4.37 Photograph of Neches River Site NR15 taken on July 25, 2014, the downstream view of the 150-m transect.

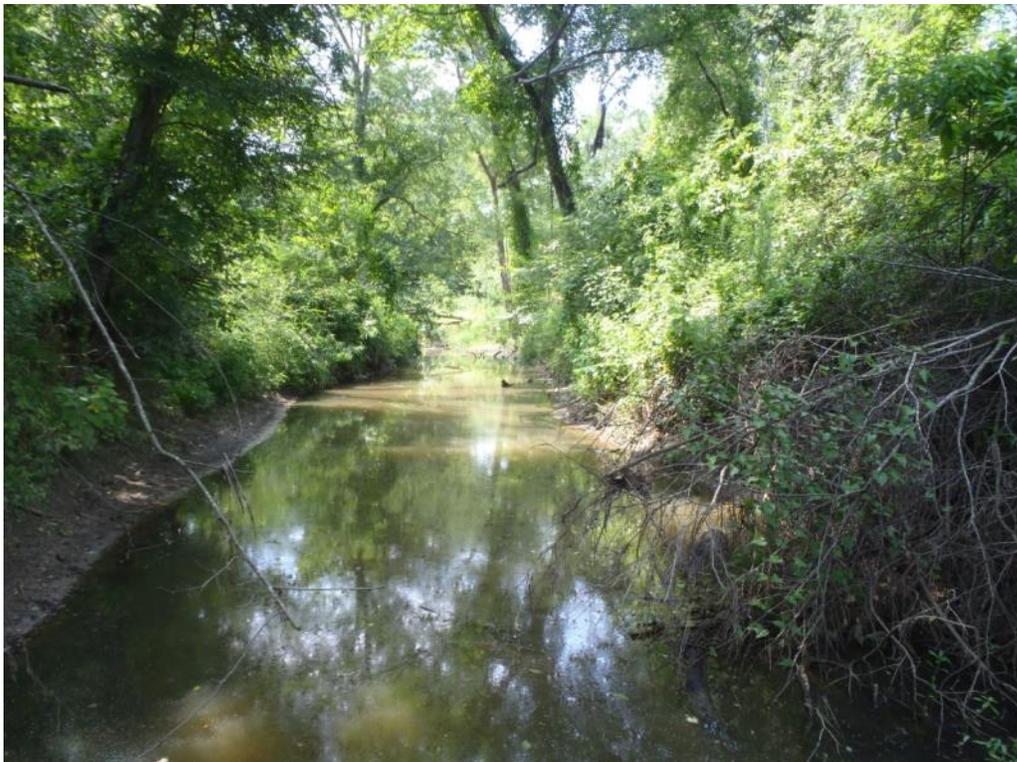
Figure 4.38 Photograph of Neches River Site NR15 taken on July 25, 2014, the upstream view of the 0-m transect.

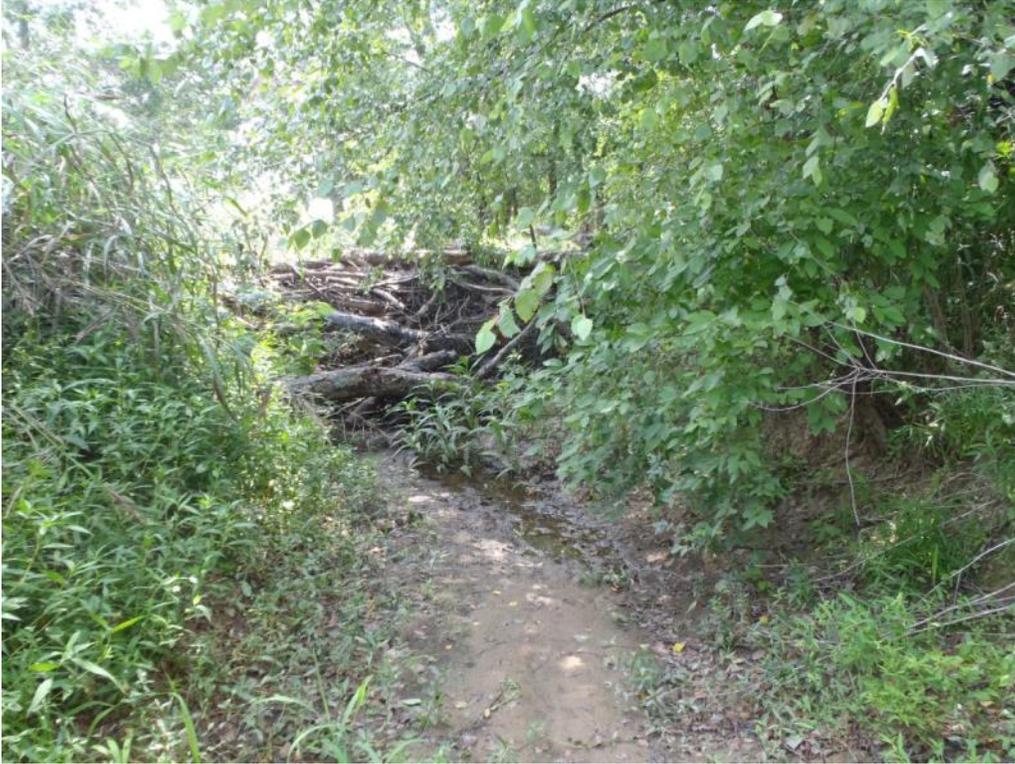
Figure 4.39 Photograph of Neches River Site NR16 taken on July 25, 2014, the downstream view of the 300-m transect.

Neches River at Site NR16 was visited on July 25 and August 23, 2014. This site was located at the bridge crossing on Farm-to-Market Road 314, south of Van, Texas in Van Zandt County. The site was only publicly accessible at the bridge crossing as there was fenced private property upstream and downstream of the crossing. With landowner permission, TIAER personnel entered private property over the downstream fence to gain stream access at the site. Native pasture lined the stream corridor (Table 4.5). Access to the stream was moderately easy with moderately steep banks and some areas of dense vegetation (Table 4.6). The general appearance of the stream at this site is shown in Figures 4.39 and 4.40.

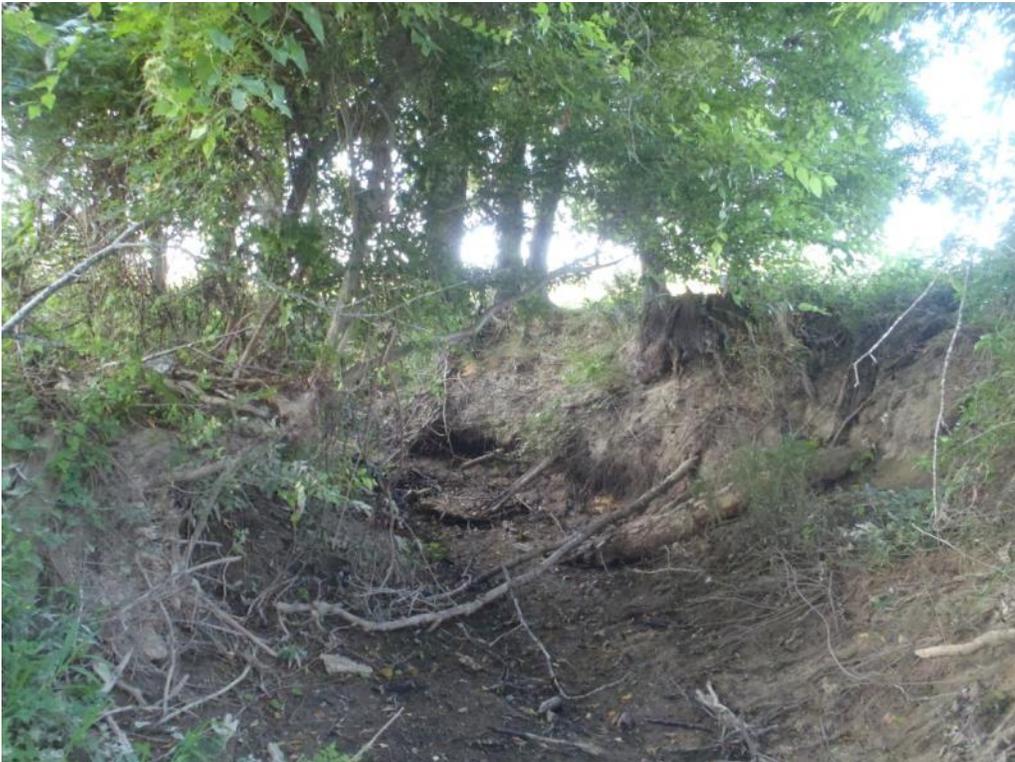
Figure 4.40 Photograph of Neches River Site NR16 taken on August 23, 2014, the downstream view of the 150-m transect.

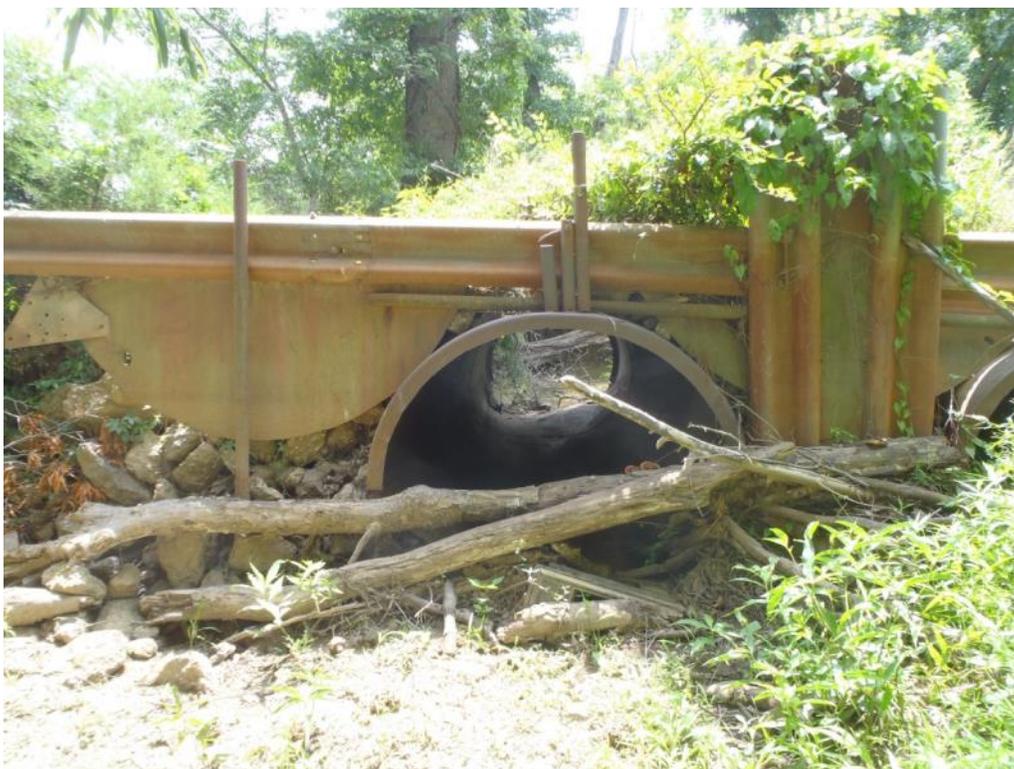
Figure 4.41 Photograph of Neches River Site NR16 taken on July 25, 2014 showing the primitive bridge (hydrologic modification).

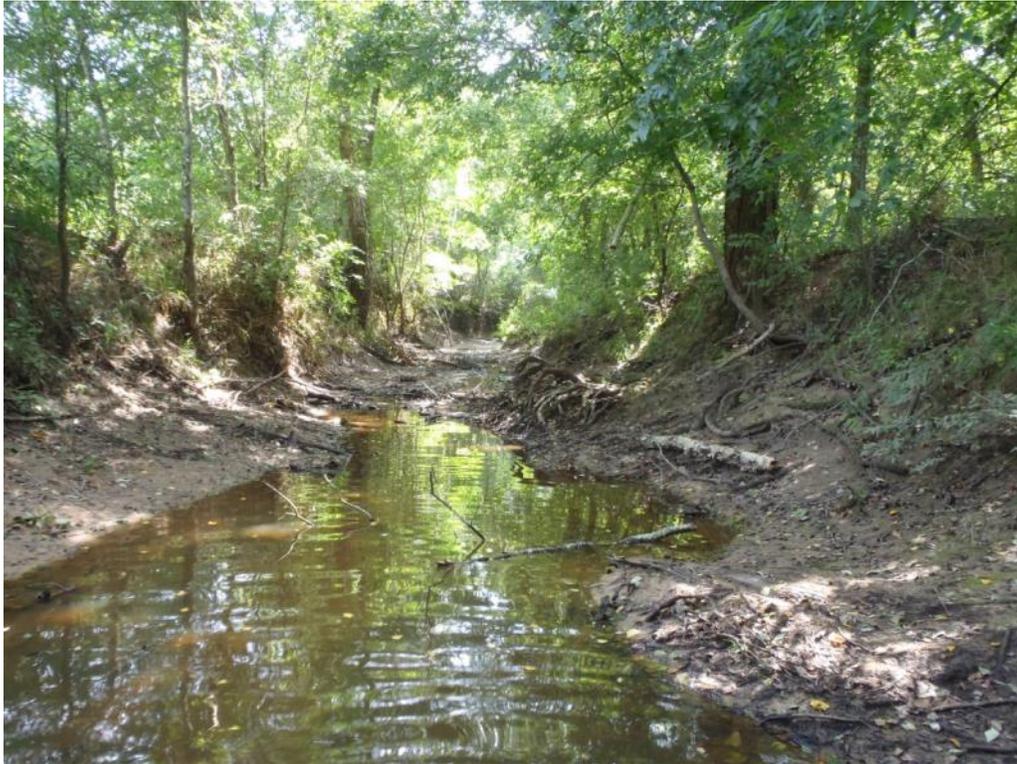
Figure 4.42 Photograph of Neches River Site NR17 taken on July 25, 2014, the downstream view of the 150-m transect.

Neches River at Site NR17 was visited on July 25 and August 23, 2014. This site was located on private property south of Van, Texas in Van Zandt County. The site was accessible through fenced private property via a locked gate with landowner permission or by access at the upstream bridge crossing on Van Zandt County Road 4511. A survey site (Site NR18) had been established on the Neches River Crossing at Van Zandt County Road 4511, so for convenience, TIAER personnel accessed Site NR17 by walking from the County Road 4511 bridge crossing approximately 0.38 miles along the streambank on a mowed clearing. Forest dominated the stream corridor (Table 4.5), and access to the stream was moderately difficult due to steep banks (Table 4.6). The general appearance of the stream is shown in Figures 4.42 and 4.43.

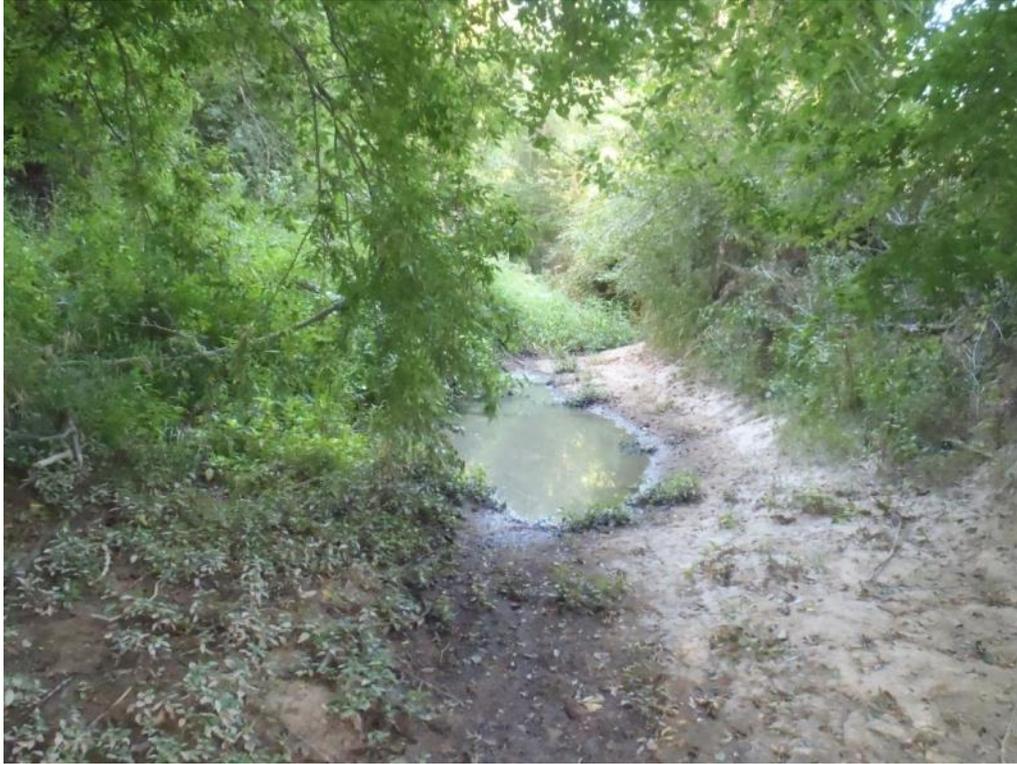
Figure 4.43 Photograph of Neches River Site NR17 taken on August 23, 2014, the upstream view of the 0-m transect.

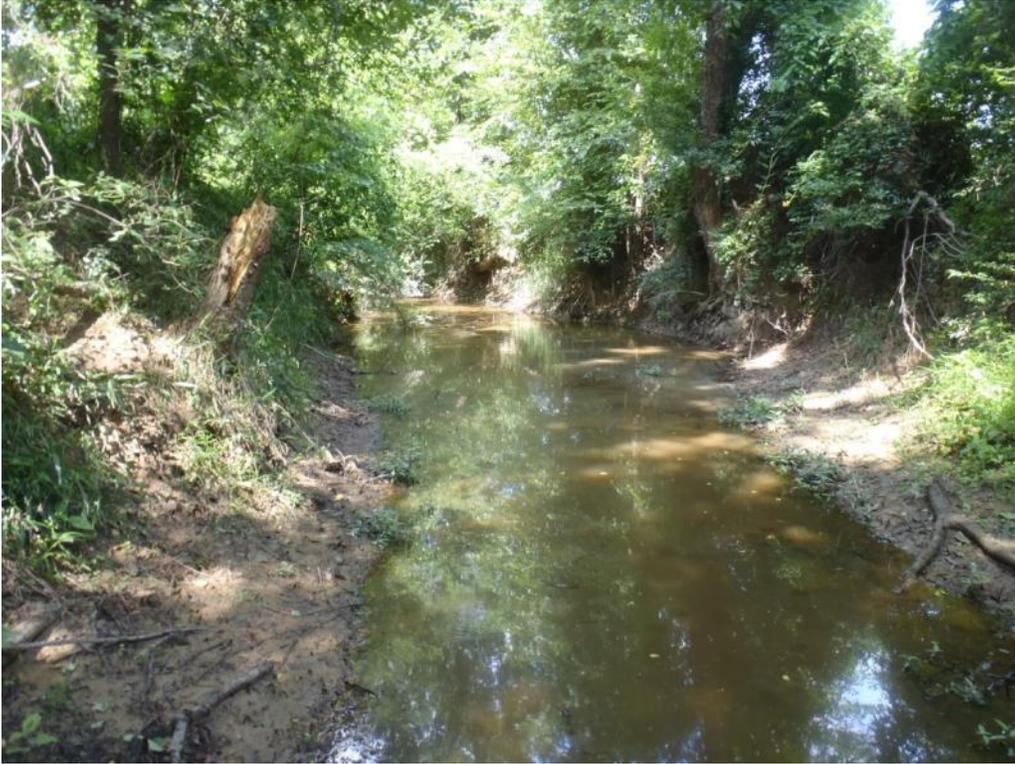
Figure 4.44 Photograph of Neches River Site NR18 taken on July 25, 2014, the upstream view of the 0-m transect.

Neches River at Site NR18 was visited on July 25 and August 23, 2014. This site was located at the bridge crossing on Van Zandt County Road 4511, southwest of Van, Texas in Van Zandt County. The site was only publicly accessible at the bridge with fenced private property upstream and downstream of the crossing. TIAER personnel accessed the site by walking under the county road bridge. The site is located in a forest dominated corridor (Table 4.5). At the bridge crossing, access to the stream was moderately easy with some patches of dense vegetation. Access at other locations along the reach would prove more difficult due to steep banks and dense vegetation. The general appearance of the stream at this site is shown in Figures 4.44 and 4.45.

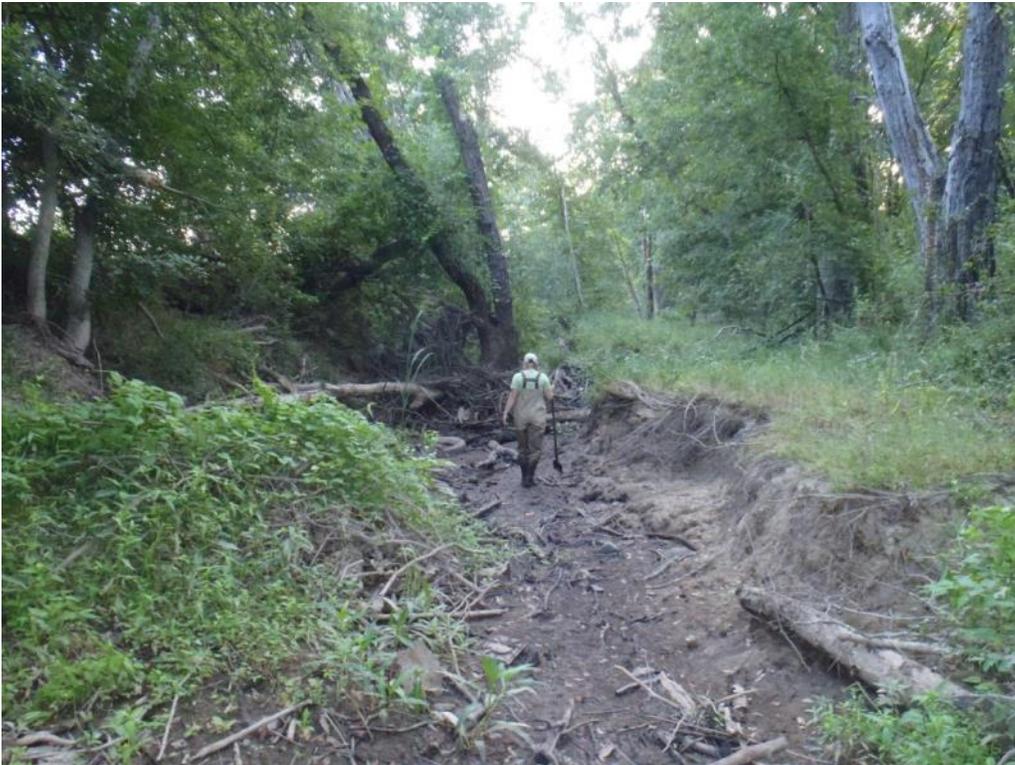
Figure 4.45 Photograph of Neches River Site NR18 taken on August 23, 2014, the downstream view of the 150-m transect. TIAER personnel in photograph.
