Recreational Use Attainability Analysis for
Kickapoo Creek in Henderson County (0605A),
the Neches River Above Lake Palestine (0606),
Prairie Creek (0606A), Mud Creek (0611C), and
West Mud Creek (0611D)
in the Neches River Basin

Prepared for:
Texas State Soil and Water Conservation Board
Project 14-52

Texas Institute for Applied Environmental Research
Tarleton State University
Stephenville, Texas

TR1503
September 2015

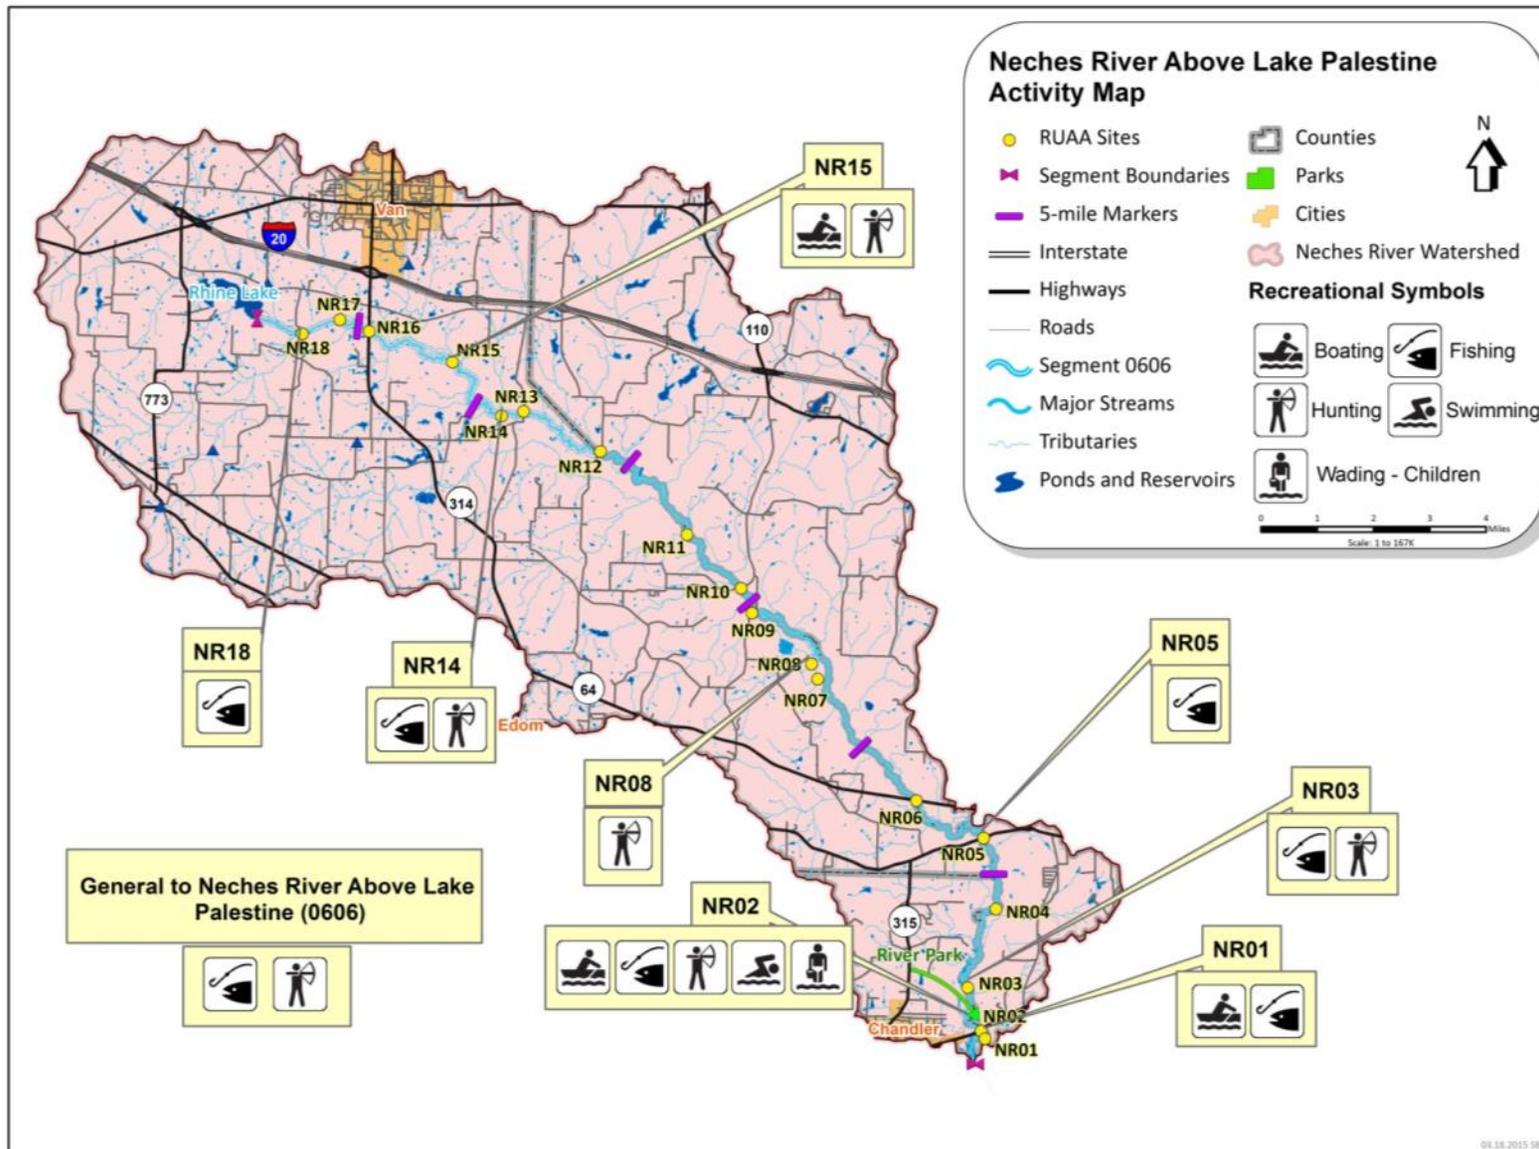
Figure 4.46 Summary of observed and interviewed human activities on Neches River above Lake Palestine.

During the first survey, three individuals were observed by TIAER field staff fishing from the stream bank at Site NR02. In February 2014 when scouting for survey sites, multiple individuals were observed by TIAER field staff fishing from the stream bank at Site NR02. There were no other recreational activities observed by TIAER field staff. Interviews revealed that fishing and hunting have occurred at various sites throughout the reach. Boating was associated with only the two most downstream sites, NR01 and NR02. Interviews also revealed that swimming and children wading in the Neches River has occurred at Site NR02. Anecdotal evidence through field staff observations and information gathered from interviews indicate that the majority of recreational activities along Segment 0606 occur in the vicinity of Site NR02. This is likely due to the availability of a maintained public boat ramp and ample parking spaces, in addition to having perennial streamflow conditions. A maintained public boat ramp, ample parking spaces, a concrete walking path, and covered picnic area were located at Site NR02. Based on interviews and observations during the field surveys, Site NR02 appears to be popular fishing sites. While fishing likely occurs throughout the year at these sites the frequency and number of individuals is probably greatest during late February through March when white bass (*Morone chrysops*) are migrating up the river from Lake Palestine to spawn. With the exception of Site NR02, areas of the stream open to the public are typically limited to the right-of-ways immediately underneath bridge crossings or areas immediately up and down stream of culvert crossings. Recreational activities reported by interviewees are summarized in Figure 4.46. Overall RUAA findings are summarized in the form below.

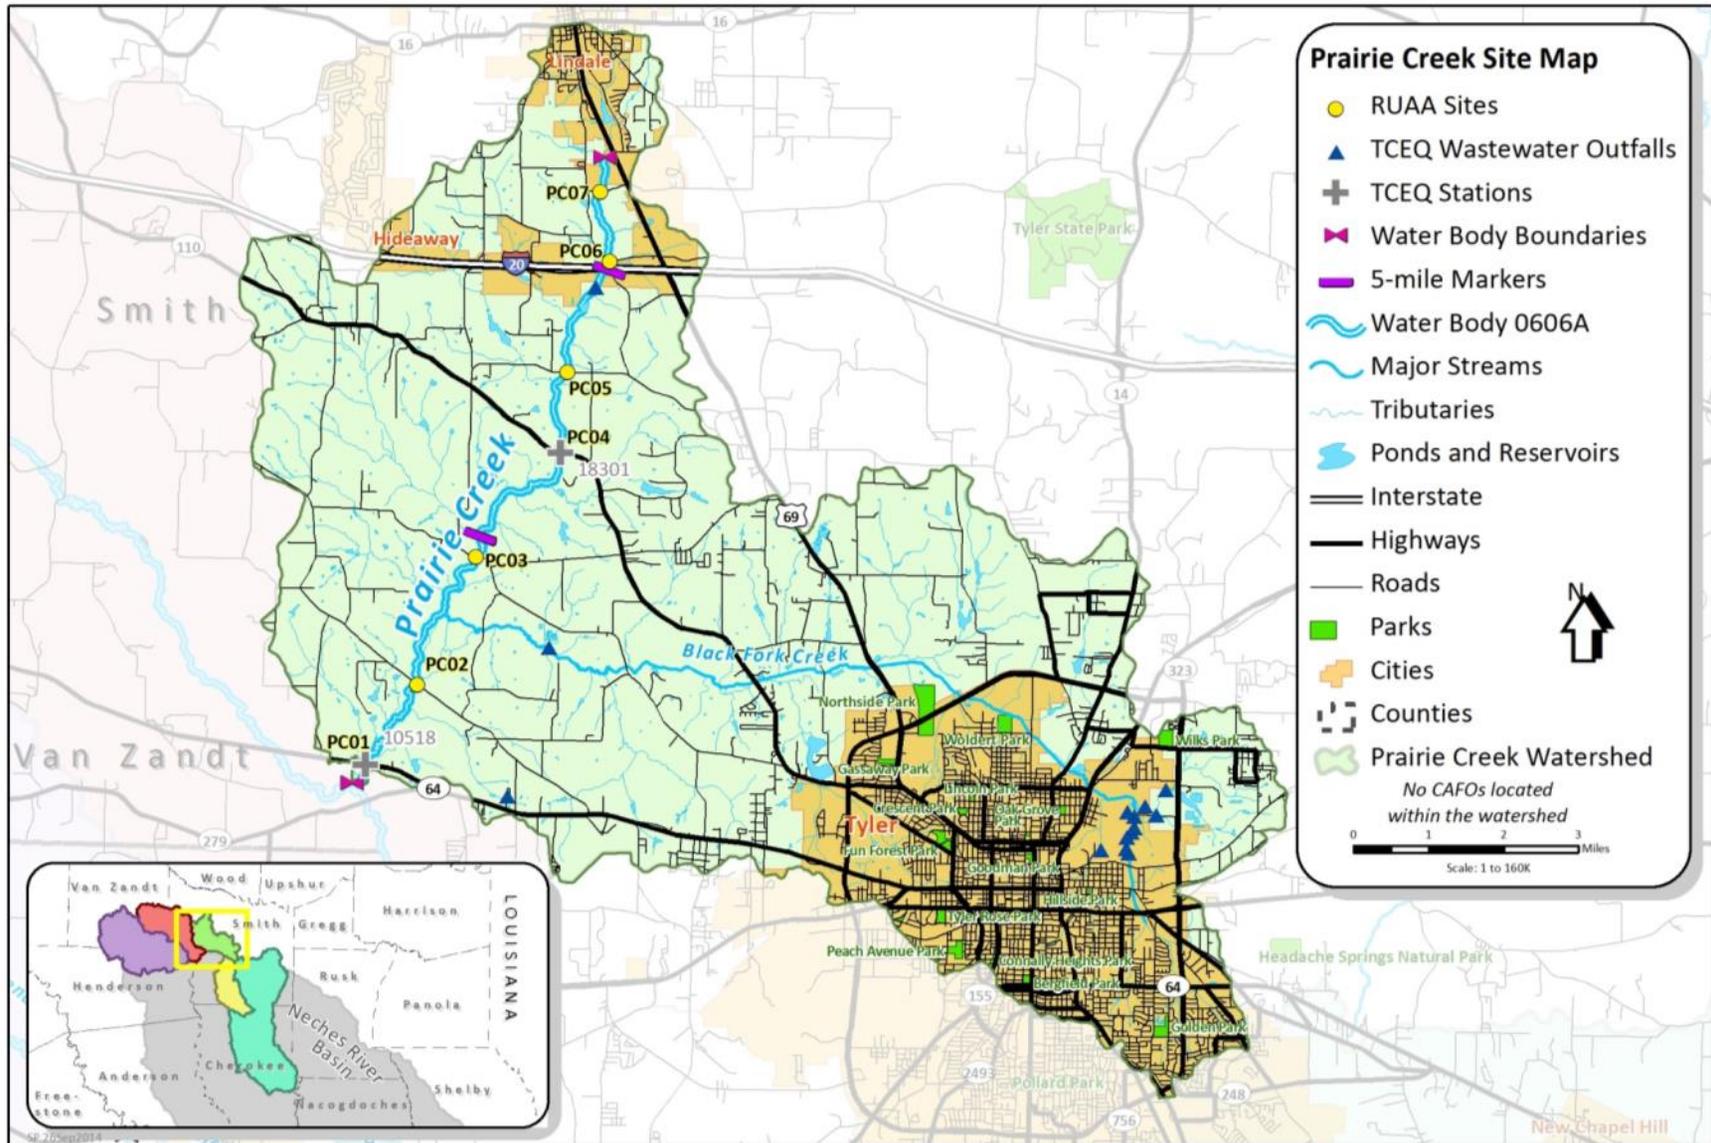
Figure 5.1 Overview of Prairie Creek watershed and RUAA sites for water body 0606A.

The watershed of Prairie Creek (0606A) located within Smith County covers 57,300 acres and includes significant portions of the cities of Tyler (estimated population 100,223), Hideaway (estimated population 3,185), and Lindale (estimated population 5,323) (Figure 5.1). Prairie Creek is nearly 12 miles long and flows southwest from its headwaters near Lindale, Texas until it merges with the Neches River (Segment 0606) just south of State Highway 64. Black Fork Creek (0606D), which is about 14 miles long, is a major tributary of Prairie Creek that flows northwest through Tyler and then westward until reaching its confluence with Prairie Creek. While surface water is the primary focus of this study, the watershed overlays the Carizzo-Wilcox Aquifer (George et al., 2011). The terrain of the watershed varies from flat to rolling hills and dominant soil types include brown, loamy, fine sand (TSHA, 2010b). The bottom lands are fairly flat with loamy soils that are frequently flooded and often strongly acidic (Hatherly, 1993).

With the help of cooperating stakeholders, TIAER was able to establish seven sites along the 12 mile long stretch of water body 0606A (Figure 5.1 and Table 5.2). The optimum number of survey sites following the RUAA guidelines from TCEQ was seven or three per each five miles of stream, so this goal was met. All seven sites were at public road crossings that did not require private landowner permission for access to the creek, but did require landowner cooperation to conduct the full 300 meter assessment. Public accessibility at five of the seven sites was very limited due to private property fences. Four of the seven sites were located at TCEQ sampling stations. The average distance between survey sites was 1.80 river miles and ranged from 1.11 to 2.42 miles. The largest gap of 2.42 river miles was between PC02 and PC03. RUAA surveys were performed in June and August of 2014 at these locations. A brief description of each site follows.

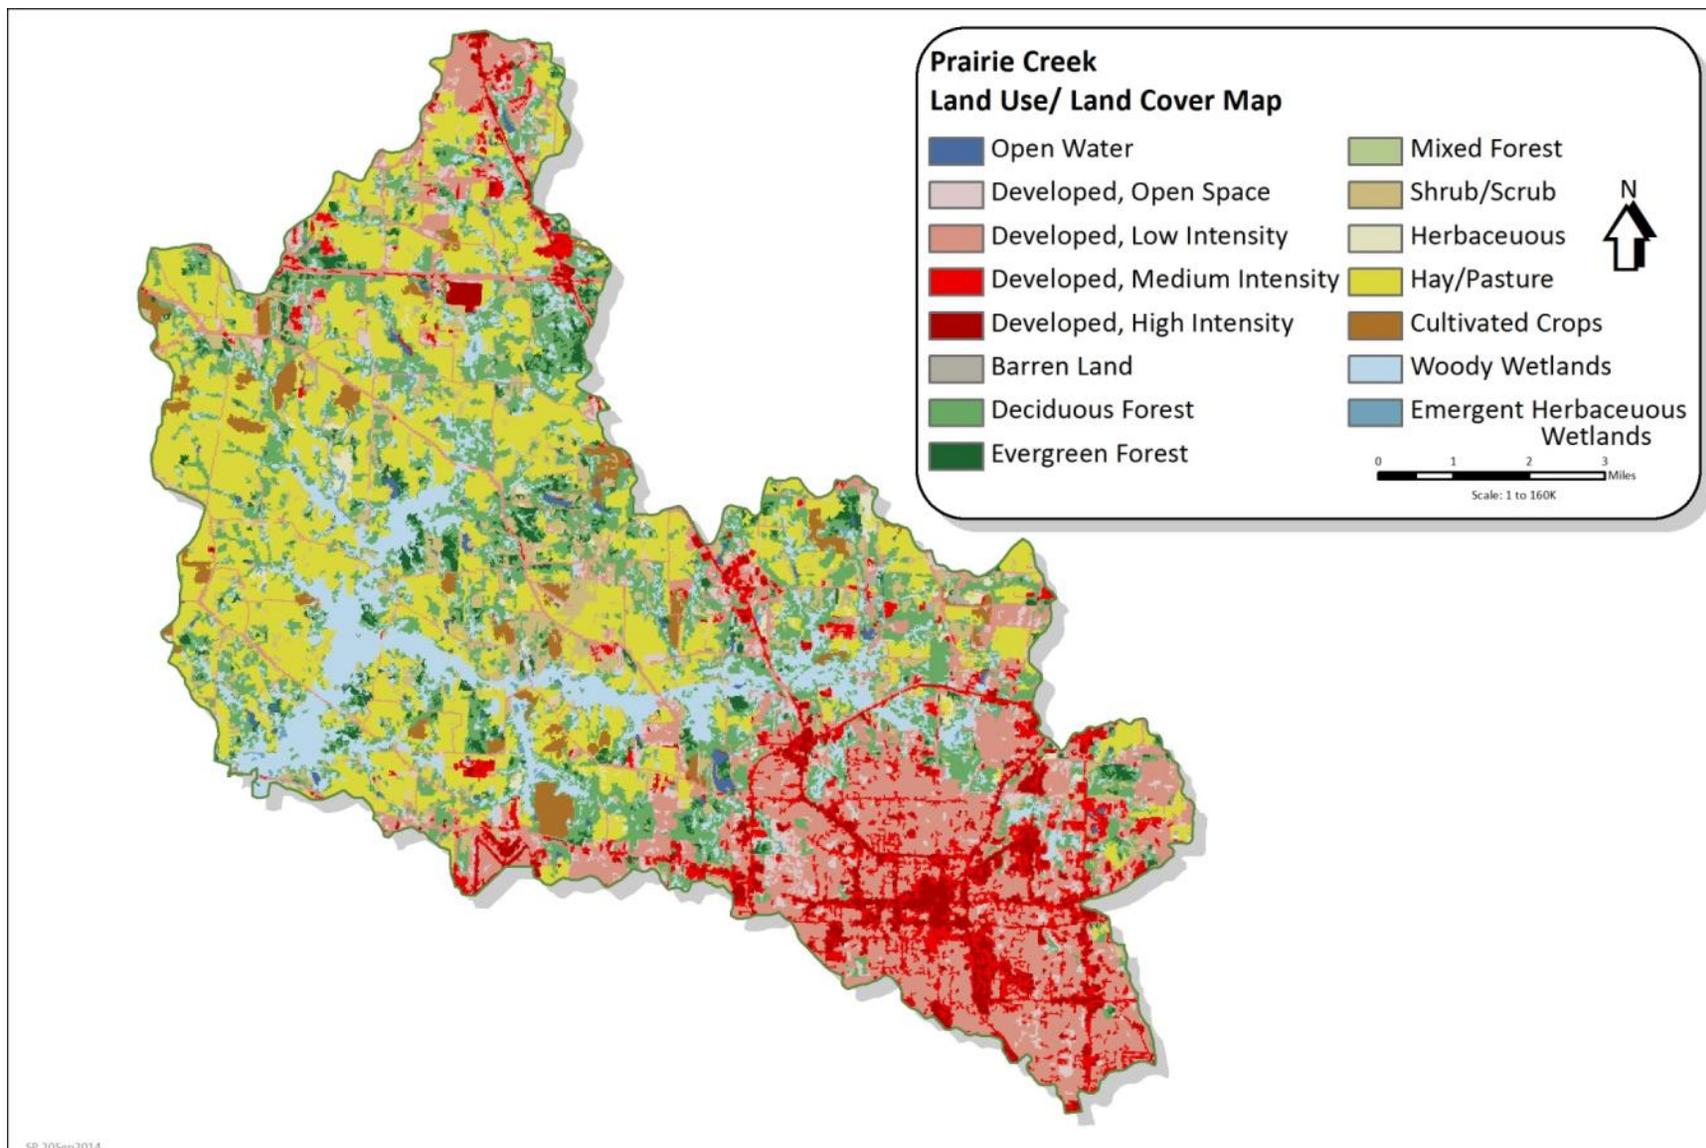
Figure 5.2 Land use/land cover for the Prairie Creek watershed. Source: 2011 National Land Cover Database (USGS, 2013).

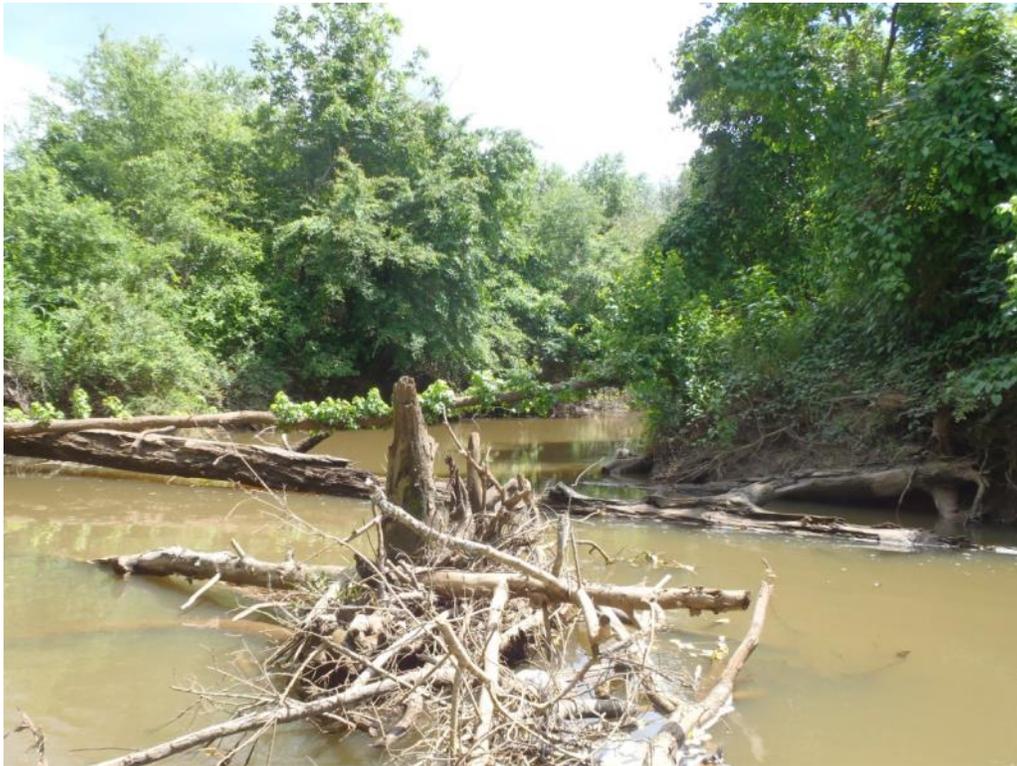
Figure 5.3 Photograph of Prairie Creek Site PC01 taken on June 3, 2014. The downstream view of the 0-m transect.

Prairie Creek at Site PC01 was visited on June 3 and August 8, 2014. This site is located at the bridge crossing of State Highway 64 approximately 9 miles west of Tyler, Texas in Smith County. Site PC01 is publicly accessible at the bridge crossing. A dirt trail is located on the south side of the bridge crossing, which made access to the stream easy (Table 5.6). TIAER personnel were able to drive directly to the stream and launch a small boat. The corridor on either side of the stream was forested at this site (Table 5.5), as shown in Figures 5.3 and 5.4 showing the general appearance of the site during each survey.

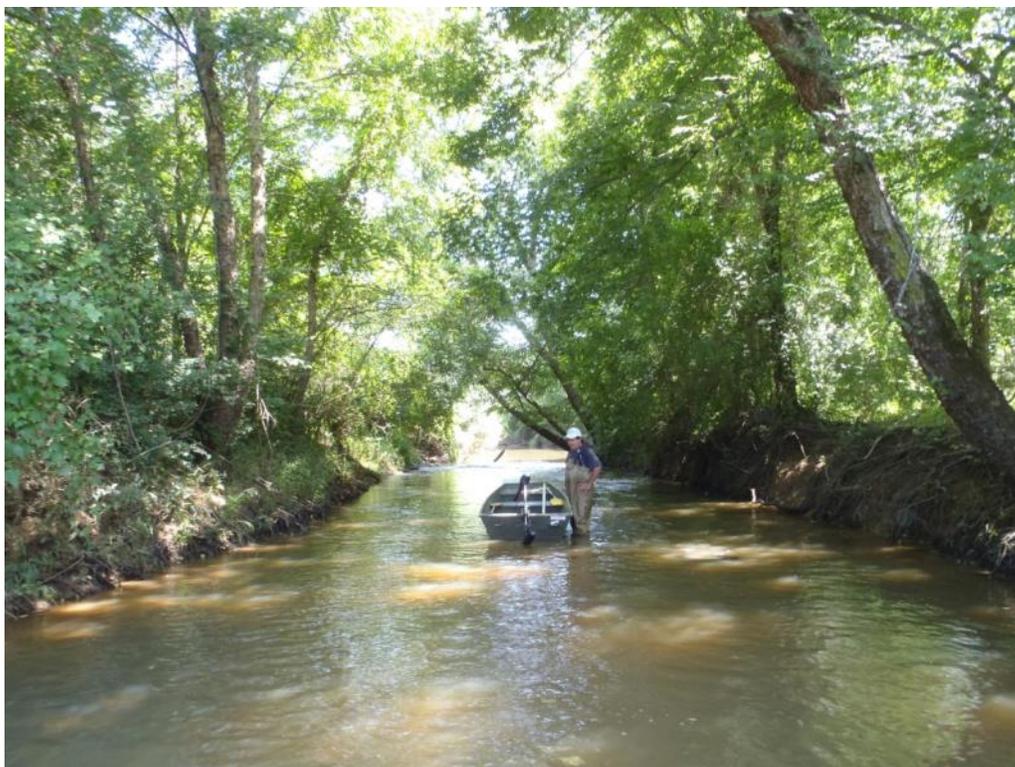
Figure 5.4 Photograph of Prairie Creek Site PC01 taken on August 8, 2014. The downstream view of the 150-m transect. TIAER personnel in photograph.

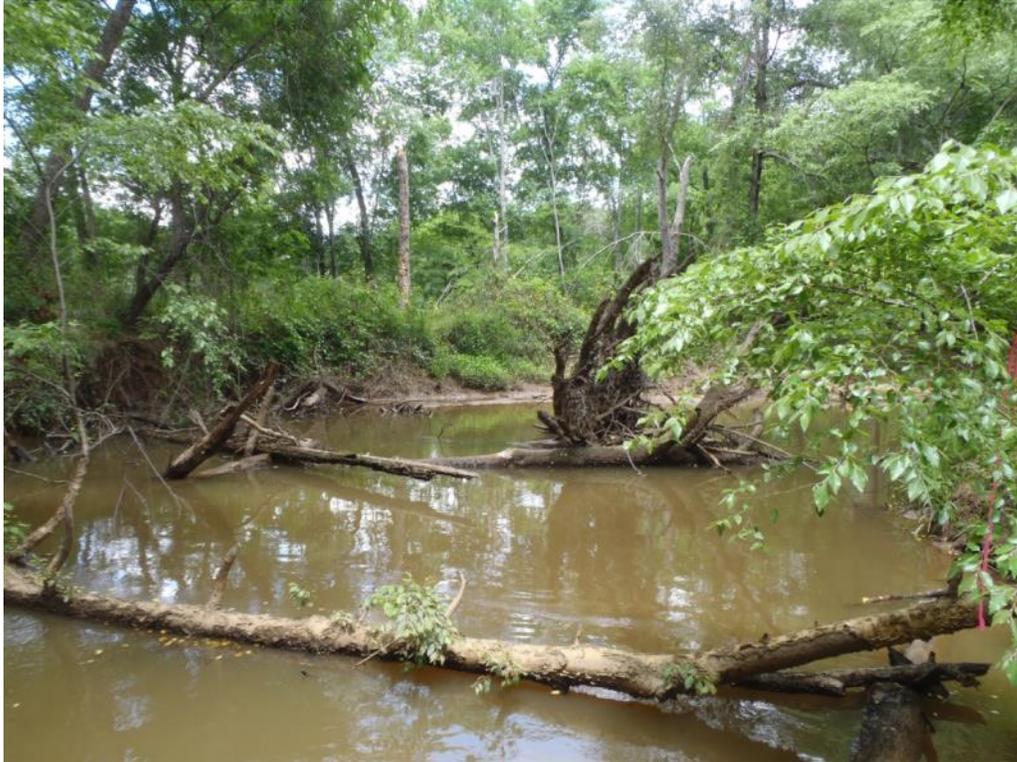
Figure 5.5 Photograph of Prairie Creek Site PC02 taken on June 3, 2014. The upstream view of the 300-m transect.

Prairie Creek at Site PC02 was visited on June 3 and August 8, 2014. This site is located at the bridge crossing of Farm to Market 724 approximately 9 miles west of Tyler, Texas in Smith County. Site PC02 is publicly accessible at the bridge crossing, and a trail large enough for a vehicle to drive down was located along the northwest side of the bridge. TIAER used this trail to access the creek and deployed a small boat for use during the surveys. The stream corridor was dominated by forest on both sides (Table 5.5). Access to the stream was moderately easy (Table 5.6) rather than easy due to slightly steep banks and relatively deep water at the stream edge. There were banks throughout the reach that were steep and more treacherous. The general appearance of the creek is shown in Figures 5.5 and 5.6.

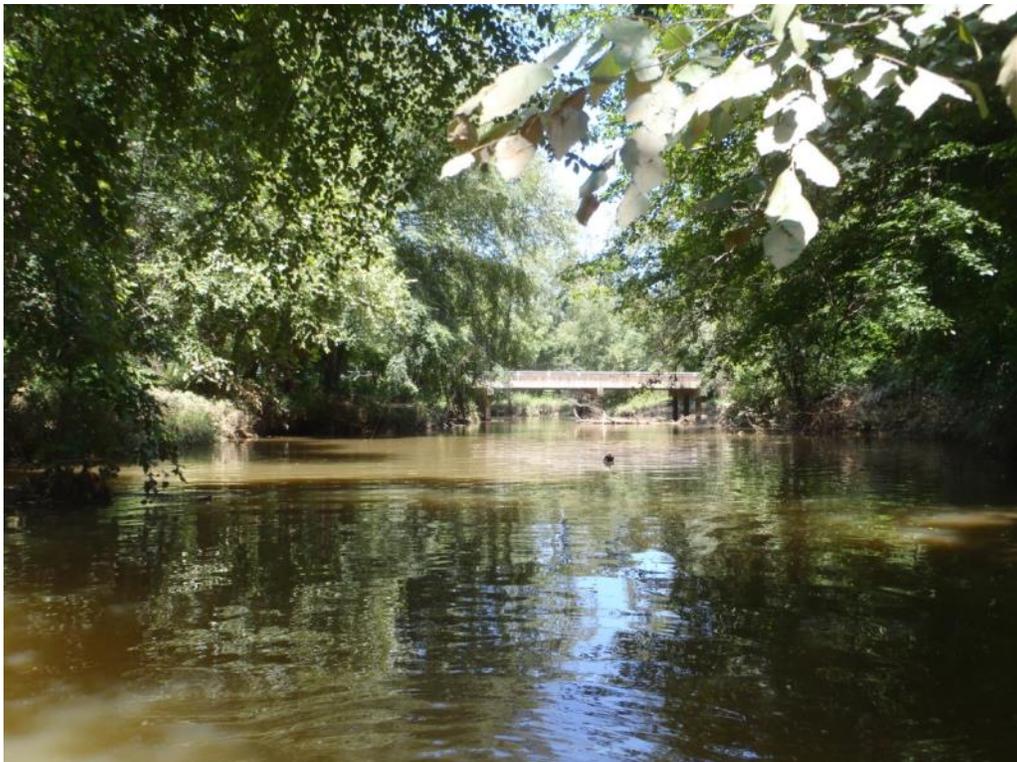
Figure 5.6 Photograph of Prairie Creek Site PC02 taken on August 8, 2014. The upstream view of the 0-m transect.

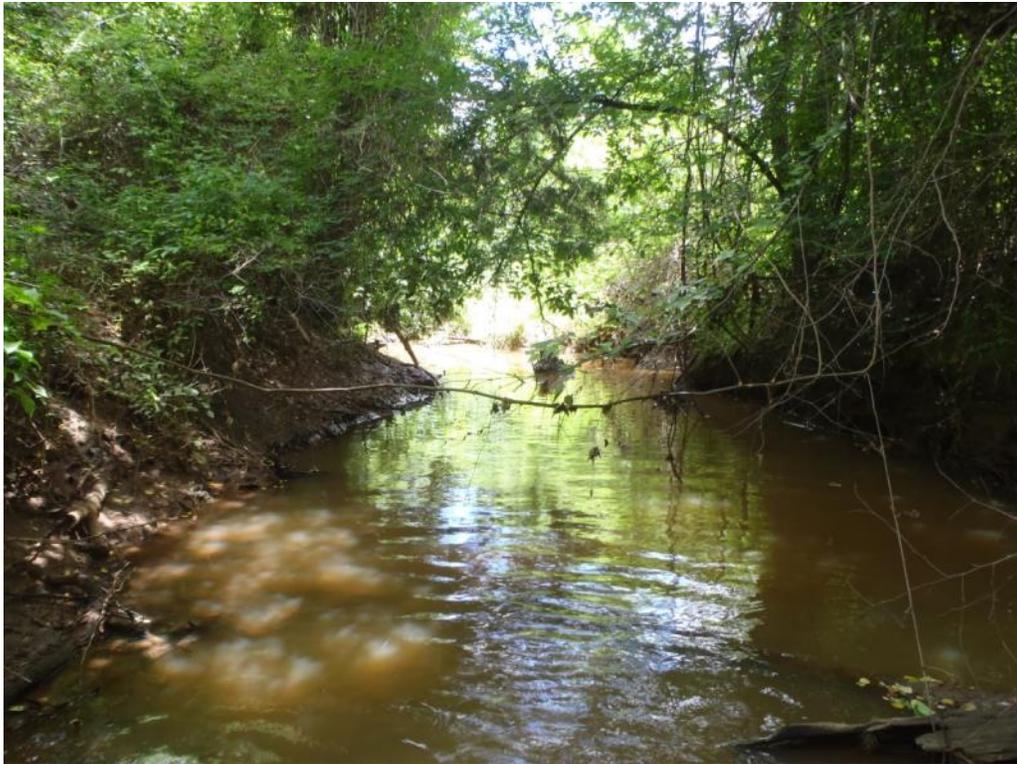
Figure 5.7 Photograph of Prairie Creek Site PC03 taken on June 3, 2014, the upstream view of the 300-m transect.

Prairie Creek at Site PC03 was visited on June 3 and August 8, 2014. This site is located at the bridge crossing on Old Harmony Road, 9 miles northwest of Tyler, Texas. Site PC03 was only publicly accessible at the bridge crossing with fenced private property located upstream and downstream of the road right-of-way. The stream corridor was forested (Table 5.5), and dense vegetation and steep banks under the bridge and throughout the reach made access difficult (Table 5.6). To access the stream, TIAER personnel lowered a small boat by rope from the bridge down to the stream. Figures 5.7 and 5.8 depict the general appearance of the site during each survey.

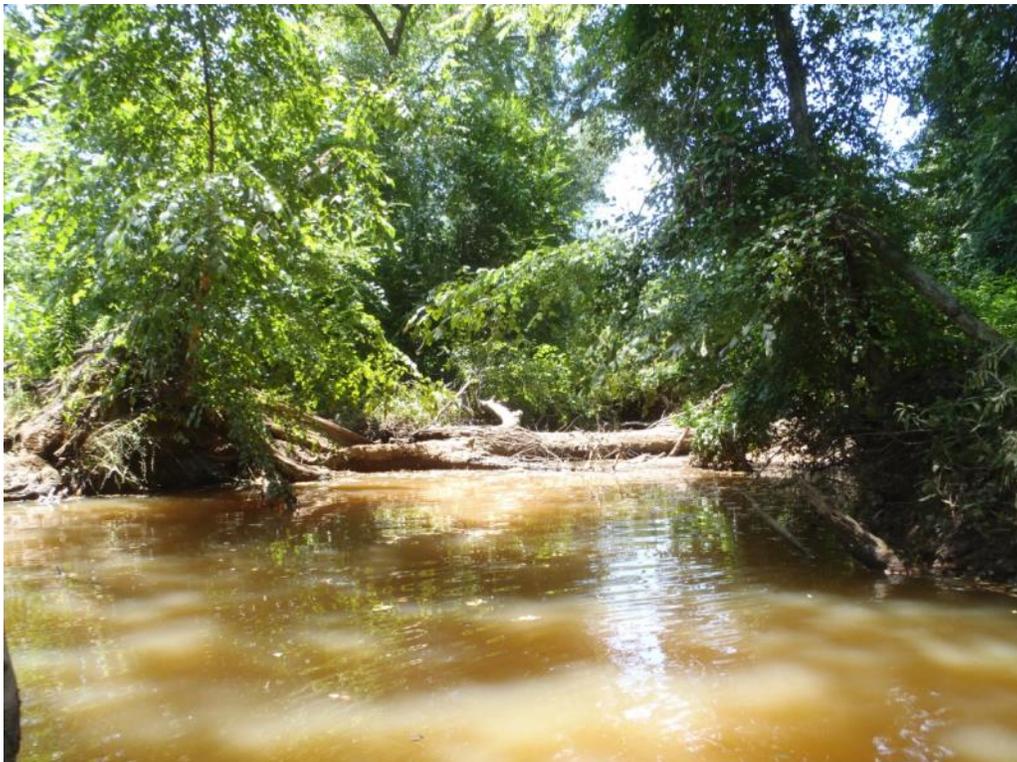
Figure 5.8 Photograph of Prairie Creek Site PC03 taken on August 8, 2014, the downstream view of the 0-m transect.

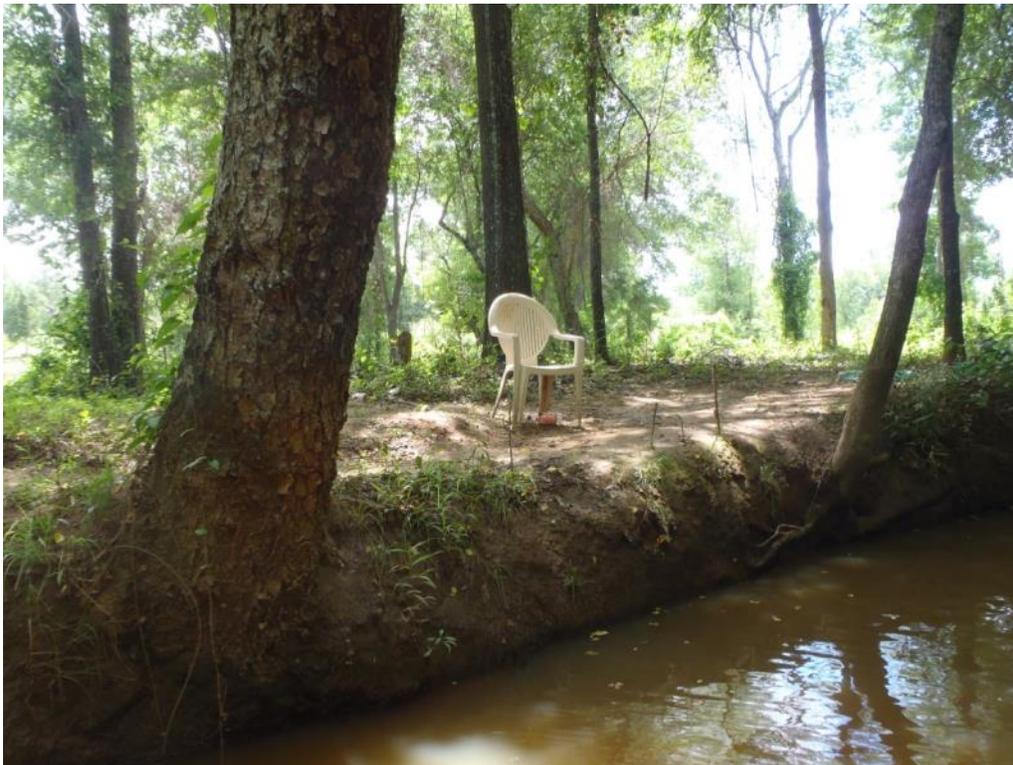
Figure 5.9 Photograph of Prairie Creek Site PC03 taken on June 3, 2014, showing a chair and fishing rod holders located near the 60 m transect.

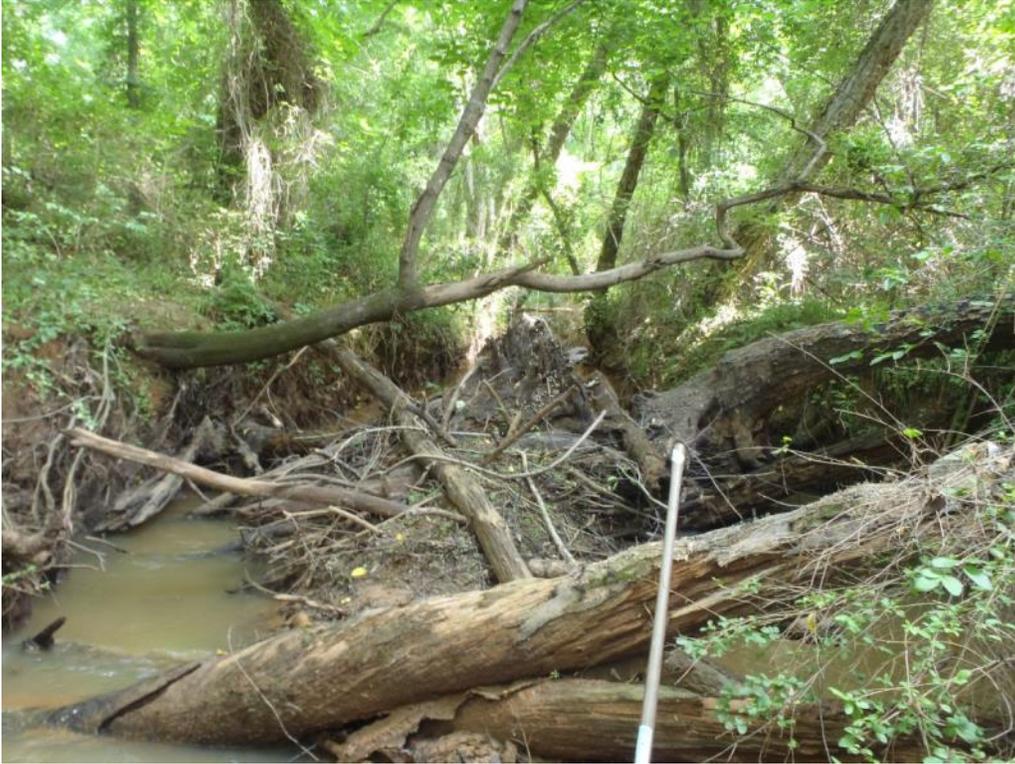
Figure 5.10 Photograph of Prairie Creek Site PC04 taken on June 3, 2014, the upstream view of the 300-m transect.

Prairie Creek at Site PC04 was visited on June 3 and August 8, 2014. This site is located at the bridge crossing on State Highway 110, northwest of Tyler, Texas. Site PC04 was only publicly accessible at the bridge crossing with fenced private property located upstream and downstream of the road right-of-way. The stream corridor was forested along this reach (Table 5.5), and access to the stream was moderately easy at the bridge crossing; however, access would have been difficult elsewhere along the reach due to steep banks and dense vegetation. The general appearance of the stream at PC04 is shown in Figures 5.10 and 5.11.

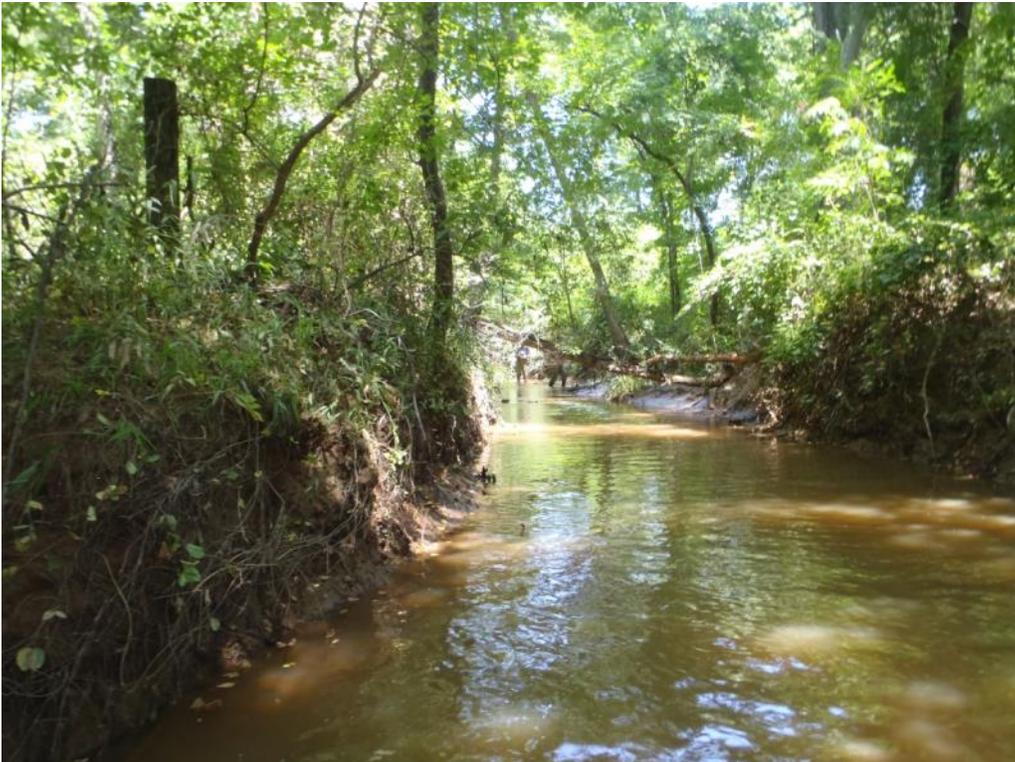
Figure 5.11 Photograph of Prairie Creek Site PC04 taken on August 8, 2014, the upstream view of the 0-m transect.

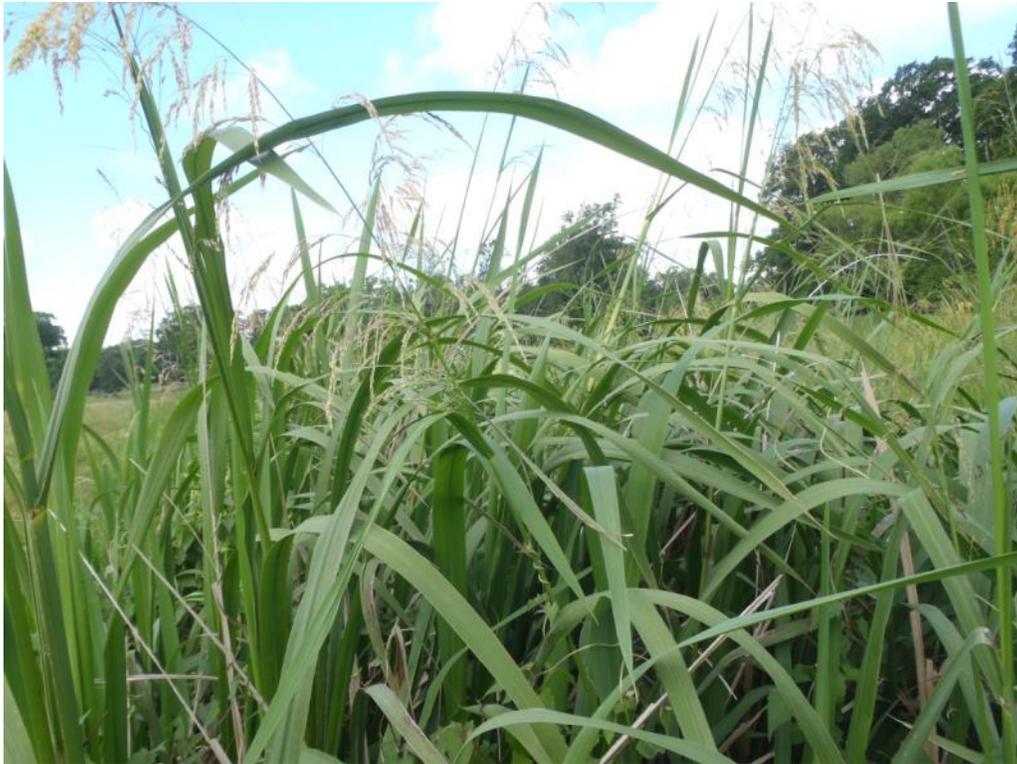
Figure 5.12 Photograph of Prairie Creek Site PC05 taken on June 3, 2014, the downstream view of the 150-m transect.

Prairie Creek at Site PC05 was visited on June 3 and August 8, 2014. This site is located at the bridge crossing on Smith County Road 471, south of Lindale, Texas. Site PC04 was only publicly accessible at the bridge crossing with fenced private property located upstream and downstream of the road right-of-way. With landowner permission, TIAER personnel entered private property on the upstream side of the bridge crossing. Pastures were located on either side of the creek (Table 5.5), making access to the stream moderately easy (Table 5.6). Figures 5.12 and 5.13 depict the appearance of the site during each survey.

Site PC05 was wadeable for the entire 300-m reach length; however, dense tall aquatic vegetation made traversing the reach very difficult (Figure 5.12). Average thalweg was 0.7 m during both surveys (Table 5.6). Stream widths ranged from 1.0 m to 30 m during the first survey and from 2.0 m to 33 m during the second survey (Tables 5.7 and 5.8).

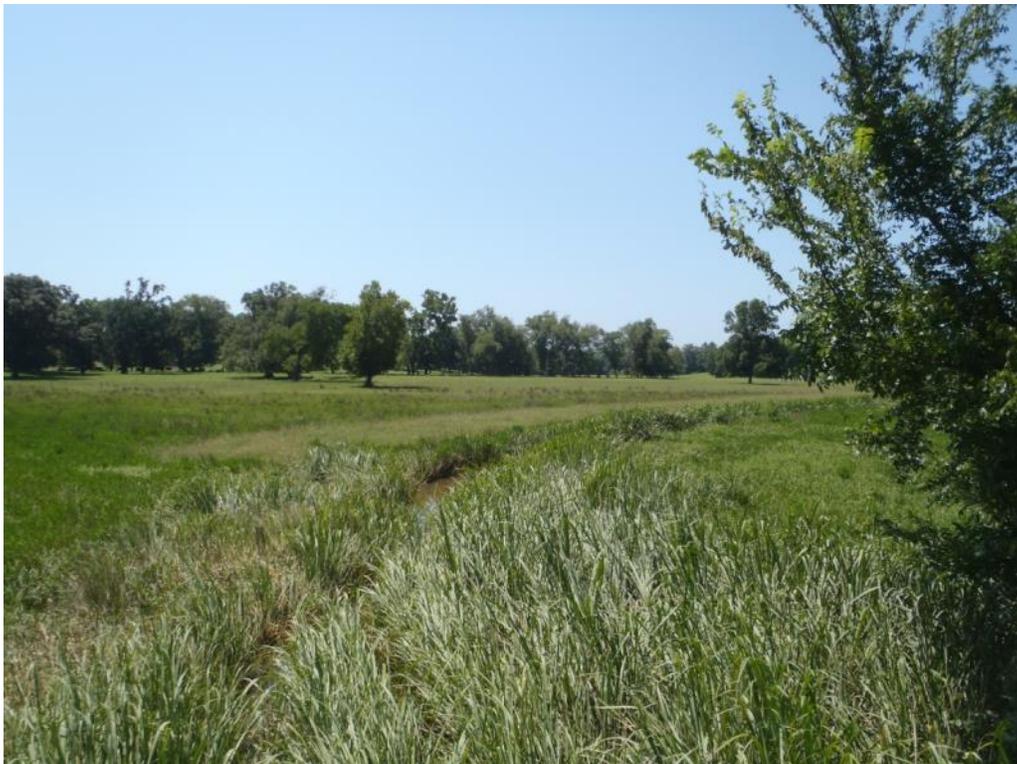
Figure 5.13 Photograph of Prairie Creek Site PC05 taken on August 8, 2014, the downstream view of the 300-m transect.

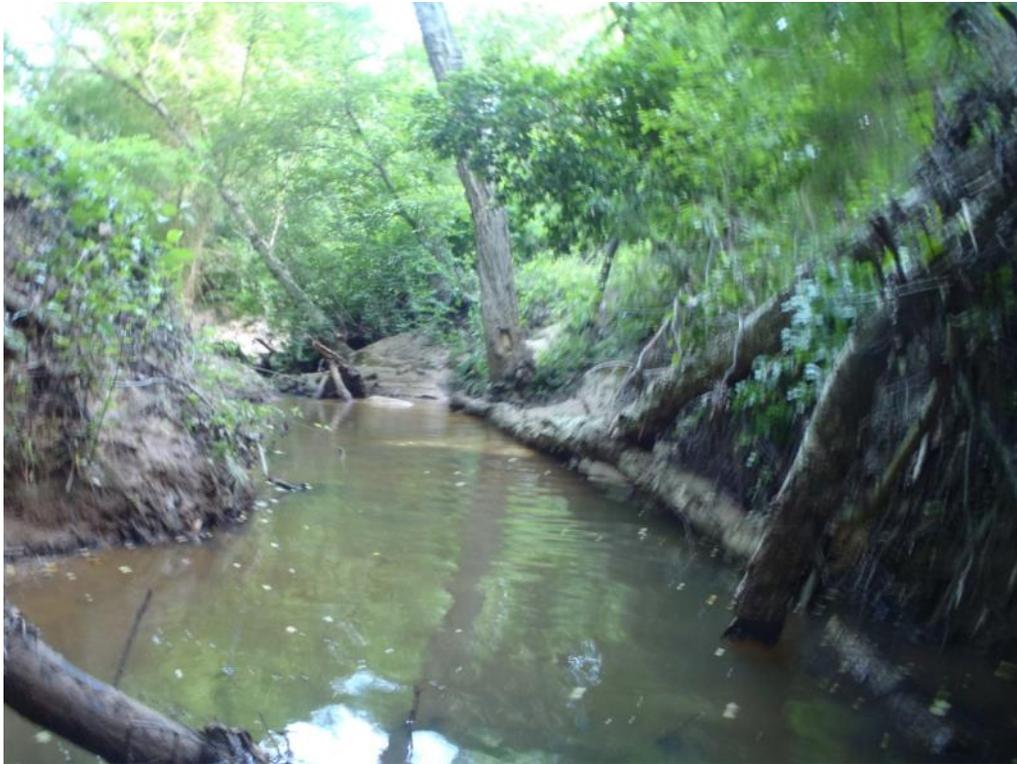
Figure 5.14 Photograph of Prairie Creek Site PC06 taken on June 3, 2014, the upstream view of the 300-m transect.

Prairie Creek at Site PC06 was visited on June 3 and August 8, 2014. This site is located at the bridge crossing on Smith County Road 472, south of Lindale, Texas. Site PC06 was publicly accessible at the bridge crossing on County Road 472 and also at a bridge crossing associated with Interstate Highway 20, which was located within the surveyed reach. Private properties upstream and downstream of the county road crossing were fenced. The upstream portion of the site was located in a forest dominated corridor and the downstream portion was largely in a shrub dominated corridor (Table 5.5). Access to the stream was moderately easy at the county road crossing and at the Interstate Highway crossing (Table 5.6). Access at other locations upstream and directly downstream of the county road crossing would be challenging due to steep banks and dense vegetation. The general appearance of the stream is shown in Figures 5.14 and 5.15.

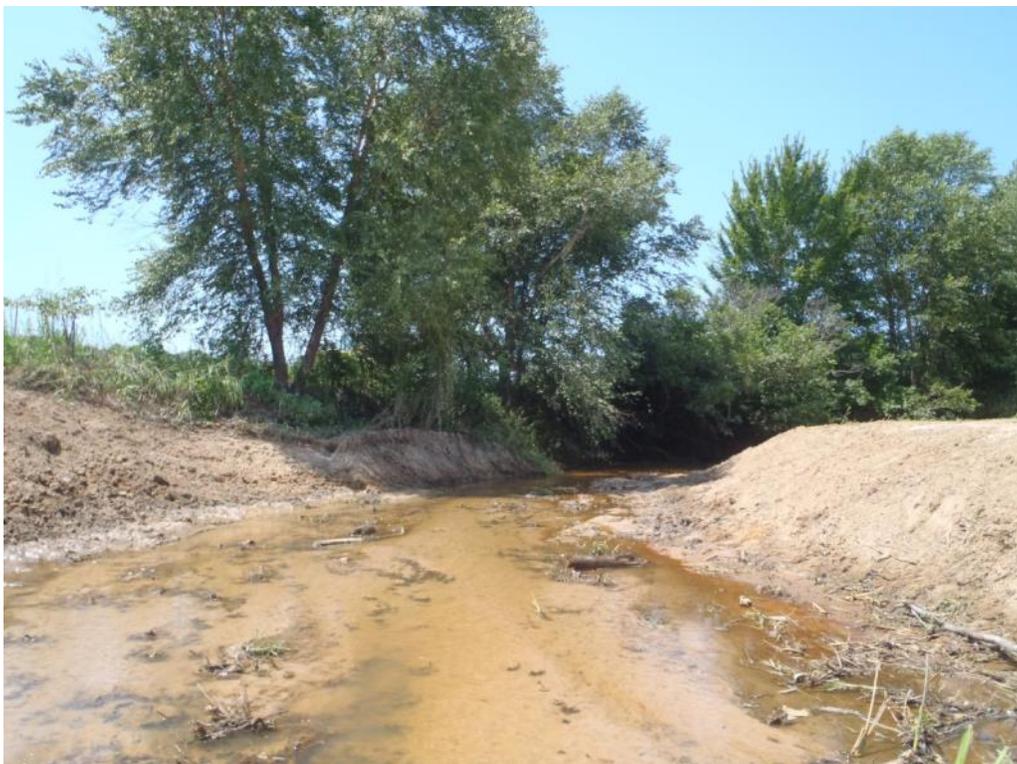
Figure 5.15 Photograph of Prairie Creek Site PC06 taken on August 8, 2014, the downstream view of the 0-m transect.

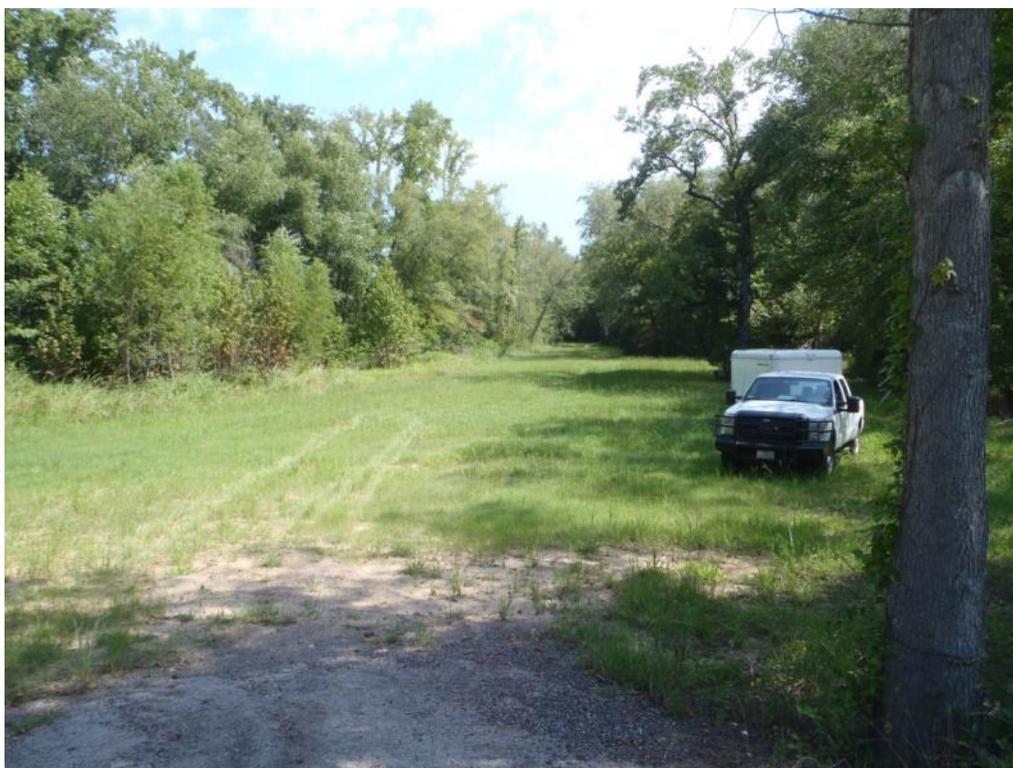
Figure 5.16 Photograph of mowed corridor along the right bank of Prairie Creek Site PC07 taken on August 8, 2014. TIAER vehicle in photograph.

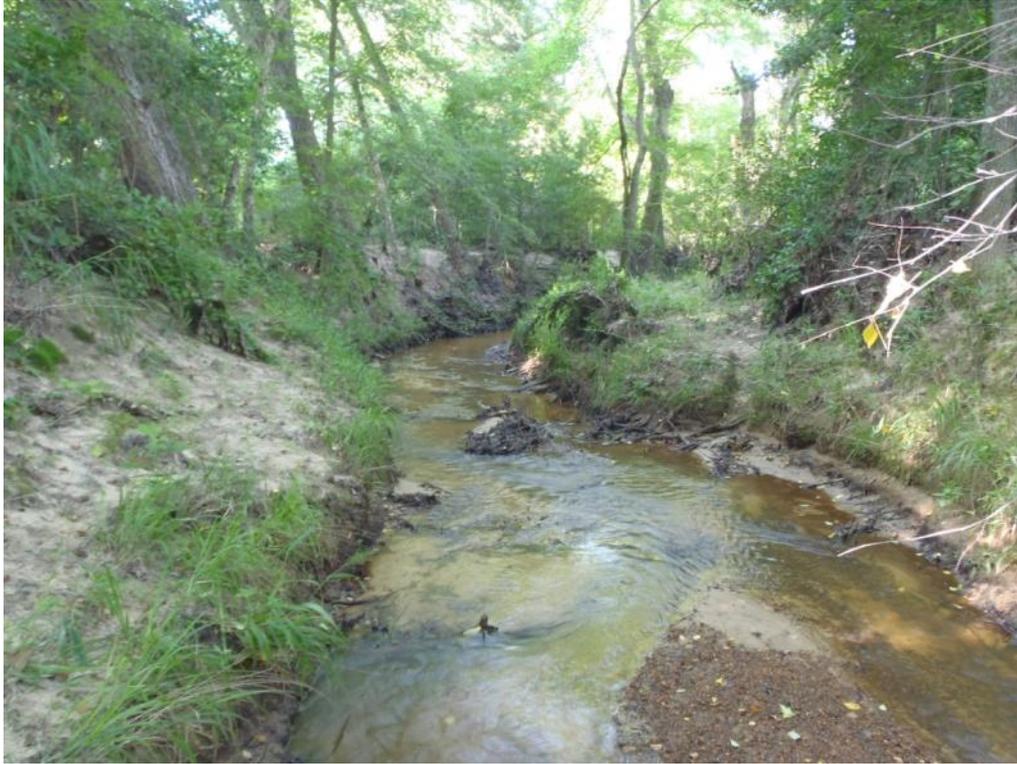
Figure 5.17 Photograph of Prairie Creek Site PC07 taken on June 3, 2014, the downstream view of the 150-m transect.

Prairie Creek at Site PC07 was visited on June 3 and August 8, 2014. This site is located at the bridge crossing on Smith County Road 474, south of Lindale, Texas. Site PC07 was publicly accessible upstream of the crossing, but fenced private property was located south of the crossing. Although landowner permission was sought and granted for the downstream property, the survey was conducted upstream of the crossing because a utility easement bordered the west side of the stream making the stream more readily accessible. The Lindale Junior High School is located approximately 0.2 miles northwest of the bridge crossing. The stream corridor was forested along the left bank and mowed along the right bank (Figure 5.16). Access to the stream was easy along the right bank. The general appearance of the site is shown in Figures 5.17 and 5.18.

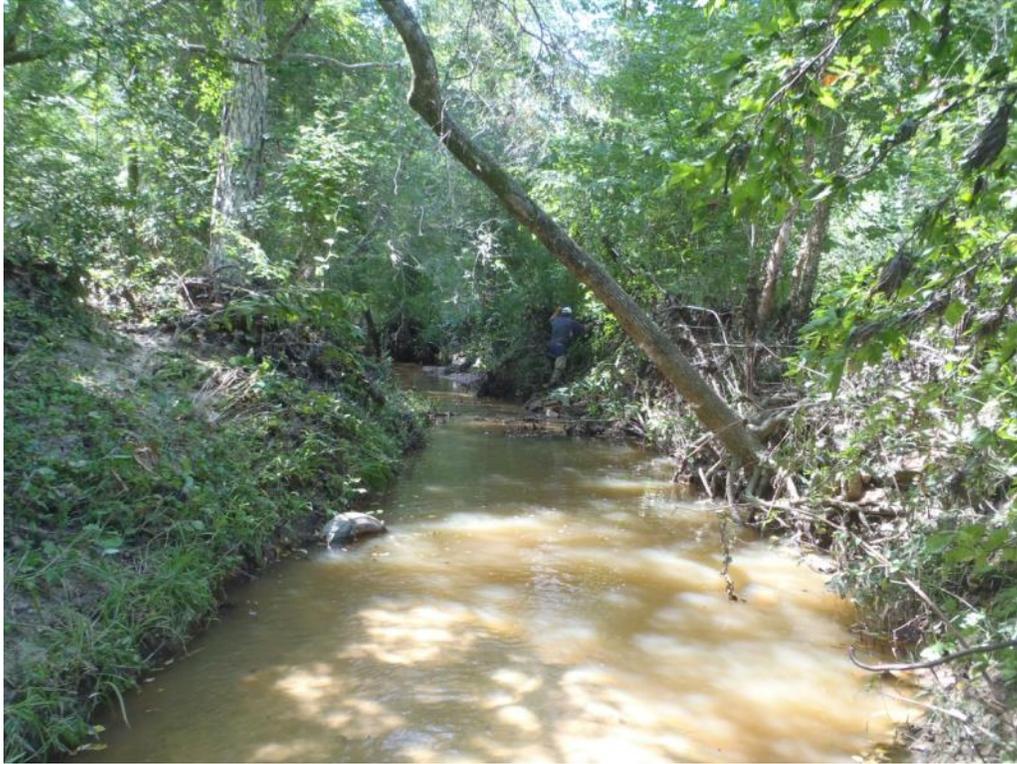
Figure 5.18 Photograph of Prairie Creek Site PC07 taken on June 3, 2014, the downstream view of the 300-m transect. TIAER personnel in photograph.
