Recreational Use Attainability Analysis for
Kickapoo Creek in Henderson County (0605A),
the Neches River Above Lake Palestine (0606),
Prairie Creek (0606A), Mud Creek (0611C), and
West Mud Creek (0611D)
in the Neches River Basin

Prepared for:
Texas State Soil and Water Conservation Board
Project 14-52

Texas Institute for Applied Environmental Research
Tarleton State University
Stephenville, Texas

TR1503
September 2015

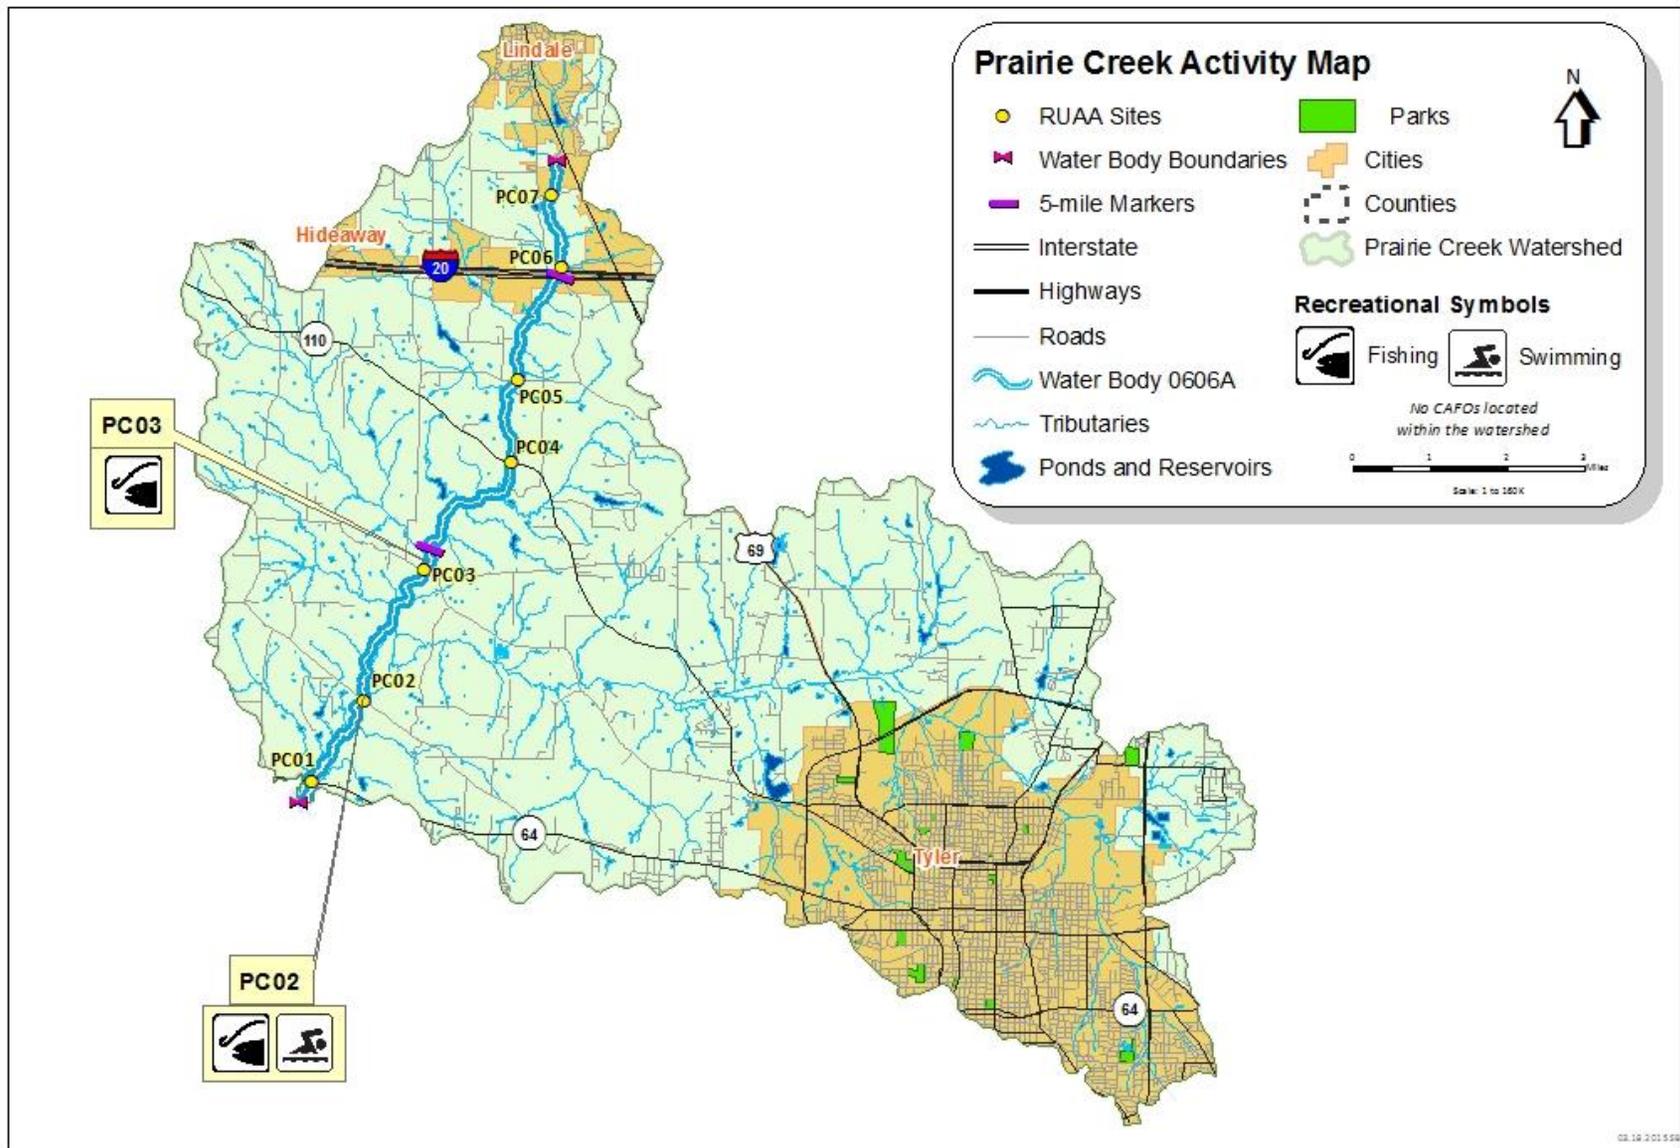
Figure 5.19 Summary of observed and interviewed human activities on Prairie Creek.

RUAA surveys were conducted at seven sites along Prairie Creek (0606A) on the days of June 3, 2014 and August 8, 2014. The Palmer Drought Severity Index (PDSI) represented slightly wet conditions during both surveys (TWDB, 2014). During the two surveys, TIAER field staff observed only one individual fishing and this was at Site PC02 at the FM 724 bridge crossing. Interviews for Prairie Creek revealed that swimming had occurred at least one time in the last year at Site PC02. Additionally interviews indicated that fishing occurs at Sites PC02 and PC03. Site PC03 is located at the bridge crossing of Old Harmony Road. Areas of the stream open to the public are limited to the right-of-ways immediately underneath bridge crossings at all sites except PC07, which has a maintained utility right-of-way along the right bank. Recreational activities observed and reported by interviewees are summarized in Figure 5.19. Overall RUAA findings are summarized in the form below.

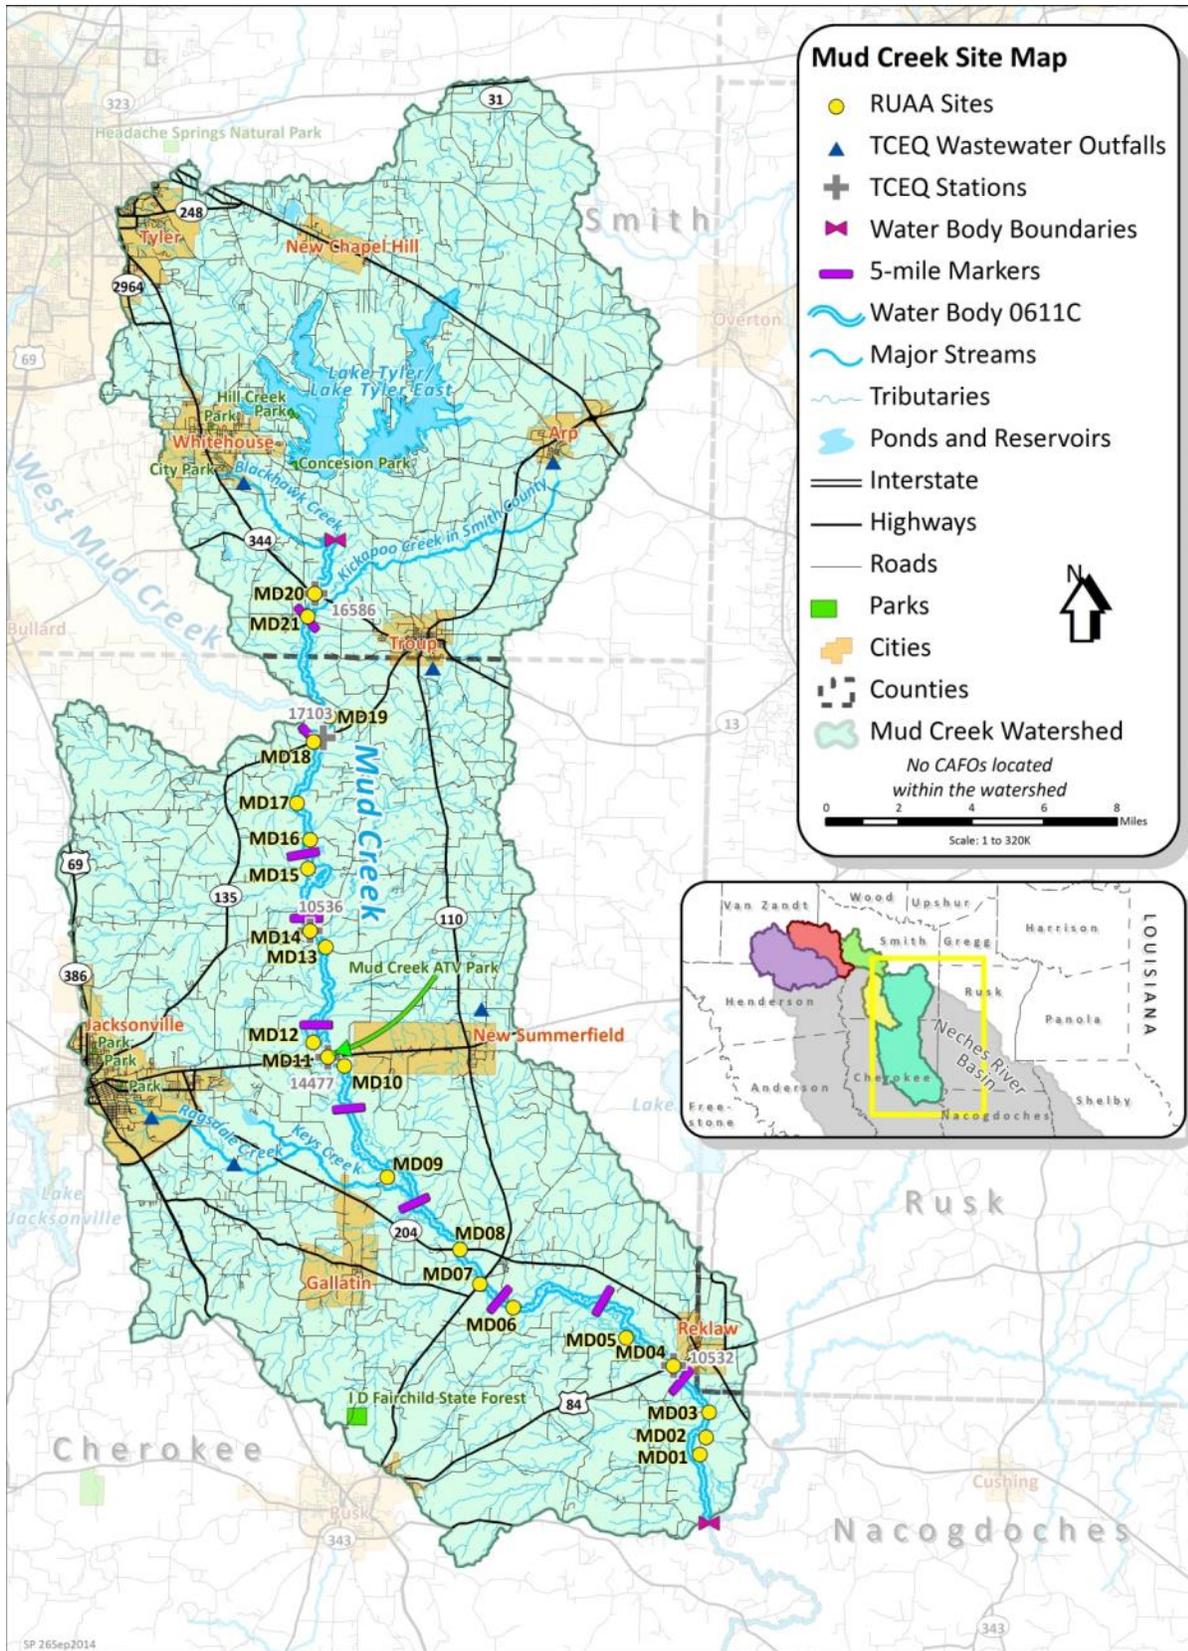
Figure 6.1 Overview of Mud Creek watershed and RUAA sites for water body 0611C.

With the help of cooperating stakeholders, TIAER was able to establish 21 survey sites along the almost 54 mile long water body of Mud Creek, 0611C (Figure 6.1 and Table 6.2). Although the optimum number of sampling stations would have been 32, following the RUAA guidelines, acceptance of using only 21 stations was sought and granted from TCEQ. Eleven sites were chosen at public road crossings that did not require permission for access to the creek, but did require landowner cooperation to conduct the full 300 meter assessment. The remaining ten privately controlled sites were selected to provide physical characterization of Mud Creek in areas between public access points. Entrances to sites on private lands were generally limited by fences and locked gates and were often several meters to kilometers from the stream.

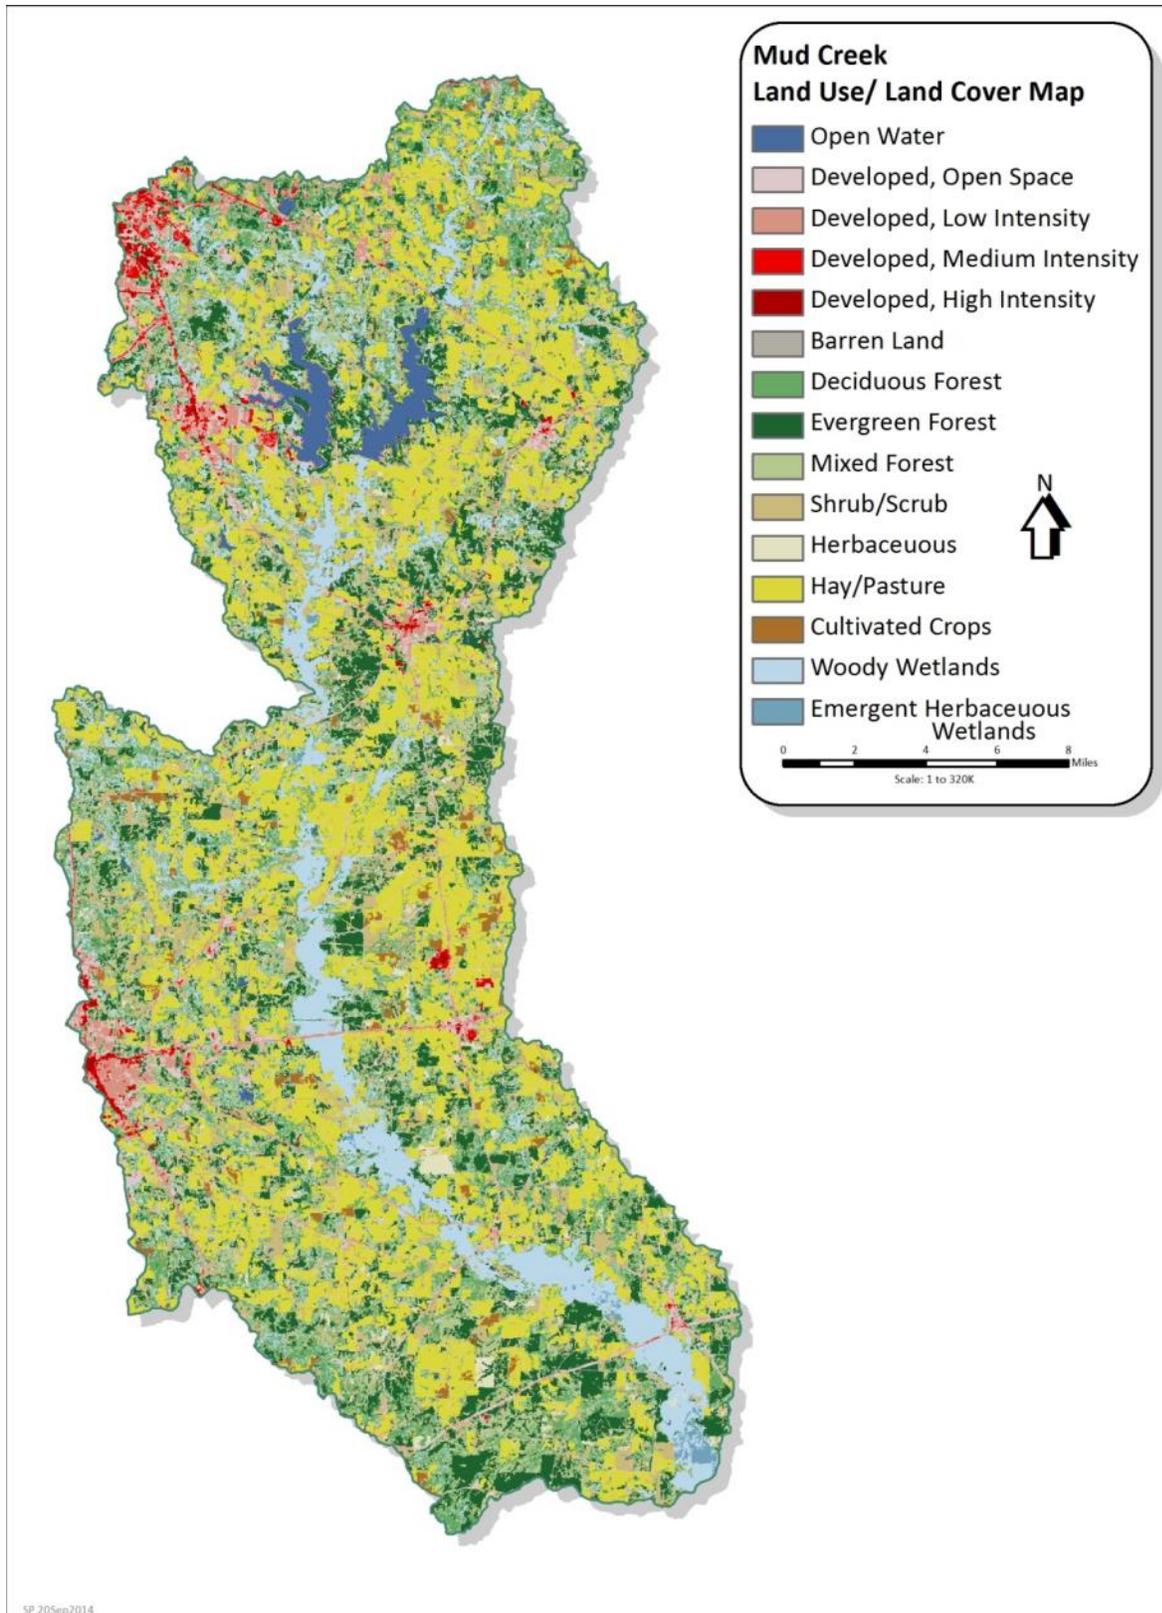
Figure 6.2 Land use/land cover for the Mud Creek watershed. Source: 2011 National Land Cover Database (USGS, 2013).

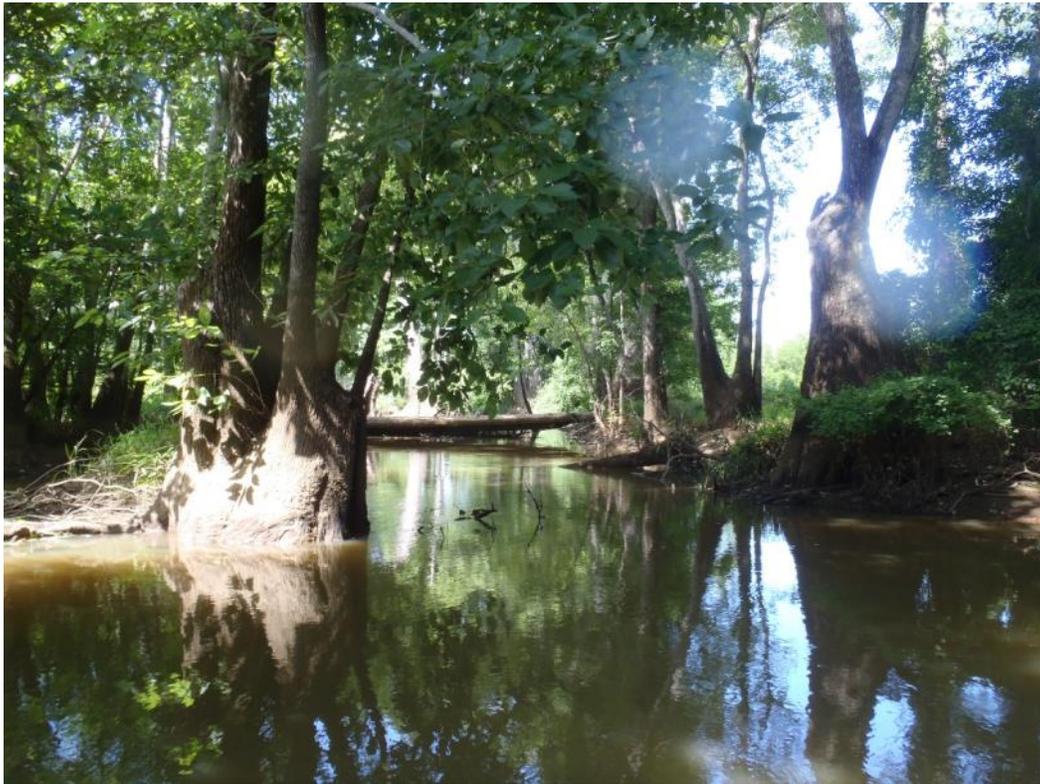
Figure 6.3 Photograph of Mud Creek Site MD01 taken on July 27, 2014. The downstream view of a bridge located at the 0-m transect.

Mud Creek at Site MD01 was visited on July 27 and August 24, 2014. This site, located south of Reklaw, Texas in Cherokee County, was accessible only through private property that was fenced with a locked gate. After entering the private property, TIAER personnel drove approximately 1.7 miles down a pasture road to reach the stream and then waded an additional 0.4 miles to reach site MD01. The site is located in a forest dominated corridor (Table 6.5). At the site, access to the stream was moderately difficult due to abundant vegetation (Table 6.6). At the 0-m transect, a small privately owned bridge was located across the stream (Figure 6.3). Large tupelo trees were common within and adjacent to the stream channel, and thick canopy cover persisted throughout the reach. Figures 6.3 and 6.4 depict the appearance of the site during each survey.

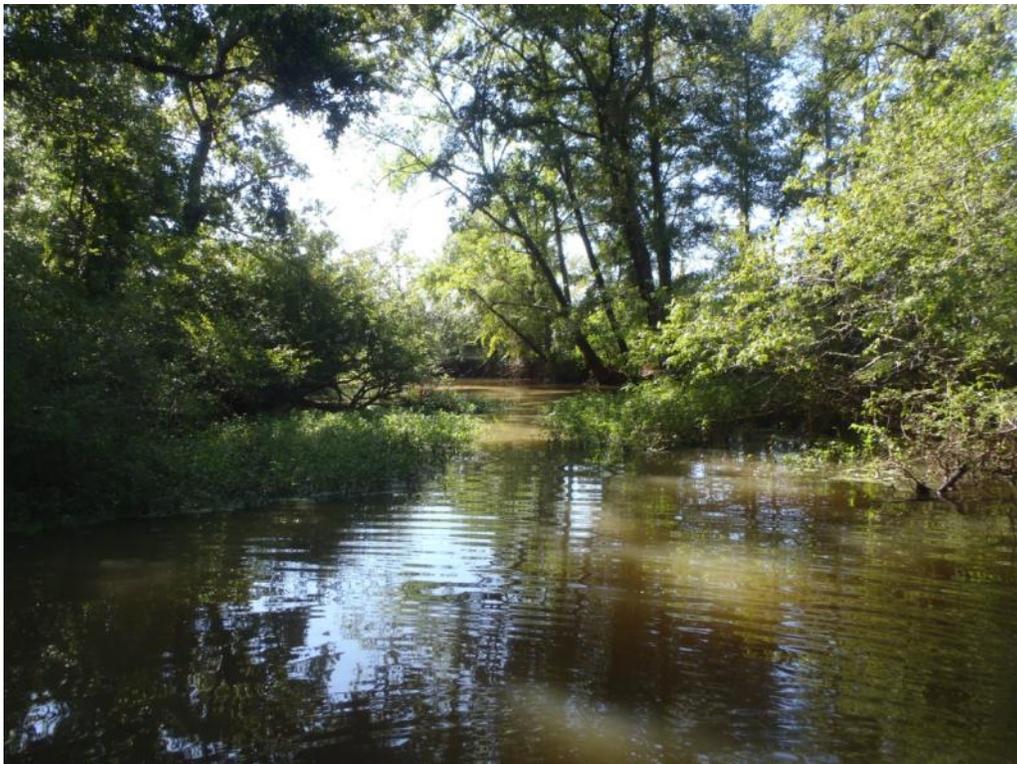
Figure 6.28 Photograph of Mud Creek Site MD09 taken on August 24, 2014, the downstream view of the 0-m transect.

Mud Creek at Site MD09 was visited on July 27 and August 24, 2014. This site was located 1.2 miles north of Highway 204, north of Gallatin, Texas. Site MD09 was only accessible through fenced private property via a locked gate with landowner permission. With landowner permission, TIAER personnel drove approximately 1.6 miles through the fenced private property to reach the site and used a small boat to traverse the reach. A camper trailer and small cabin was located at the site along with a privately owned walkway bridge that crossed the stream (Figure 6.26). Figures 6.27 and 6.28 depict the appearance of the site during each survey.

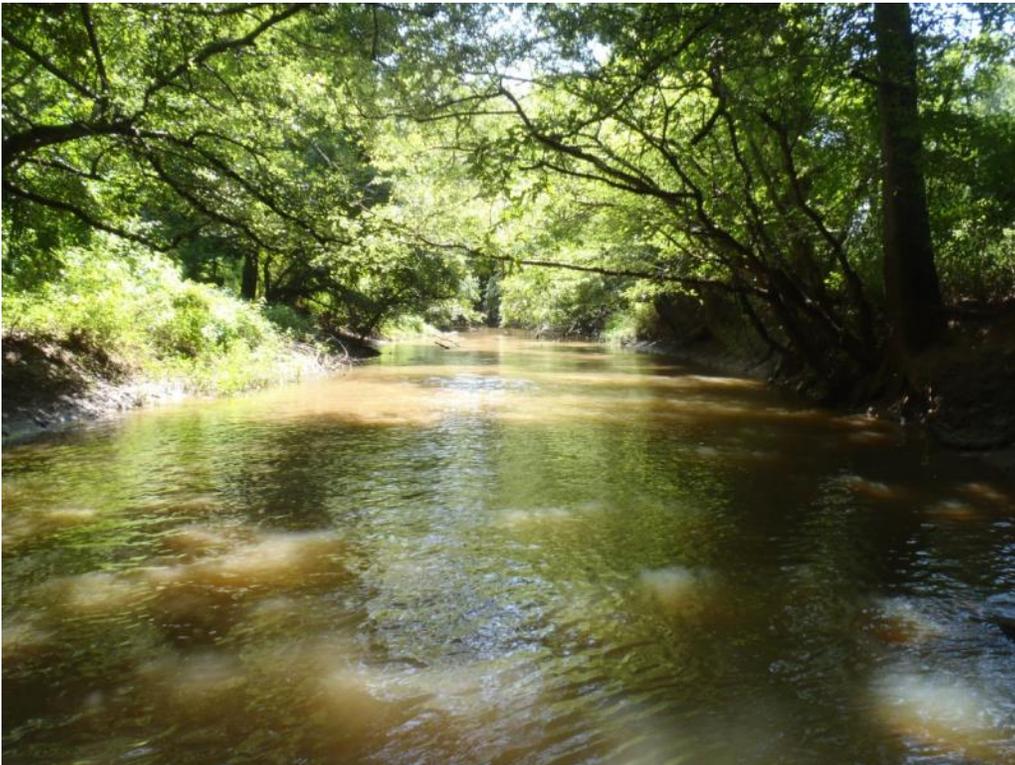
Figure 6.29 Photograph of Mud Creek Site MD10 taken on July 27, 2014, the upstream view of the 0-m transect.

Mud Creek at site MD10 was visited on July 27 and August 24, 2014. This site, located east of Jacksonville, Texas in Cherokee County, was accessible only through private lands that were fenced with a locked gate. This property is home to an all-terrain vehicle (ATV) park with many trails throughout the property. With landowner permission, TIAER personnel entered private property and drove approximately 0.5 mile on an ATV trail to reach the site. The site is located in a forest dominated corridor (Table 6.5). At the site, access to the stream was moderately difficult due to dense vegetation and steep, easily erodible banks (Table 6.6). Figures 6.29 and 6.30 depict the appearance of the site during each survey.

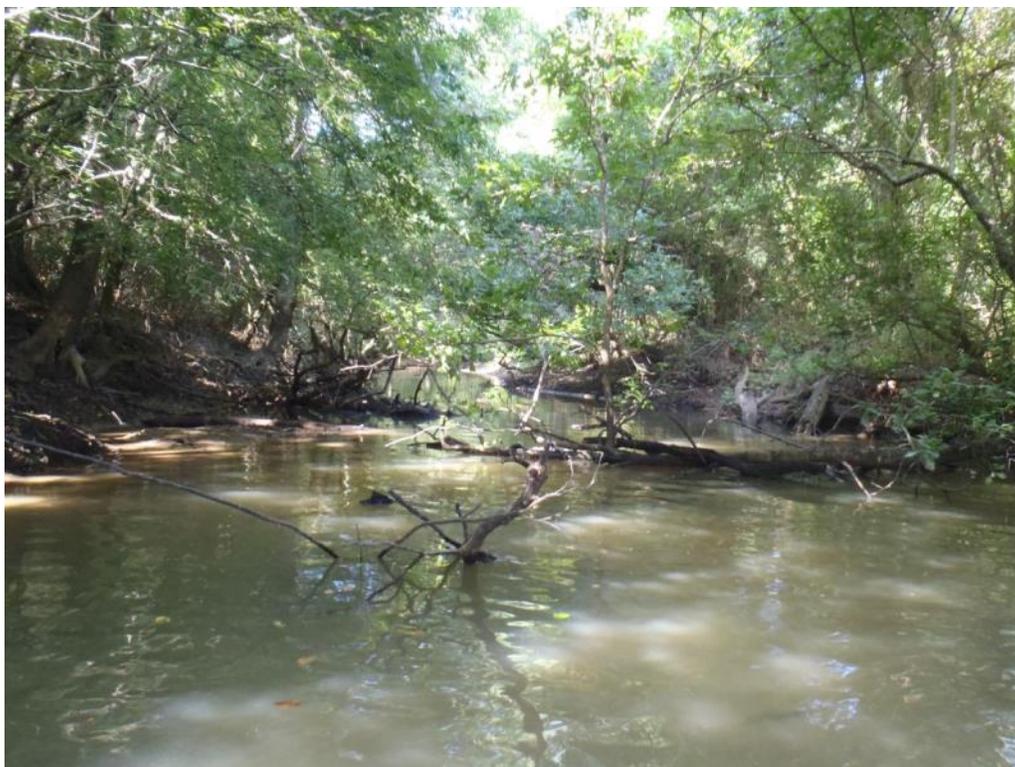
Figure 6.30 Photograph of Mud Creek Site MD10 taken on August 24, 2014, the upstream view of the 150-m transect.

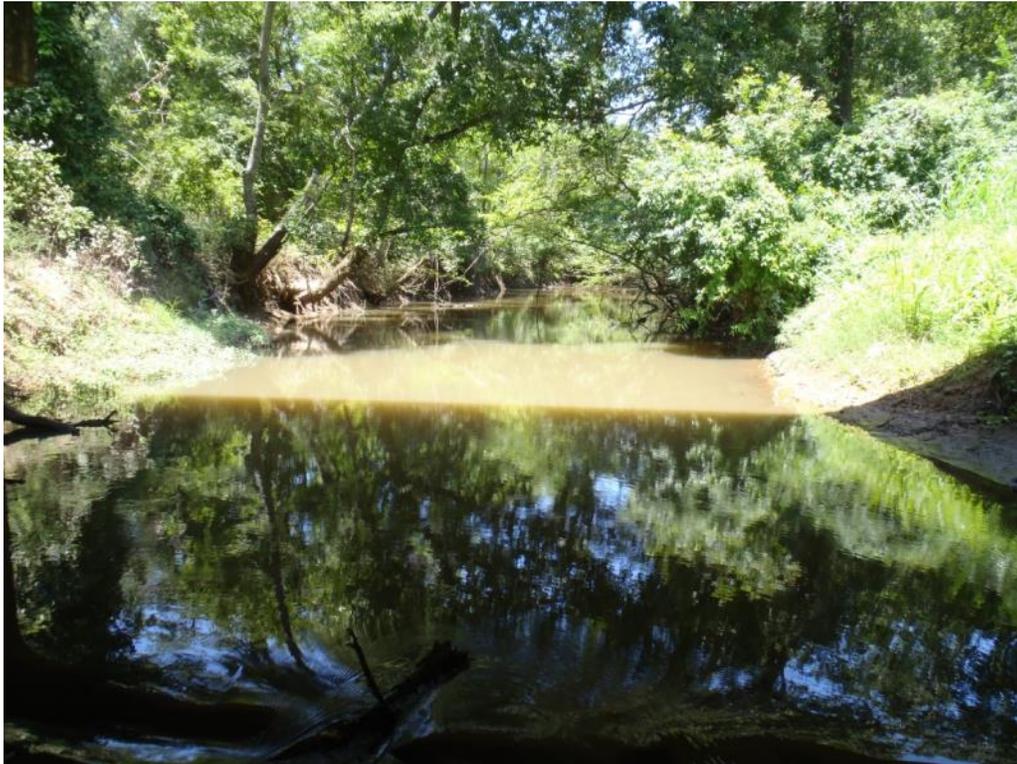
Figure 6.31 Photograph of Mud Creek Site MD11 taken on July 27, 2014, the upstream view of the 0-m transect.

easily erodible banks (Table 6.6). Figures 6.31 and 6.32 depict the appearance of the site during each survey.

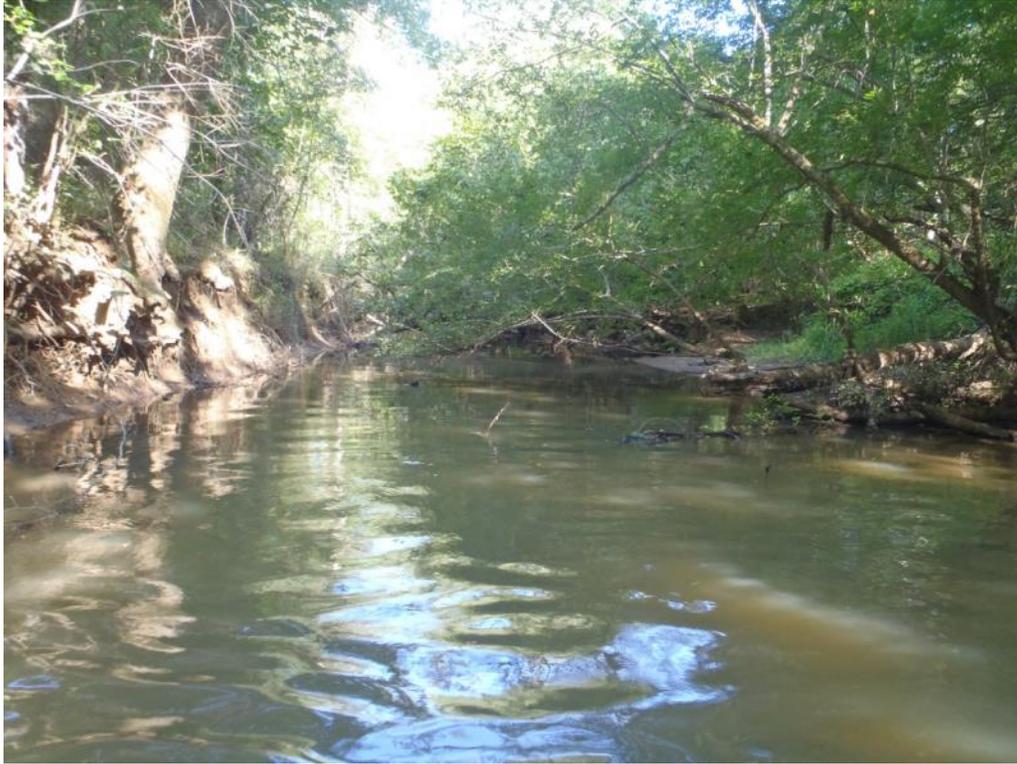
Figure 6.32 Photograph of Mud Creek Site MD11 taken on August 27, 2014, the upstream view of the 300-m transect.

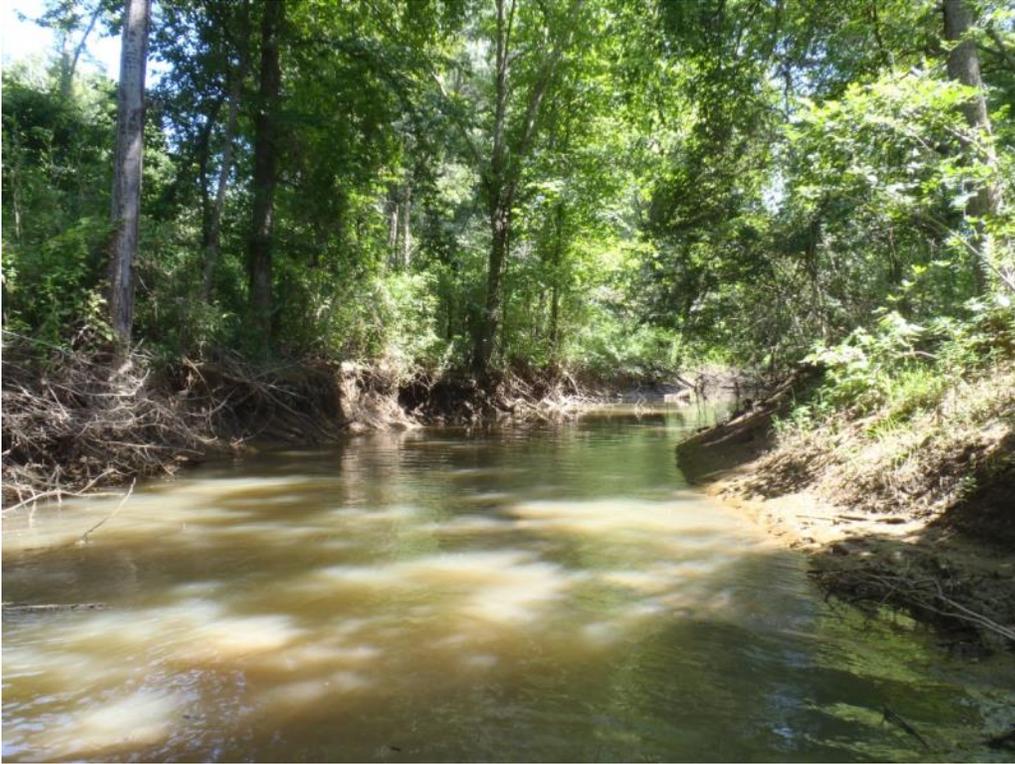
Figure 6.33 Photograph of Mud Creek Site MD12 taken on July 27, 2014, the downstream view of the 150-m transect.

Mud Creek at site MD12 was visited on July 27 and August 24, 2014. This site, located east of Jacksonville, Texas in Cherokee County, was accessible only through private lands, belonging to the Mud Creek ATV Park. With landowner permission, TIAER personnel entered private property through a locked gate and drove approximately one mile down a caliche road, which was a power line right-of-way, to reach the site. The site was located in a forest dominated corridor with ATV trails throughout the area (Table 6.5). Access to the stream was easy (Table 6.6). Figures 6.33 and 6.34 depict the appearance of the site during each survey.

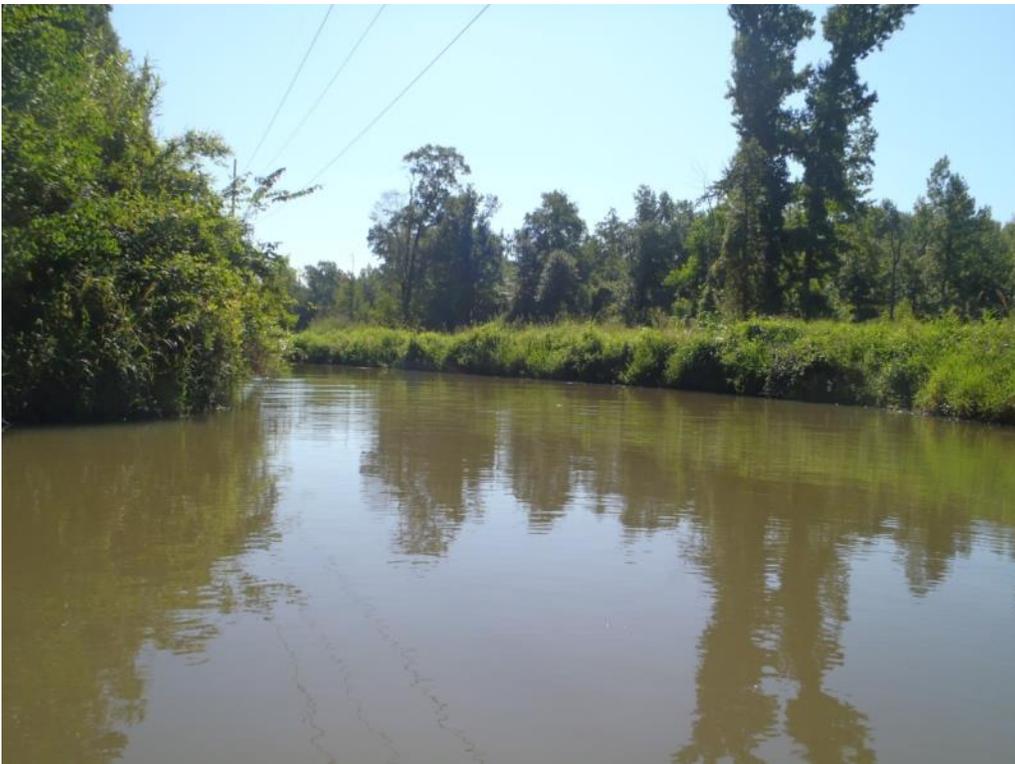
Figure 6.34 Photograph of Mud Creek Site MD12 taken on August 24, 2014, the downstream view of the 300-m transect.

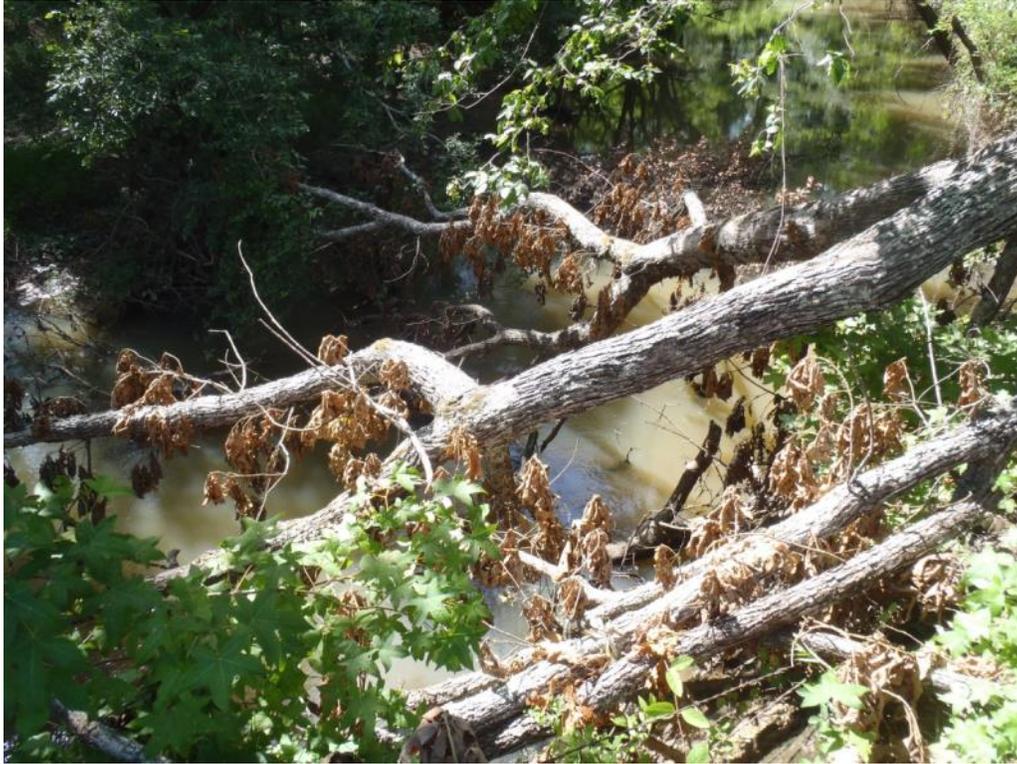
Figure 6.35 Photograph of Mud Creek Site MD13 taken on July 27, 2014, view near the 300 m transect from the left bank.

Mud Creek at Site MD13 was visited on July 27 and August 24, 2014. Site MD13 (TCEQ station 10535) is located on Mud Creek at the bridge crossing Cherokee County Road 4223, northeast of Jacksonville, Texas. Site MD13 is publicly accessible at the area immediately underneath the bridge crossing. The site is located in a forest dominated corridor (Table 6.5). Access to the stream was moderately difficult due to steep banks, vegetation, and large tree obstructions (Table 6.6). Figures 6.35 and 6.36 depict the appearance of the site during each survey.

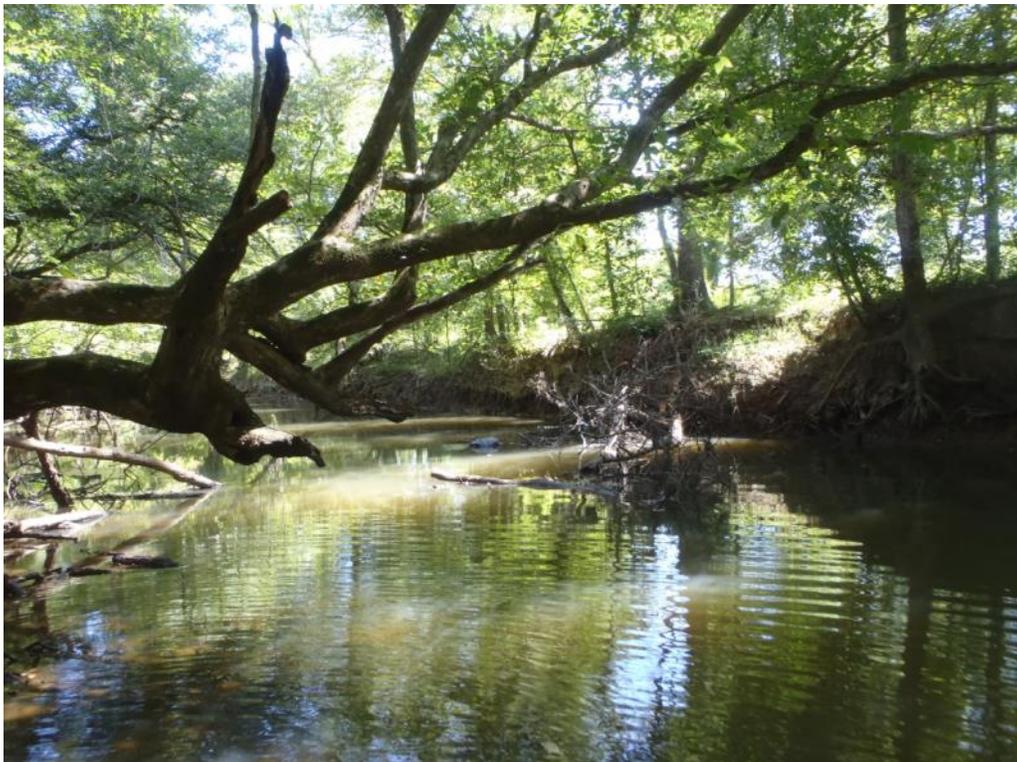
Figure 6.36 Photograph of Mud Creek Site MD13 taken on August 24, 2014, the downstream view of the 0-m transect.

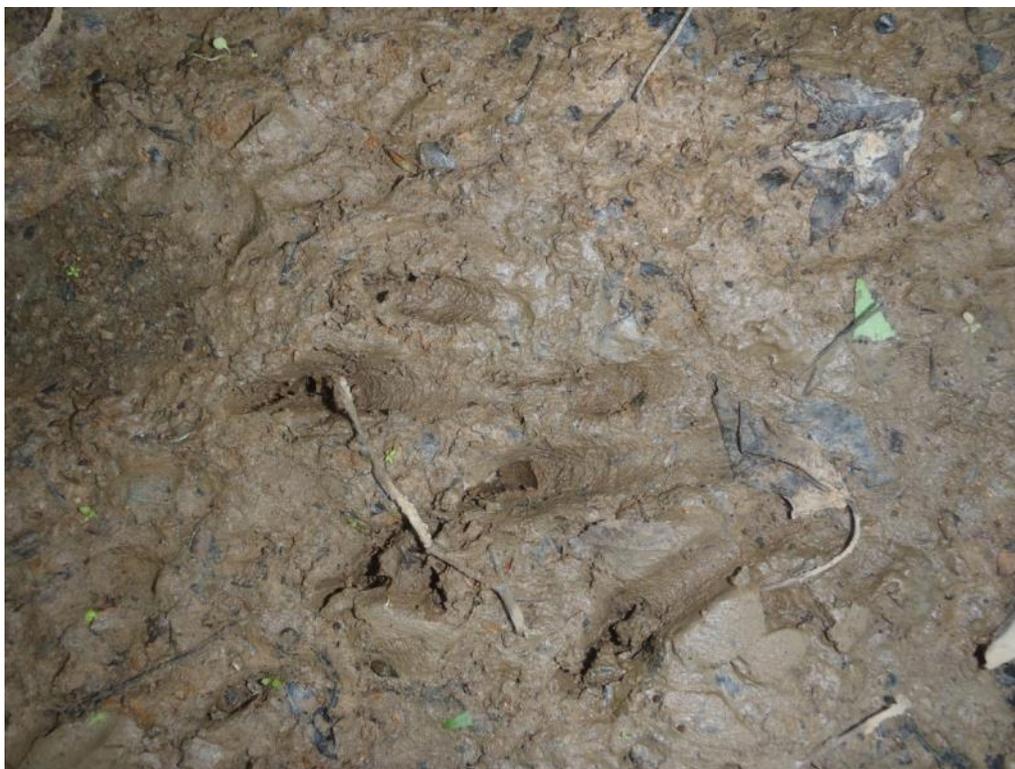
Figure 6.37 Photograph of alligator track near the 30-m transect at Mud Creek Site MD13 taken on August 24, 2014.

There were no reptiles, water dependent birds, or mammals observed during either survey (Tables 6.9 and 6.10). Tracks observed during the first survey consisted of deer and raccoon. Tracks observed during the second survey consisted of feral hog, deer, raccoon, and alligator (Figure 6.37). Water color was brown with a clear surface and aquatic vegetation and algae cover was absent during both surveys. Trash was common both instream and along the bank and included tires, typical plastics, cans, and scrap metal. Remnants of a camp fire near the bridge crossing and graffiti on the bridge railing were the only evidence of human activity observed during the either survey.

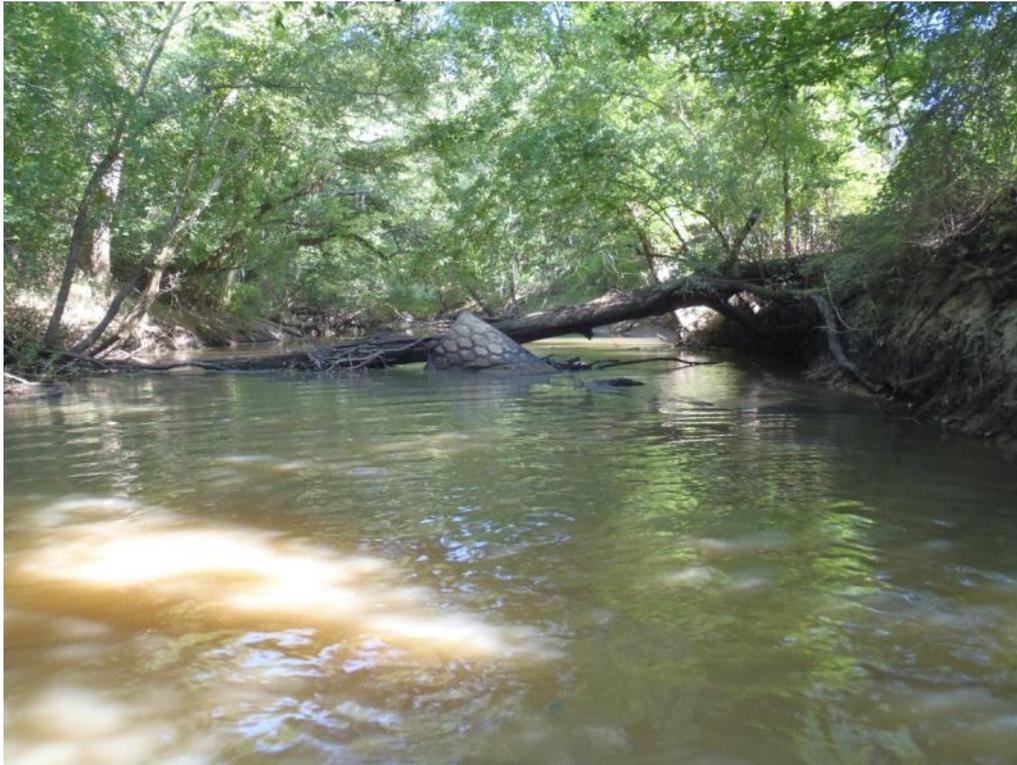
Figure 6.38 Photograph of Mud Creek Site MD14 taken on July 27, 2014, view near the 90 m transect showing a large log obstruction and a discarded mattress.

Mud Creek at site MD14 was visited on July 27 and August 24, 2014. Site MD14 (TCEQ station 10536) is located on Mud Creek at the bridge crossing Farm to Market Road 2064, northeast of Jacksonville, Texas. Site MD14 is publicly accessible at the area immediately underneath the bridge crossing. The site is located in a forest dominated corridor (Table 6.5). Access to the stream was moderately difficult due to steep banks, vegetation, no parking area, and large tree obstructions (Table 6.6). Figures 6.38 and 6.39 depict the appearance of the site during each survey.

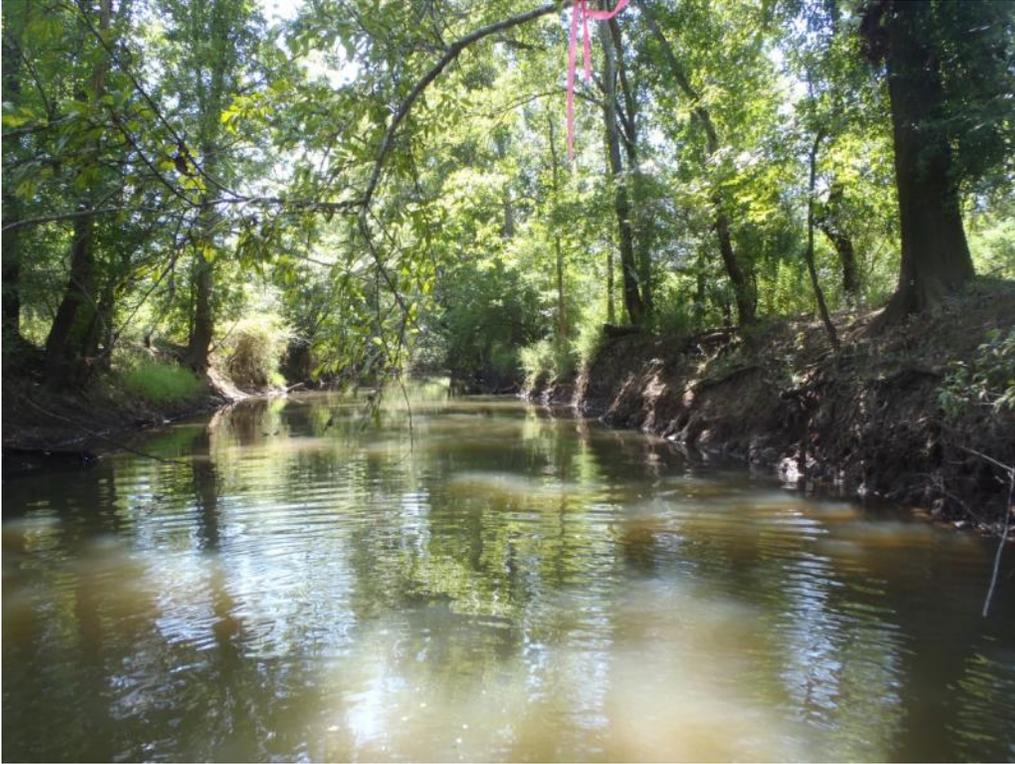
Figure 6.39 Photograph of Mud Creek Site MD14 taken on August 24, 2014, the downstream view of the 150-m transect.

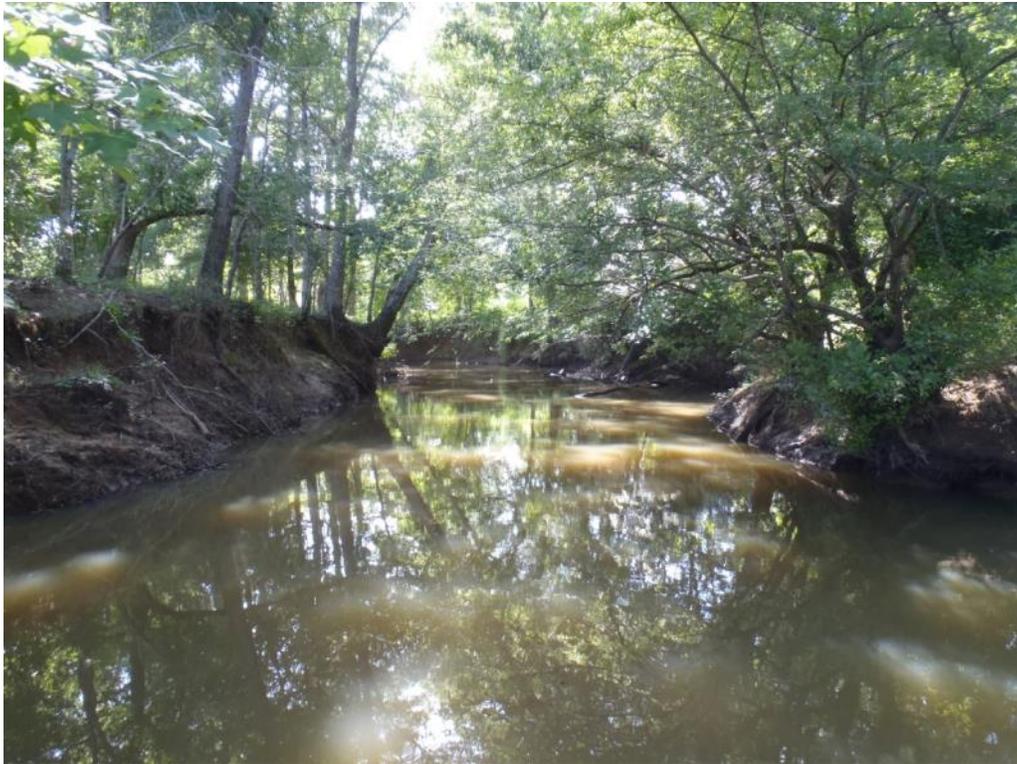
Figure 6.40 Photograph of Mud Creek Site MD15 taken on July 27, 2014, the downstream view of the 300-m transect.

Mud Creek at Site MD15 was visited on July 27 and August 24, 2014. This site, located northeast of Jacksonville, Texas in Cherokee County, was accessible only through private land that was fenced with a locked gate. With landowner permission, TIAER personnel entered private property through the gate and drove approximately 1.5 mile along a pasture and gravel oil field road to reach the site. The site is located in a forest and pasture dominated corridor (Table 6.5). At the site, access to the stream was difficult due to steep banks (Table 6.6). Figures 6.40 and 6.41 depict the appearance of the site during each survey.

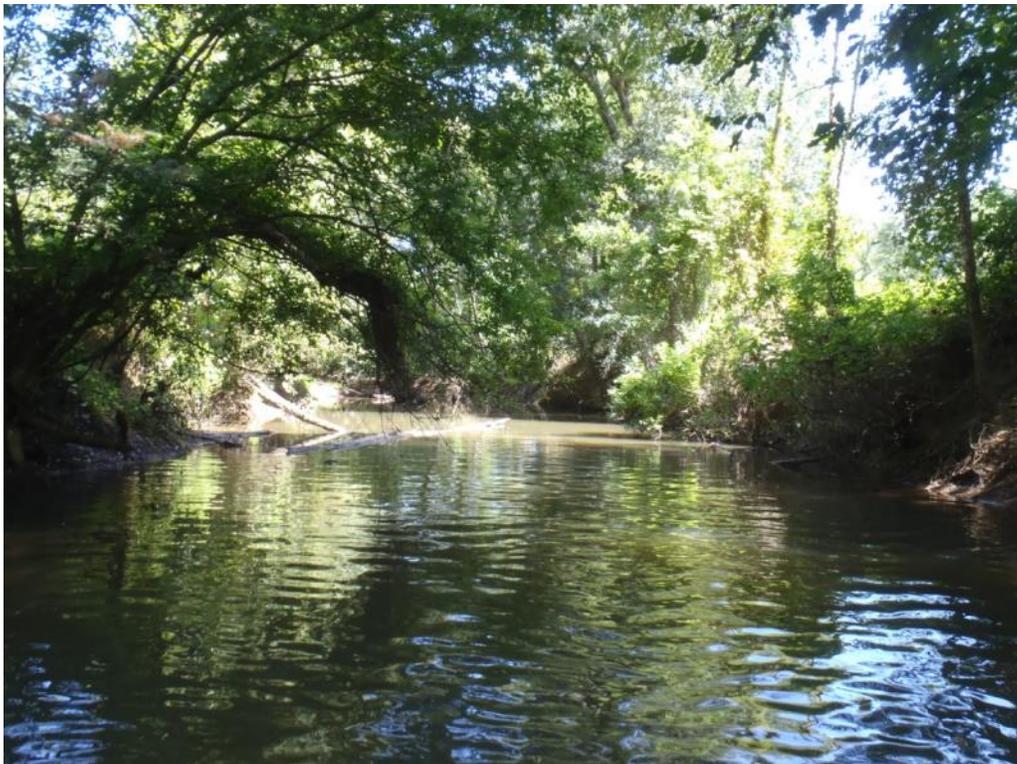
Figure 6.41 Photograph of Mud Creek Site MD15 taken on August 24, 2014, the upstream view of the 0-m transect.

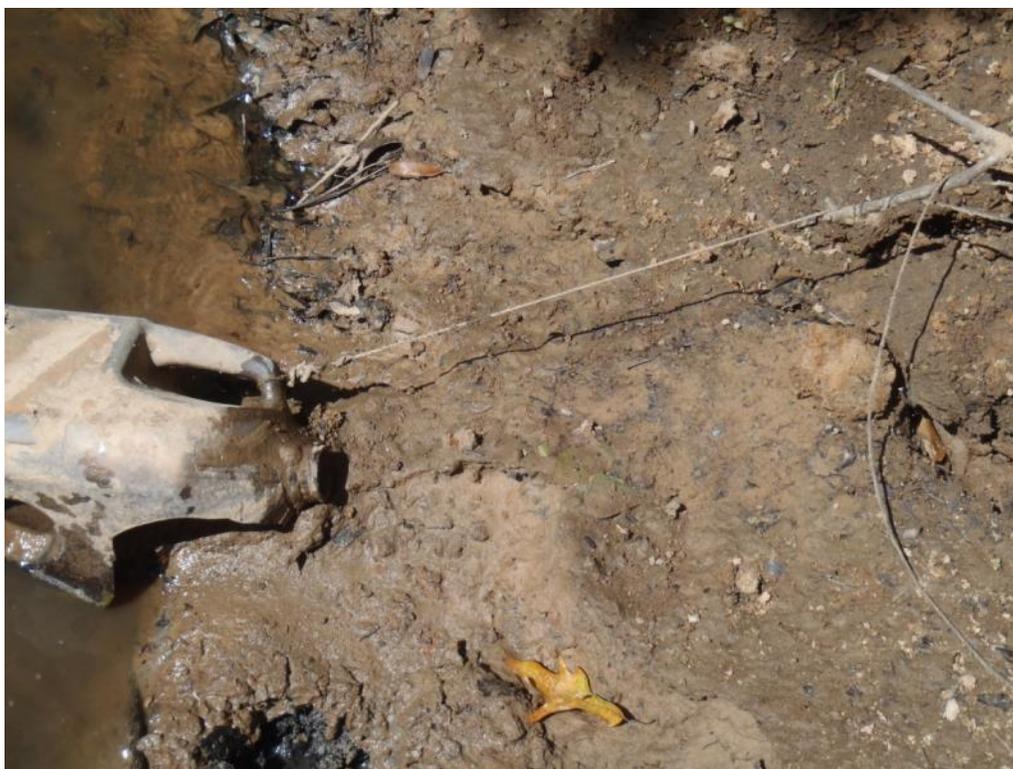
Figure 6.42 Photograph of Mud Creek Site MD15 taken on July 27, 2014, the milk jug trotline.

During the first survey, there was a slight presence of cattle with no other mammals or vertebrates observed (Table 6.9). There was no observance of any animals during the second survey (Table 6.10). Tracks observed during each trip consisted of cattle, deer, and canine. Bird and cattle feces were found throughout the reach during both surveys. Aquatic vegetation was absent and algae was rare during both surveys. Water color was brown during both surveys with surface scum encountered during both surveys. Trash, which was rarely observed and only during the first survey, consisted of typical plastics, bottles, and aluminum cans. Evidence of human recreational activity was found in the form of a milk jug trotline (Figure 6.42) and a boat located just out of the survey reach.

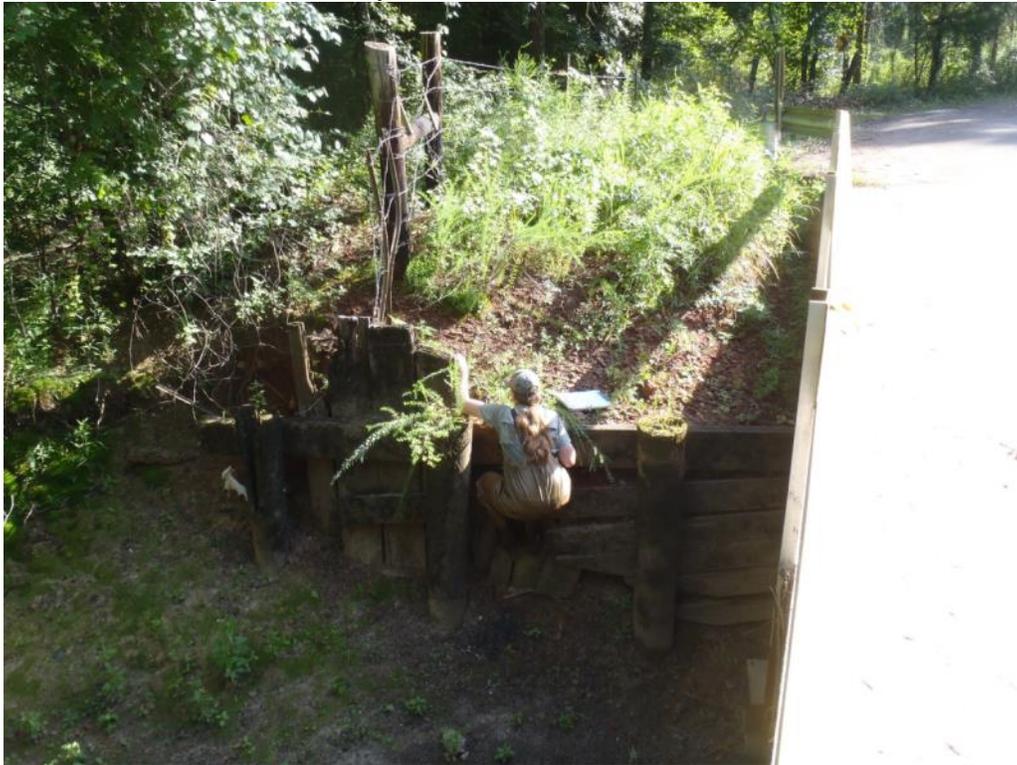
Figure 6.43 Photograph of Mud Creek Site MD16 taken on July 26, 2014 showing difficult access to the stream. TIAER personnel in the photograph.

crossing (Figure 6.43). The site is located in a forest dominated corridor (Table 6.5). Figures 6.40 and 6.41 depict the appearance of the site during each survey.

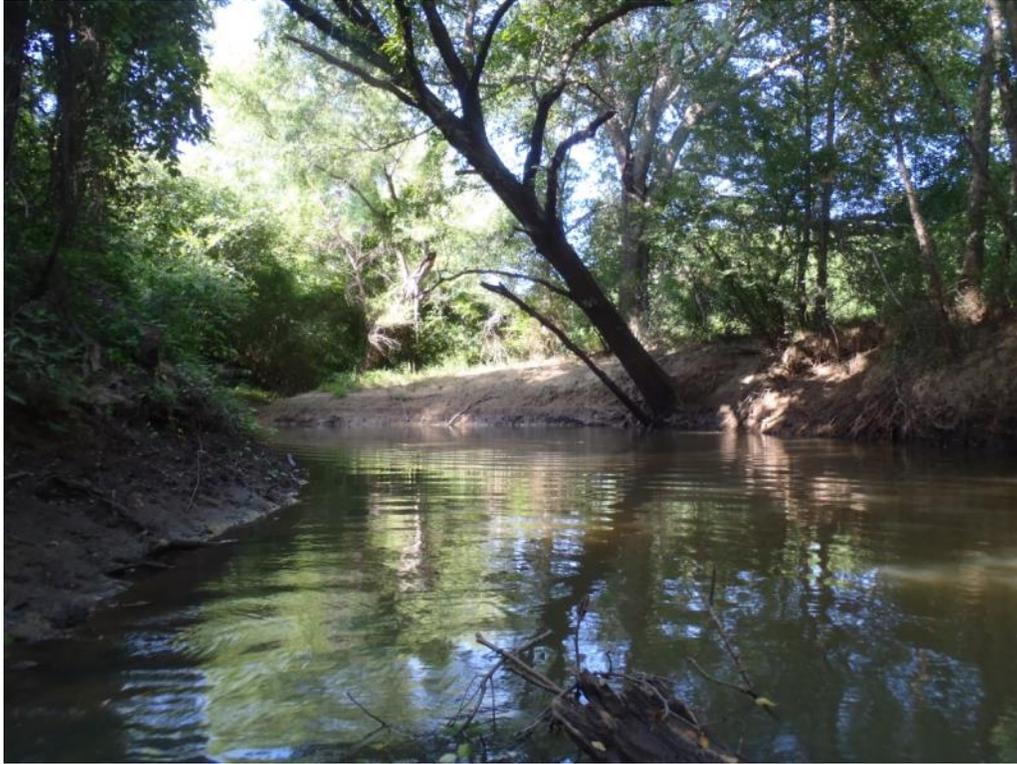
Figure 6.44 Photograph of Mud Creek Site MD16 taken on July 26, 2014, the upstream view of the 300-m transect.
