Recreational Use Attainability Analysis for
Kickapoo Creek in Henderson County (0605A),
the Neches River Above Lake Palestine (0606),
Prairie Creek (0606A), Mud Creek (0611C), and
West Mud Creek (0611D)
in the Neches River Basin

Prepared for:
Texas State Soil and Water Conservation Board
Project 14-52

Texas Institute for Applied Environmental Research
Tarleton State University
Stephenville, Texas

TR1503
September 2015

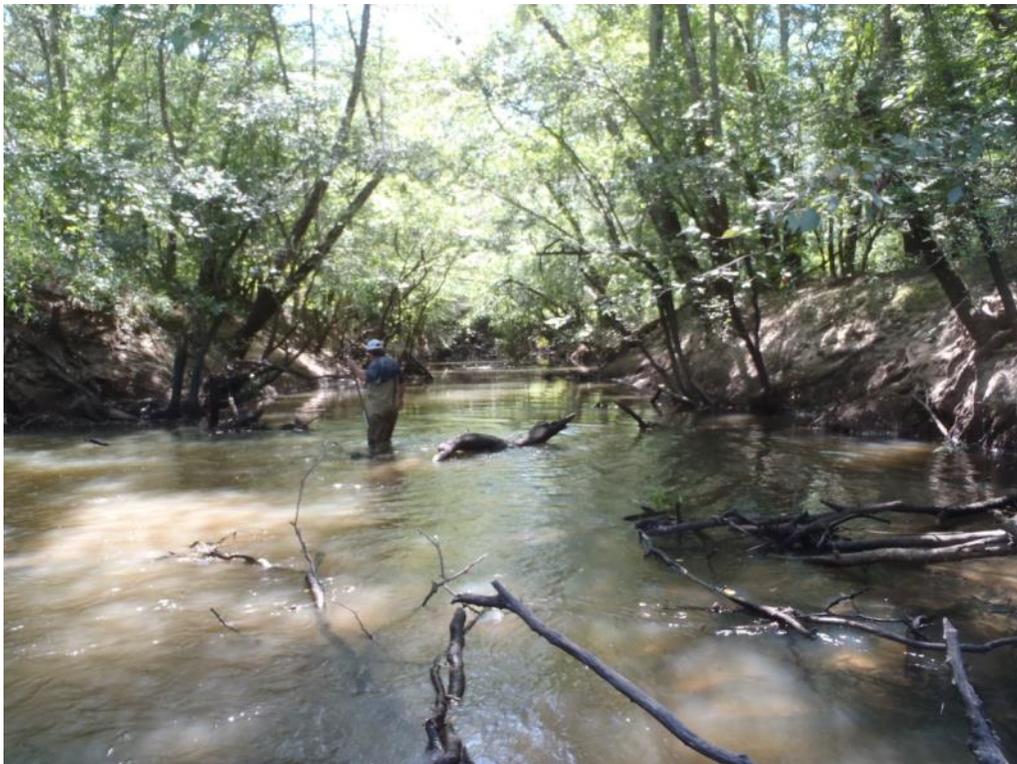
Figure 6.45 Photograph of Mud Creek Site MD16 taken on August 24, 2014, the downstream view of the 150-m transect. TIAER personnel in the photograph.

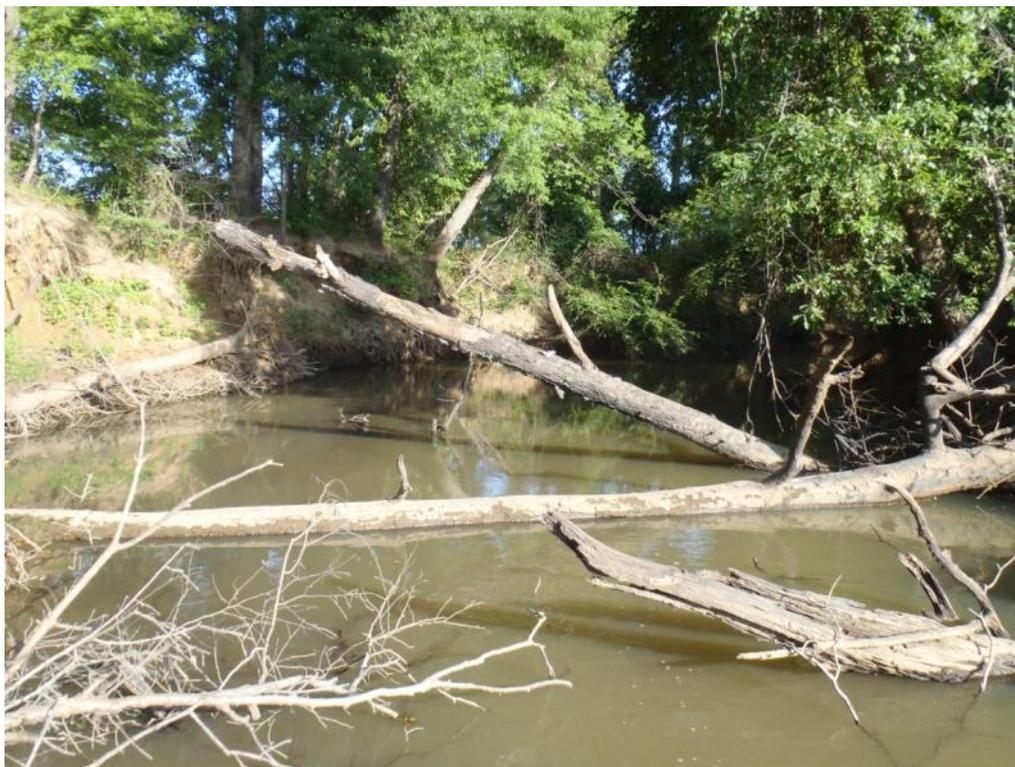
Figure 6.46 Photograph of Mud Creek Site MD17 taken on July 27, 2014, the downstream view of the 150-m transect.

Mud Creek at Site MD17 was visited on July 27 and August 24, 2014. This site, located southwest of Troup, Texas in Cherokee County, was accessible only through private land that was fenced and required landowner permission to access. With landowner permission, TIAER personnel drove approximately 0.6 mile through a coastal field to reach the site. The site is located in a pasture dominated corridor with trees along the stream bank (Table 6.5). At the site, access to the stream was moderately difficult due to tall steep banks throughout most of the reach (Table 6.6). TIAER field personnel were very selective on choosing an entry point to the stream. Figures 6.46 and 6.47 depict the appearance of the site during each survey.

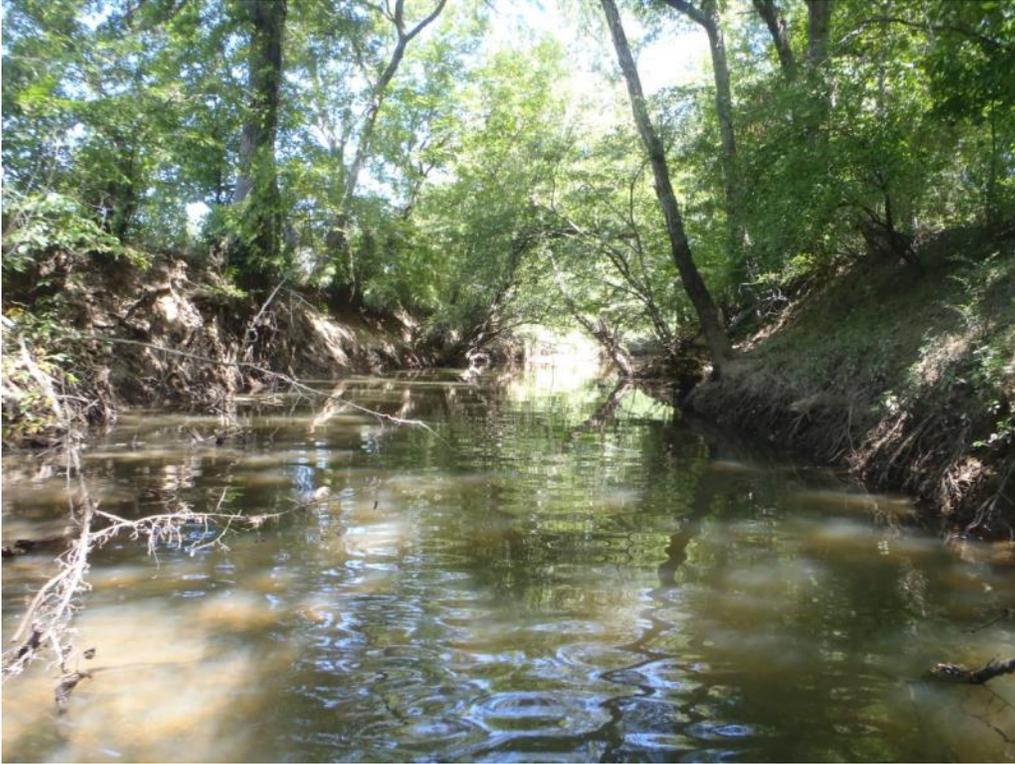
Figure 6.47 Photograph of Mud Creek Site MD17 taken on August 24, 2014, the upstream view of the 0-m transect.

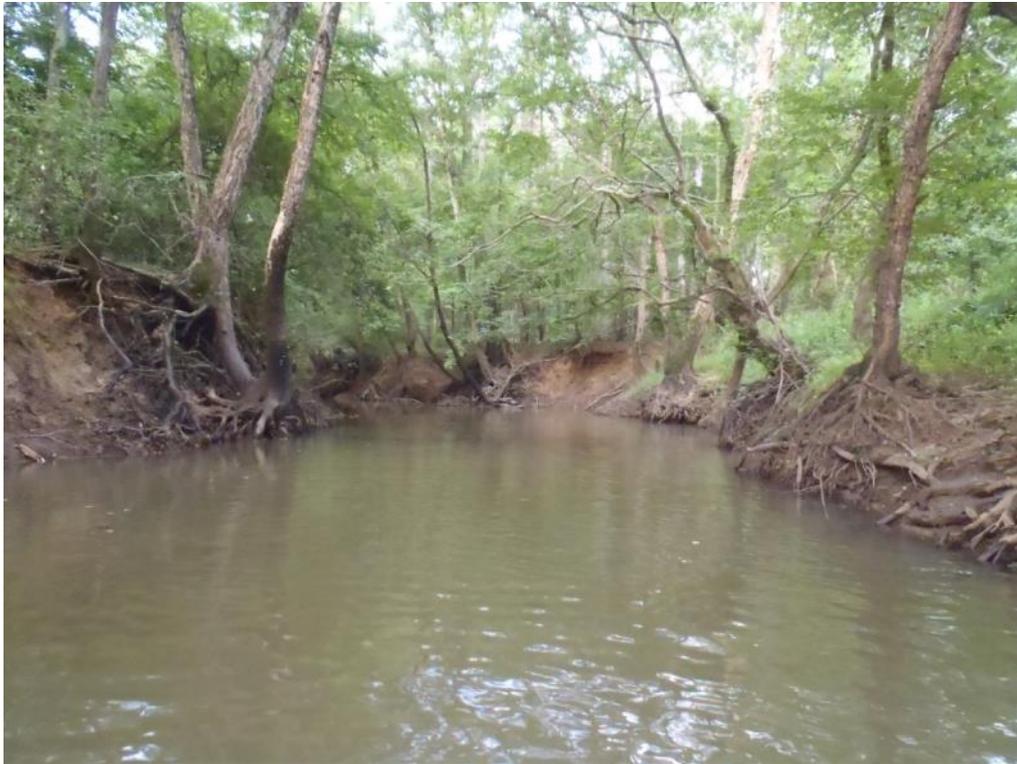
Figure 6.48 Photograph of Mud Creek Site MD18 taken on July 28, 2014, the downstream view of the 0-m transect.

Mud Creek at Site MD18 was visited on July 28 and August 23, 2014. This site, located southwest of Troup, Texas in Cherokee County, was only publicly accessible at the bridge crossing at State Highway 135, with fenced private property upstream and downstream of the crossing. The site is located in a forest dominated corridor with a power line right of way just downstream of the bridge (Table 6.5). Access to the stream was moderately easy depending on the entry point to the stream. Some of the banks were low, while others were of moderate height with dense vegetation along the banks (Table 6.6). Figures 6.48 and 6.49 depict the appearance of the site during each survey.

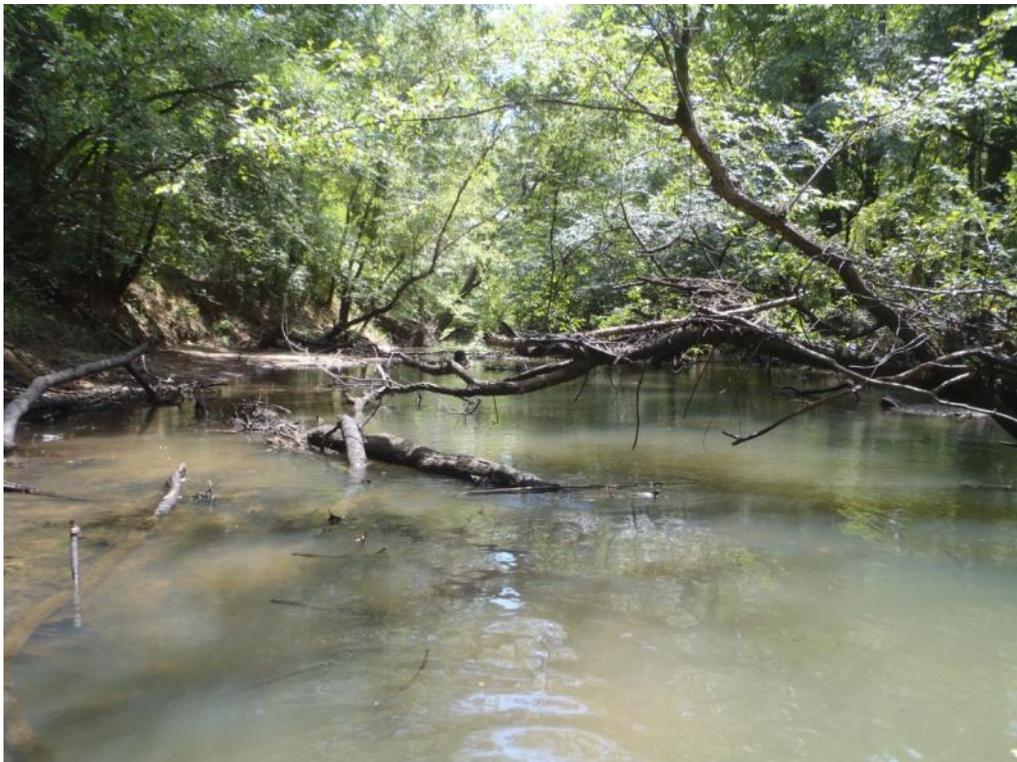
Figure 6.49 Photograph of Mud Creek Site MD18 taken on August 23, 2014, the downstream view of the 300-m transect.

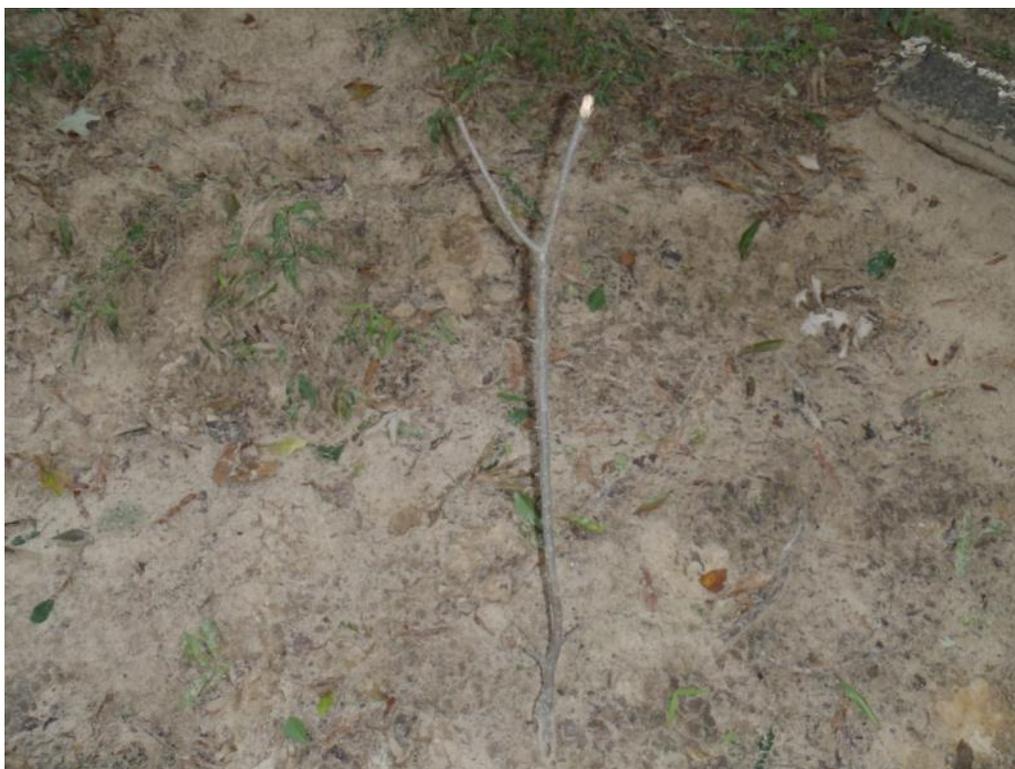
Figure 6.50 Photograph of Mud Creek Site MD18 taken on July 28, 2014 showing the fishing pole prop observed on private property, downstream of the bridge.

There was a slight presence of snakes and water dependent birds observed during the first survey with no other mammals or vertebrates during either survey (Tables 6.9 and 6.10). Tracks observed during each trip consisted of feral hog and deer. Bird feces were found throughout the reach during both surveys. Aquatic vegetation and algae were rare during both surveys. Water color was brown during the first survey and clear during the second survey with no surface scum or foam. Trash observed during the surveys was common to rare consisting of tires, pieces of metal, typical plastics, cups, cans, and bottles. Evidence of human recreational activity was observed during both surveys in the form of fishing tackle and fishing pole prop sticks as shown in Figure 6.50.

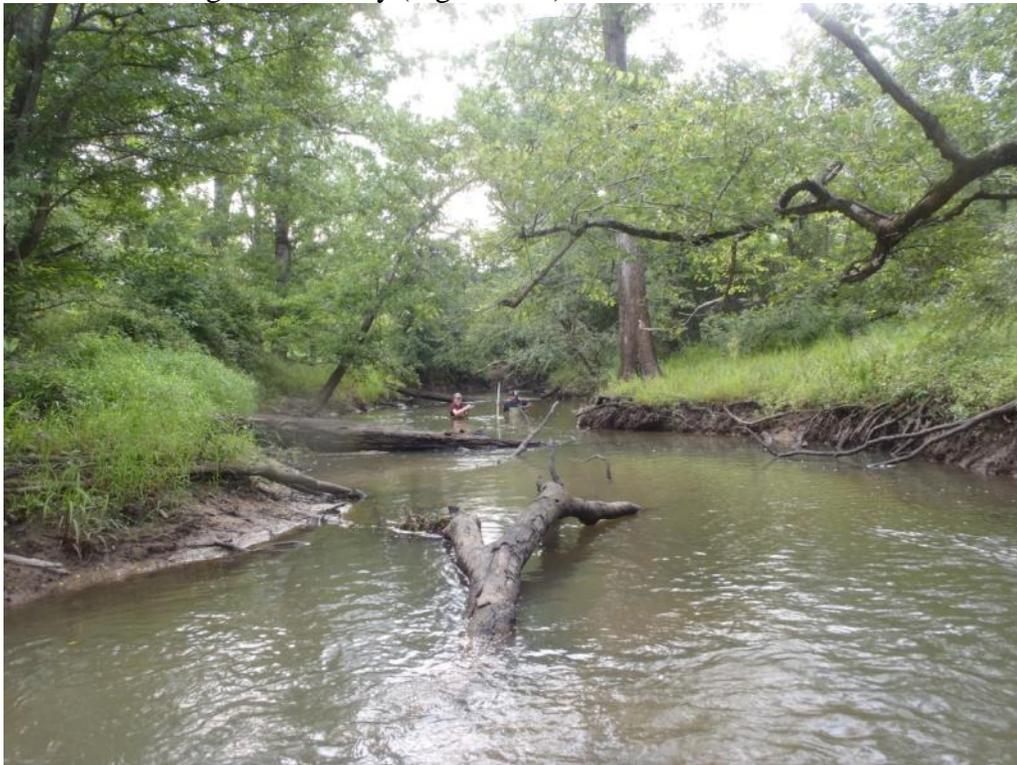
Figure 6.51 Photograph of Mud Creek Site MD19 taken on July 28, 2014, the downstream view of the 300-m transect. TIAER personnel in the photograph.

dominated corridor (Table 6.5). Figures 6.51 and 6.52 depict the appearance of the site during each survey.

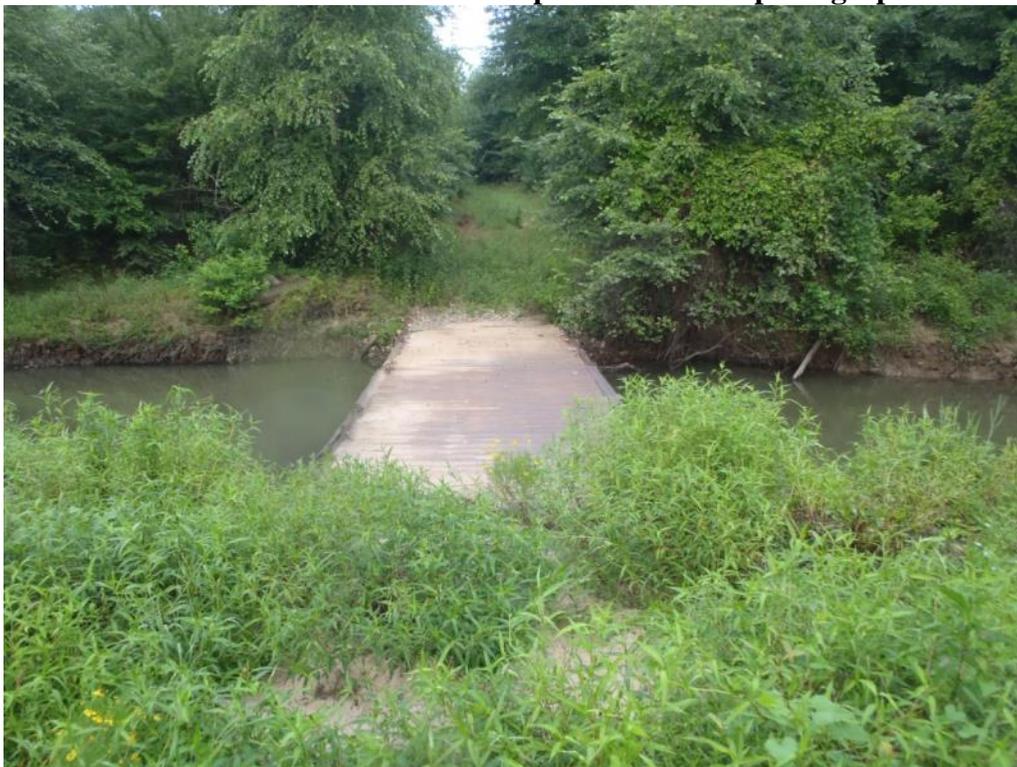
Figure 6.52 Photograph of Mud Creek Site MD19 taken on August 23, 2014, the upstream view of the 0-m transect. TIAER personnel in the photograph.

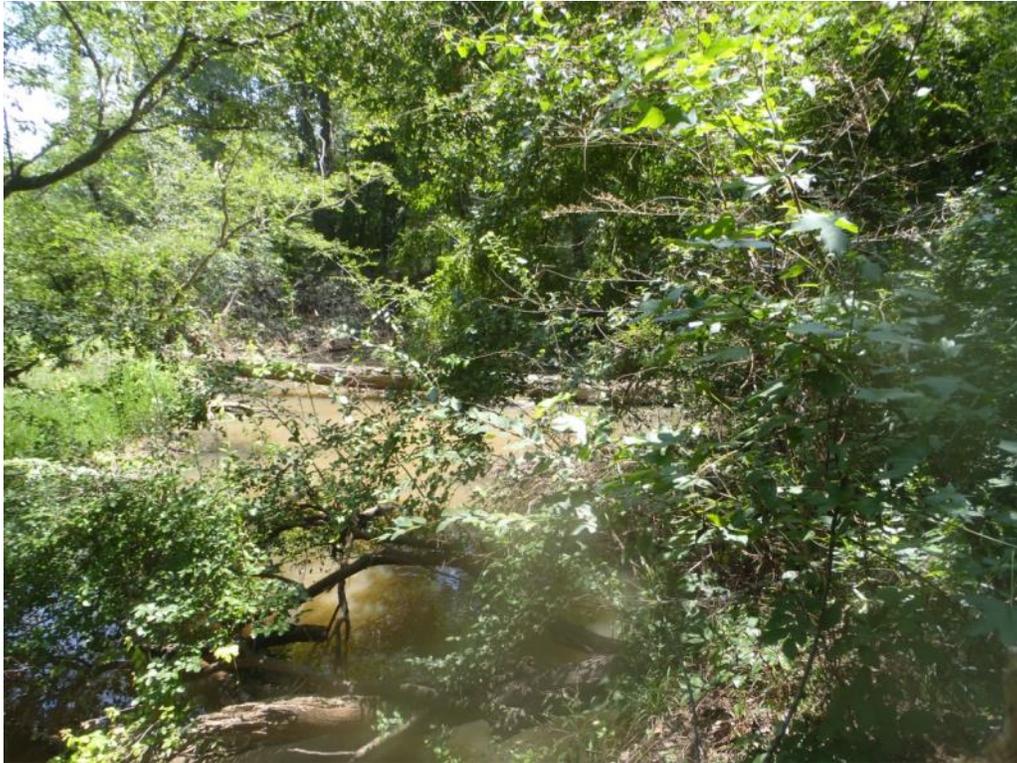
Figure 6.55 Photograph of Mud Creek Site MD20 taken on July 28, 2014, the downstream view of the 0-m transect.

Mud Creek at Site MD20 was visited on July 28 and August 23, 2014. Site MD20 (TCEQ Station 10537) is located on Mud Creek at the bridge crossing Smith County Road 2138, west-northwest of Troup, Texas. Site MD14 is publicly accessible at the area immediately underneath the bridge crossing. A sign located near the bridge stated that no parking was allowed within 10 feet of the paved road (Figure 6.54). The distance from privately fenced property to the paved road was typically less than 10 feet, so parking was unavailable near this site. Access to the stream was moderately difficult due to steep banks and dense vegetation. The site is located in a forest dominated corridor (Table 6.5). Figures 6.55 and 6.56 depict the appearance of the site during each survey.

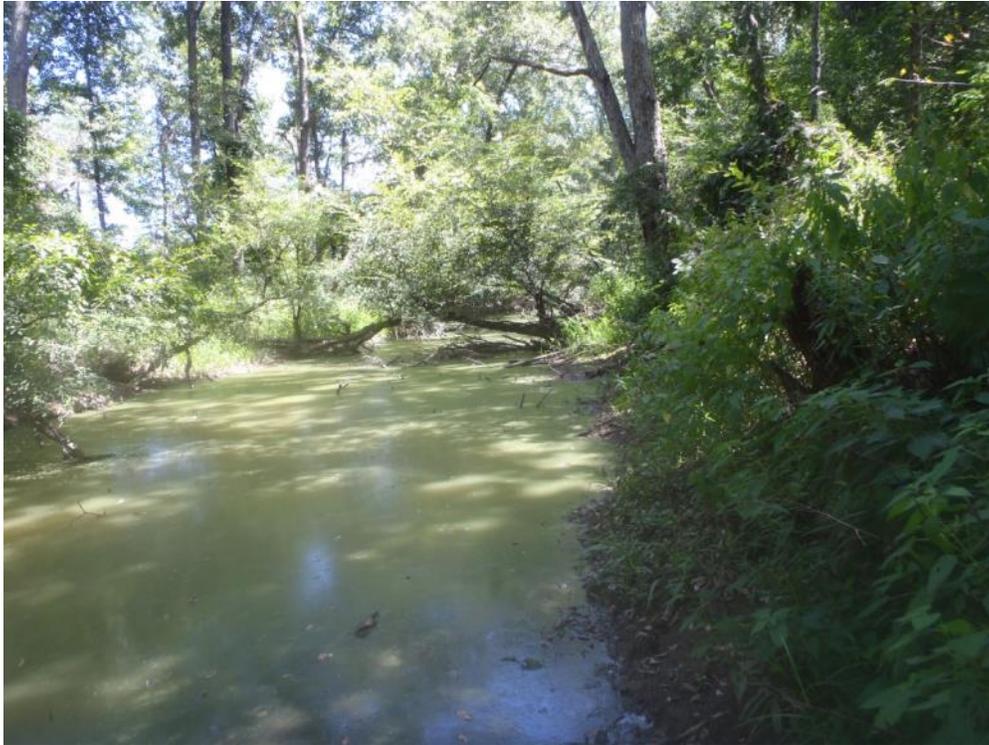
Figure 6.56 Photograph of Mud Creek Site MD20 taken on July 28, 2014, the downstream view of the 150-m transect.

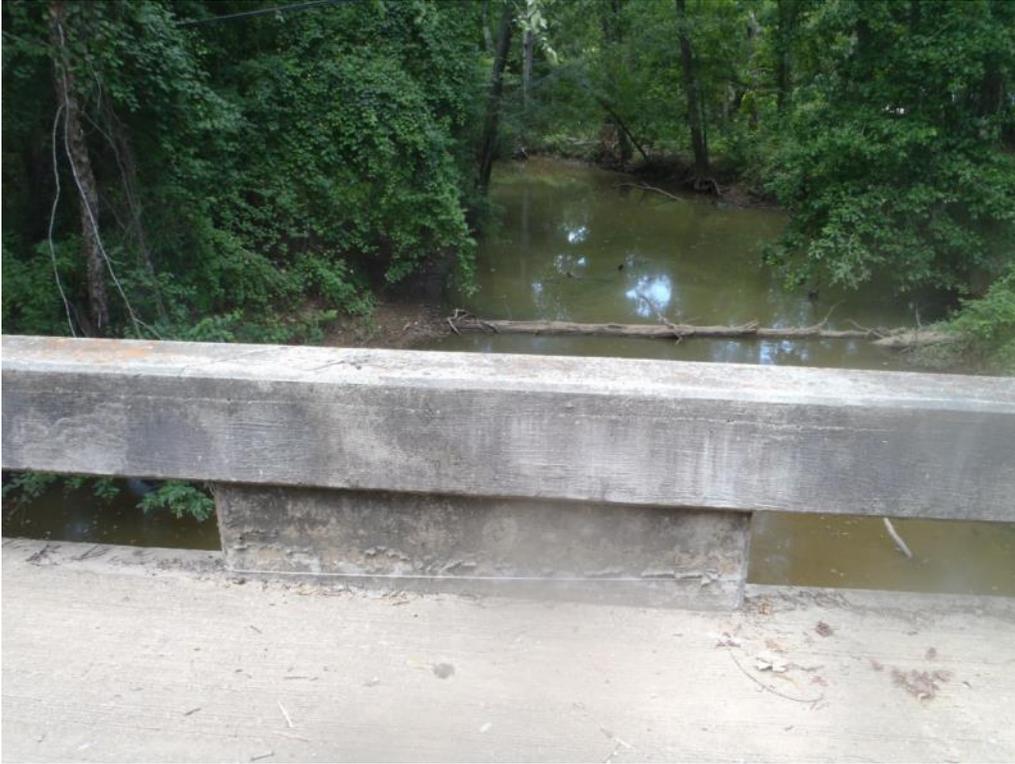
Figure 6.57 Photograph of Mud Creek Site MD20 taken on July 28, 2014, downstream view from the 0 m transect showing a fishing drop-line attached to the top of the bridge.

and algae cover was common during the second survey. Trash was observed near the bridge crossing and consisted of typical plastics and cans. A drop-line with attached hook was found secured to railing on top of the bridge during the first survey and had been removed by the time the second survey occurred. The drop-line was the only evidence of human activity observed at the site (Figure 6.57).

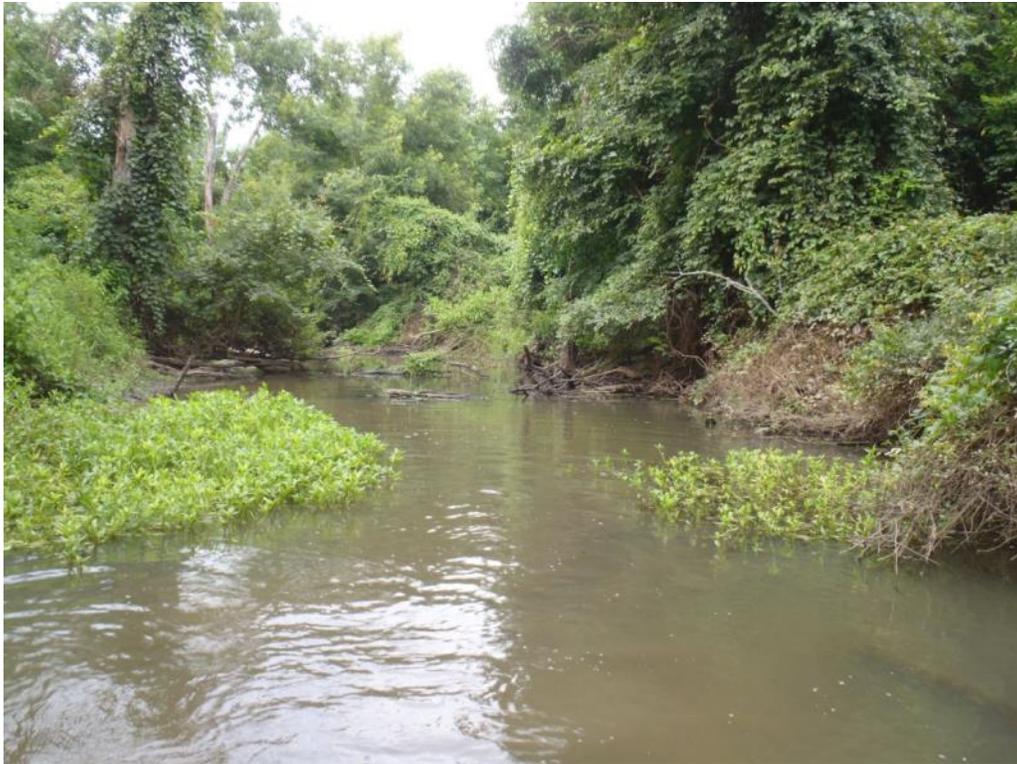
Figure 6.58 Photograph of Mud Creek Site MD21 taken on July 28, 2014, the downstream view of the 300-m transect.

Mud Creek at Site MD21 was visited on July 28 and August 23, 2014. This site (TCEQ Station 16586), located northwest of Troup, Texas in Smith County, was publicly accessible at the bridge crossing on State Highway 110 with fenced private property upstream and downstream of the crossing. TIAER personnel parked on the highway right of way and entered the stream underneath the bridge crossing. The site is located in a forest dominated corridor (Table 6.5). Access to the stream was moderately difficult due to the densely vegetated stream banks (Table 6.6). Figures 6.58 and 6.59 depict the appearance of the site during each survey.

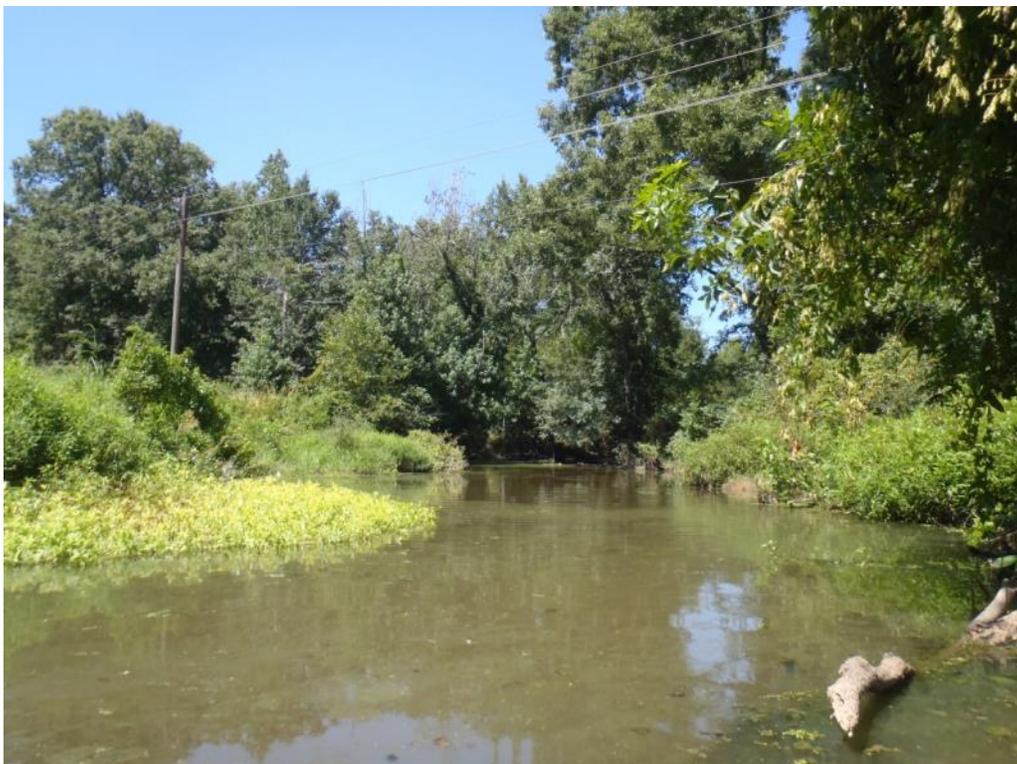
Figure 6.59 Photograph of Mud Creek Site MD21 taken on August 23, 2014, the upstream view of the 0-m transect.

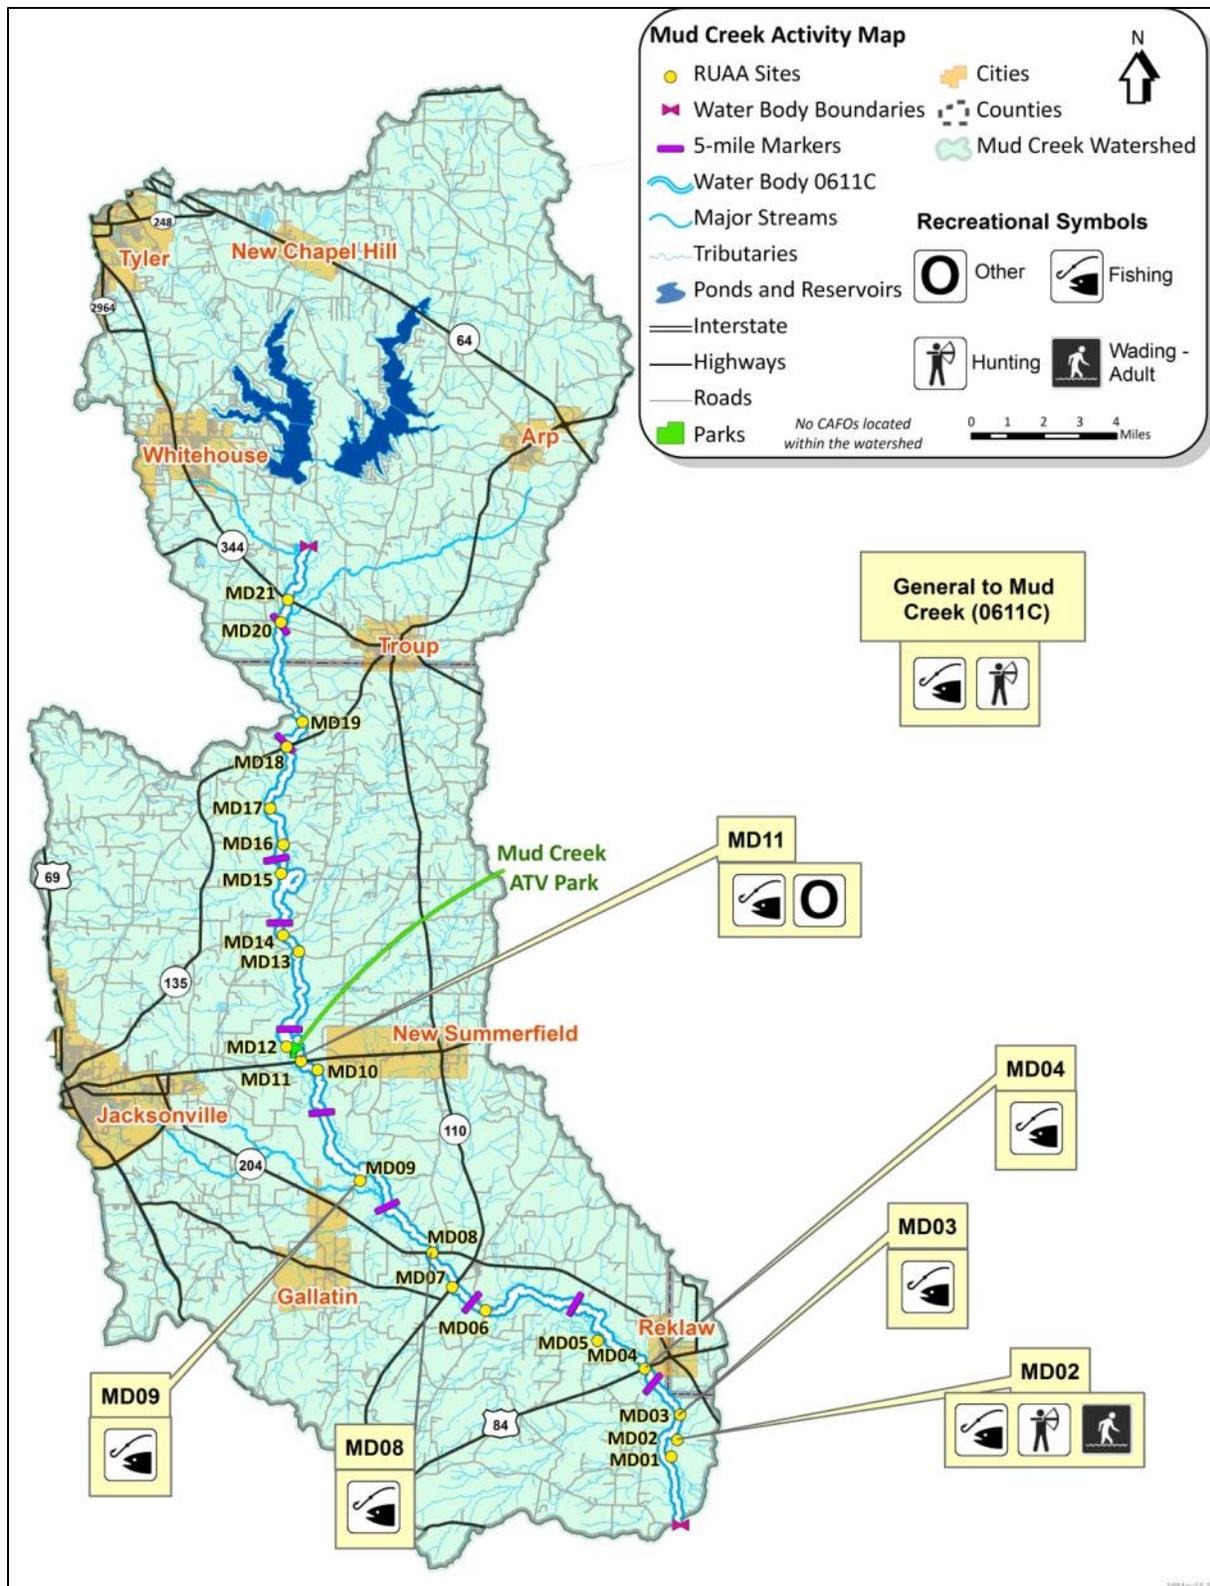
Figure 6.60 Summary of observed and interviewed recreational activities on Mud Creek.

RUAA surveys were conducted at 20 sites along Mud Creek (0611C) on the days of July 27-28, 2014 and August 23-24, 2014. The Palmer Drought Severity Index (PDSI) represented slightly wet conditions for East Texas during both July and August 2014 (TWDB, 2014). During the two surveys, the only recreational activity observed were two gentlemen fishing at a bridge crossing near site MD08 during the first survey. Interviews revealed that fishing has occurred at various sites throughout the reach. Recreational activities observed and reported by interviewees are summarized in Figure 6.60. Overall RUAA findings are summarized in the form below.

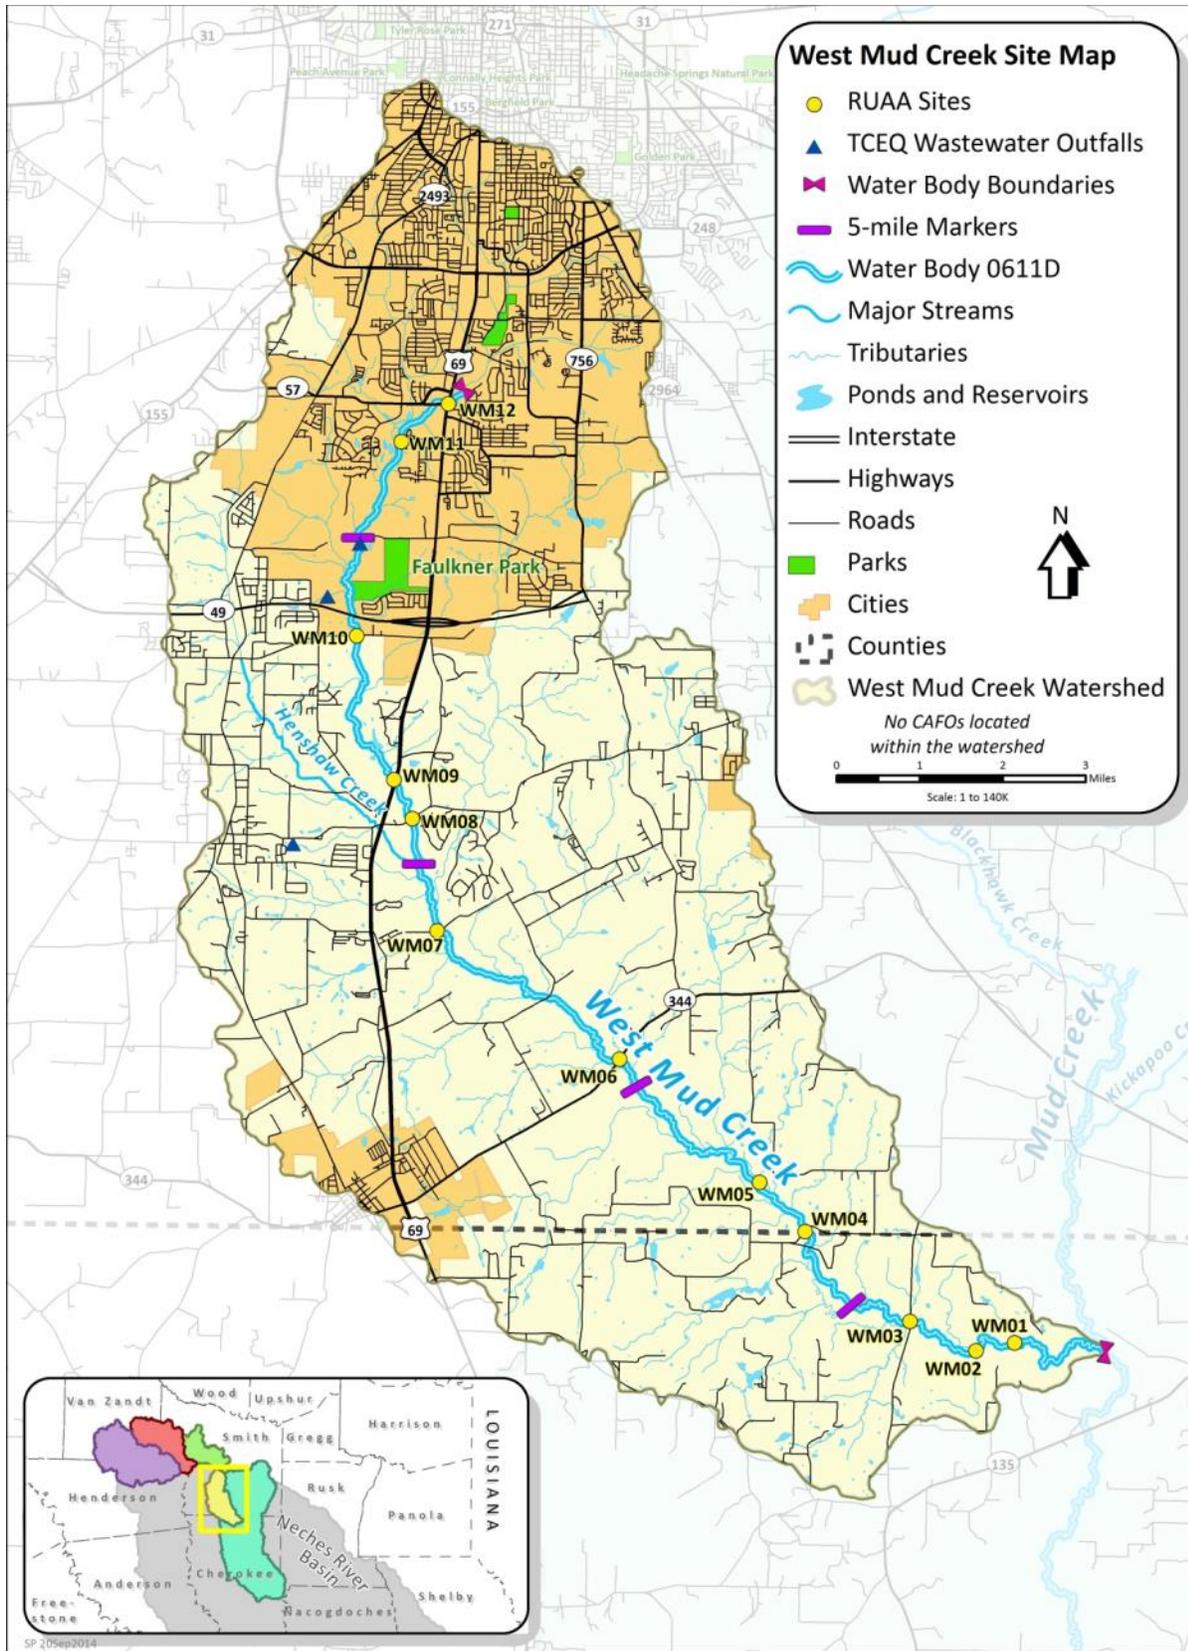
Figure 7.1 Overview of West Mud watershed and RUA sites for water body 0611D.

The West Mud Creek watershed (water body 0611D) covers 59,200 acres and includes portions of the cities of Tyler (estimated population 100,223) and Bullard (estimated population 2,599) (Figure 7.1). West Mud Creek is approximately 23 miles long and flows from its headwaters in Smith County within the City of Tyler to its confluence with Mud Creek (water body 0611C) in Cherokee County. Henshaw Creek (water body 0611F) in Smith County is a major tributary of West Mud Creek. While the focus is on surface water, the watershed overlays the Carizzo-Wilcox Aquifer (George et al., 2011). The terrain varies from flat to rolling hills and dominant soil types consist of sandy loams (TSHA, 2013). The nearly flat flood plain of West Mud Creek allows the stream to meander and soils along the creek are often strongly acidic (Hatherly, 1993). Frequent flooding within the riparian area supports a hardwood forest, which is good wildlife habitat but poorly suited for commercial timber production. The uplands are generally considered suitable for pasture or woodland and support some commercial pine production (Hatherly, 1993).

With the help of cooperating stakeholders, TIAER was able to establish a total of 12 sampling stations along the 23 river miles of West Mud Creek, 0611D (Figure 7.1, Table 7.2). Although the optimum number of sampling stations would have been 14, following the RUAA guidelines, acceptance of using only 12 stations was sought and granted from TCEQ. Of the 12 stations, 8 were publically accessible via road crossings and the remaining 4 were accessible via private property (Table 7.2). Of the eight publically accessible sites, five were at recognized TCEQ sampling stations.

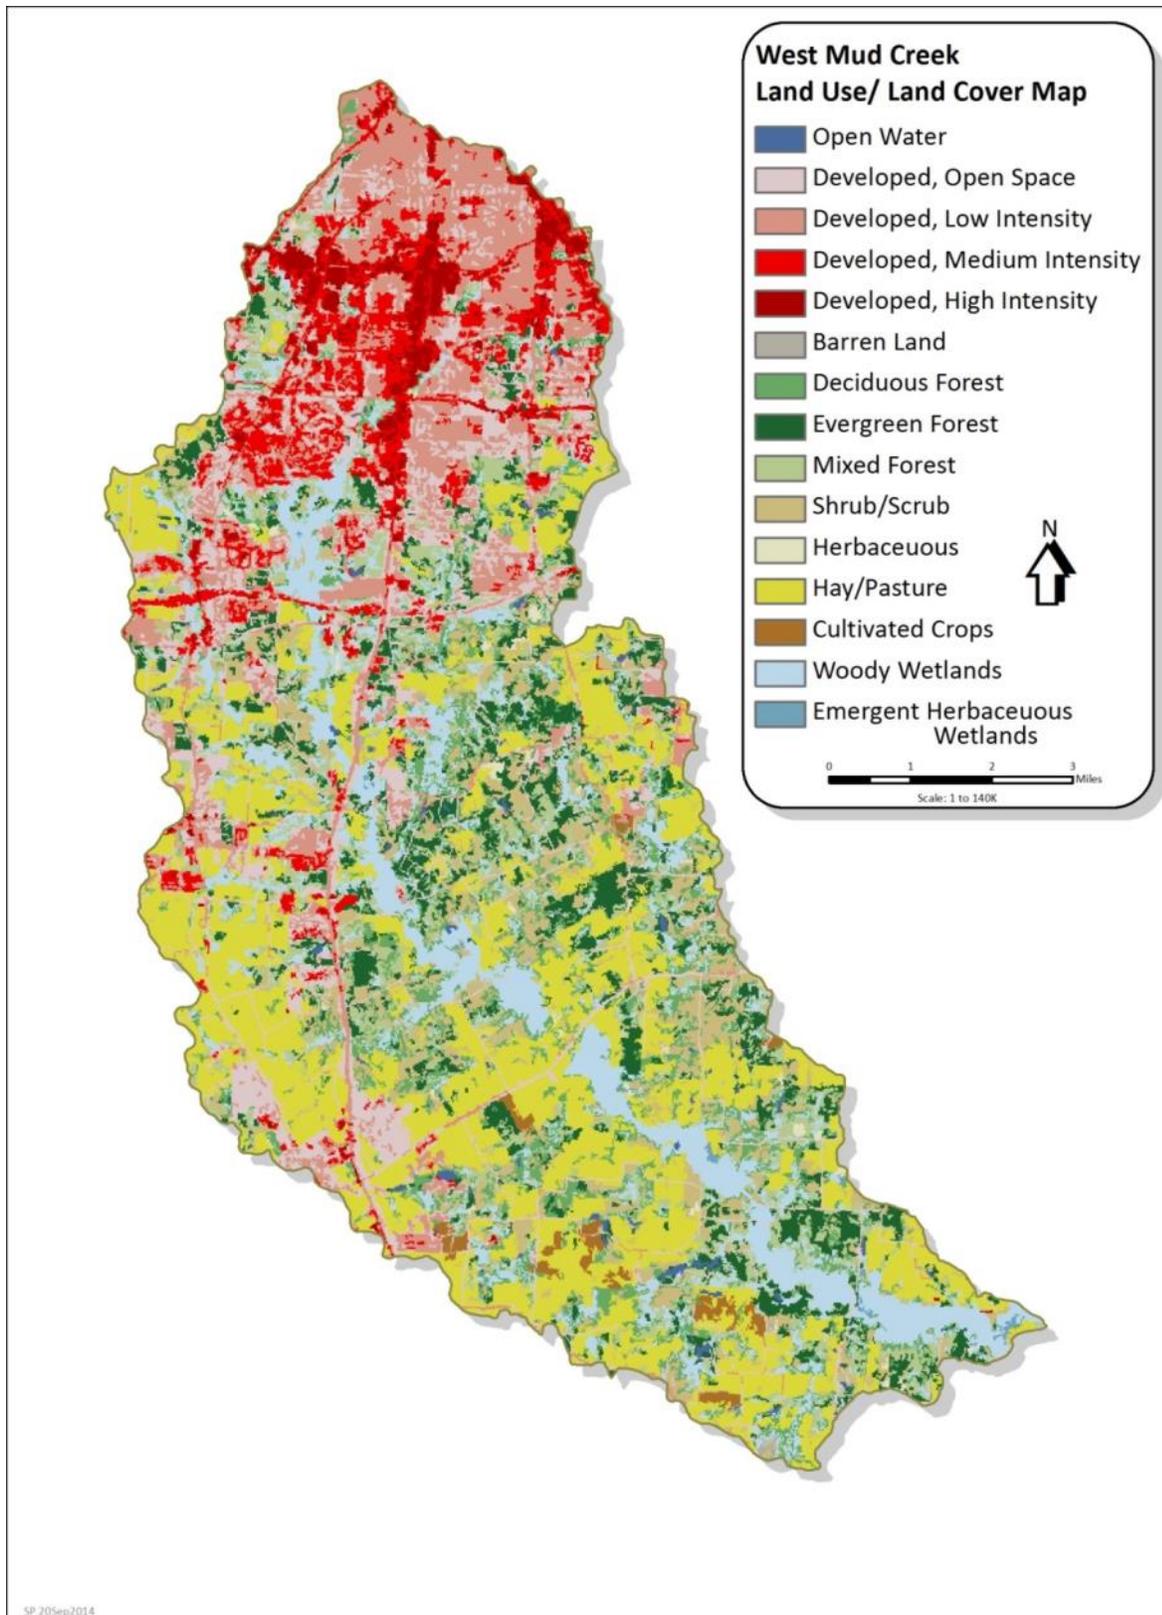
Figure 7.2 Land use/land cover for the West Mud Creek watershed. Source: 2011 National Land Cover Database (USGS, 2013).

The West Mud Creek watershed lies within the Tertiary Uplands ecoregion (35a) (Griffith et al., 2007). Average annual rainfall for the region is 42 inches annually (Tyler Texas Weather, 2015). Mean minimum and maximum temperatures for the region range from 36 to 57°F in January and 73 to 94°F in July. Developed land as represented by the City of Tyler, and to a lesser degree the City of Bullard, comprises almost 32 percent of the watershed area (Figure 7.2). Hay/pasture intermingled with woodland represents most of the remaining watershed area with woody wetlands surrounding the area nearest to West Mud Creek.

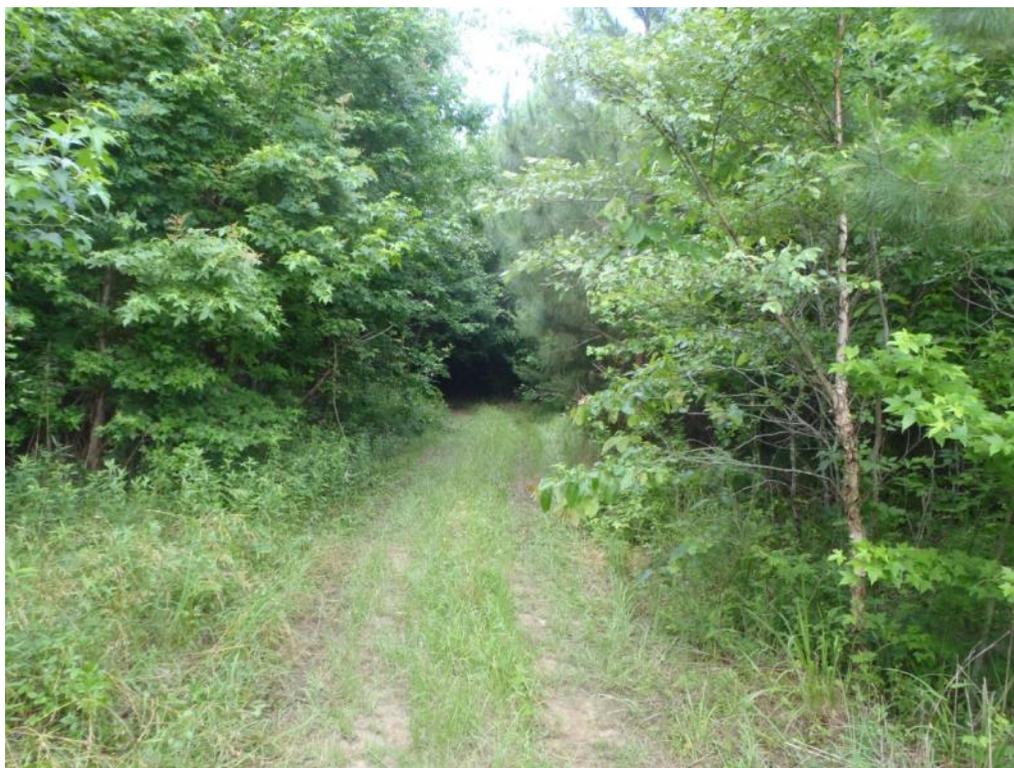
Figure 7.3 Photograph of ATV trail leading to West Mud Creek Site WM01 taken on June 4, 2014.

West Mud Creek at Site WM01 was visited on June 4 and August 9, 2014. This site is located in Cherokee County approximately 4 miles west of Troup, Texas. Access to the creek was obtained via an ATV trail that started near a gas well location and terminated at West Mud Creek (Figure 7.3). The ATV trail passed through what was presumed private property; however, no postings or fences were observed in the area. TIAER personnel walked down the heavily wooded ATV trail approximately 0.2 miles to reach the site. The site is located in a forest dominated corridor (Table 7.5). Access to the creek was moderately easy at an abandoned low water crossing; however, access at other areas of the reach would have been much more challenging due to densely wooded vegetation (Table 7.6). Depending on the location within the reach, banks were gently sloping to moderately steep. Figures 7.4 and 7.5 depict the appearance of the site during each survey.

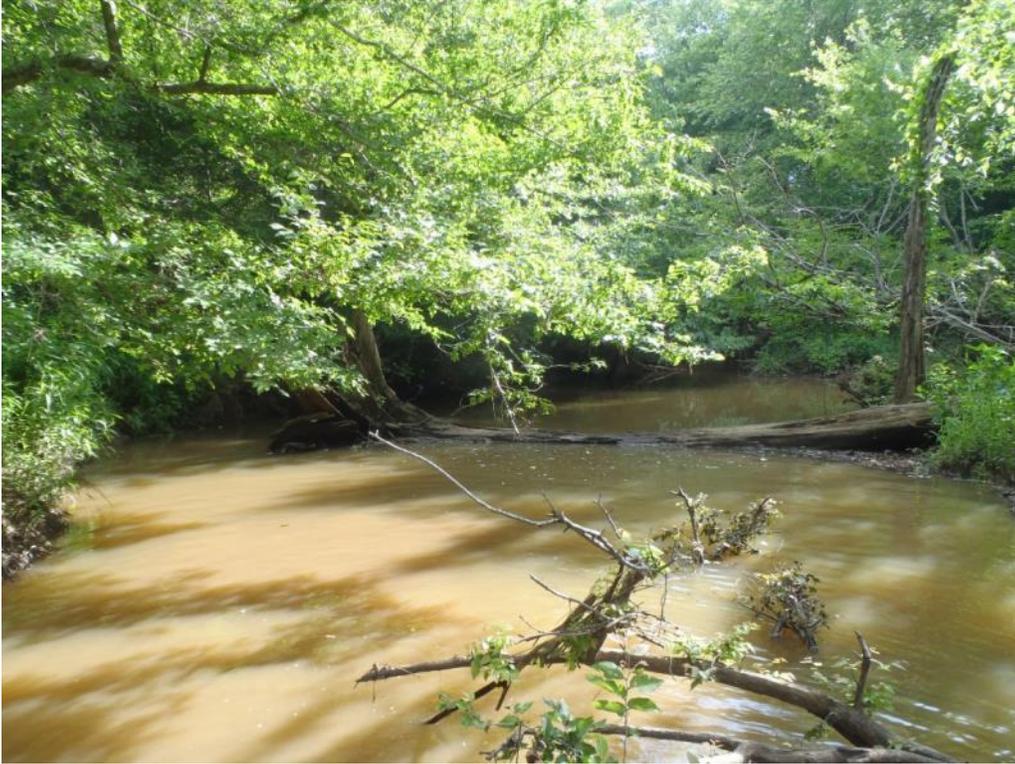
Figure 7.4 Photograph of West Mud Creek Site WM01 taken on June 4, 2014. The downstream view of the 150-m transect.

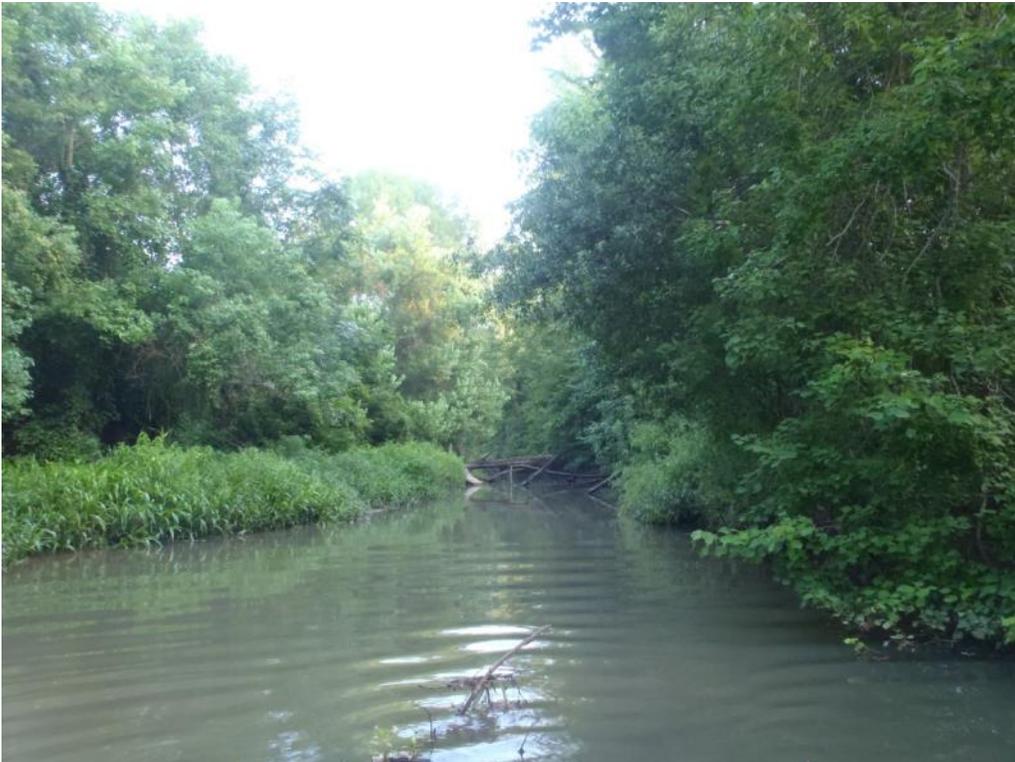
Figure 7.5 Photograph of West Mud Creek Site WM01 taken on August 9, 2014. The upstream view of the 300-m transect.

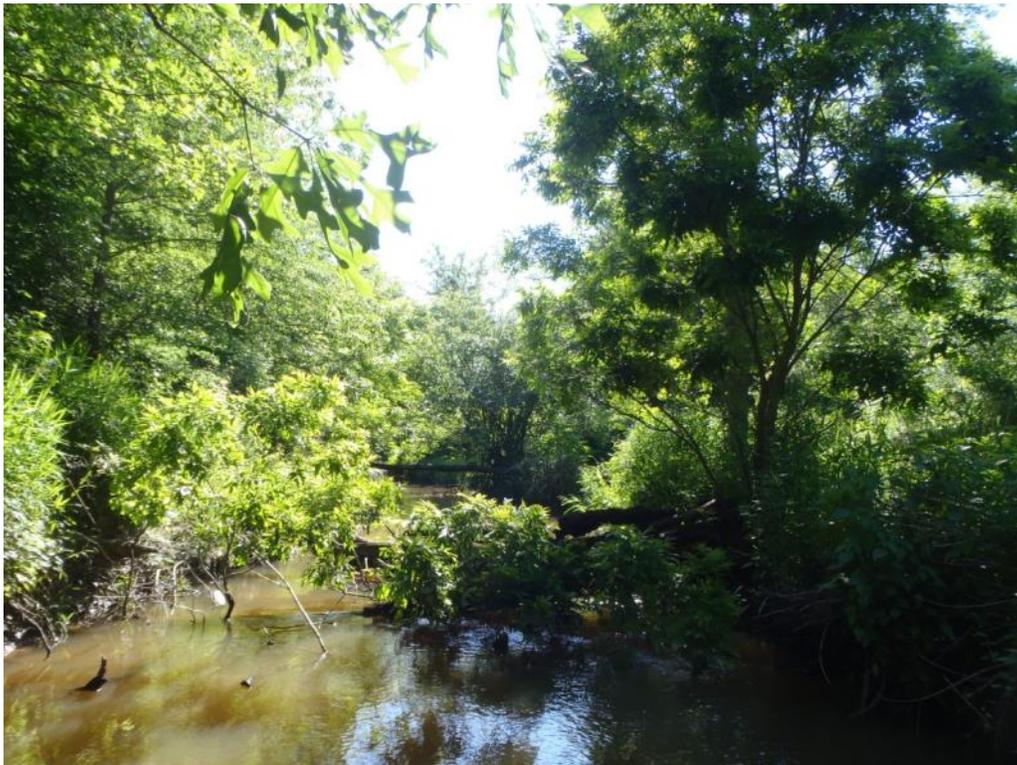
Figure 7.6 Photograph of West Mud Creek Site WM02 taken on June 3, 2014. The upstream view of the 0-m transect.

West Mud Creek at Site WM02 was visited on June 3 and August 9, 2014. This site is located in Cherokee County approximately 4.5 miles southwest of Troup, Texas. The site was accessible only through private lands that were fenced with a potentially locked gate. With landowner permission, TIAER personnel entered private property and drove approximately 0.5 miles on a heavily vegetated road to reach the site. The site is located in a forest dominated corridor (Table 7.5). At the site, access to the stream was moderately difficult (Table 7.6), due to relatively steep banks and dense vegetation. Figures 7.6 and 7.7 depict the appearance of the site during each survey.
