Recreational Use Attainability Analysis for
Kickapoo Creek in Henderson County (0605A),
the Neches River Above Lake Palestine (0606),
Prairie Creek (0606A), Mud Creek (0611C), and
West Mud Creek (0611D)
in the Neches River Basin

Prepared for:
Texas State Soil and Water Conservation Board
Project 14-52

Texas Institute for Applied Environmental Research
Tarleton State University
Stephenville, Texas

TR1503
September 2015

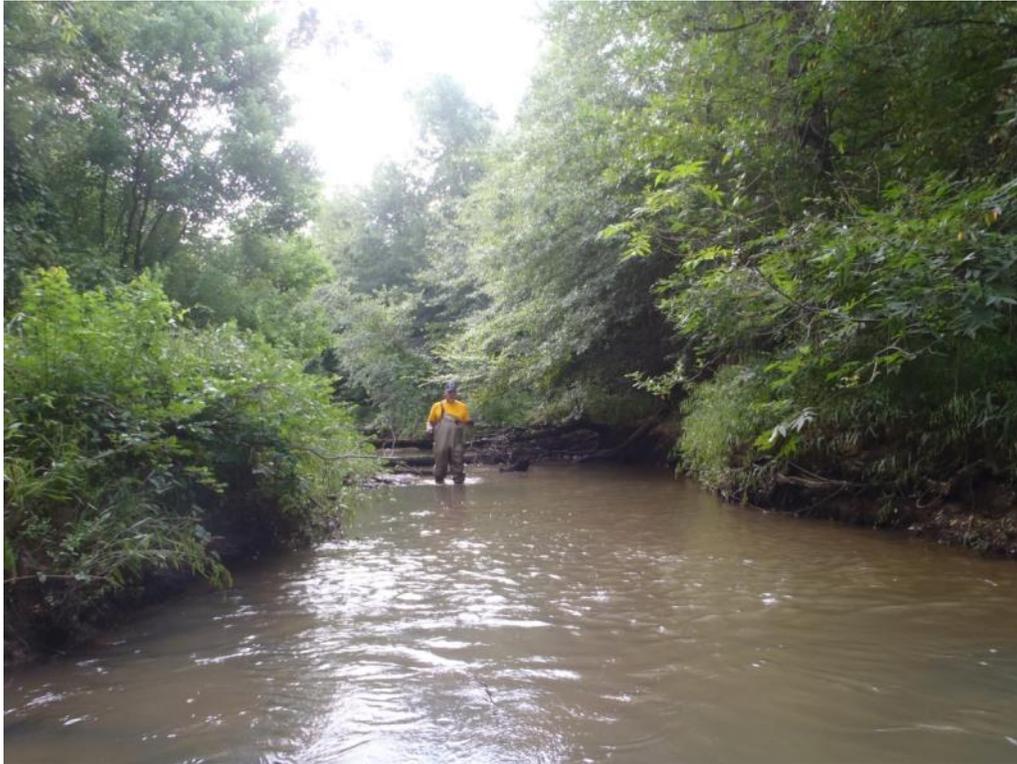
Figure 7.7 Photograph of West Mud Creek Site WM02 taken on August 9, 2014. The downstream view of the 150-m transect. TIAER personnel in photograph.

West Mud Creek at Site WM02 was visited on June 3 and August 9, 2014. This site is located in Cherokee County approximately 4.5 miles southwest of Troup, Texas. The site was accessible only through private lands that were fenced with a potentially locked gate. With landowner permission, TIAER personnel entered private property and drove approximately 0.5 miles on a heavily vegetated road to reach the site. The site is located in a forest dominated corridor (Table 7.5). At the site, access to the stream was moderately difficult (Table 7.6), due to relatively steep banks and dense vegetation. Figures 7.6 and 7.7 depict the appearance of the site during each survey.

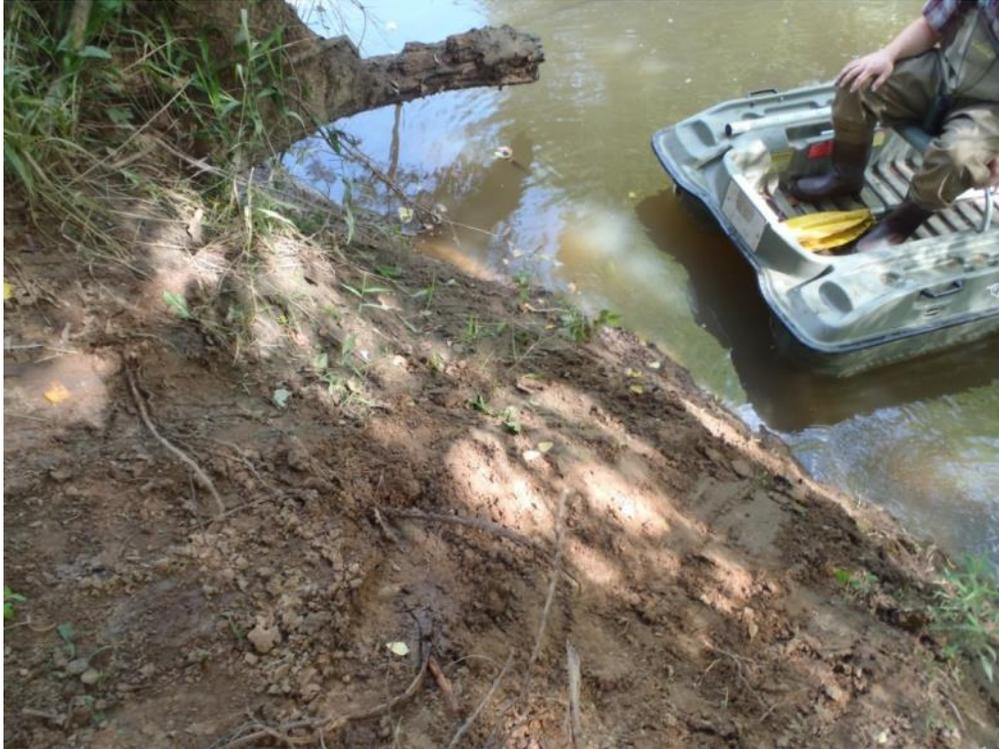
Figure 7.9 Photograph of West Mud Creek Site WM03 taken on June 4, 2014, showing stream access location near the bridge crossing. TIAER boat and personnel in photograph.

West Mud Creek at Site WM03 was visited on June 4 and August 8, 2014. This site was located 5 miles west of Troup, Texas in Cherokee County at the Farm-to-Market Road 3052 bridge crossing. The site was publicly accessible at the bridge with fenced private property upstream and downstream of the crossing. The site is located in a forest dominated corridor (Table 7.5). At the site, a cleared and slightly steep location near the bridge allowed access to the stream via small boat moderately easy (Figure 7.9). Figures 7.10 and 7.11 depict the appearance of the site during each survey.

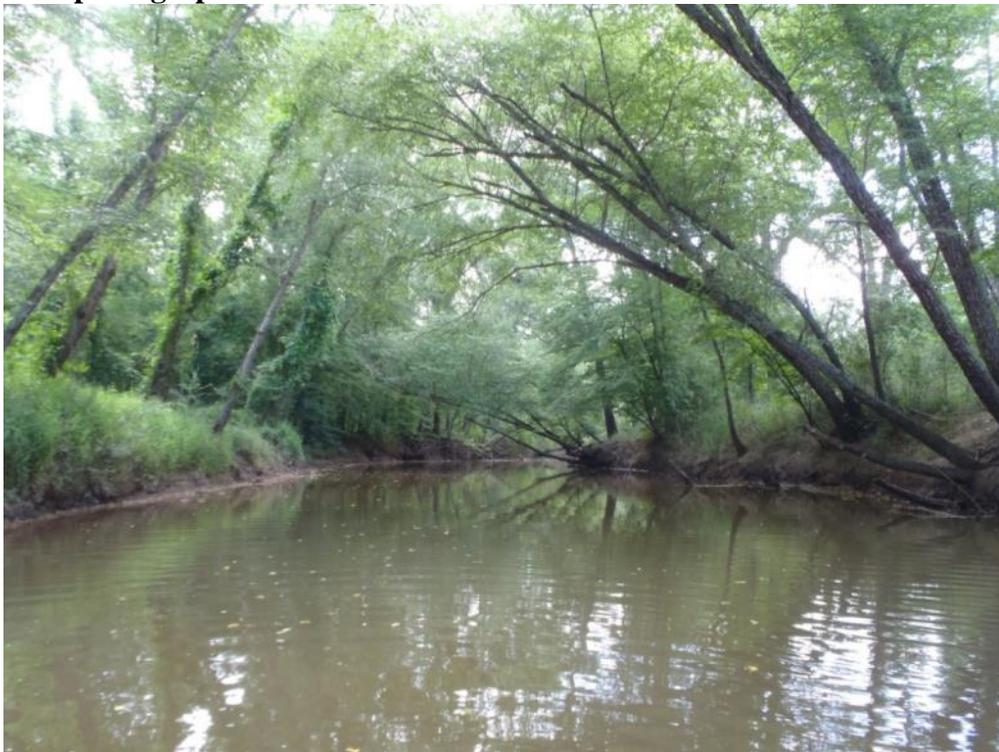
Figure 7.10 Photograph of West Mud Creek Site WM03 taken on June 4, 2014, the

downstream view of the 150-m transect.

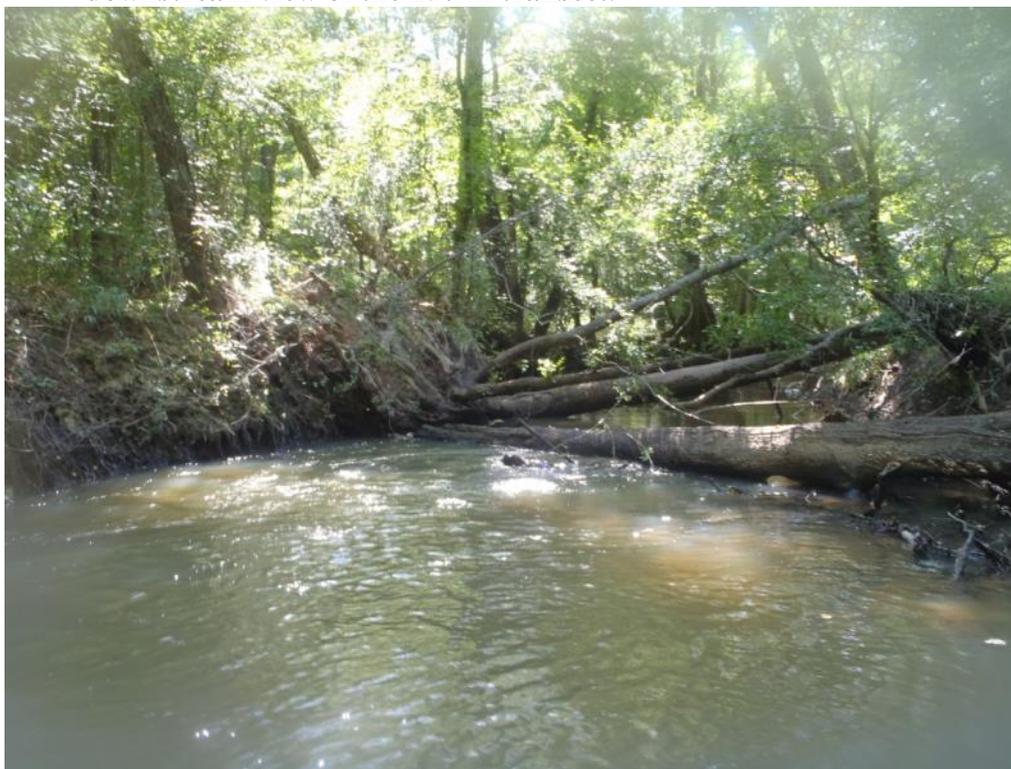
Figure 7.11 Photograph of West Mud Creek Site WM03 taken on August 8, 2014, the upstream view of the 300-m transect.

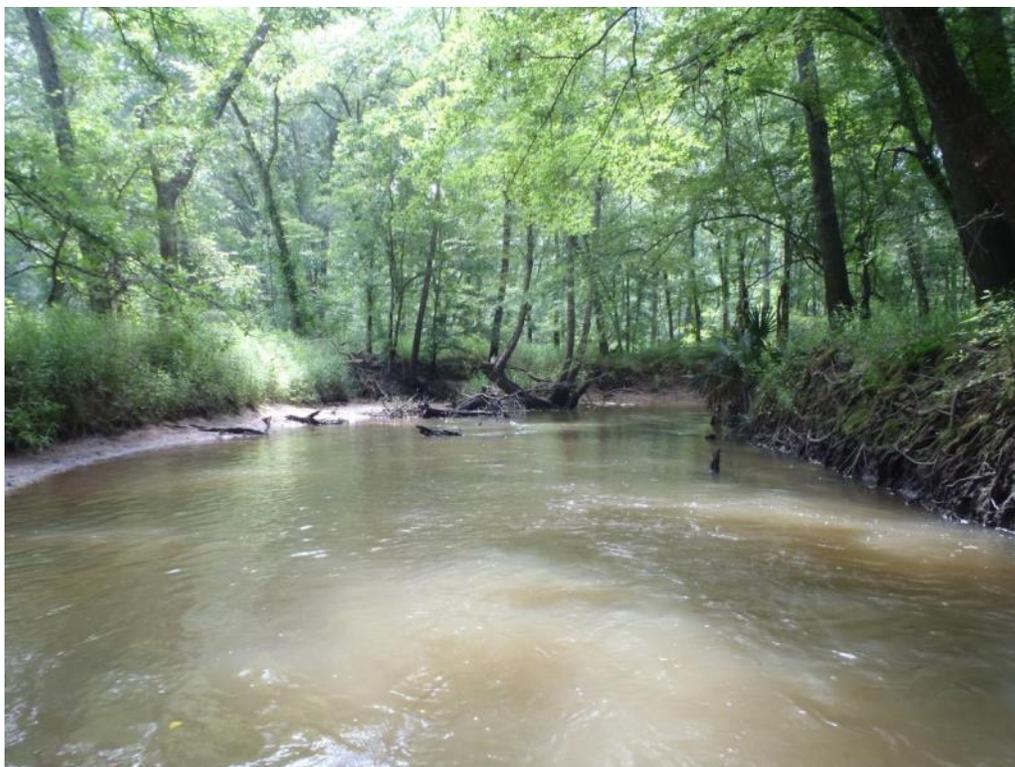
Figure 7.12 Photograph of West Mud Creek Site WM04 taken on June 4, 2014, the downstream view of the 150-m transect.

West Mud Creek at Site WM04 was visited on June 4 and August 9, 2014. This site is located on West Mud Creek at the bridge crossing at County Line Road on Cherokee/Smith County Line, west of Troup, Texas. Site WM04 was only publicly accessible at the bridge crossing with fenced private property upstream and downstream of the crossing. The site is located in a forest dominated corridor (Table 7.5). At the site, access to the stream was moderately easy near the bridge crossing. Steep and somewhat slick banks at other locations throughout the reach would make access to the stream difficult. Figures 7.12 and 7.13 depict the appearance of the site during each survey.

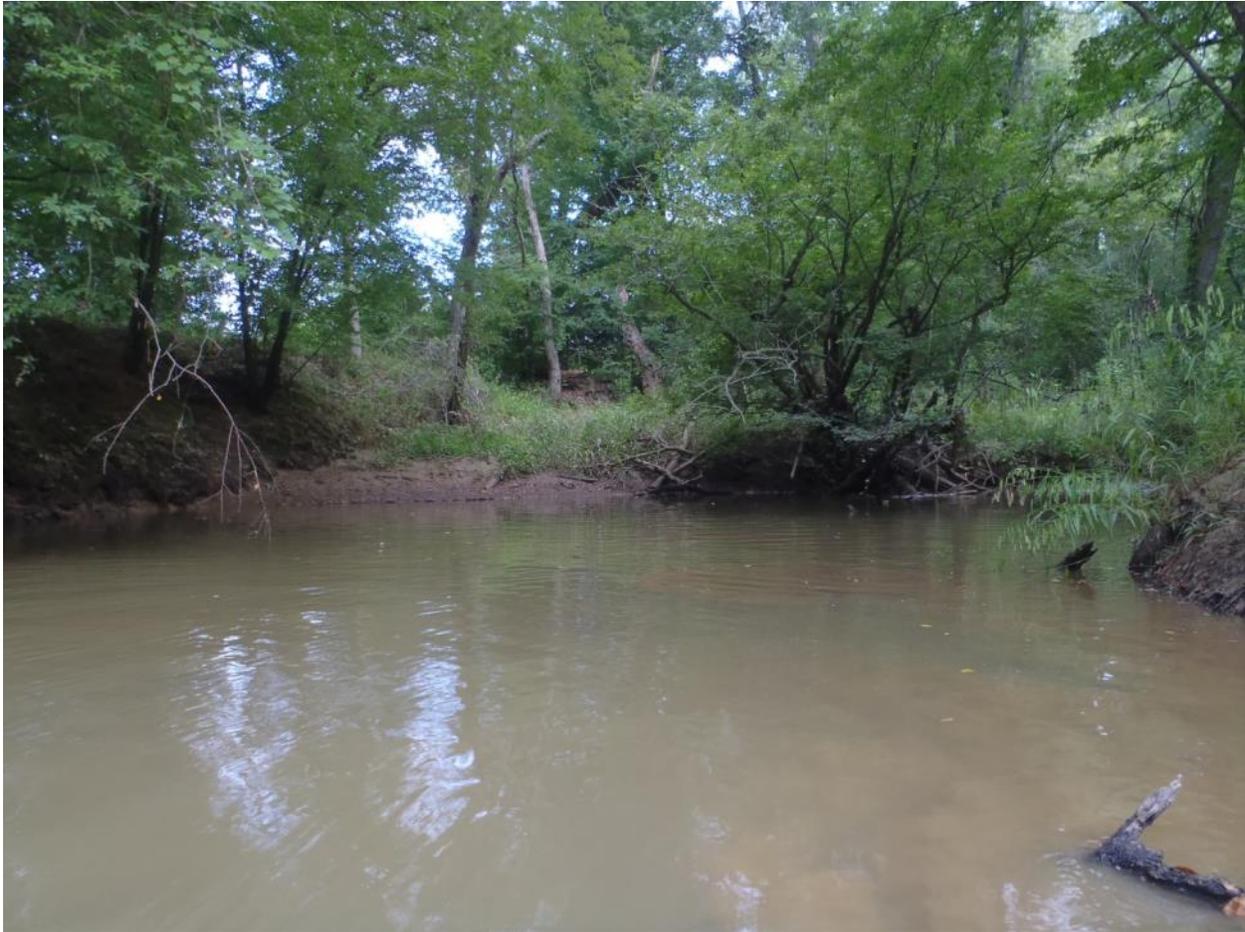
Figure 7.13 Photograph of West Mud Creek Site WM04 taken on August 9, 2014, the upstream view of the 300-m transect.

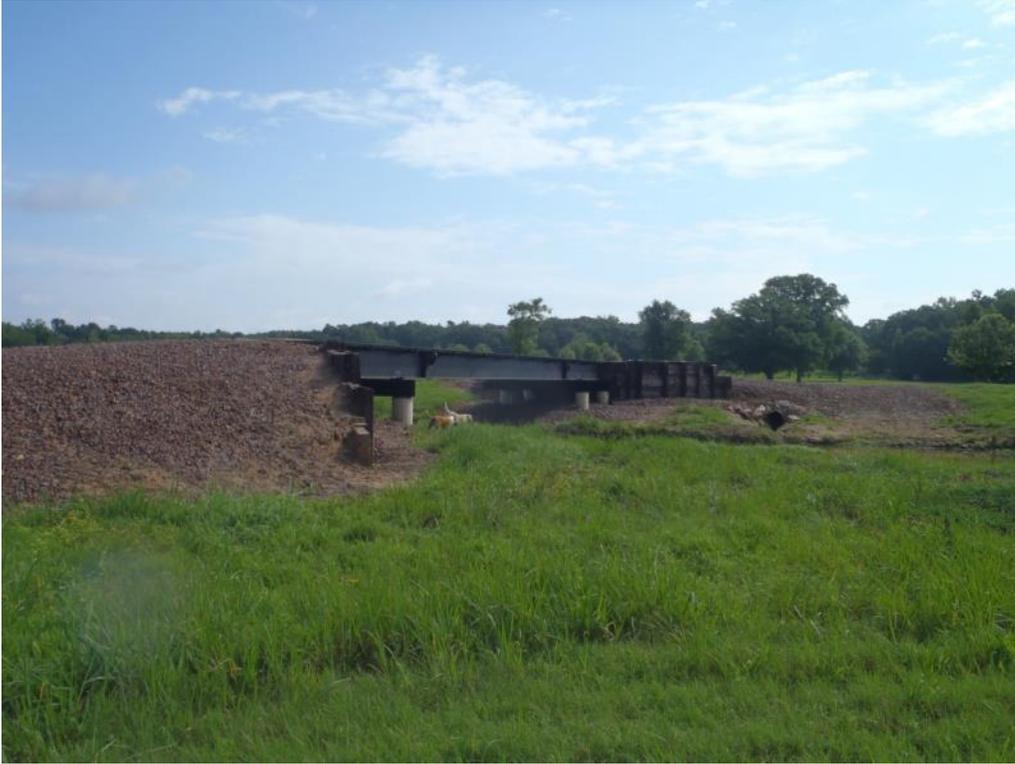
Figure 7.14 Photograph of privately owned bridge at West Mud Creek Site WM05 taken on August 9, 2014.

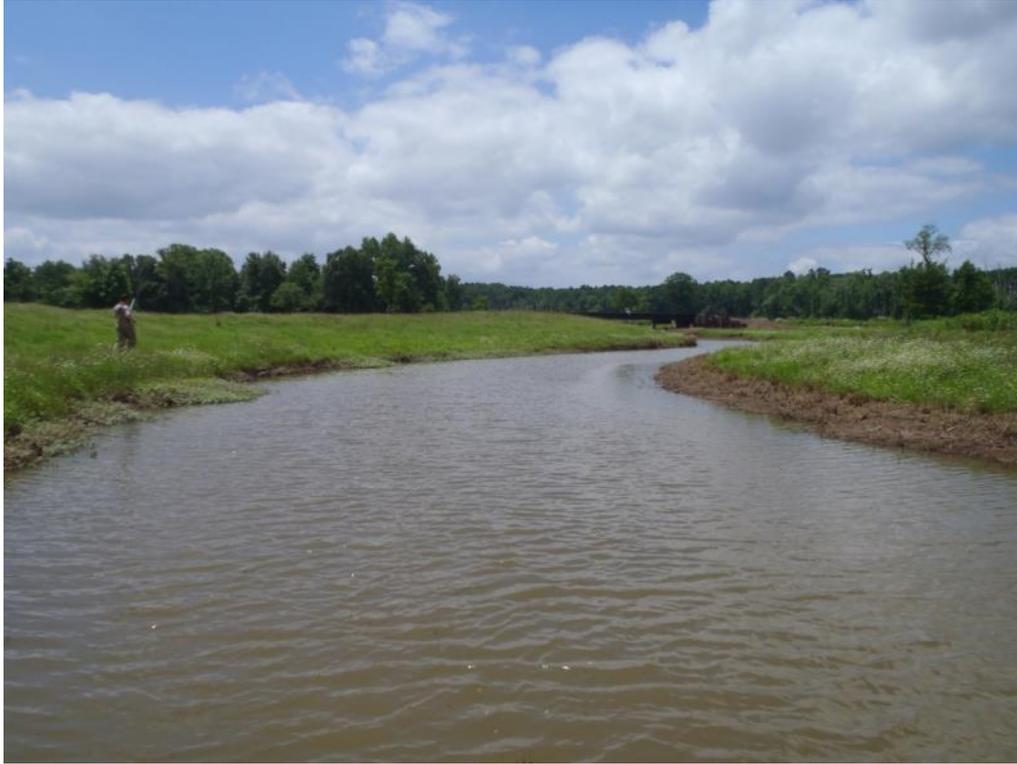
Figure 7.15 Photograph of West Mud Creek Site WM05 taken on June 4, 2014, the downstream view of the 300-m transect. TIAER personnel in photograph.

West Mud Creek at Site WM05 was visited on June 4 and August 9, 2014. This site was located west of Troup, Texas approximately 2.1 miles west of Farm-to-Market Road 2177. The site was only accessible, with landowner permission, through fenced private property with potentially locked gates. With landowner permission, TIAER personnel walked approximately 0.4 miles through a mowed path to reach the site. Access to the stream was easy due to gently sloping banks and relatively short grass dominated vegetation along the surveyed reach. A privately owned and maintained bridge at the 150-m transect also provided easy access to either side of the stream (Figure 7.14). The site is located in shrub dominated corridor that had been mowed/maintained (Table 7.5). Figures 7.15 and 7.16 depict the appearance of the site during each survey.

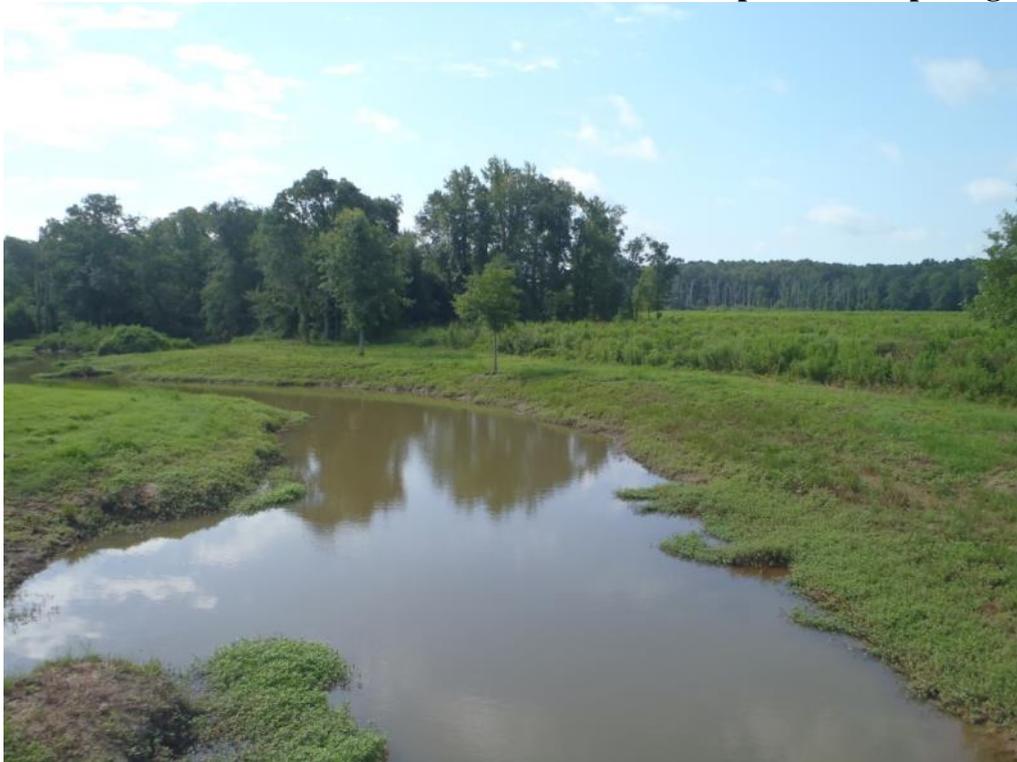
Figure 7.16 Photograph of West Mud Creek Site WM05 taken on August 9, 2014, the downstream view of the 150-m transect.

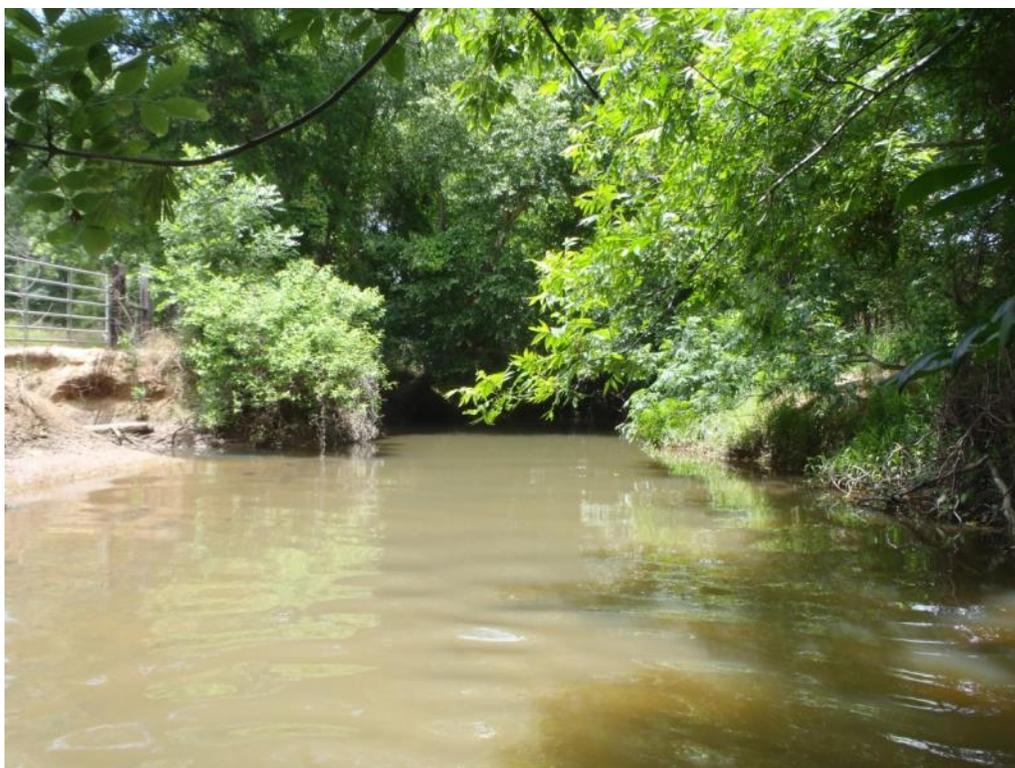
Figure 7.17 Photograph of West Mud Creek Site WM06 taken on June 4, 2014, the upstream view of the 300-m transect.

West Mud Creek at Site WM06 was visited on June 4 and August 9, 2014. This site was located at the bridge crossing at Farm-to-Market Road 344, northeast of Bullard, Texas. The site was only publicly accessible at the bridge crossing with fenced private property upstream and downstream of the crossing. The left bank at the site was dominated by a forest and shrub corridor, while the right bank was within a pasture dominated corridor (Table 7.5). A vehicle trail on the east side of the bridge crossing in addition to only slightly steep banks under the bridge allowed for moderately easy access to the stream (Table 7.6). At other locations throughout the reach, access to the stream was more challenging due to steep banks and dense vegetation. Figures 7.17 and 7.18 depict the appearance of the site during each survey.

Site WM06 was wadeable for the entire 300-m reach length. Average thalweg during the first survey was 0.7 m and during the second survey was 0.6 m (Table 7.6). During both surveys, occasional log jams and other woody debris was encountered that made wading challenging; however, wading was relatively easy within areas that were free of obstructions. Stream widths ranged from 5.0 m to 7.5 m during the first survey and 4.0 m to 8.0 m during the second survey (Tables 7.7 and 7.8).

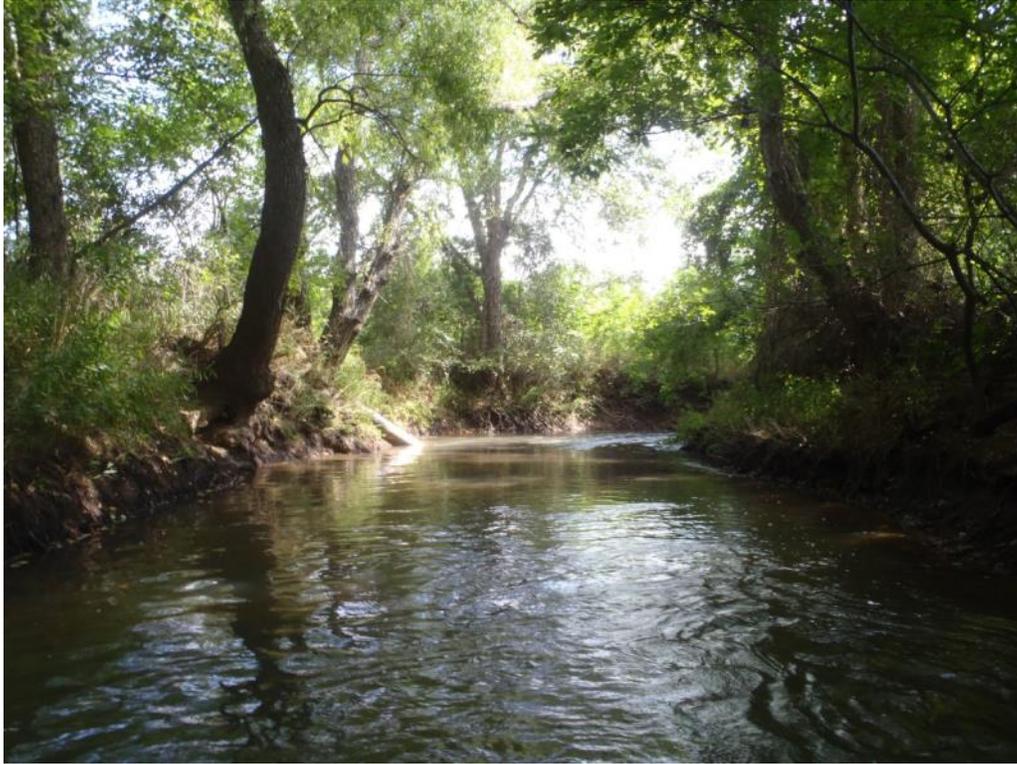
Figure 7.18 Photograph of West Mud Creek Site WM06 taken on August 9, 2014, the downstream view of the 150-m transect.

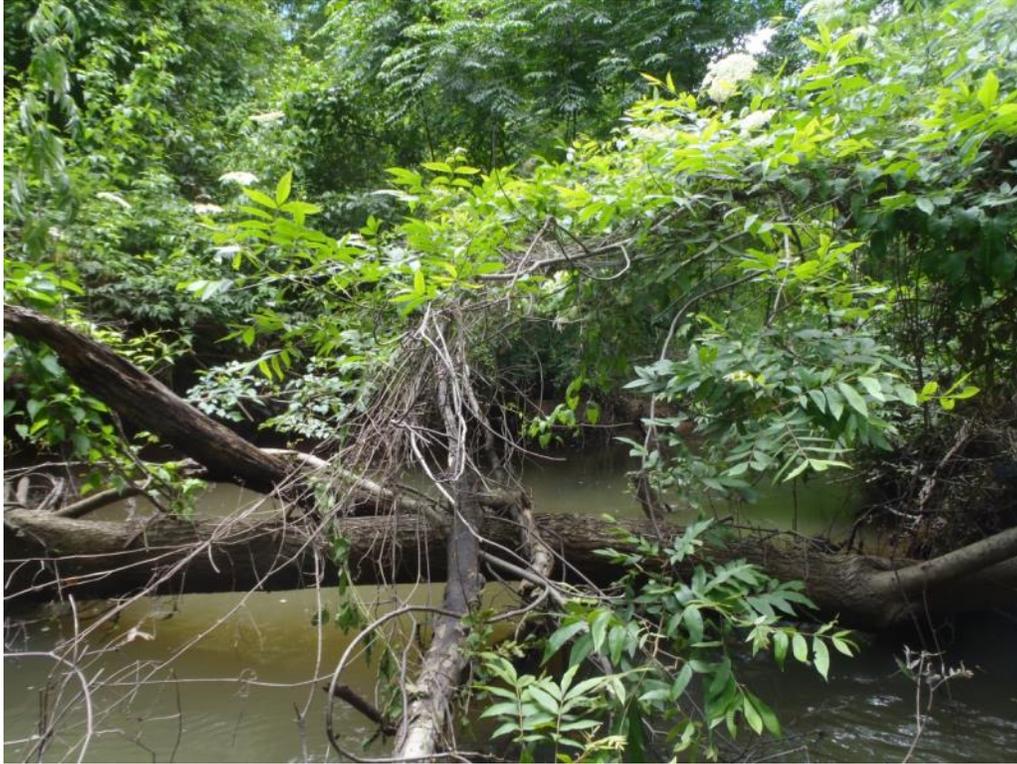
Figure 7.20 Photograph of West Mud Creek Site WM07 taken on June 4, 2014, the upstream view of the 300-m transect.

West Mud Creek at site WM07 was visited on June 4 and August 9, 2014. This site is located at the bridge crossing at Smith County Road 129, north of Bullard, Texas. Site WM07 was only publicly accessible at the bridge crossing with private property upstream and downstream of the crossing. The site is located in a forest dominated corridor (Table 7.5). At the bridge crossing, access to the stream was moderately easy (Table 7.6); however access would have been more challenging elsewhere along the surveyed reach due to dense woody vegetation and steep banks. Figures 7.19 and 7.20 depict the appearance of the site during each survey.

Site WM07 was wadeable for much of 300-m reach length, although water that was too deep for wading was encountered at a few locations along the reach. The average thalweg was 0.8 m and 0.7 m during the first and second survey, respectively (Table 7.6). During both surveys numerous log jams and other woody obstructions were encountered along the reach that made wading and traversing the reach difficult. Stream widths ranged from 4.0 to 13 m (Table 7.7 and 7.8).

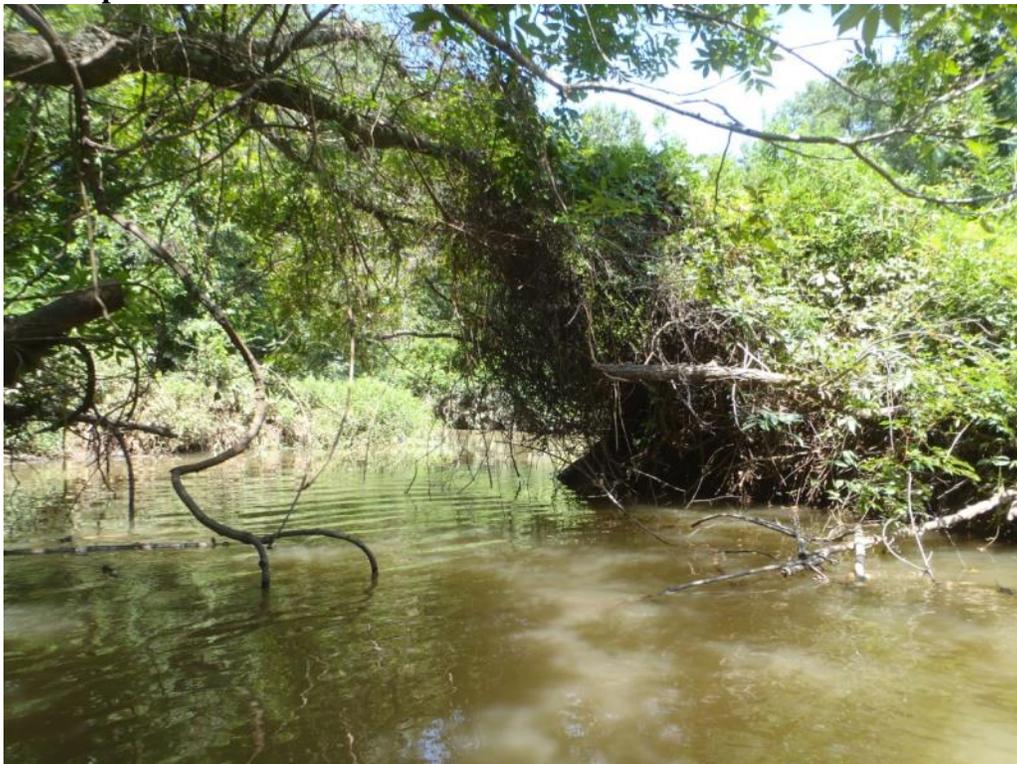
Figure 7.21 Photograph of West Mud Creek Site WM07 taken on August 9, 2014, the upstream view of the 0-m transect.

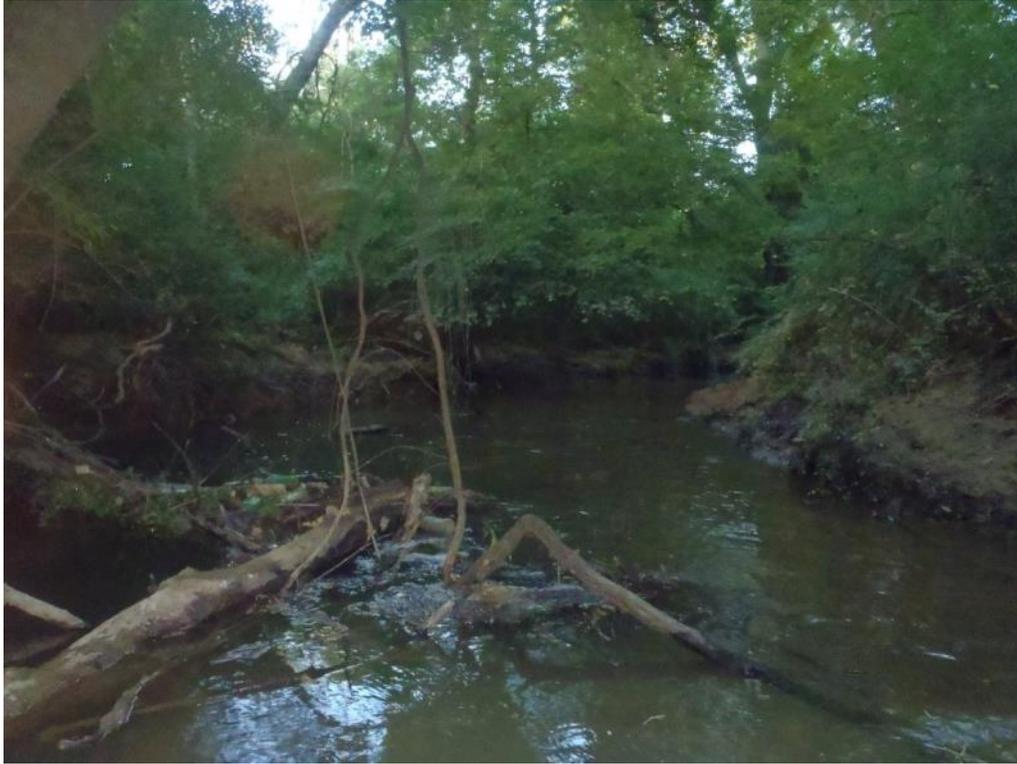
Figure 7.22 Photograph of West Mud Creek Site WM08 taken on August 10, 2014, the upstream view of the 150-m transect.

Site WM08 was wadeable for most of the entire 300-m reach, although water depth was too great for wading in a few locations. Average thalweg was 0.8 m and 0.9 m (Table 7.6) during the first and second surveys, respectively. During both surveys, beaver dams, logs jams, and instream rip rap made wading and traversing the reach difficult. Stream widths ranged from 4.0 m to 6.5 m during the first survey and 4.0 m to 7.5 m during the second survey (Tables 7.7 and 7.8).

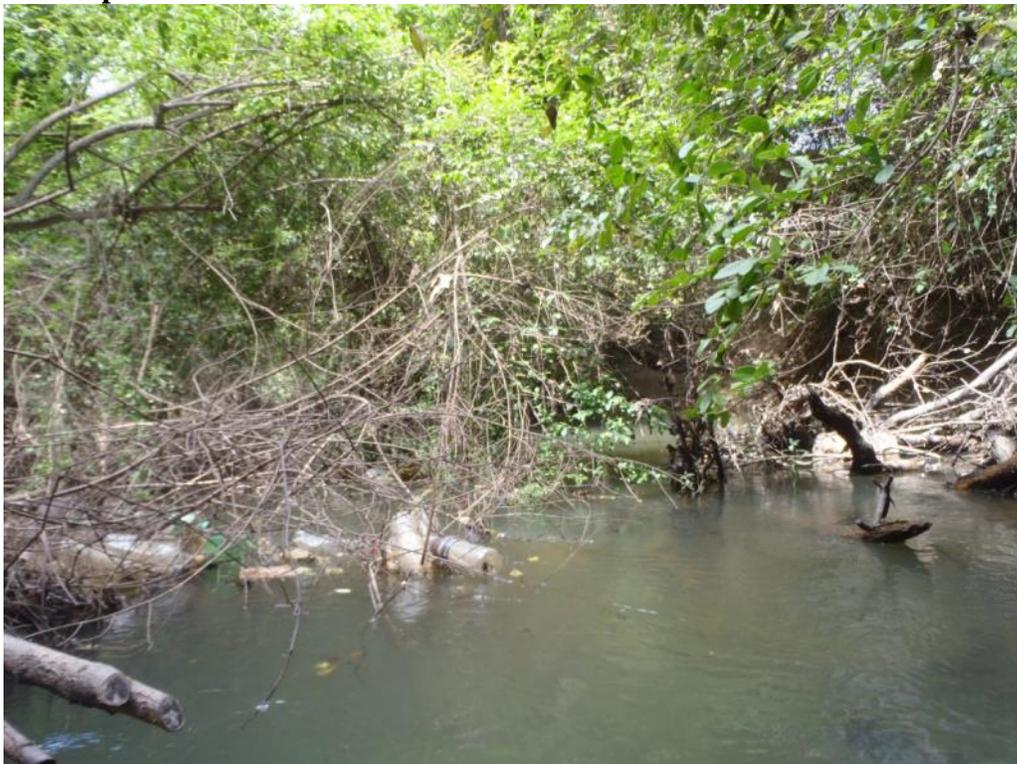
Figure 7.23 Photograph of West Mud Creek Site WM08 taken on June 4, 2014, the upstream view of the 300-m transect.

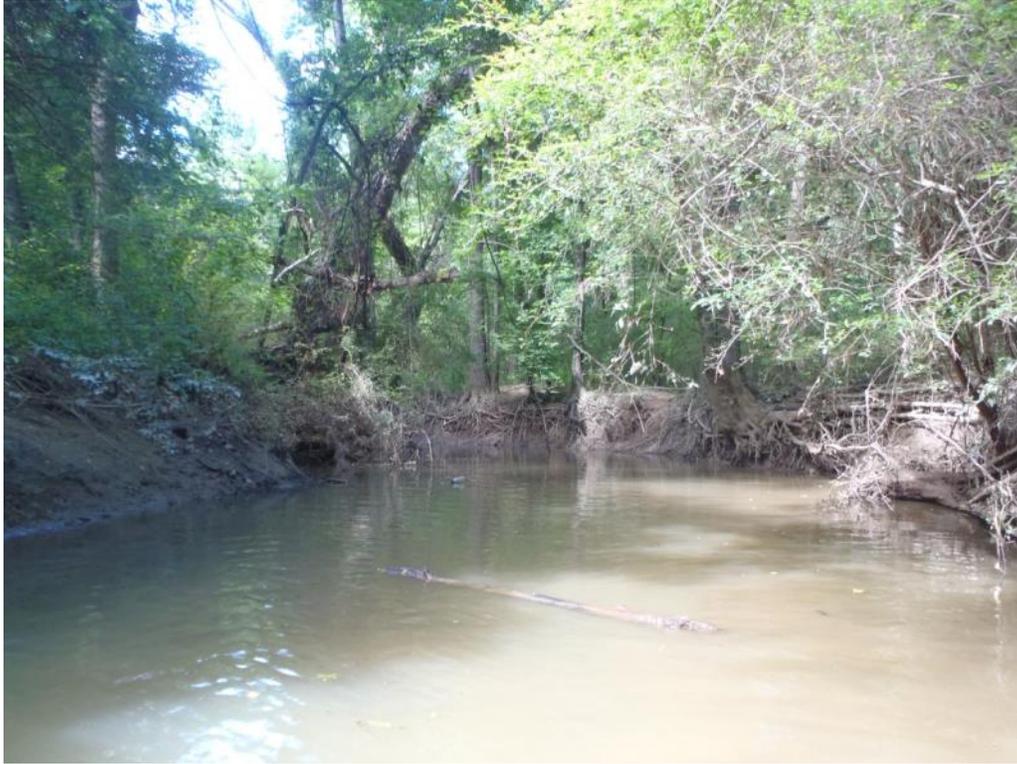
Figure 7.24 Photograph of West Mud Creek Site WM09 taken on June 4, 2014, the upstream view of the 0-m transect.

During the first survey, Site WM09 was wadeable for the entire 300-m reach length. During the second survey, water depth had increased compared to depths encountered during the first survey and caused portions of the reach to be non-wadeable. The reason is unknown as to why such a pronounced increase in water depth between the two surveys occurred at this site and not at other sites surveyed along West Mud Creek. A possible explanation could be a beaver dam or other type of instream obstruction may have been formed downstream of the surveyed reach between the time of the first and second surveys. Average thalweg was 0.9 m during the first survey and 1.2 m during the second survey (Table 7.6). During both surveys, instream obstructions and steep banks made traversing the reach moderately difficult. Widths of the stream ranged from 7.0 m to 15 m during the first survey, and 5.5 m to 8.0 m during the second survey (Tables 7.7 and 7.8). One beaver dam was observed near the 150-m transect.

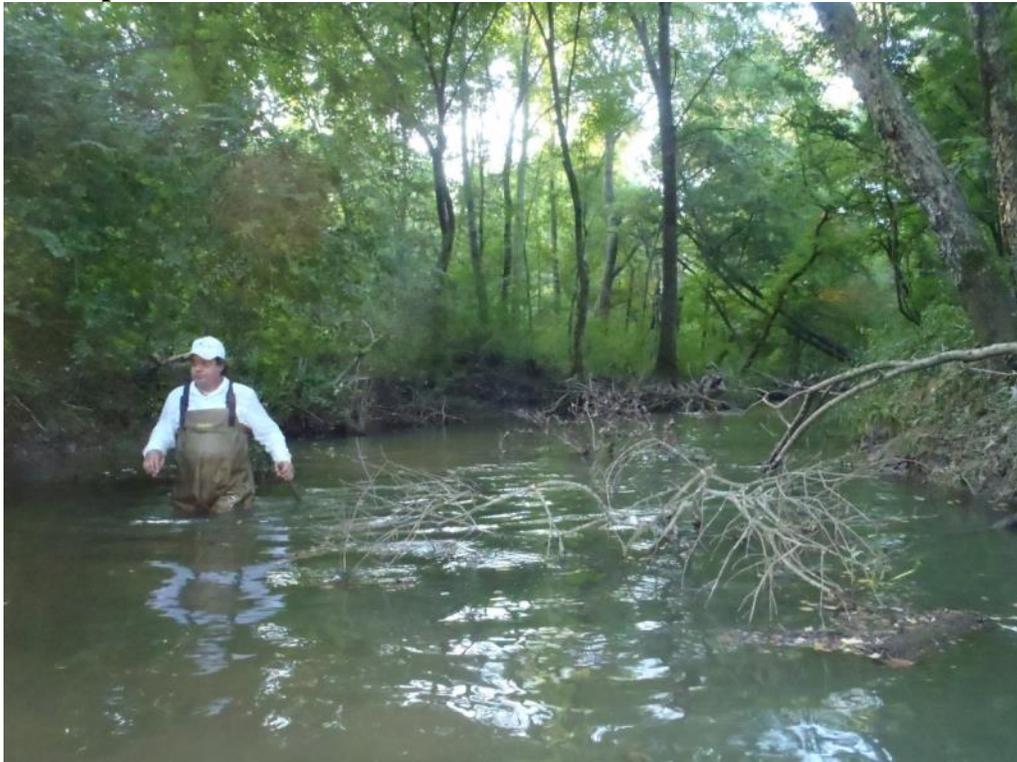
Figure 7.25 Photograph of West Mud Creek Site WM09 taken on August 10, 2014, the downstream view of the 150-m transect. TIAER personnel in photograph.

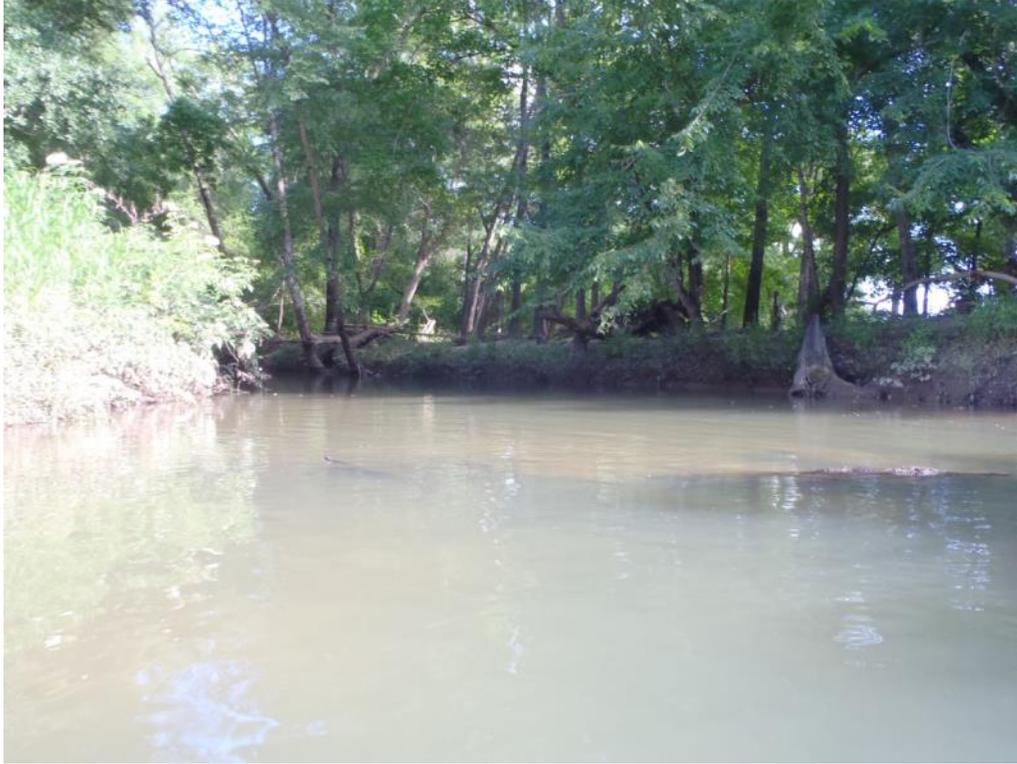
Figure 7.26 Photograph of West Mud Creek Site WM10 taken on June 4, 2014, the downstream view of the 300-m transect.

West Mud Creek at Site WM10 was visited on June 4 and August 10, 2014. This site is located at the bridge crossing on Farm-to-Market Road 2813, south of Tyler, Texas. Site WM10 was only publicly accessible at the bridge crossing with fenced private property upstream and downstream of the crossing. The left bank at this site is located in forest dominated corridor while the right bank is located in a pasture dominated corridor (Table 7.5). Access to the stream was moderately difficult due to dense vegetation and steep banks (Table 7.6). Figures 7.22 and 7.23 depict the appearance of the site during each survey.

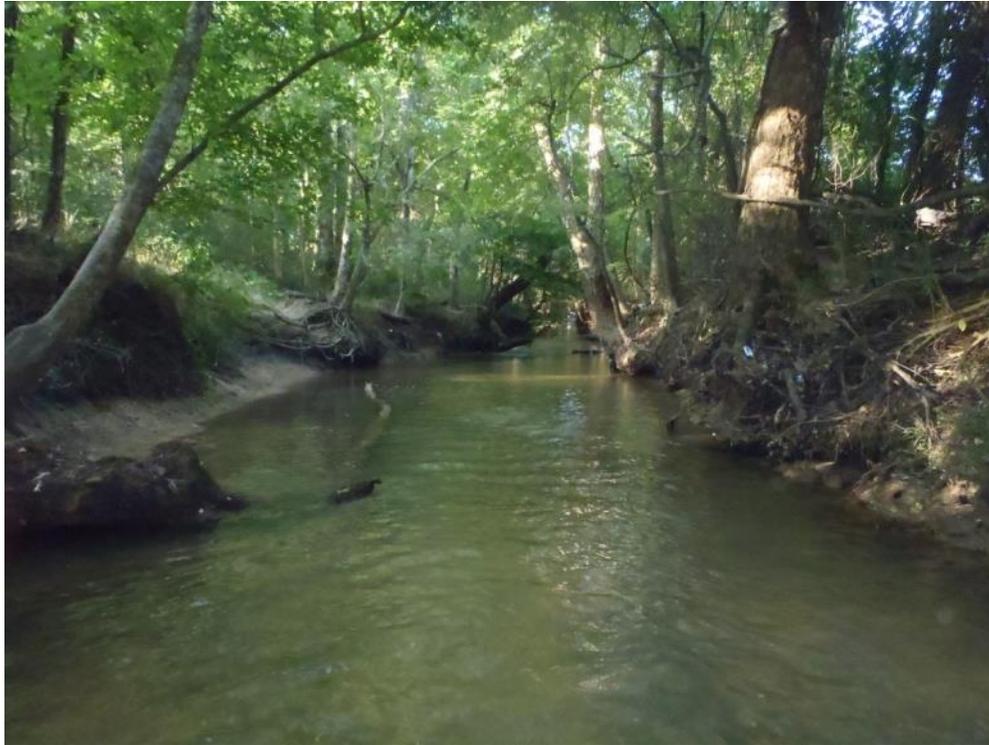
Figure 7.27 Photograph of West Mud Creek Site WM10 taken on August 10, 2014, the downstream view of the 150-m transect.

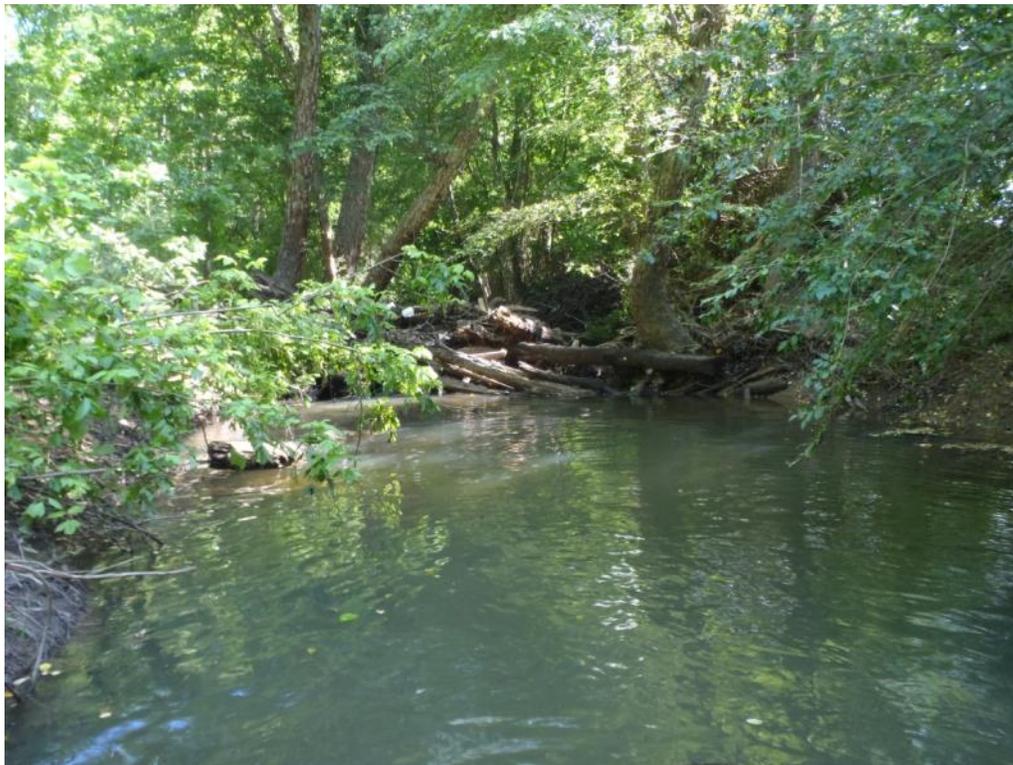
Figure 7.28 Photograph of debris dam near 180-m transect on West Mud Creek Site WM10 taken on June 4, 2014.

Site WM10 was wadeable for the entire 300-m reach length. Average thalweg was 0.8 m during the first survey and 0.6 m during the second survey (Table 7.6). During the first survey a large debris dam composed of logs and other woody debris was located near the 180-m transect (Figure 7.24). The debris dam was substantial enough to cause water depths on the upstream side of the dam to be at least 0.2 m deeper than what was measured on the downstream side. During the second survey the debris dam was no longer present. During the first survey, wading was moderately difficult due to the deeper water on the upstream side of the debris dam. Wading was also challenging due to occasional log jams and other instream debris. Stream widths during the first survey ranged from 3.0 m to 12 m and from 2.5 m to 13 m during the second survey (Tables 7.7 and 7.8).

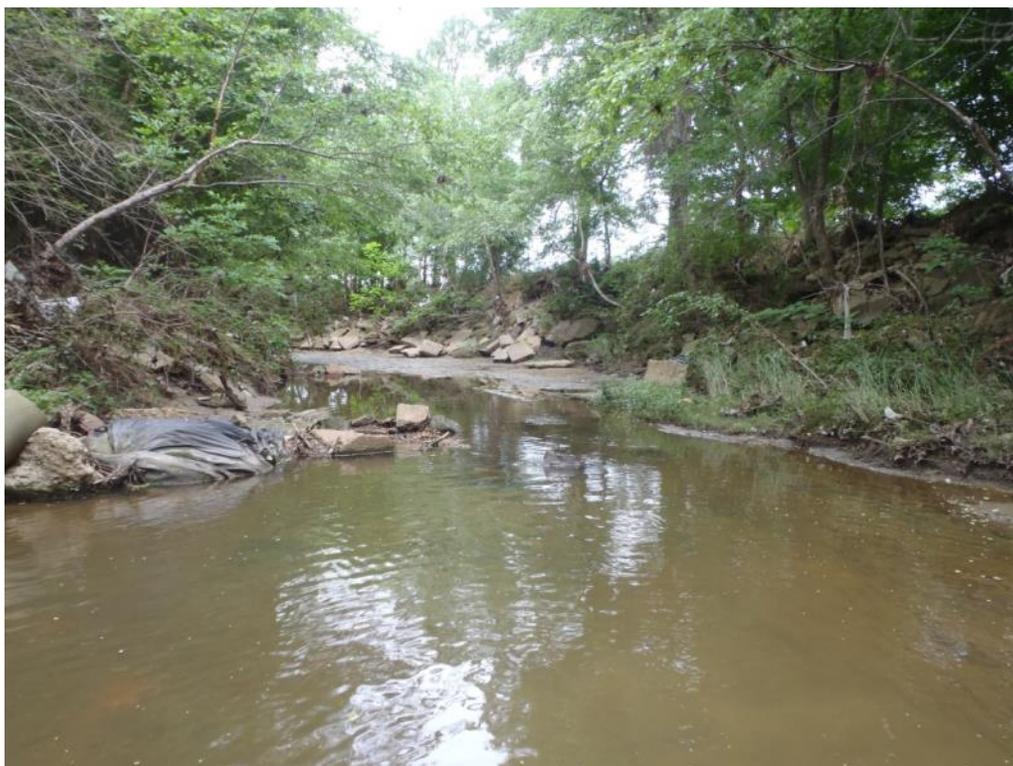
Figure 7.29 Photograph of West Mud Creek Site WM11 taken on June 5, 2014, the downstream view of the 300-m transect.

West Mud Creek at Site WM11 was visited on June 5 and August 10, 2014. This site is located on private property owned by the Holly Tree Country Club in Tyler, Texas. With permission from the Country Club management, TIAER personnel accessed the stream by traveling approximately 0.30 miles down concrete golf paths. The left bank of the site is located in a shrub and forest dominated corridor while the right bank is dominated by a mowed golf course (Table 7.5). Access to the stream was moderately easy due to the mowed/maintained nature of the right bank. Steep banks throughout the reach however did pose some challenges to accessing the stream (Table 7.6). Figures 7.25 and 7.26 depict the appearance of the site during each survey.

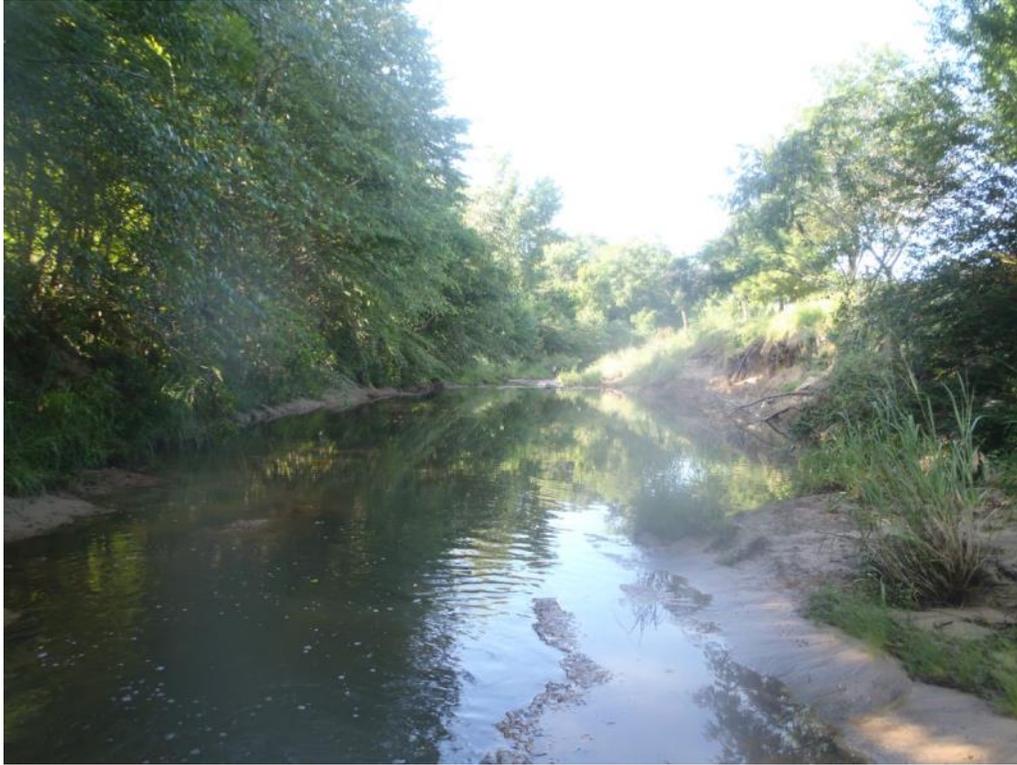
Figure 7.30 Photograph of West Mud Creek Site WM11 taken on August 10, 2014, the downstream view of the 0-m transect.

Site WM11 was wadeable for the entire 300-m reach length. Average thalweg was 0.5 m during both surveys (Table 7.6). The shallow water depths and compacted clay substrate made wading in the stream channel easy. Stream widths ranged from 1.0 m to 6.5 m during the first survey and 1.0 m to 7.0 m during the second survey (Tables 7.7 and 7.8).

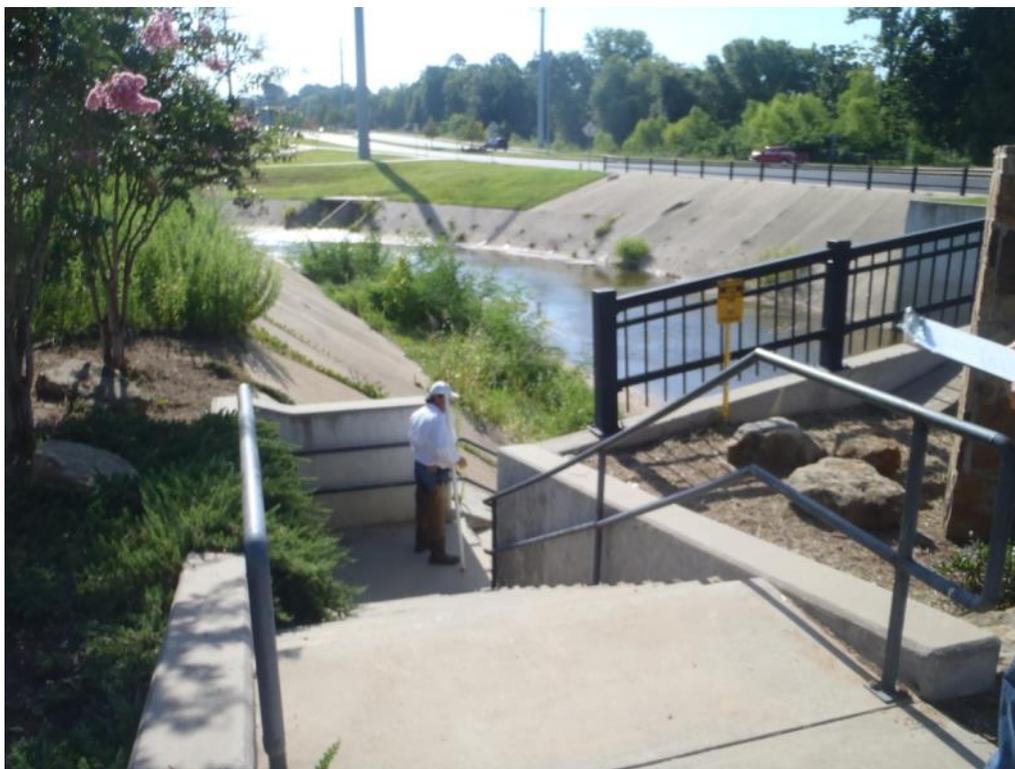
Figure 7.31 Photograph of stairs leading to a pedestrian walkway at West Mud Creek Site WM12 taken on August 10, 2014. TIAER personnel in the photograph.

concrete stairway with hand rails that led to a pedestrian tunnel that passed under State Highway 69 (Table 7.6 and Figure 7.27). Figures 7.28 and 7.29 depict the appearance of the site during each survey.

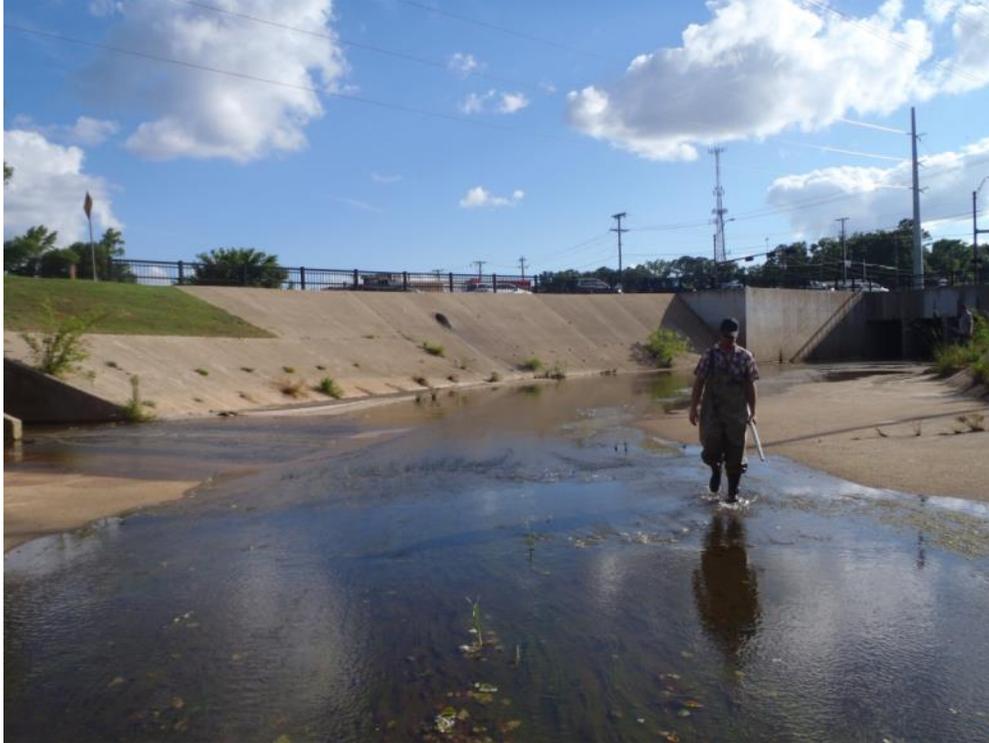
Figure 7.32 Photograph of West Mud Creek Site WM12 taken on June 4, 2014, the downstream view of the 300-m transect. TIAER personnel in photograph.

Shallow water depths within the concrete lined channel made wading in the stream channel easy at Site WM12 for the entire 300-m reach. Average thalweg was 0.1 m during both surveys (Table 7.6). Stream widths ranged from 3.5 to 15 m (Tables 7.7 and 7.8).
