Recreational Use Attainability Analysis for
Kickapoo Creek in Henderson County (0605A),
the Neches River Above Lake Palestine (0606),
Prairie Creek (0606A), Mud Creek (0611C), and
West Mud Creek (0611D)
in the Neches River Basin

Prepared for:
Texas State Soil and Water Conservation Board
Project 14-52

Texas Institute for Applied Environmental Research
Tarleton State University
Stephenville, Texas

TR1503
September 2015

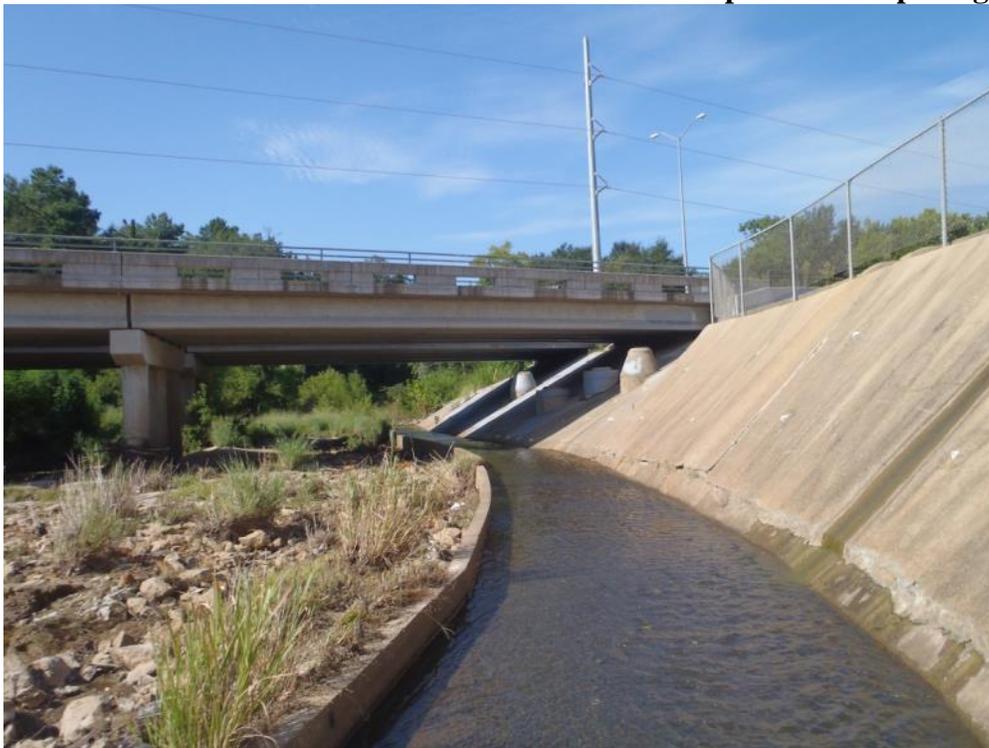
Figure 7.33 Photograph of West Mud Creek Site WM12 taken on August 10, 2014, the downstream view of the 0-m transect.

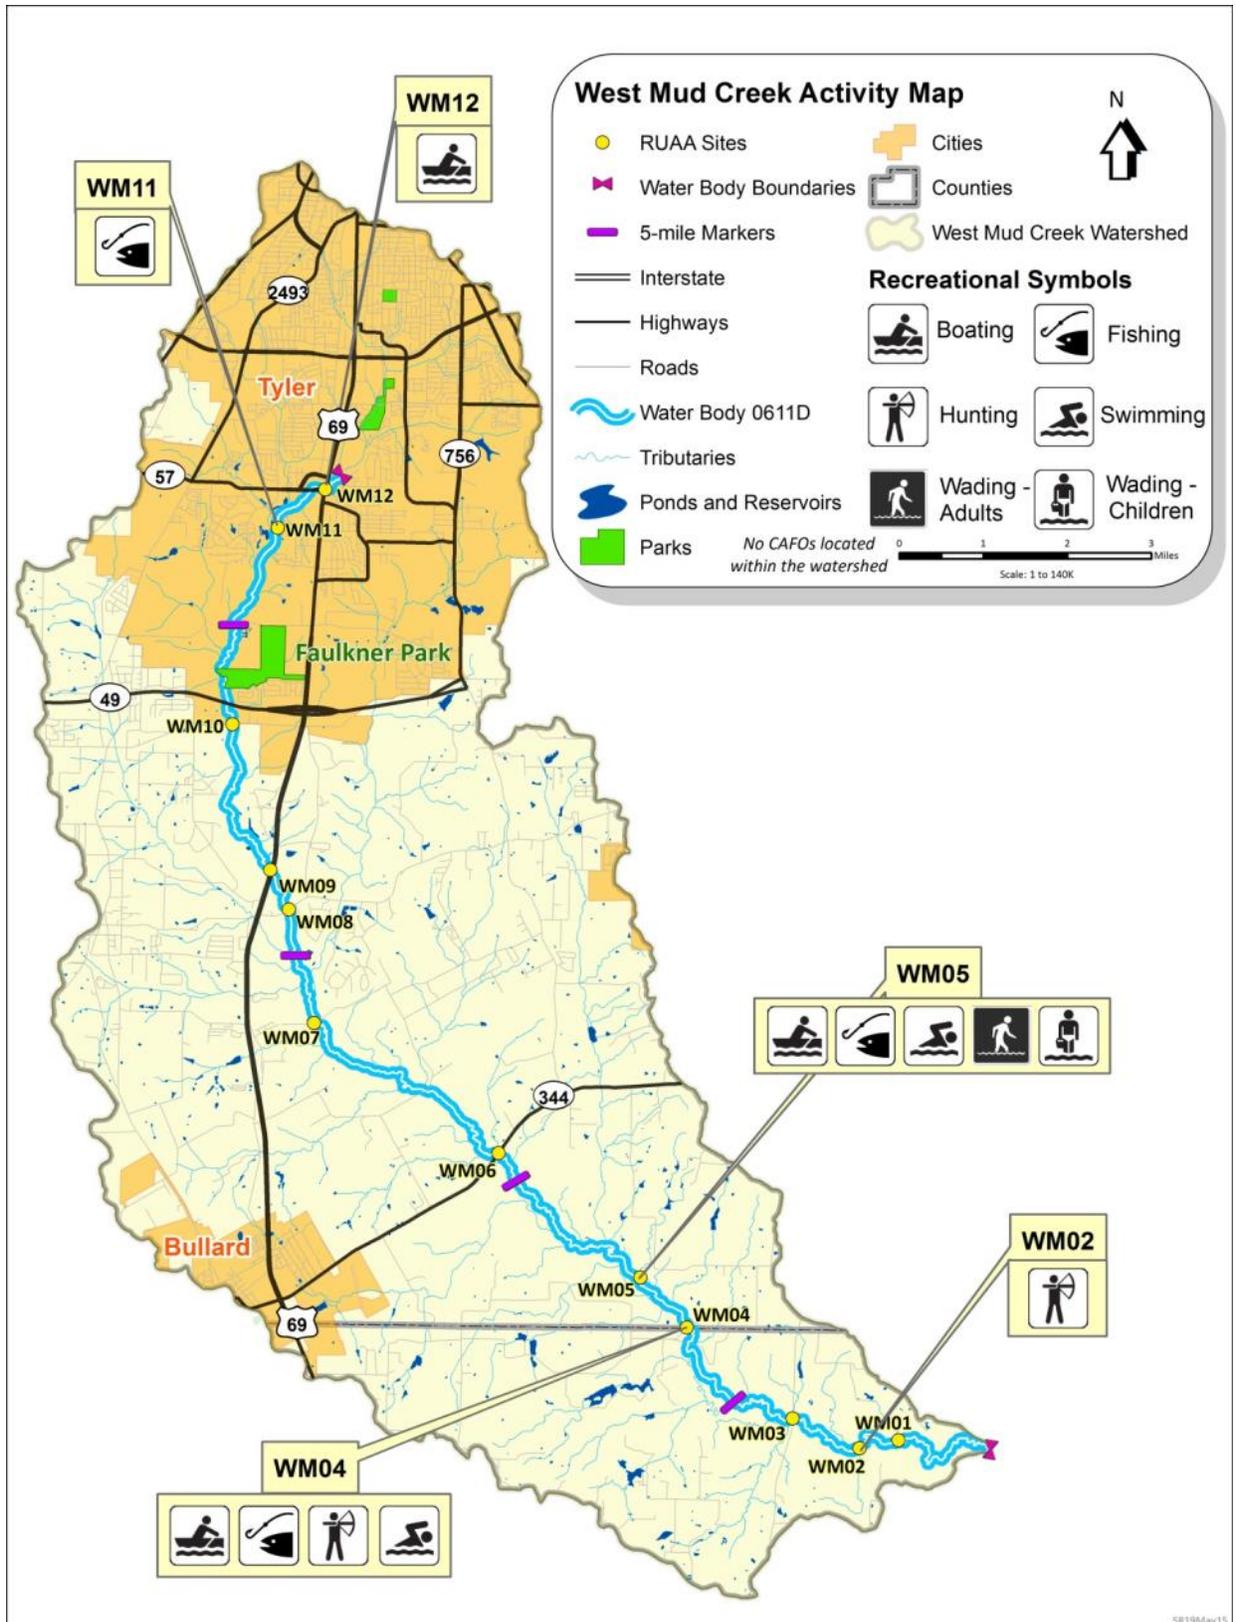
Figure 7.34 Summary of observed and interviewed human activities on West Mud Creek.

RUAA surveys were conducted at 12 sites along West Mud Creek (0611D) on the days of June 3-5, 2014 and August 8-10, 2014. The Palmer Drought Severity Index (PDSI) represented slightly wet conditions for East Texas during both surveys (TWDB, 2014). During the two surveys, there were no recreational activities directly observed by TIAER field staff. Interviews revealed that swimming, adult wading, children wading, hunting and/or fishing has occurred at a few sites throughout the reach, although not frequently. Areas of the stream open to the public are limited to the right-of-ways immediately underneath bridge crossings or areas immediately up and down stream of culvert crossings, typically ranging from 5 to 20 meters. Recreational activities reported by interviewees are summarized in Figure 7.85. Overall RUAA findings are summarized in the form below.
