**San Miguel Creek (Segment 2108)  
Recreational Use Attainability Analysis**

**Texas State Soil and Water Conservation Board  
Project 14-51**

**Nueces River Authority – Coastal Bend Division  
Corpus Christi, Texas**

**November 2015**

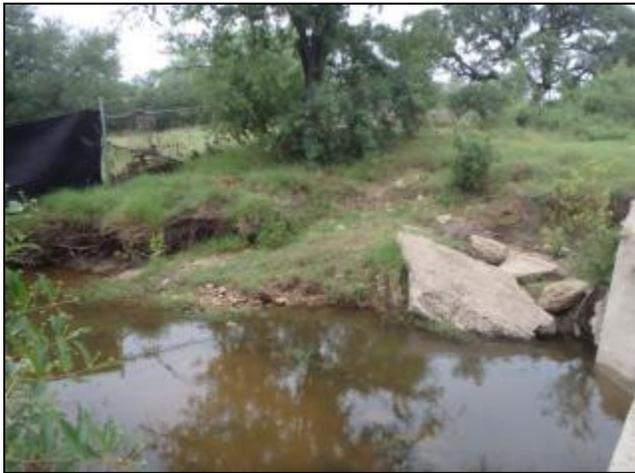
**Figure 4-37.** Downstream view from bridge during Survey 1.

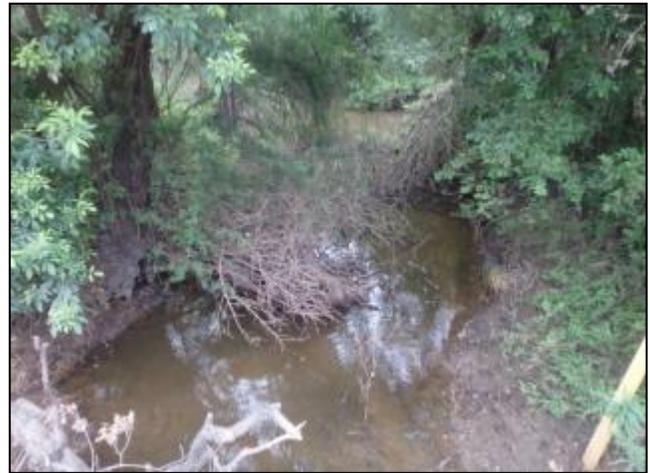
**Figure 4-38.** Upstream view from bridge during Survey 1.

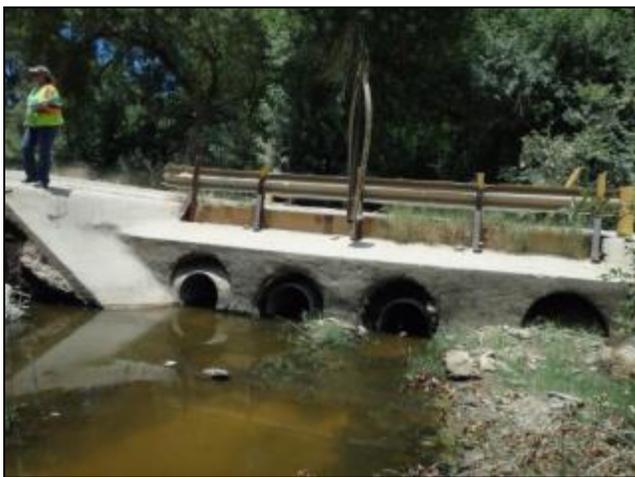
**Figure 4-39.** Downstream view during Survey 2.

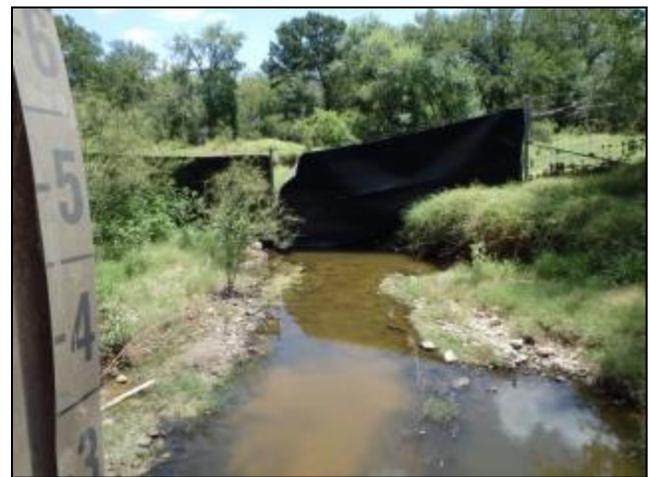
**Figure 4-40.** Downstream view during Survey 2.

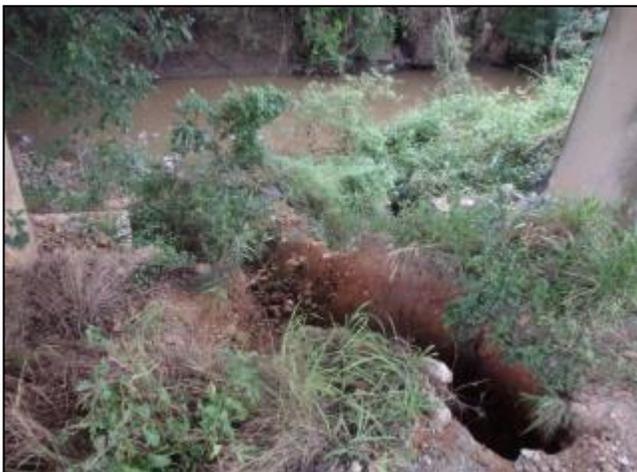
The riparian area adjacent to the creek was observed to be dense forest with a partially denuded and eroded bank. Under the bridge, concrete, rip rap and a discarded bench seat from a vehicle were observed. Bank angles under the bridge were very steep. Streamflow was observed during the first survey site visits following the May 2015 flood but returned to no flow conditions during the second survey site visit. Three pools were observed during the second survey: a pool upstream extending beyond sight, a small pool under the bridge, and a pool beginning just downstream of the bridge and extending beyond sight.

**Figure 4-59.** View under the bridge during Survey 2.

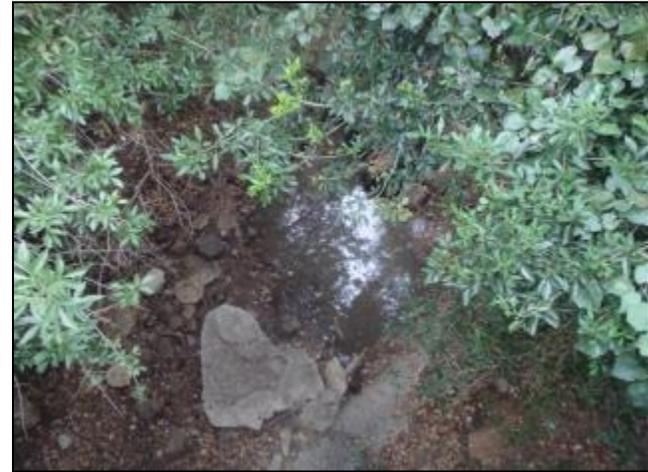
**Figure 4-60.** Pool under the bridge during Survey 2

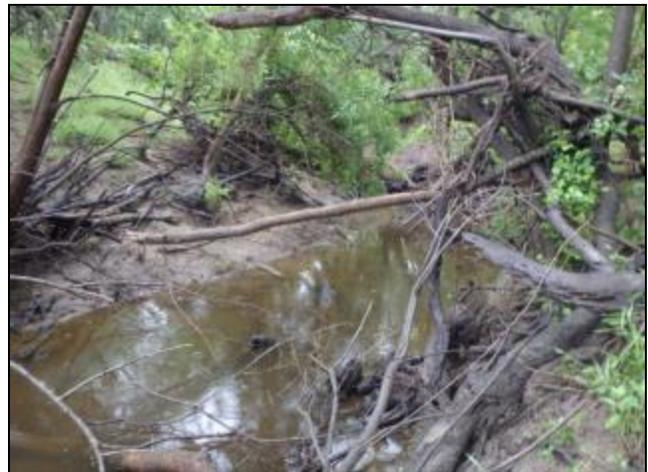
**Figure 4-62.** Downstream view at 300m during Survey 1.

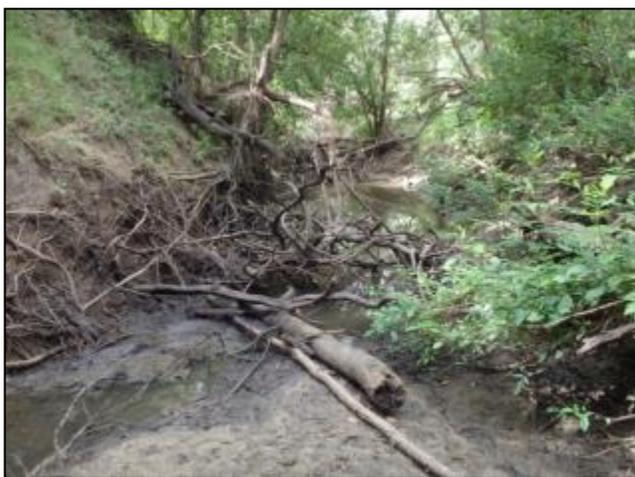
**Figure 4-63.** Downstream view at 300m during Survey 2.

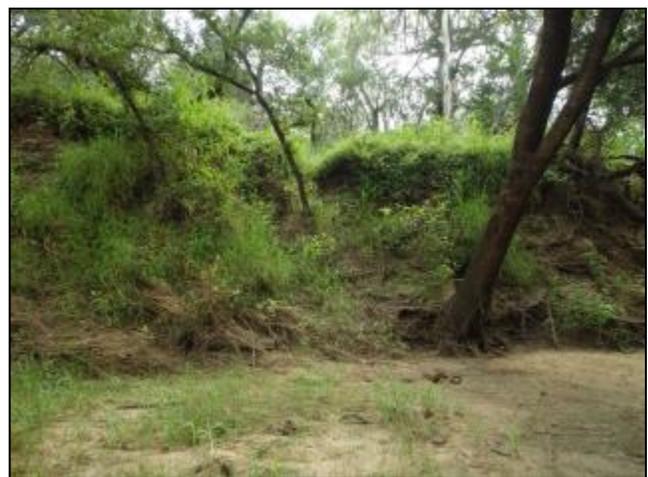
**Figure 4-64.** Left bank view at 150m during Survey 2.

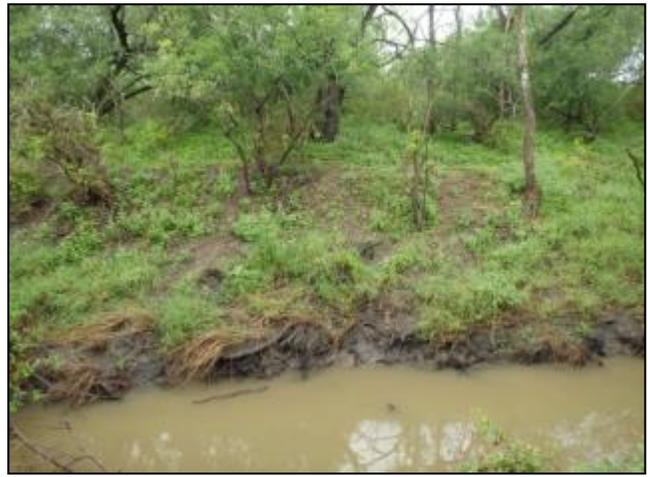
Bank access is easy at the low water crossing and moderately difficult beyond the crossing. The riparian zone is a mix of forest, grasses and in places, a denuded and eroded bank following the May 2015 flood. Bank angles were generally steep and allowed few opportunities to access the creek. A moderate amount of woody debris was observed in the creek. Streamflow was absent during both survey site visits. Evidence of wildlife included abundant frogs and spiders.

**Figure 4-66.** Right bank view at 300m during Survey 1.

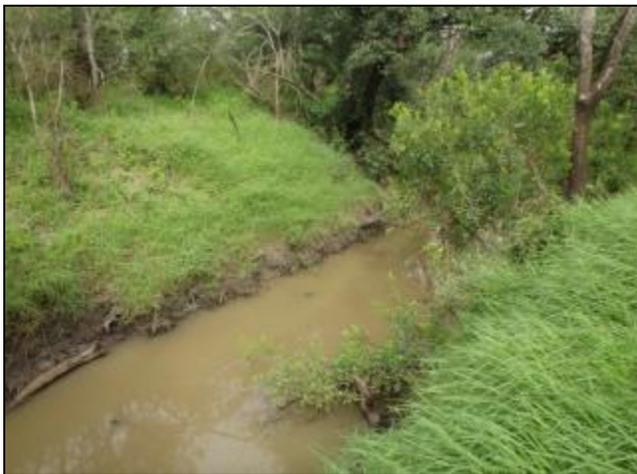
**Figure 4-67.** Right bank view at 300m during Survey 2.

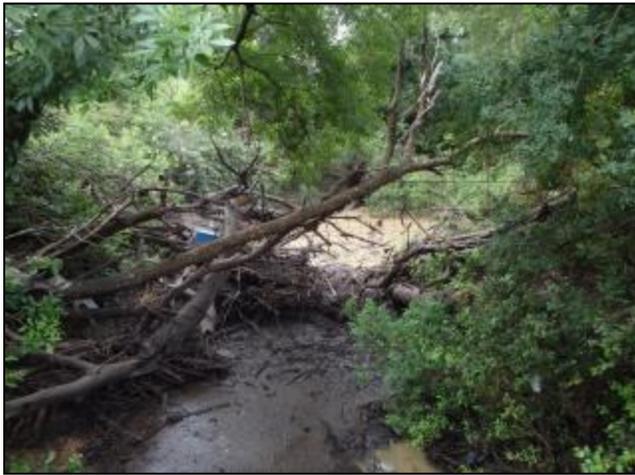
**Figure 4-77.** Downstream view during Survey 1.

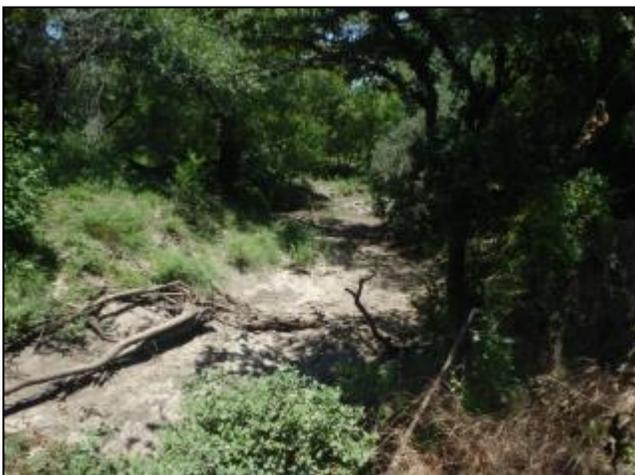
**Figure 4-79.** Upstream view during Survey 2.

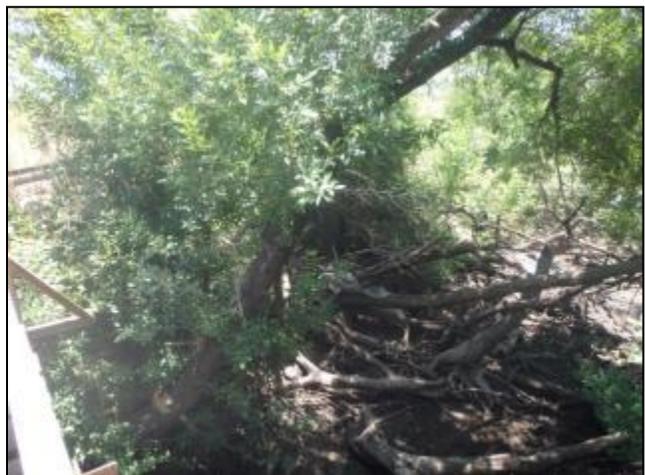
Bank access is difficult due to steep and muddy banks when the creek is flowing. Upstream, a barbed wire fence exists. Downstream, a high fence exists across the stream channel. Animal carcasses, trash, and other materials exist under the bridge. The riparian zone upstream and downstream of the crossing indicates the forest canopy is dense with areas of denuded or eroded bank. Woody debris was observed upstream and downstream from the crossing. No evidence of wildlife was reported during either of the site surveys.

**Figure 4-80.** Left bank at bridge during Survey 2.

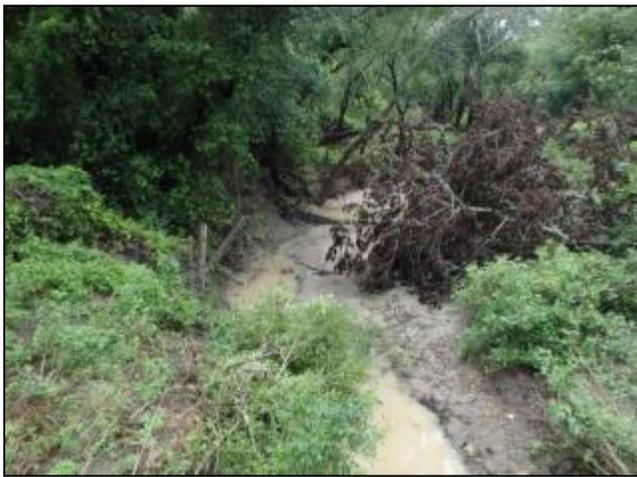
**Figure 4-81.** Downstream view during Survey 1.

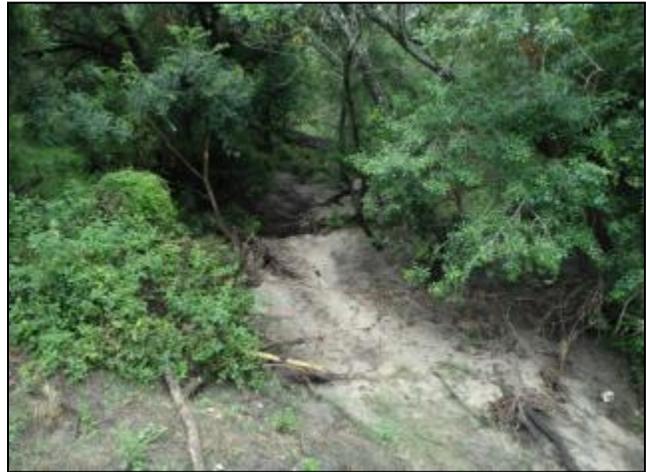
**Figure 4-82.** Upstream view during Survey 1.

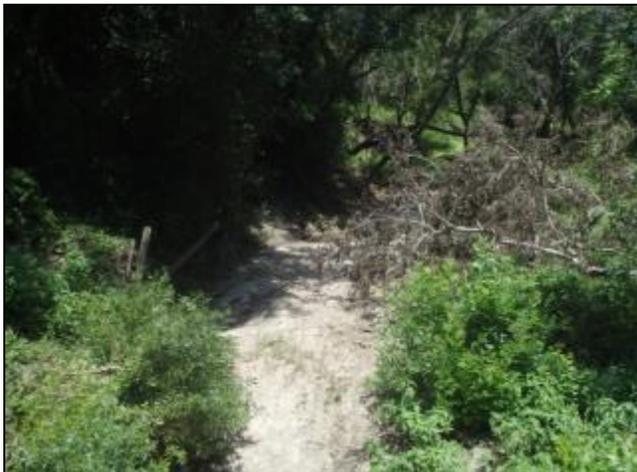
**Figure 4-83.** Downstream view during Survey 2.

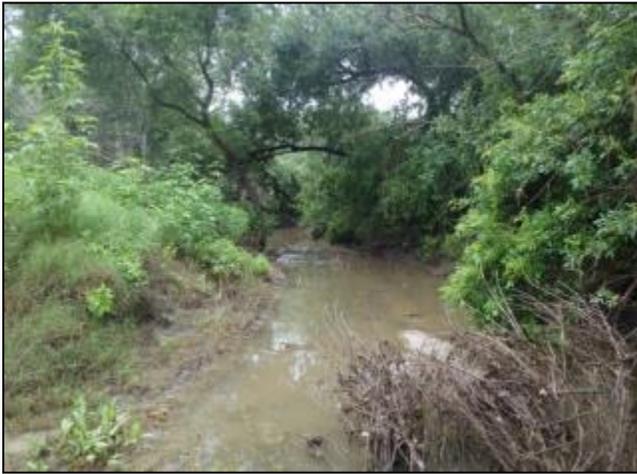
**Figure 4-85.** Downstream view at 0m during Survey 1.

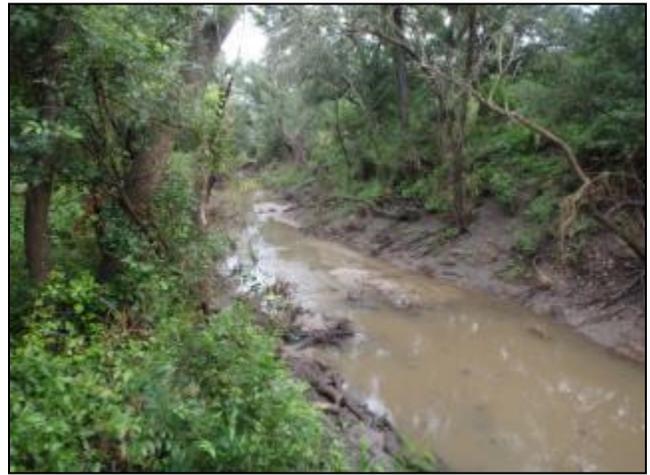
**Figure 4-86.** Downstream view at 300m during Survey 1.

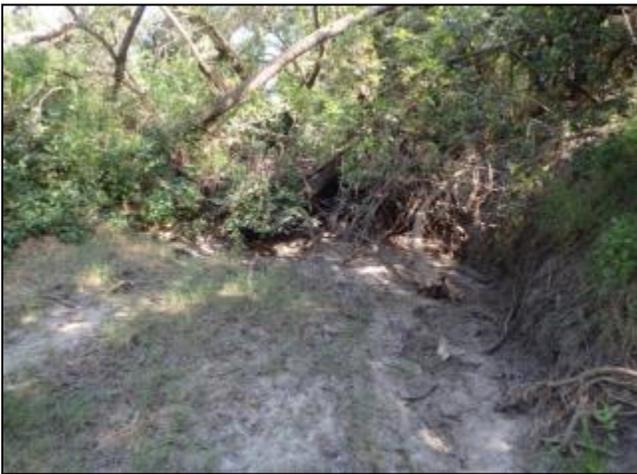
**Figure 4-87.** Upstream view at 0m during Survey 2.

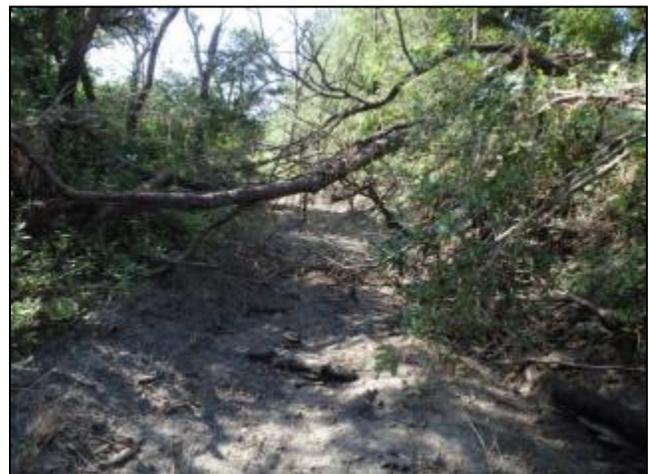
**Figure 4-88.** Downstream view at 150m during Survey 2.

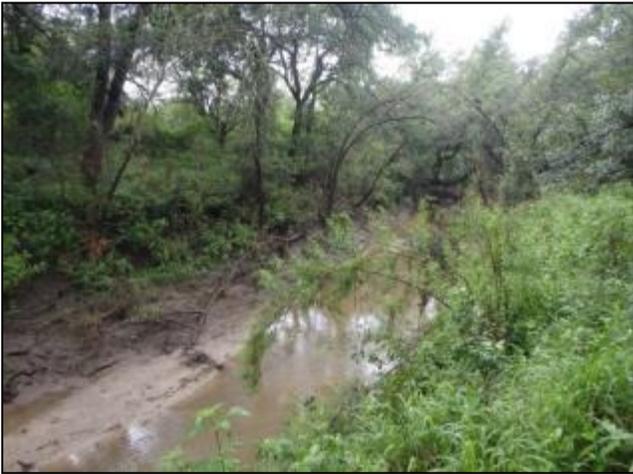
**Figure 4-89.** Upstream view at 0m during Survey 1.

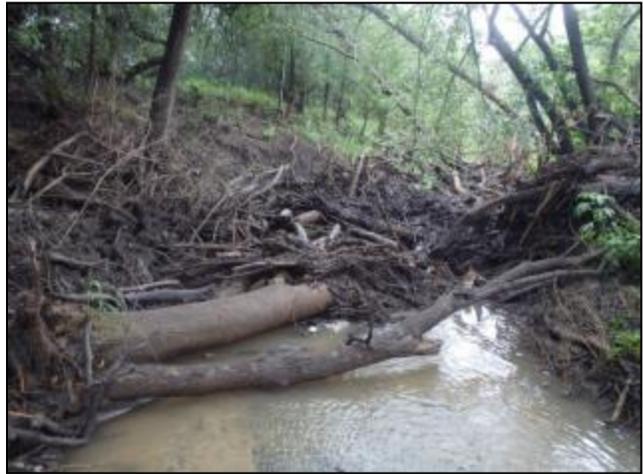
**Figure 4-90.** Downstream view at 300m during Survey 1.

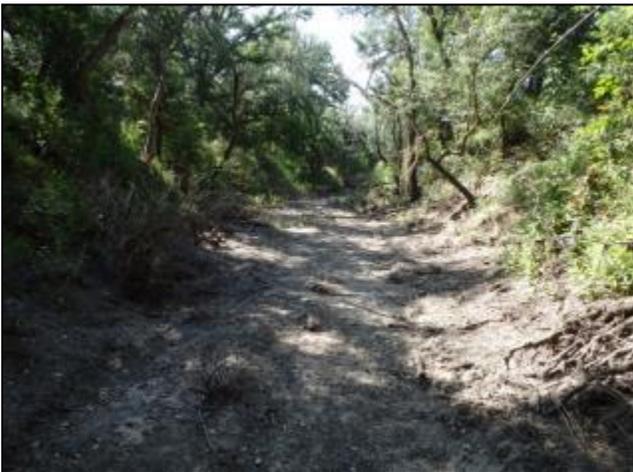
**Figure 4-91.** Downstream view at 0m during Survey 2.

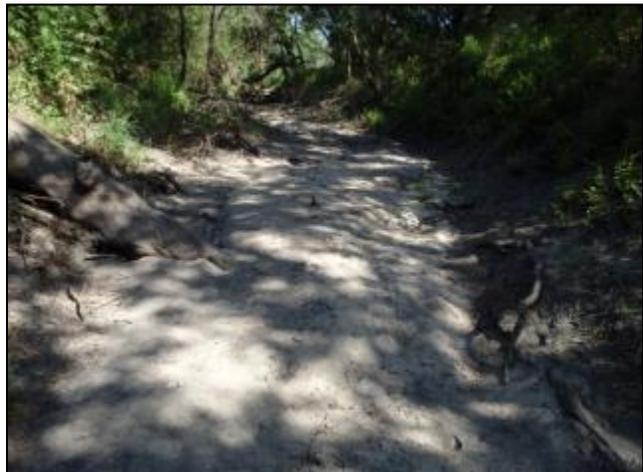
**Figure 4-92.** Upstream view at 300m during Survey 2.

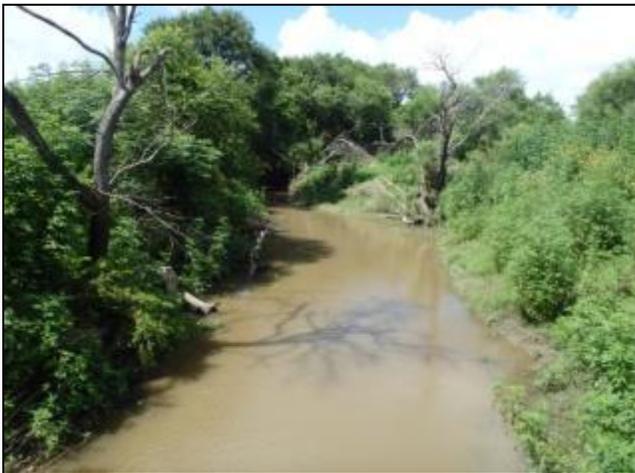
**Figure 4-93.** Downstream view at 0m during Survey 1.

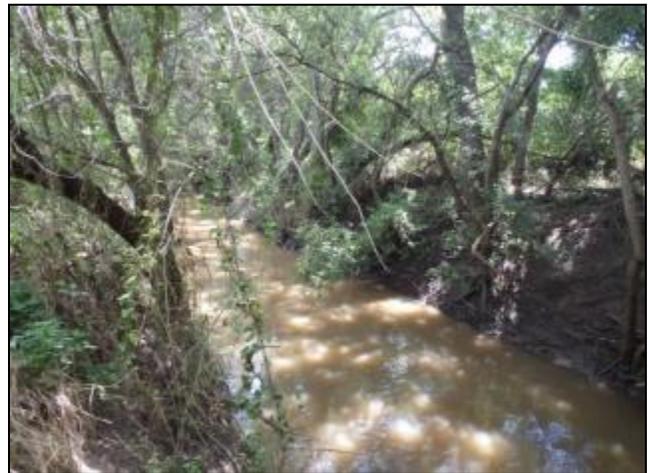
**Figure 4-94.** Upstream view at 300m during Survey 1.

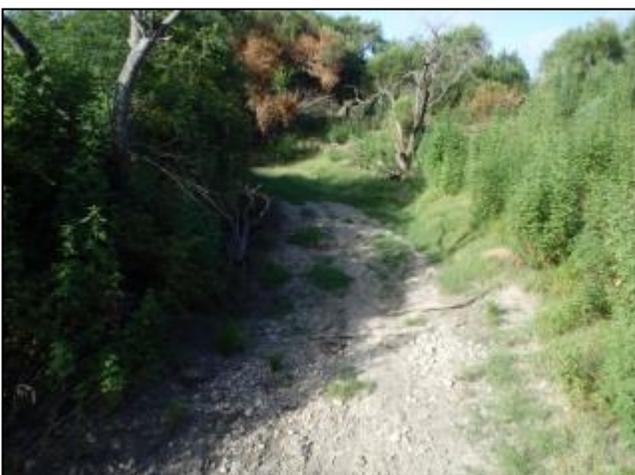
**Figure 4-95.** Downstream view at 0m during Survey 2.

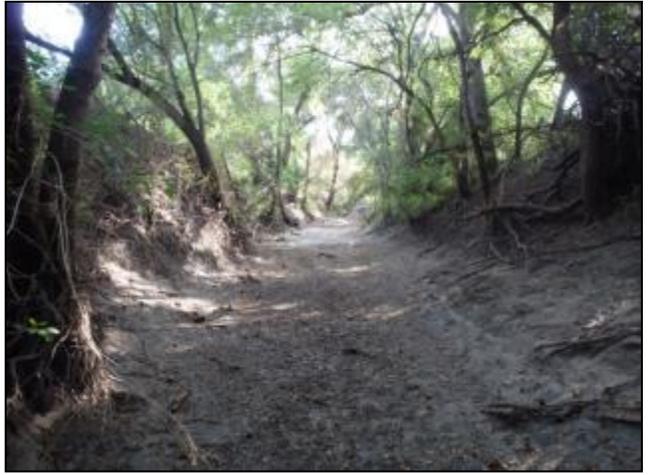
**Figure 4-96.** Upstream view at 150m during Survey 2.

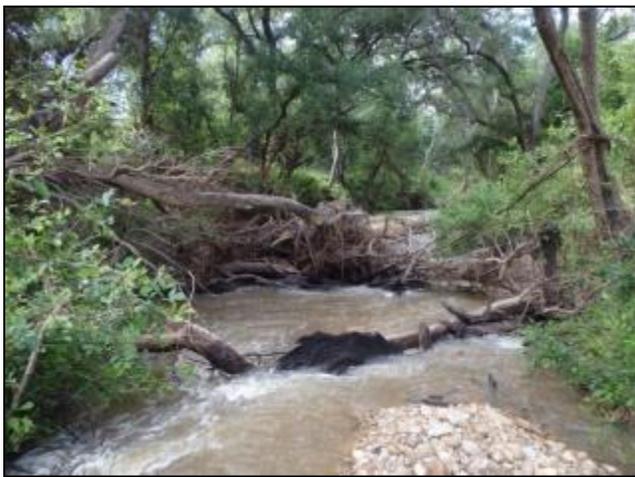
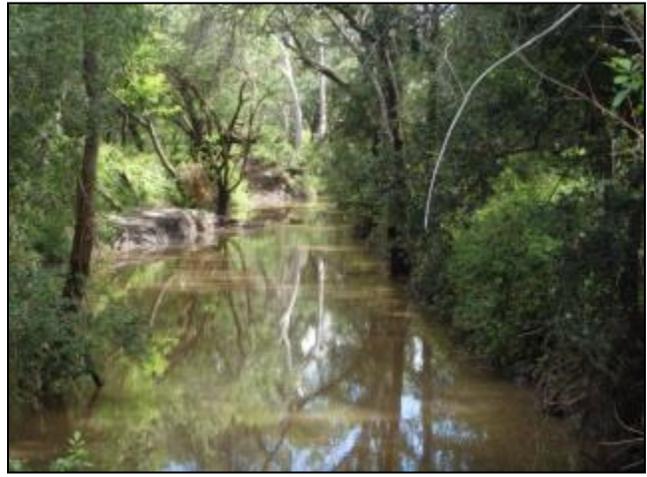
**Figure 4-97.** Downstream view from bridge during Survey 1. **Figure 4-98.** Upstream view from bridge during Survey 1.

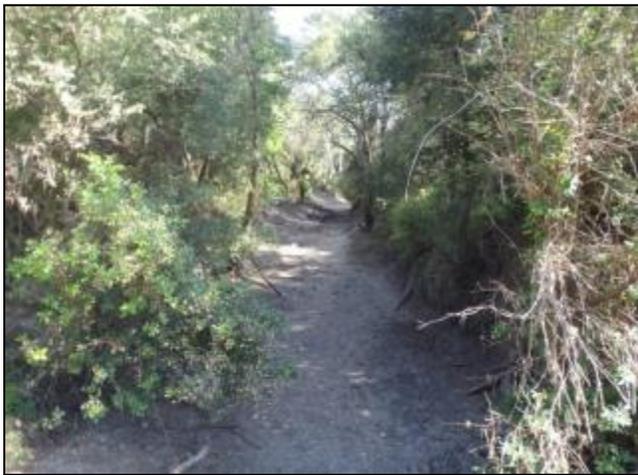
**Figure 4-99.** Upstream view of bridge during Survey 2. **Figure 4-100.** Upstream view of bridge during Survey 2.

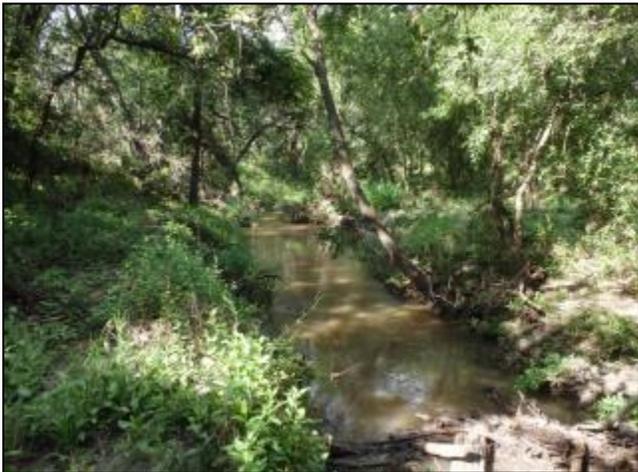
**Figure 4-101.** Downstream view at 150m during Survey 1.

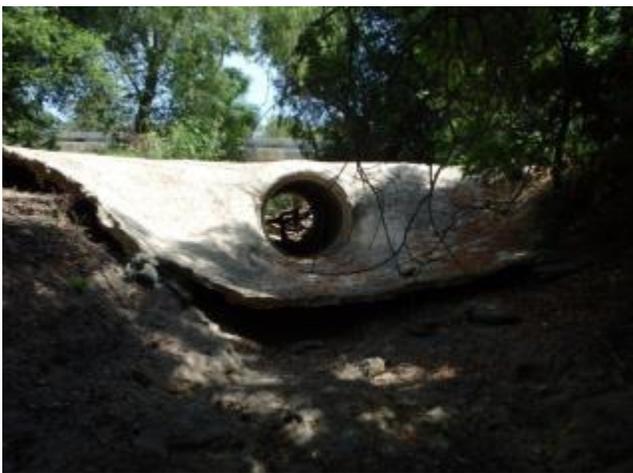
**Figure 4-103.** Upstream view of culvert during Survey 2.

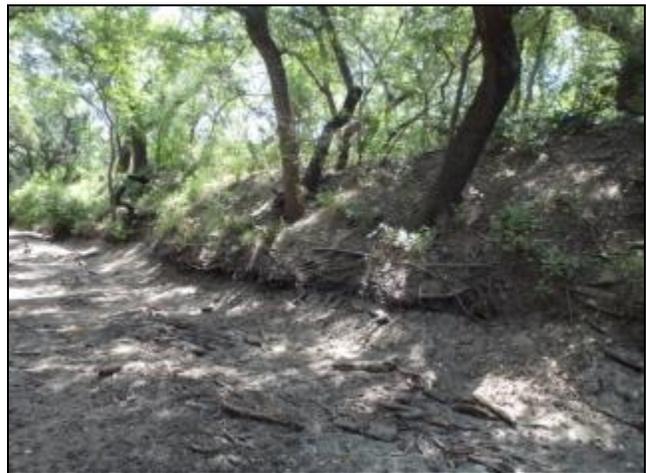
**Figure 4-104.** Right bank view at 300m during Survey 2

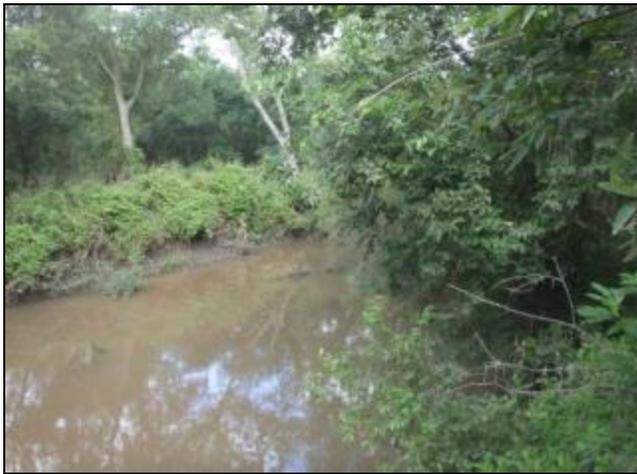
**Figure 4-105.** Upstream view at 150m during Survey 1.

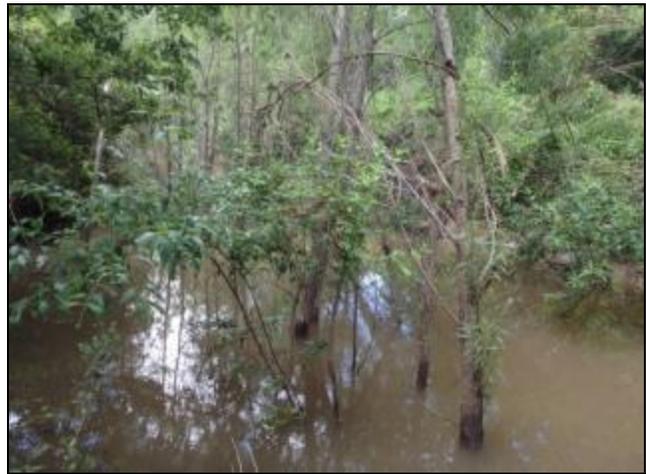
**Figure 4-106.** Downstream view at 0m during Survey 1.

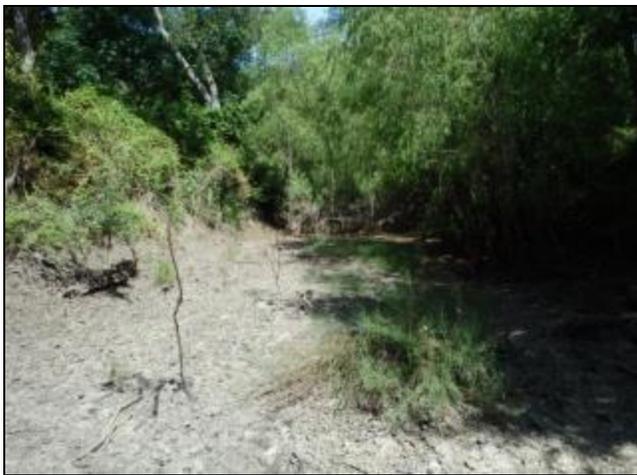
**Figure 4-107.** Upstream view at 150m during Survey 2.

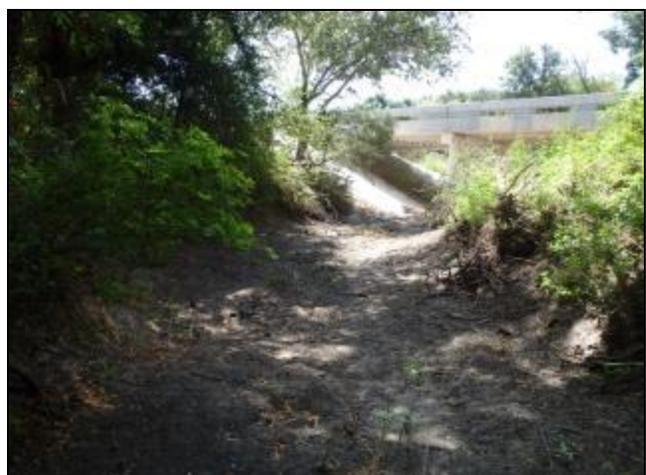
**Figure 4-107.** Downstream view at 300m during Survey 2.
